**Mud Bay Geotechnical Services, LLC**

Subject: Geotechnical Recommendations for Foundation Stabilization  
9007 SE 44<sup>th</sup> St,  
Mercer Island, WA 98040  
Parcel # 759810-0082

Foundation Repair Geotechnical Report

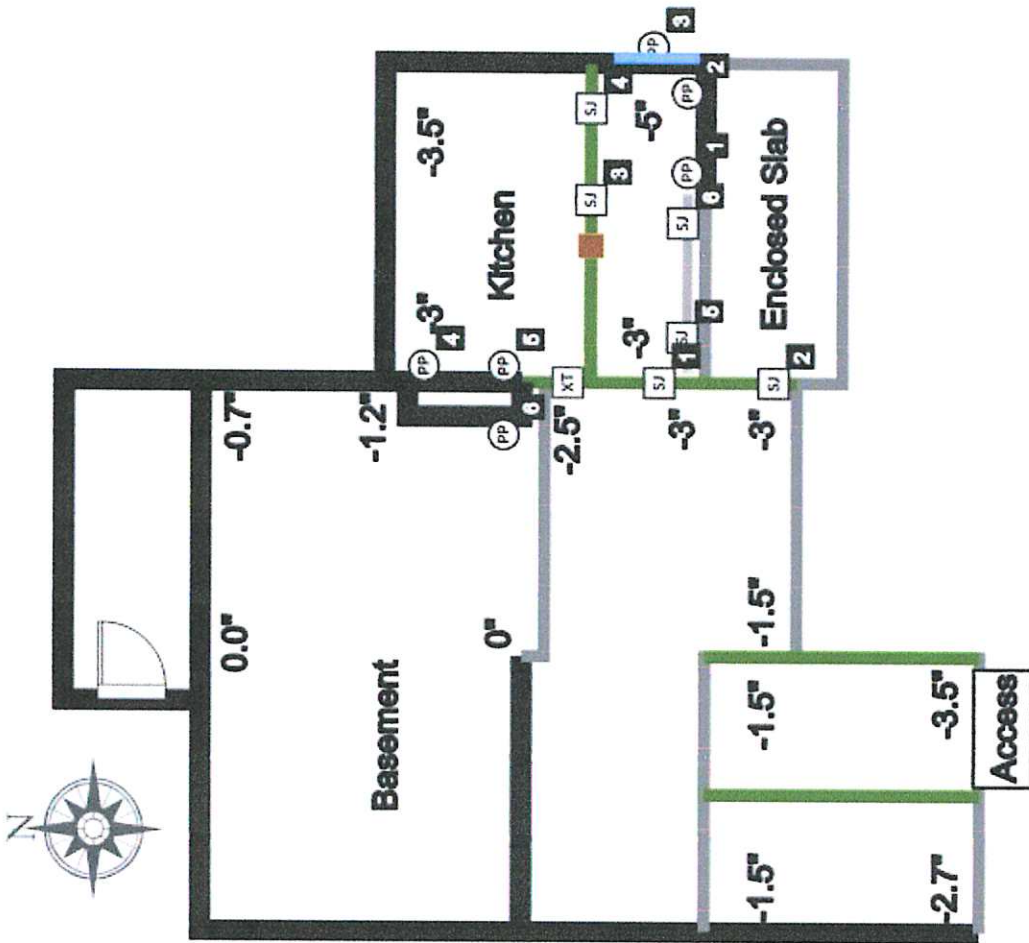
**Figure 2: Matvey Job Details**  
 9007 SE 44th St,  
 Mercer Island, WA 98040  
 Foundation Repair Geotechnical Report

Based on the proposed Foundation/Pier Layout Plan provided by Matvey, we understand the scope of the project to include the installation of 6, 3-inch push piers on the eastern side of the home. The proposed Foundation/Pier Layout plan has been attached to this report as Figure 2, Matvey Job Details.

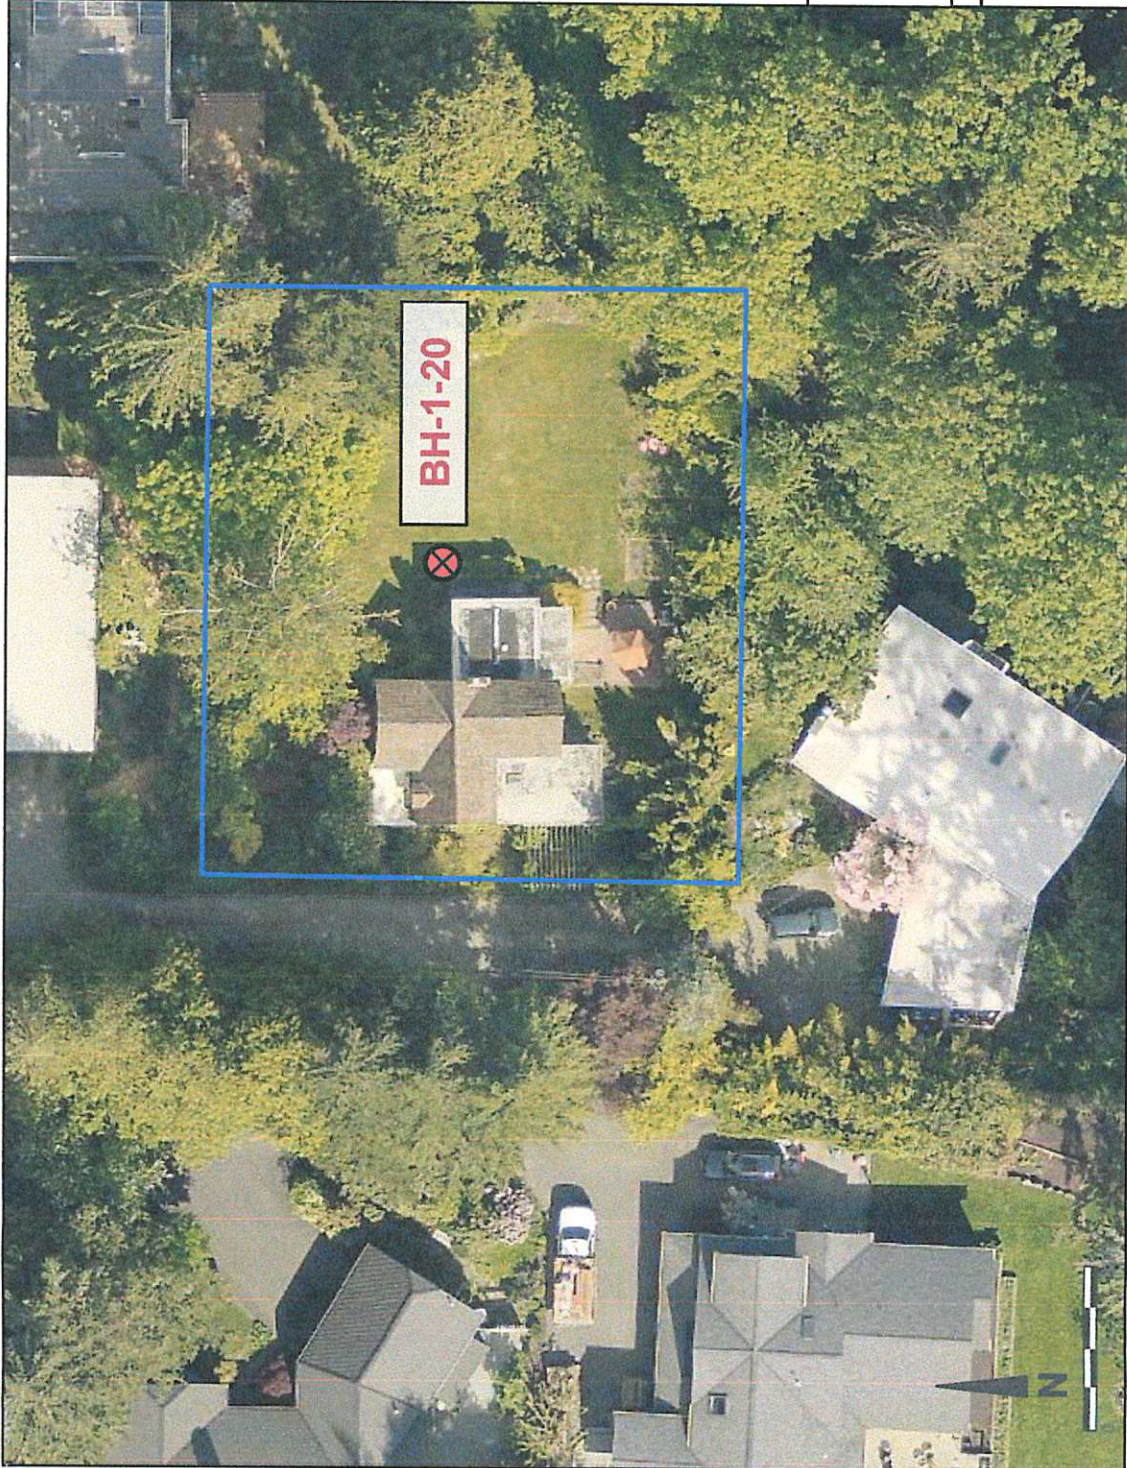
-   Parcel Boundary
-   Boring Location

**Figure 5: Site Exploration Map**  
9007 SE 44th St,  
Mercer Island, WA 98040  
Foundation Repair Geotechnical Report

material from the spoil piles. The approximate location of the boring is shown on the Site Exploration Map attached as Figure 5 in this report.
