**STORMWATER DRAINAGE REPORT**

**WISHWAS SFR REMODEL**  
**8203 Avalon Drive**  
**Mercer Island, WA**

**MERCER ISLAND #: 2505-004**

The proposed project is to remodel a single-family residence. The one-story structure with basement will have its interior taken out and reconfigured while replacing the roof. The existing garage will remain attached via breezeway. The finished structure will be a two-story single-family residence with a basement and detached garage sharing a common roof. No landscaping or additional driveway areas are proposed. Drainage management consists of utilizing the existing tight-line downspout drainage for the roofs.

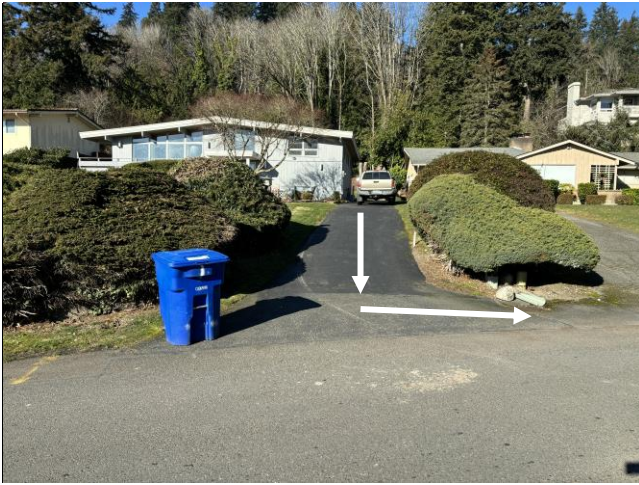
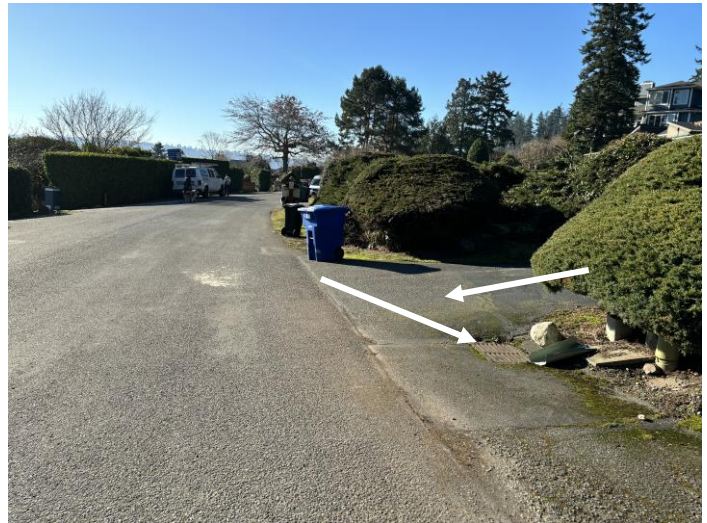
## DOWNSTREAM PHOTOGRAPHS

**PHOTO 1 (left):**  
Looking westerly from  
Avalon Drive

**PHOTO 2 (right):**  
Looking southerly from  
Avalon Drive

Runoff flows tends to down slop to the southern portion of the site uniformly. The driveway stormwater flow is capture in an open grated catch basin. Any other flow from the landscaped yard will also flow onto Avalon Drive flowing towards the same catch basin or the neighboring driveway catch basin to the west. Once surface stormwater flow reaches a catch basin, it continues to flow westerly along Avalon Drive for about 200 feet. It then crosses under Avalon Drive continuing its way between two residential lots through a series of other stormwater infrastructure before terminating at an outfall flowing directly into Lake Washington; the total length of travel is approximately 550 feet. See Figure 2 showing stormwater infrastructure for the surrounding area.
