**NELSON GEOTECHNICAL
ASSOCIATES. INC.**

**Geotechnical Engineering Evaluation – REVISED
Vishy and Madhuri Remodel Seismic Evaluation
8203 Avalon Drive
Mercer Island, Washington
NGA File No. 1579125**

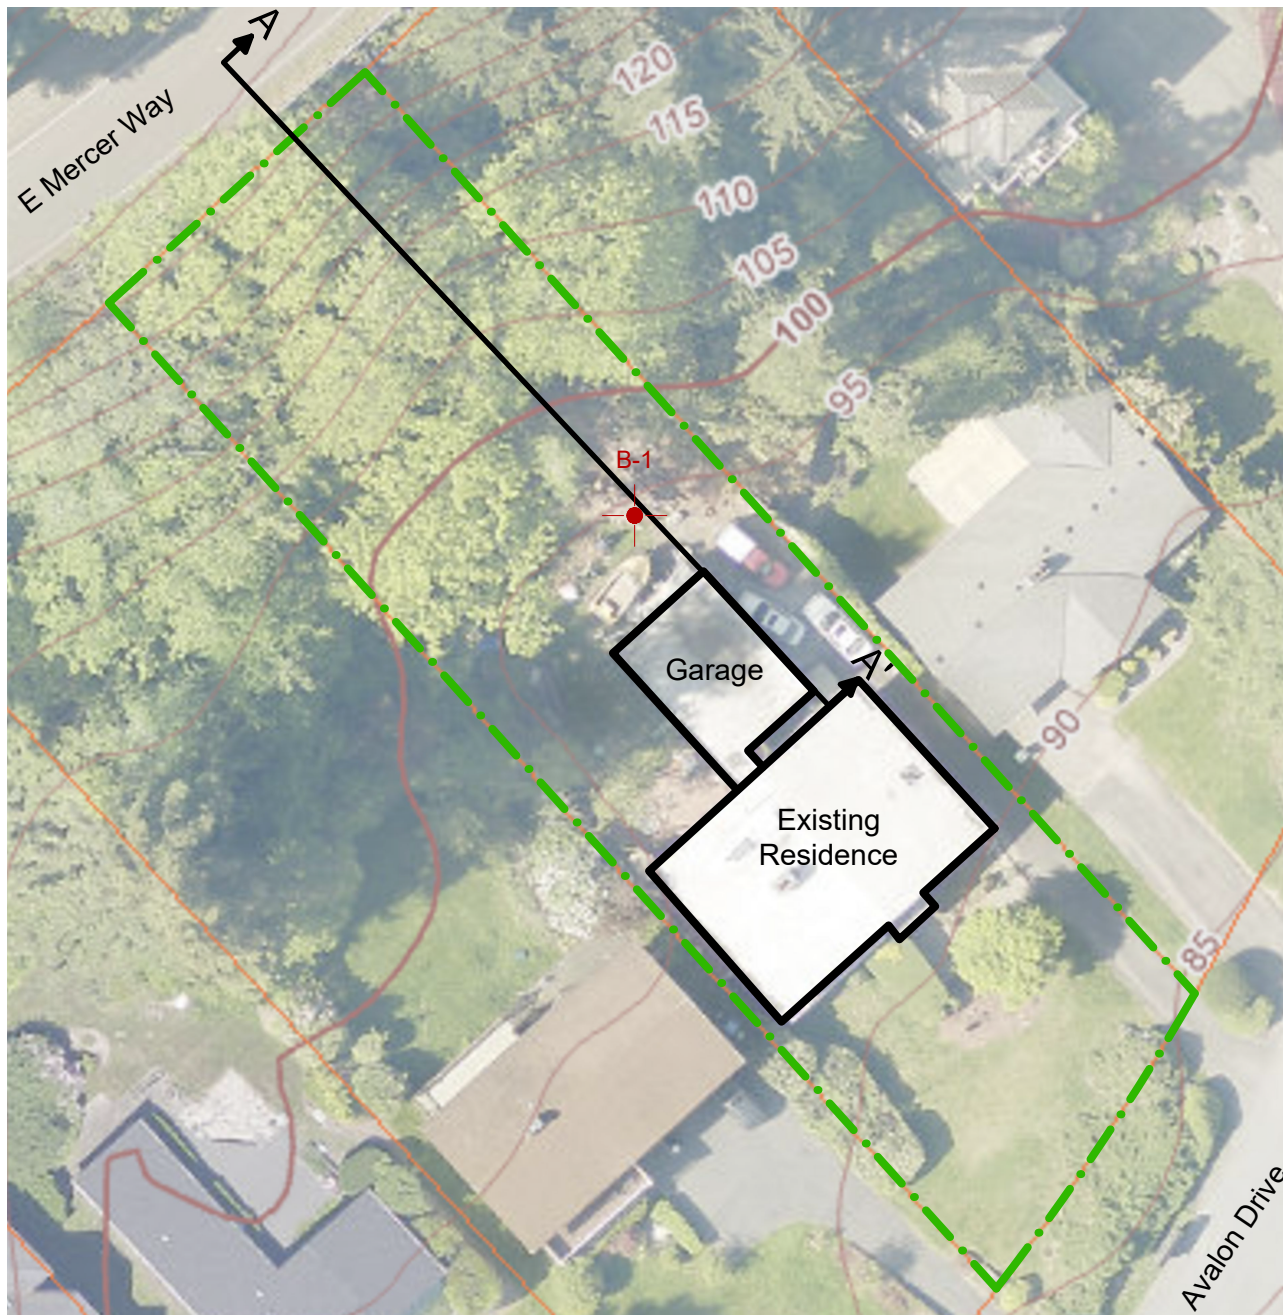
Project Number 1579125	Vishy and Madhuri Remodel Seismic Evaluation Site Plan	  www.nelsongeotech.com	NELSON GEOTECHNICAL ASSOCIATES, INC Woodinville Office 17311-135th Ave. NE, A-500 Woodinville, WA 98072 (425) 486-1669 / Fax: 481-2510	No. 1	Date 3/18/25	Revision Original	By FKS	CK KMS
Figure 2

Site Plan

Reference: Site Plan based on field measurements, observations, and aerial parcel map review.

The site is currently occupied by a single-family residence and garage in the central portion. The property is bordered by Avalon Drive to the southeast, East Mercer Way to the northwest, and neighboring residential properties on all other sides. Topographically, a majority of the site is relatively level to gently sloping and contains a moderate to steep slope within the northwestern portion of the site. We understand that plans for development include remodeling the existing residence and garage. We also understand that the majority of the existing foundations will remain. The City of Mercer Island has requested a geotechnical report to address the mapped seismic hazard that covers the property. The proposed site development is presented on the attached Site Plan in Figure 2.

Explorations: The subsurface conditions within the site were explored on March 17, 2025, by monitoring the drilling of a geotechnical boring that extended to a depth of 36.5 feet below the existing ground surface. The approximate location of the explorations is shown on the Site Plan in Figure 2. A geologist from Nelson Geotechnical Associates, Inc. (NGA) was present during the explorations, examined the soils and geologic conditions encountered, obtained samples of the soil, and maintained logs of the explorations.

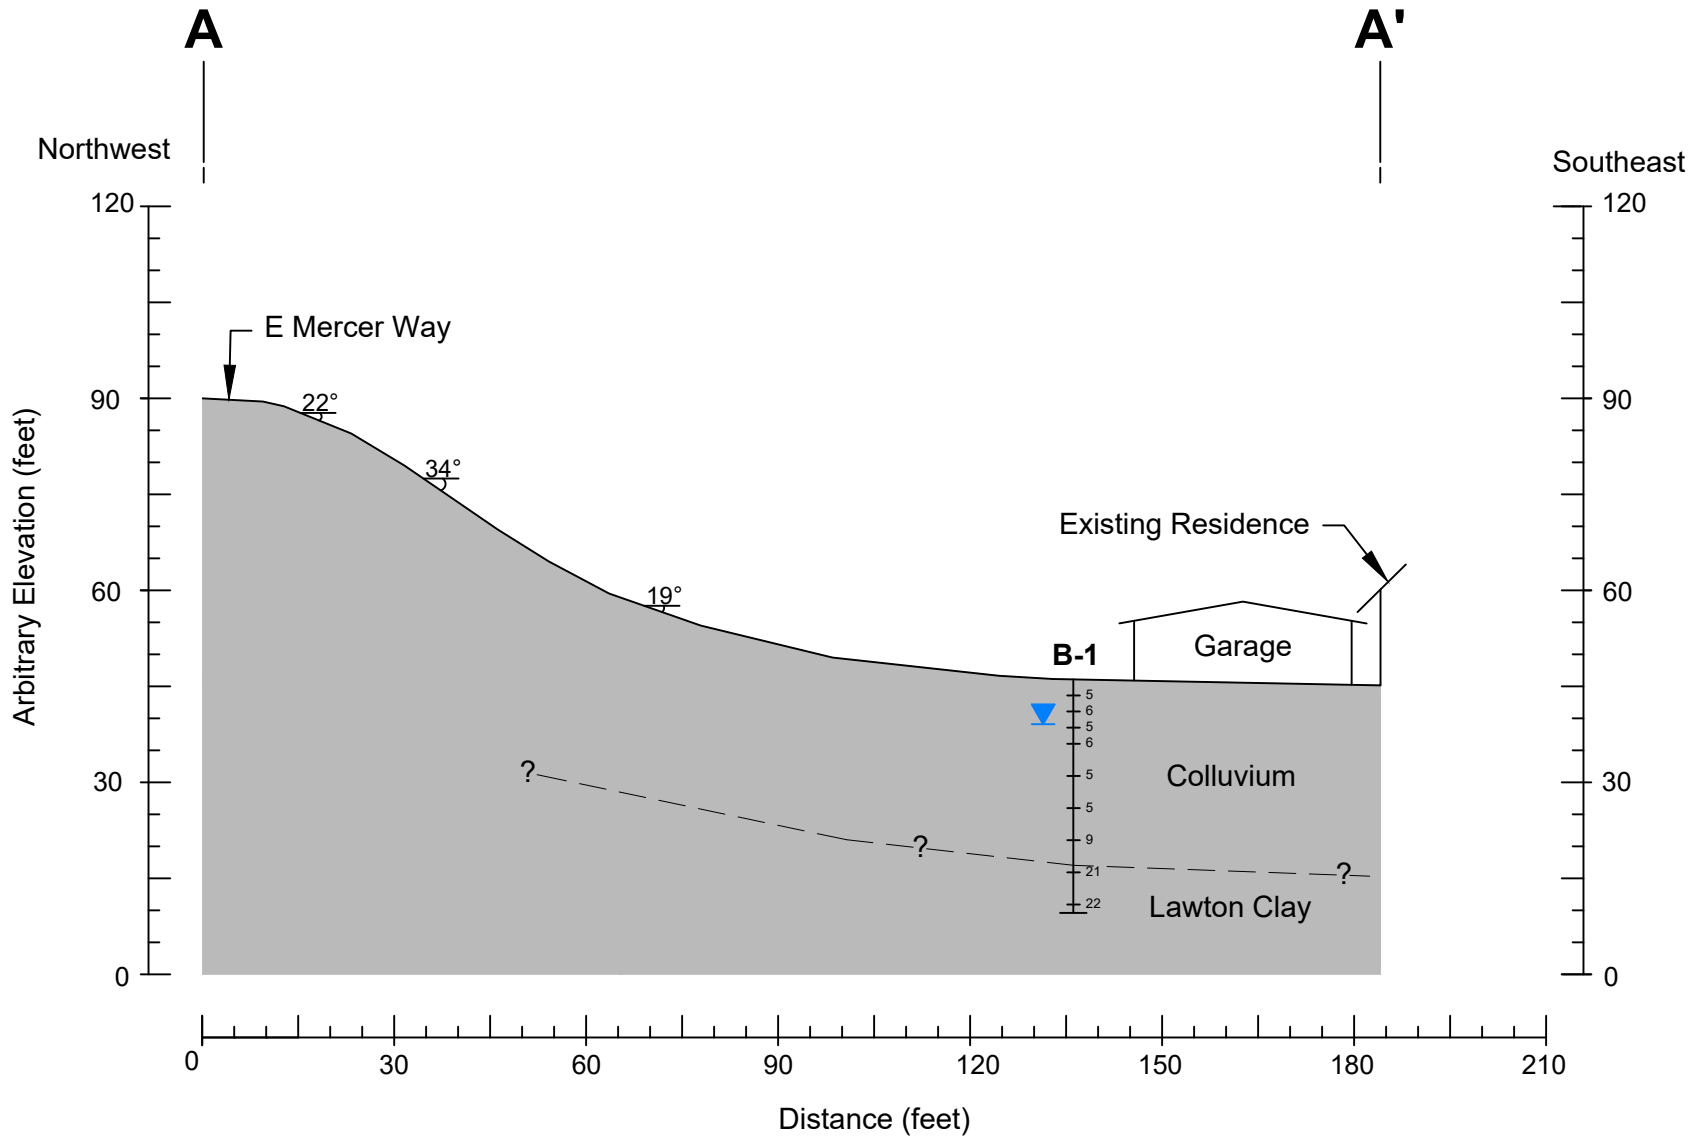
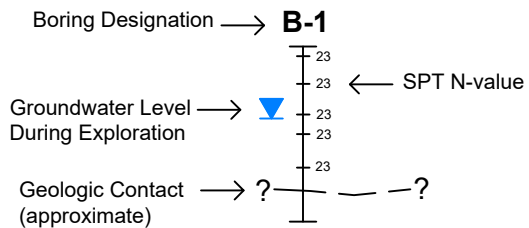
Exploration

- NOTES:
- 1) Stratigraphic conditions are interpolated between the explorations. Actual conditions may vary.
 - 2) Elevations are arbitrary.

Reference: Cross Section is based on field measurements using a hand-held clinometer and 100-ft tape measure.

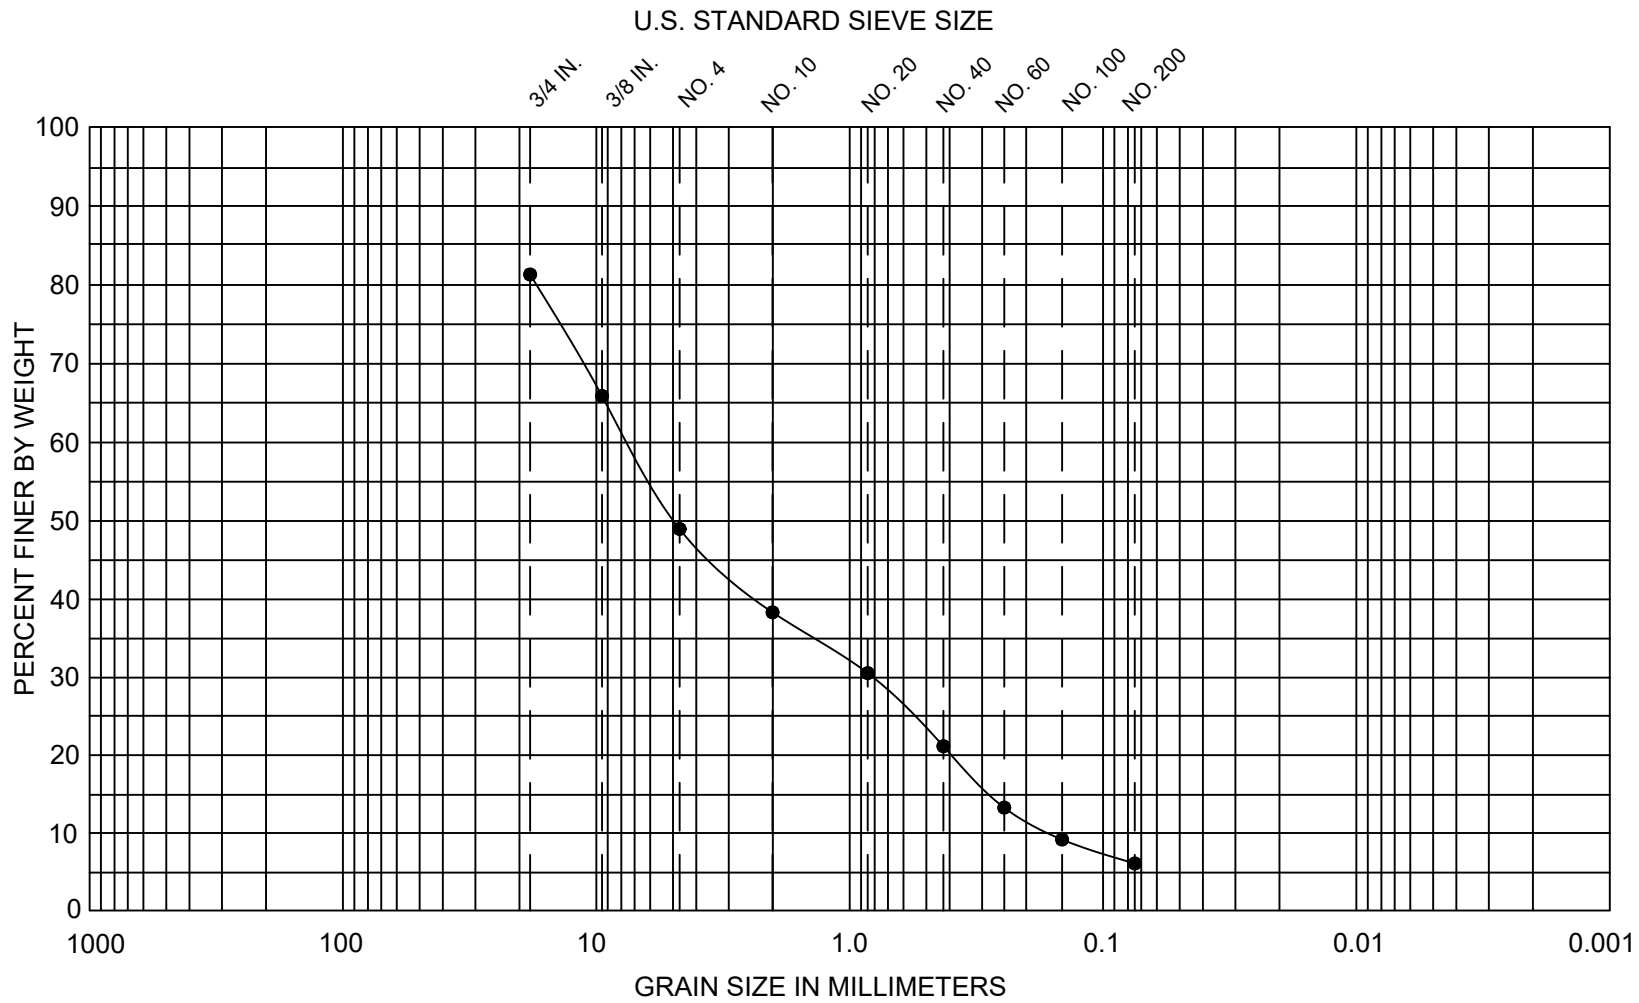
Figure 6

U.S.C. SYMBOL	EXPLORATION NUMBER	SAMPLE DEPTH	SOIL DESCRIPTION	SOIL DISTRIBUTION
●GP-GM	B-1	7.5 feet	Gray, gravelly, fine to coarse sand with silt	Gravel = 51% Sand = 43% Silt/Clay = 6%

Grain-size Analysis: We performed grain-size distribution analyses on four samples from on samples from Boring One at depths of 7.5, 15.0, 20.0, and 35.0 feet. The results of the grain-size analysis are presented in Figures 6 through 9.

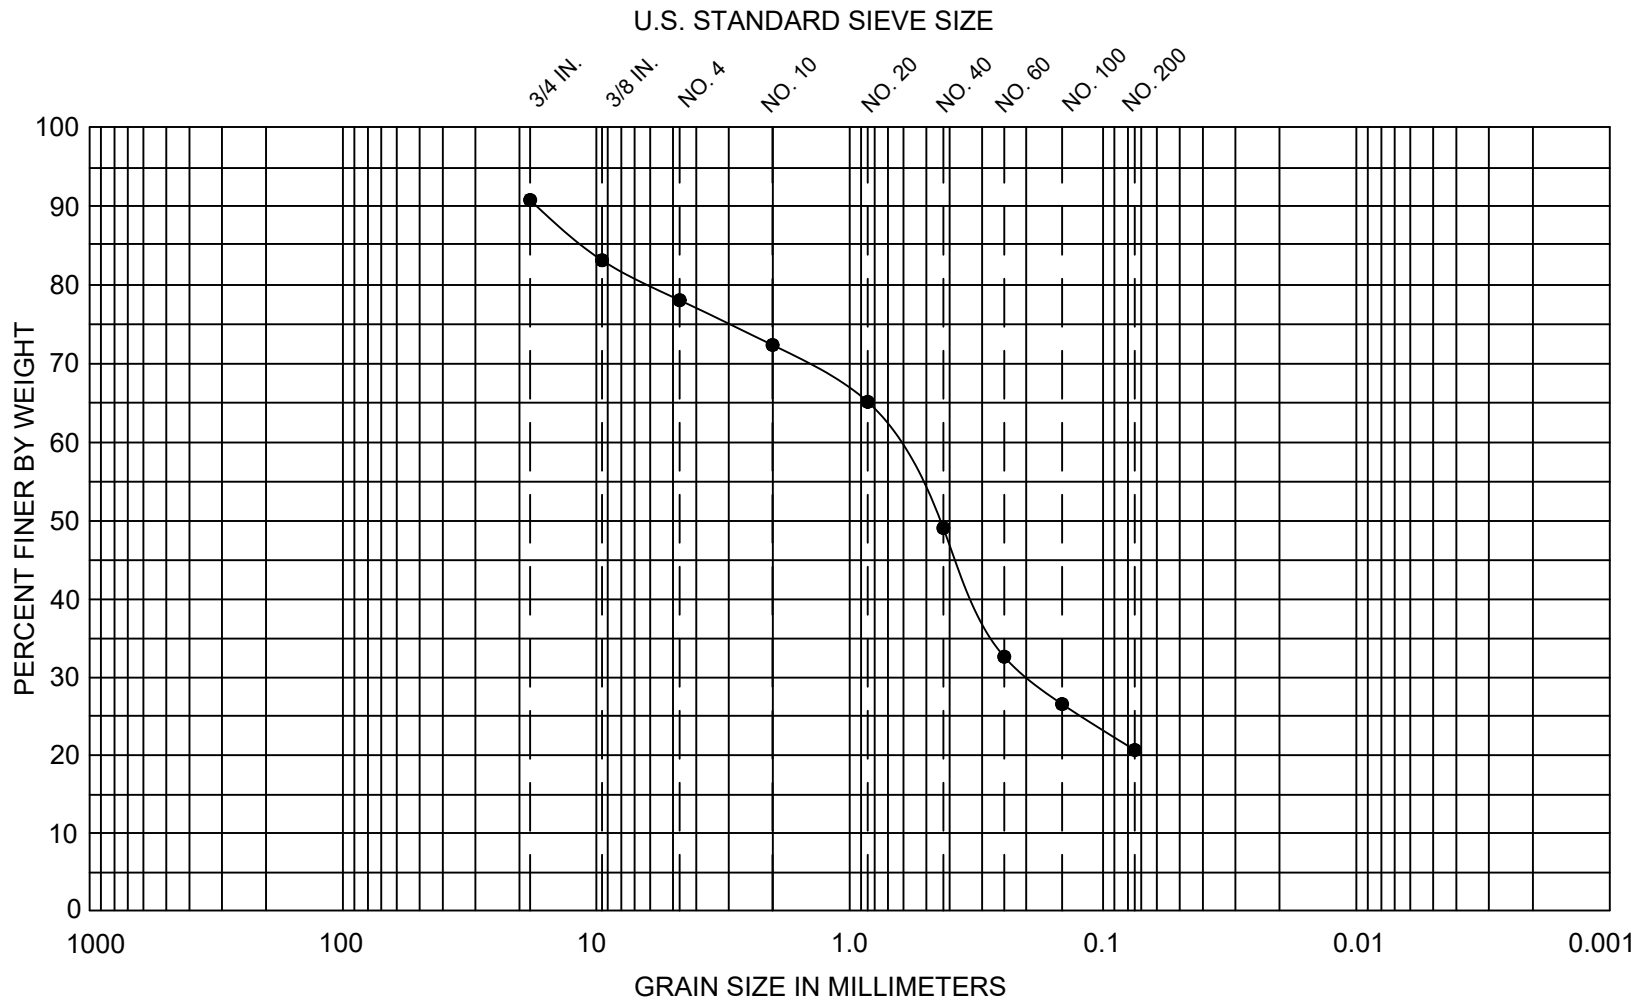
Project Number	1579125
	Figure 7

U.S.C. SYMBOL	EXPLORATION NUMBER	SAMPLE DEPTH	SOIL DESCRIPTION	SOIL DISTRIBUTION
●SM	B-1	15.0 feet	Gray, silty, fine to medium sand with gravel and iron-oxide staining	Gravel = 22% Sand = 57% Silt/Clay = 21%

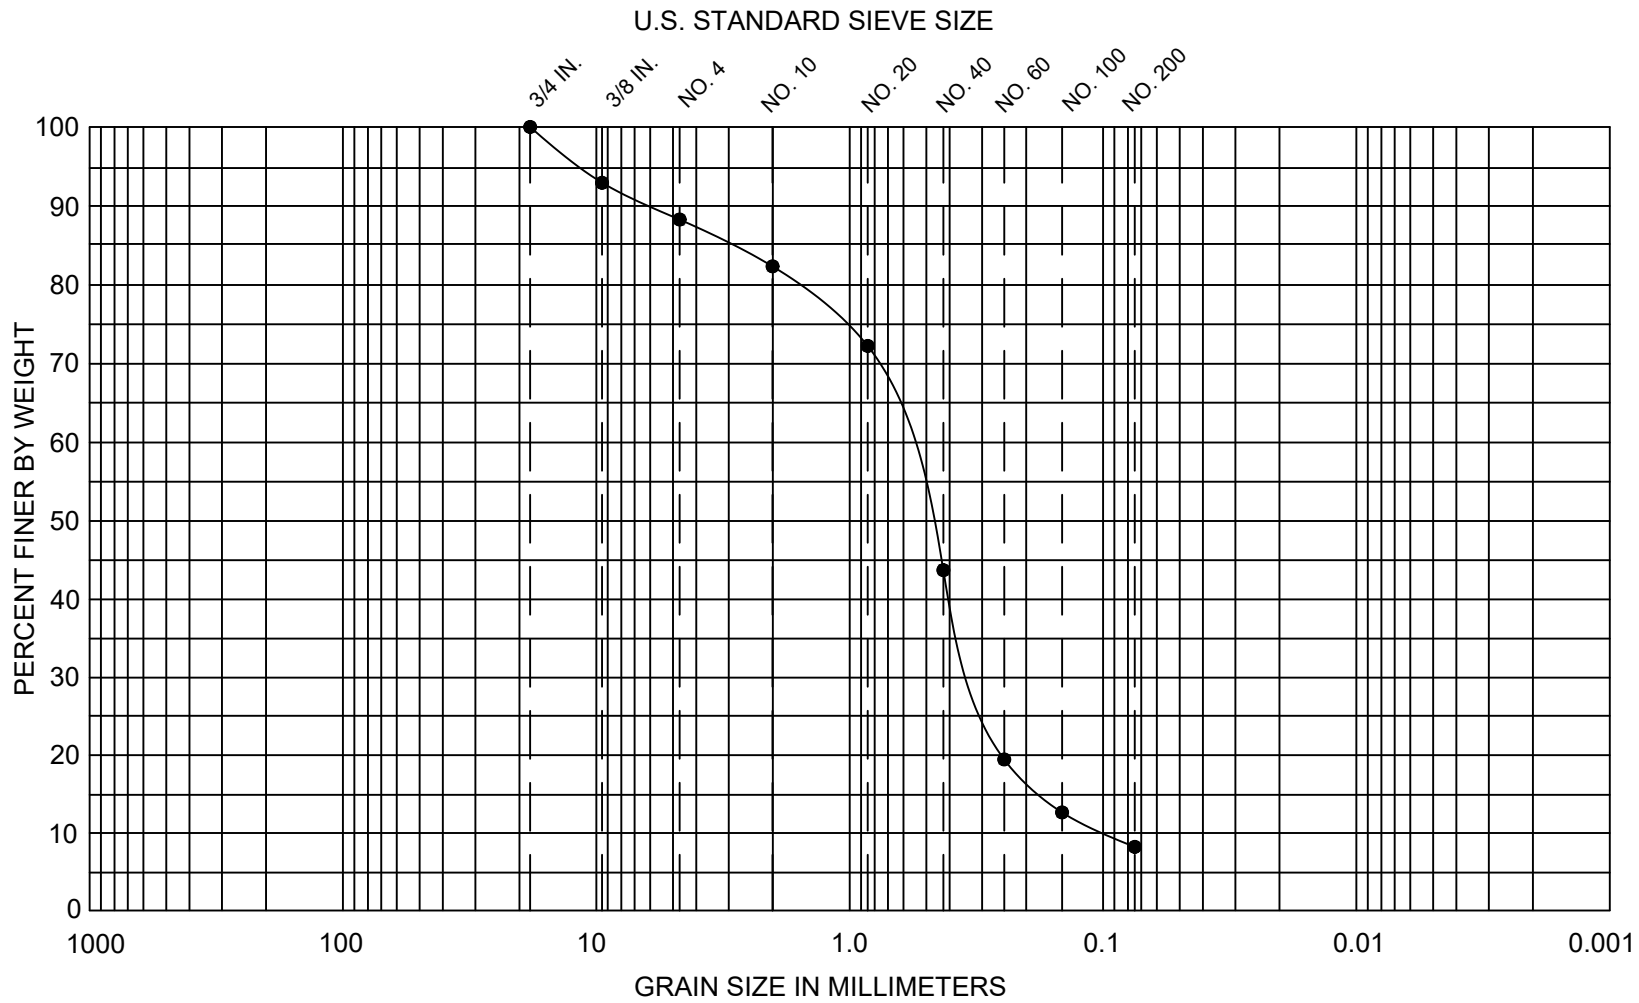
Project Number	1579125
Figure	8

U.S.C. SYMBOL	EXPLORATION NUMBER	SAMPLE DEPTH	SOIL DESCRIPTION	SOIL DISTRIBUTION
●SP-SM	B-1	20.0 feet	Gray, fine to medium sand with gravel and silt	Gravel = 12% Sand = 80% Silt/Clay = 8%

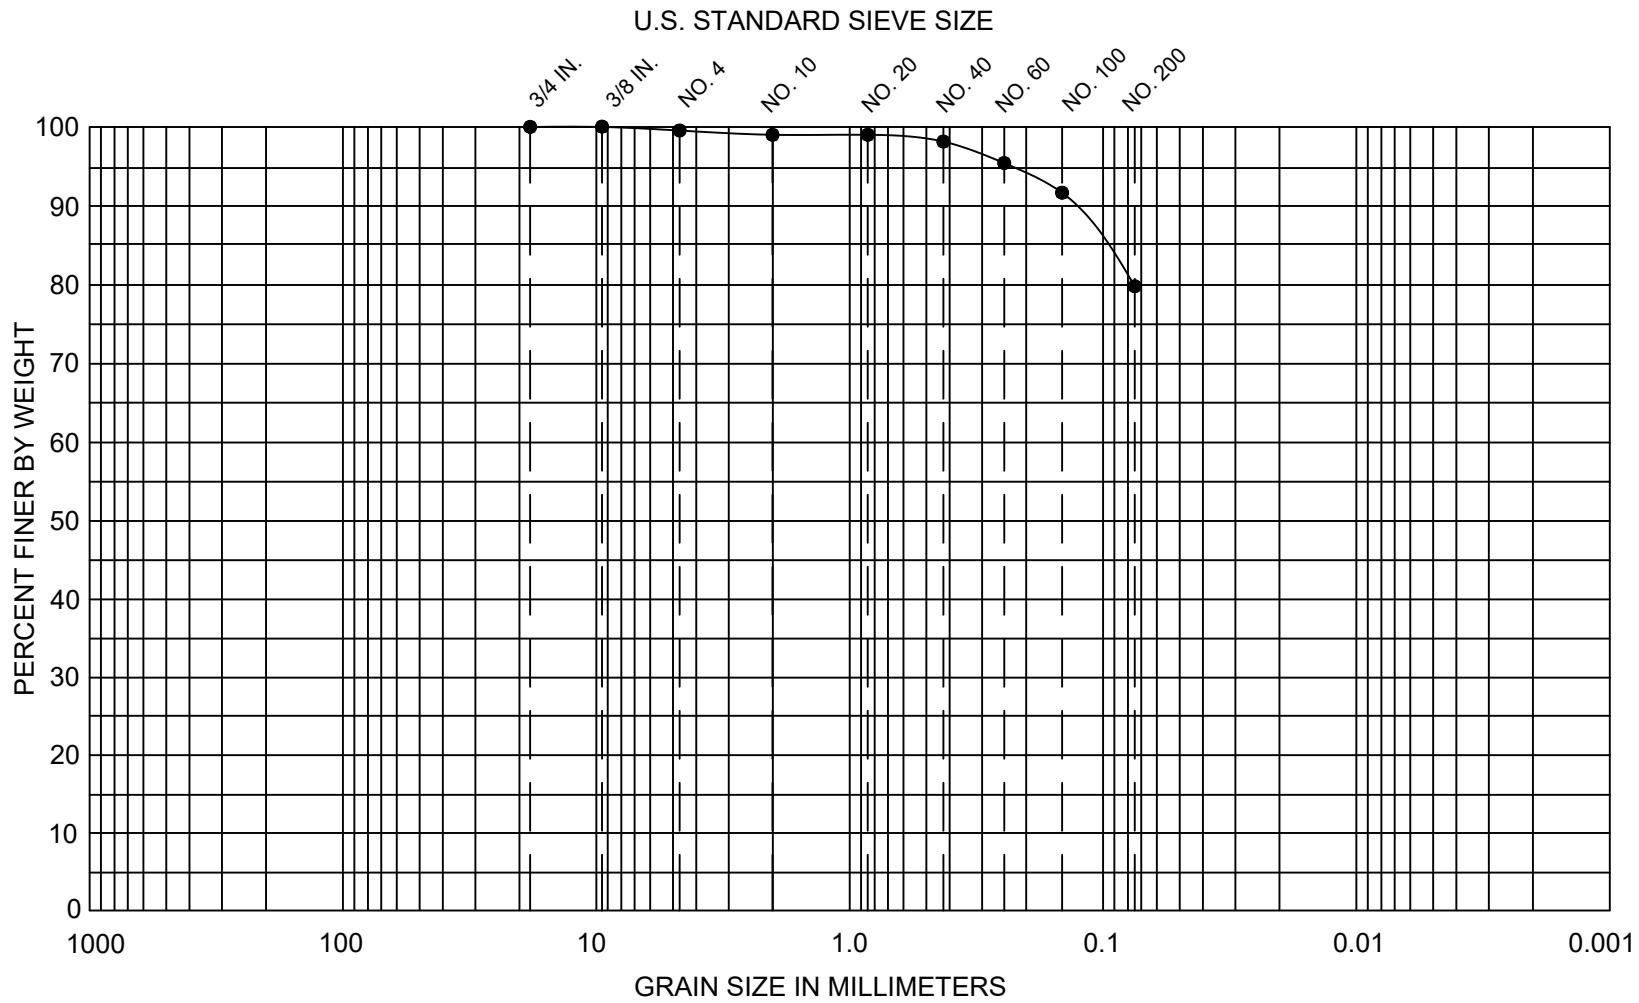
U.S.C. SYMBOL	EXPLORATION NUMBER	SAMPLE DEPTH	SOIL DESCRIPTION	SOIL DISTRIBUTION
●ML	B-1	35.0 feet	Gray, silt with fine sand	Gravel = 0% Sand = 20% Silt/Clay = 80%

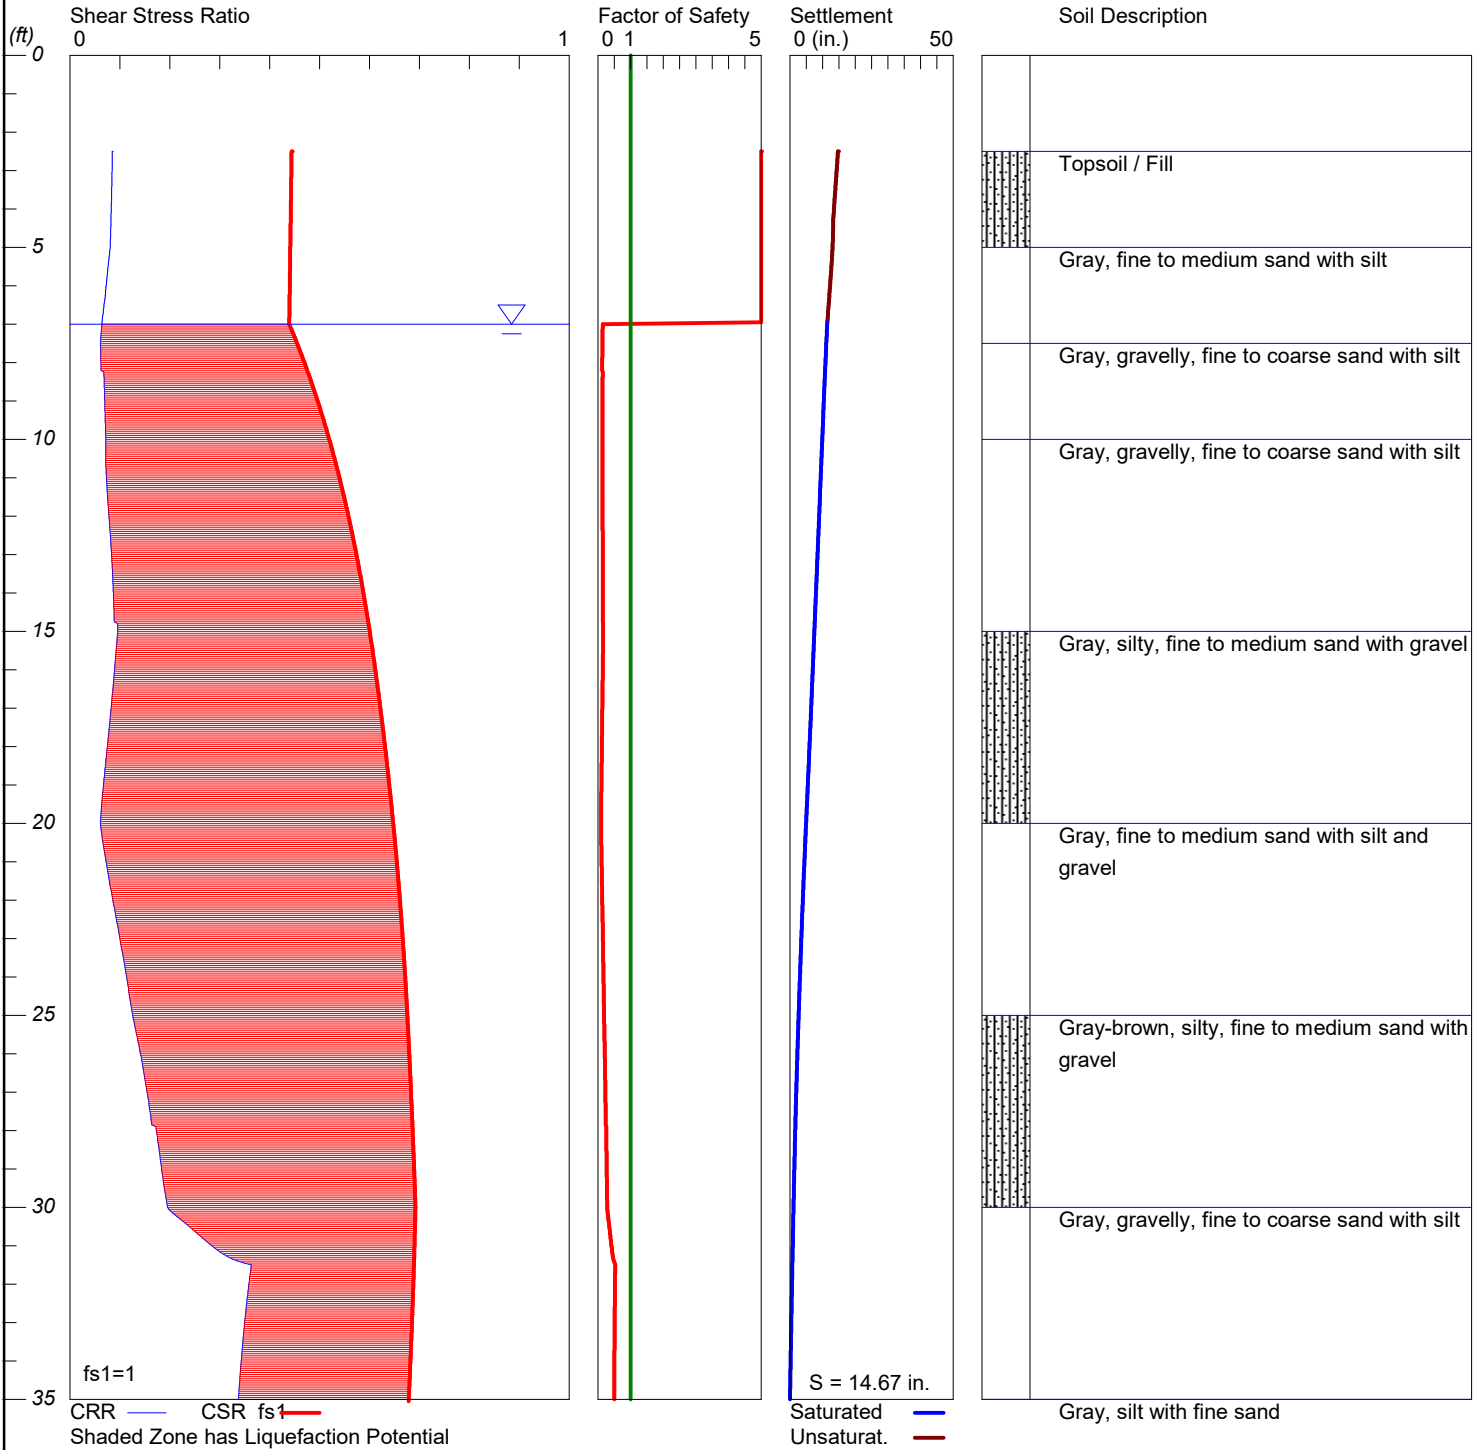
Hole No.=1 Water Depth=7 ft

Magnitude=8
Acceleration=0.687g

LiquefyPro CivilTech Software USA www.civiltch.com
