Subject: **Updated Geotechnical Engineering Study**  
Proposed Property Redevelopment  
8203 Avalon Drive  
Mercer Island, Washington

Reference: *Geotechnical Engineering Evaluation, Vishy and Madhuri Remodel Seismic Evaluation, 8203 Avalon Drive, Mercer Island, Washington, NGA File No. 1579125*; Nelson Geotechnical Associates; March 28, 2025.

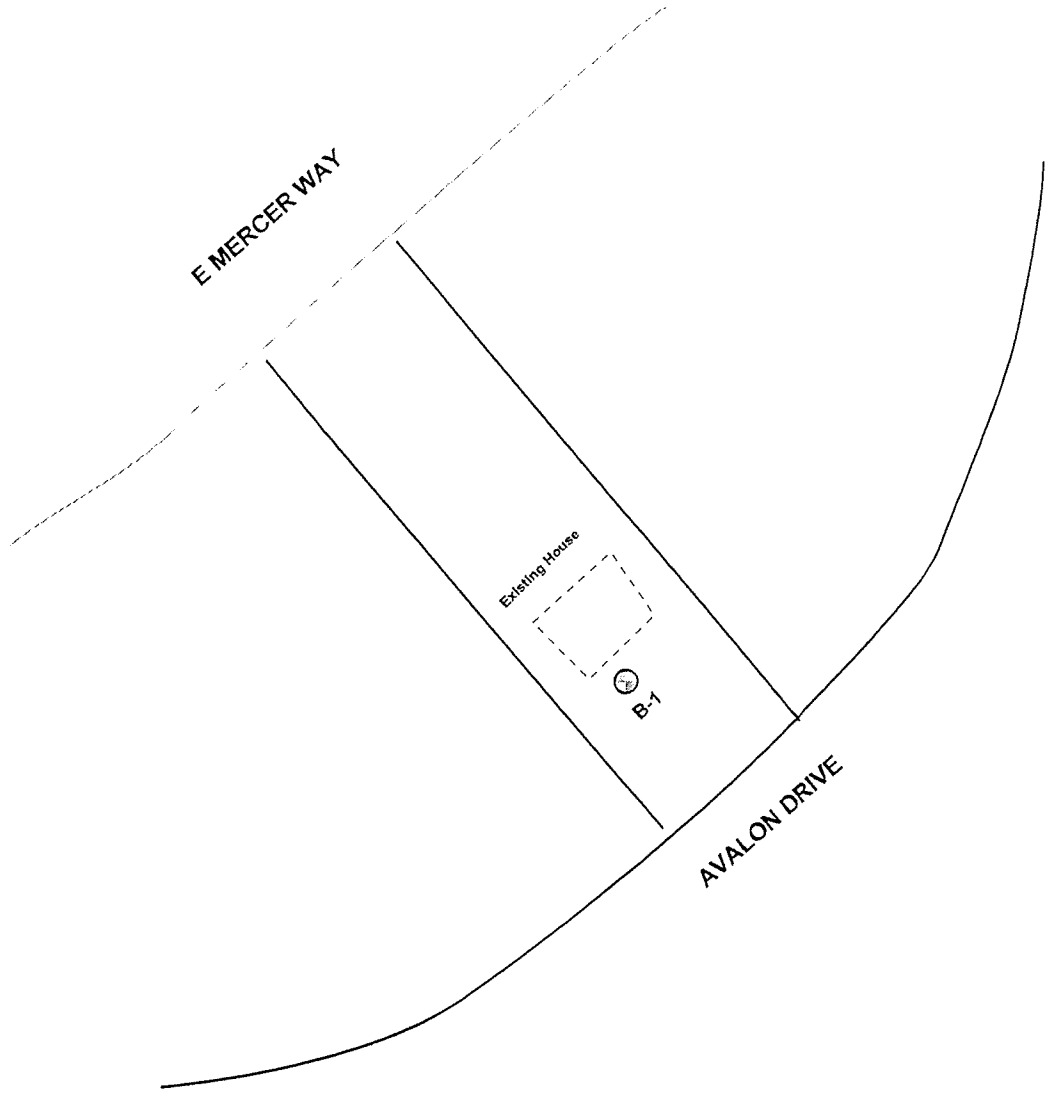
**8211 Avalon Drive**

**Mercer Island, Washington**

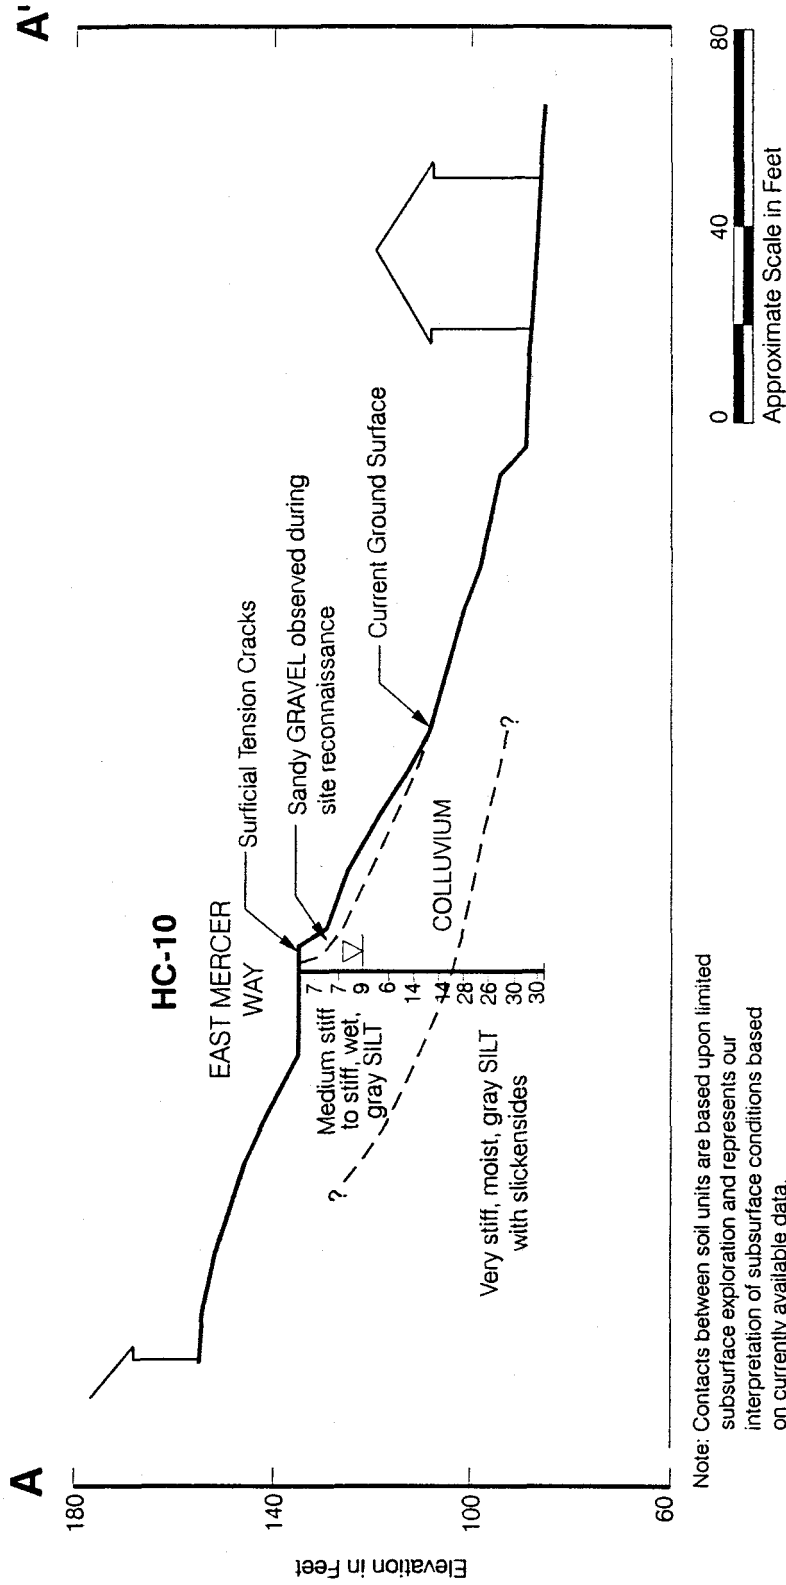
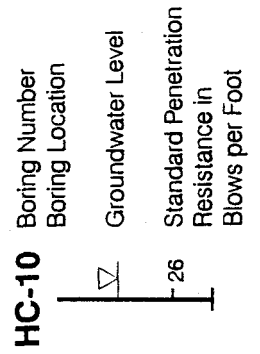
# Generalized Subsurface Cross Section A-A'

## 8250 East Mercer Way

Note: Contacts between soil units are based upon limited subsurface exploration and represents our interpretation of subsurface conditions based on currently available data.

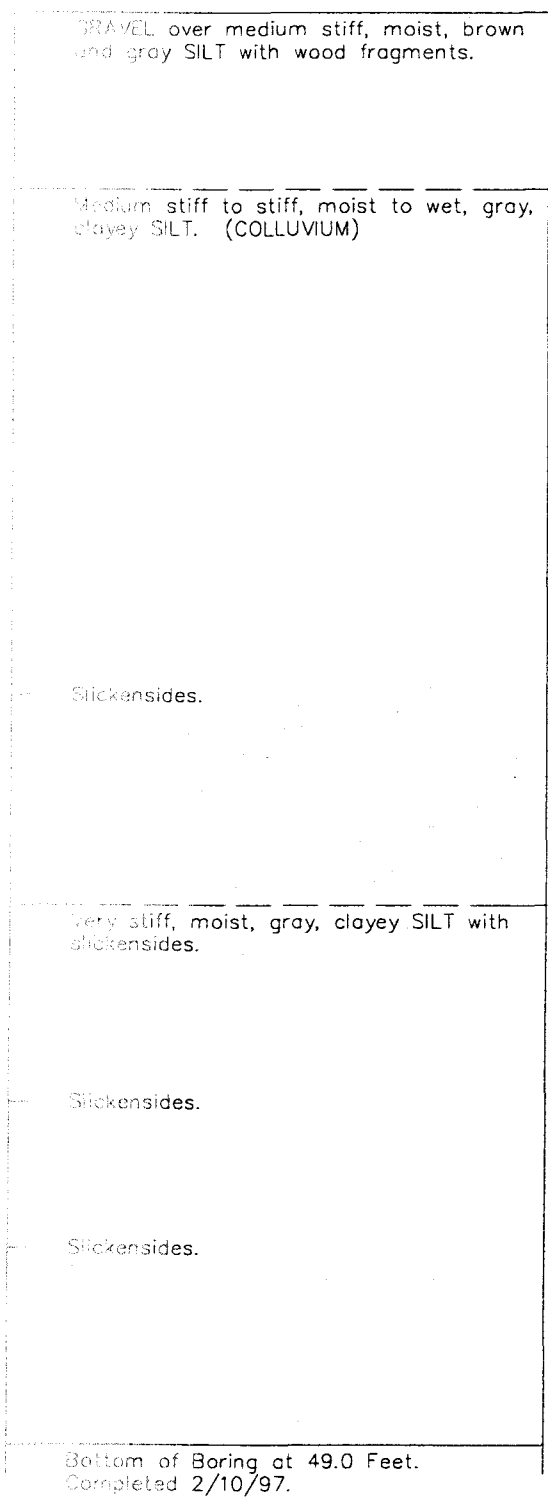
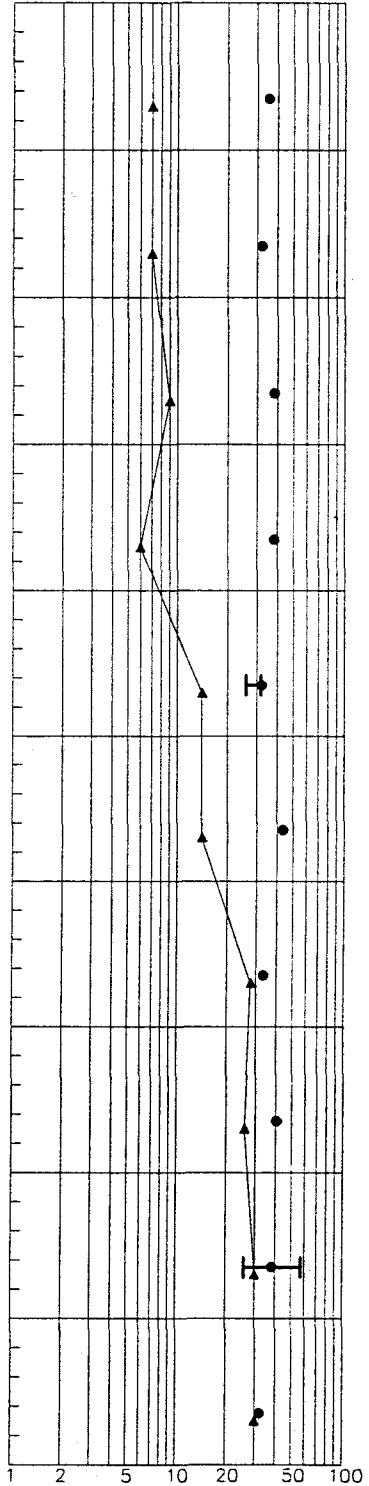
# Boring Log HC-100

## Soil Descriptions

HC-100A

▲ Blows per Foot

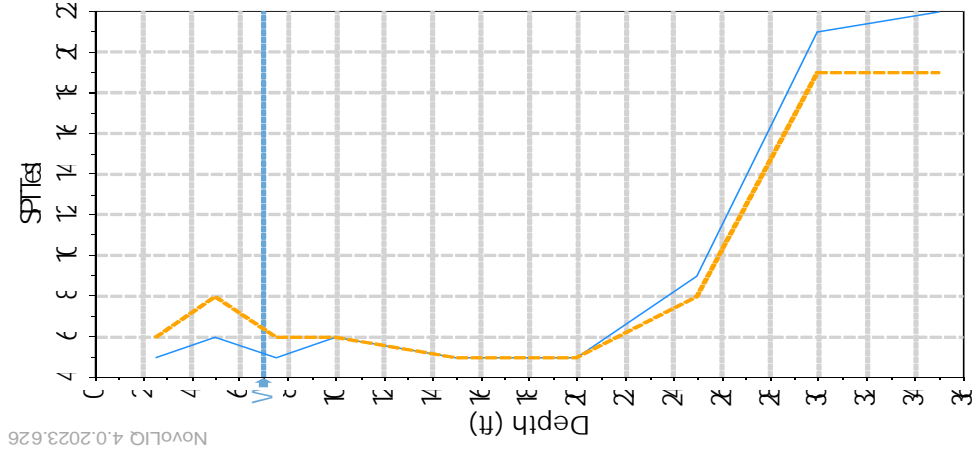
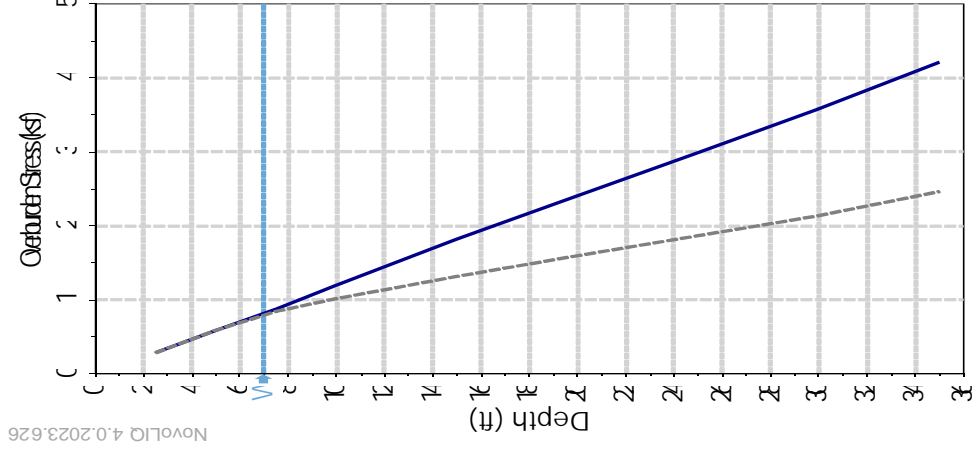
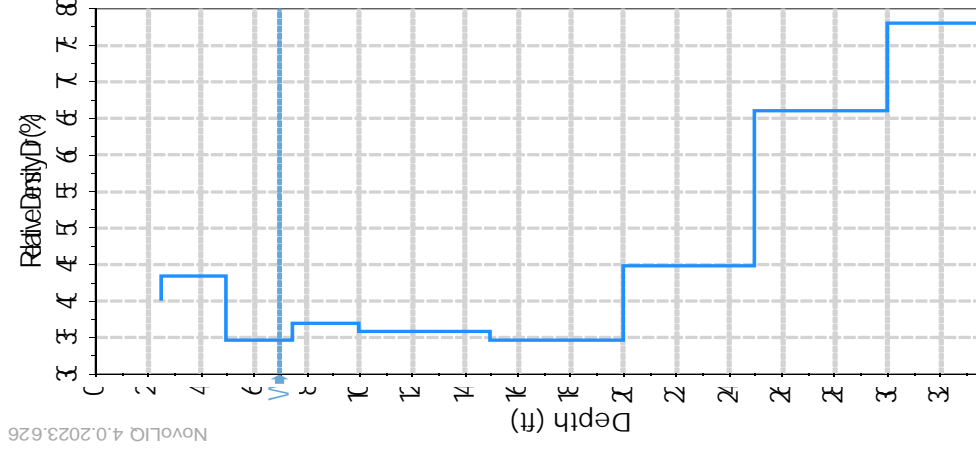
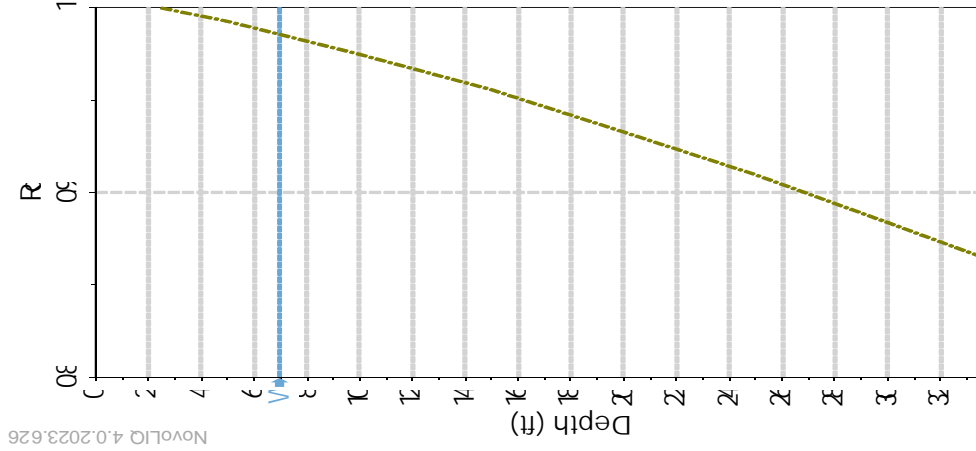
Input Assumption	Setting
Field Test Type :	Standard Penetration Test (SPT)
Apply All Corrections to SPT?	True
Groundwater Level (ft) =	7
Earthquake Magnitude M =	7.1
Magnitude Scaling Factor (MSF) :	1.15 (Idriss, 1997 -NCEER)
Fines Content Correction :	(according to user settings)
Depth Reduction Factor (Rd) :	Idriss 1999, Golesorkhi 1989
Relative Density (Dr) Estimation :	Idriss & Boulanger, 2003
Site Topography :	Gently Sloped : 3 %
Ground Improvement Feature :	None
Peak Ground Acceleration PGA (g) =	0.687

CRR Formula	Selected?
NCEER Workshop (1997)	True
Boulanger & Idriss (2014)	True
Vancouver Task Force (2007)	False
Cetin et al. (2004)	False
Chinese Code	False
Seed et al. (1983)	False
Japanese Highway Bridge Code	False
Tokimatsu and Yoshimi (1983)	False
Shibata (1981)	False
Kokusho et al. (1983)	False

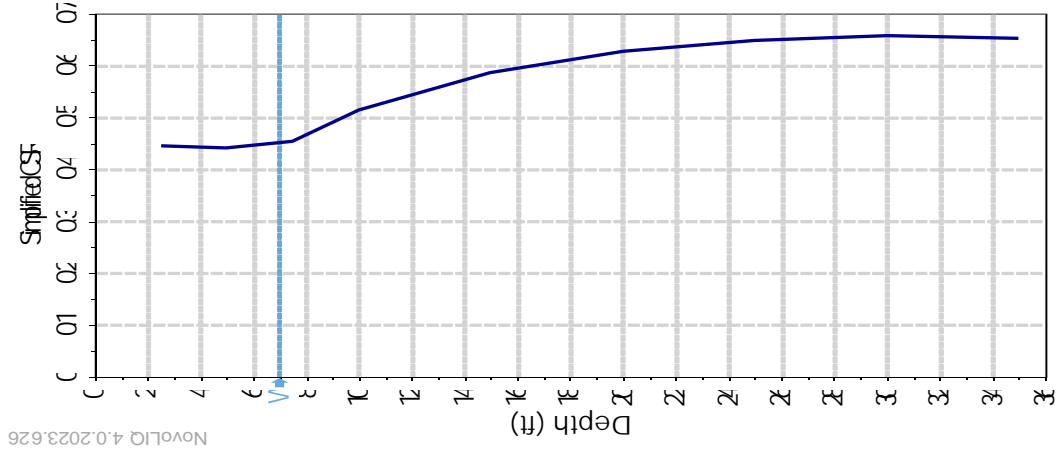
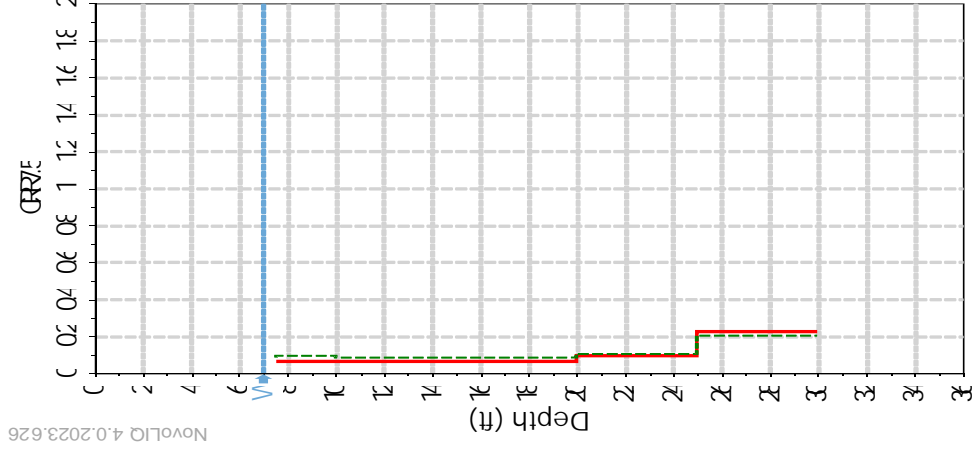
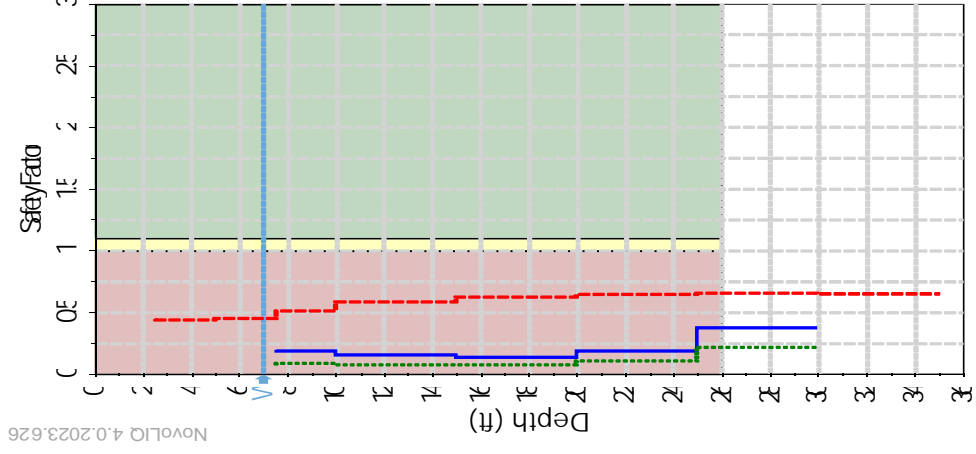
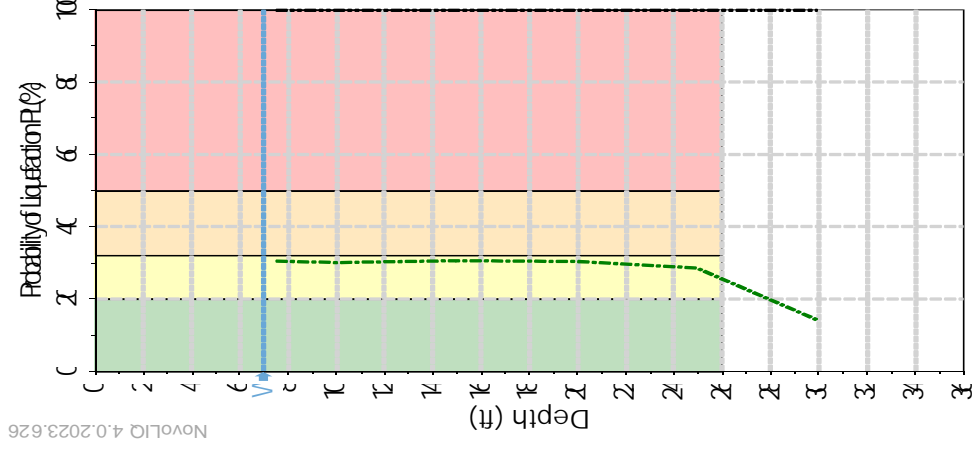
# Soil Liquefaction Analysis Report

Project : Mohan Project  
 Project No. : 25340  
 Client : Whshwas Mohan  
 Site Address : 8203 Avalon Drive, Mercer Island, Wa 98040

— NEER Whitlock (1997)   
 - - - Boulanger & Idiss (2014)   
 — Safety Factor   
 - - - Simplified CSF   
 - - - CRR7E (ae)   
 - - - Youd & Ndtje   
 - - - Gained (2014)
