September 4, 2025
Project No. 25-270

**Subject: Geotechnical Engineering Report
 Proposed SFR Addition
 3860 West Mercer Way, Mercer Island, WA**

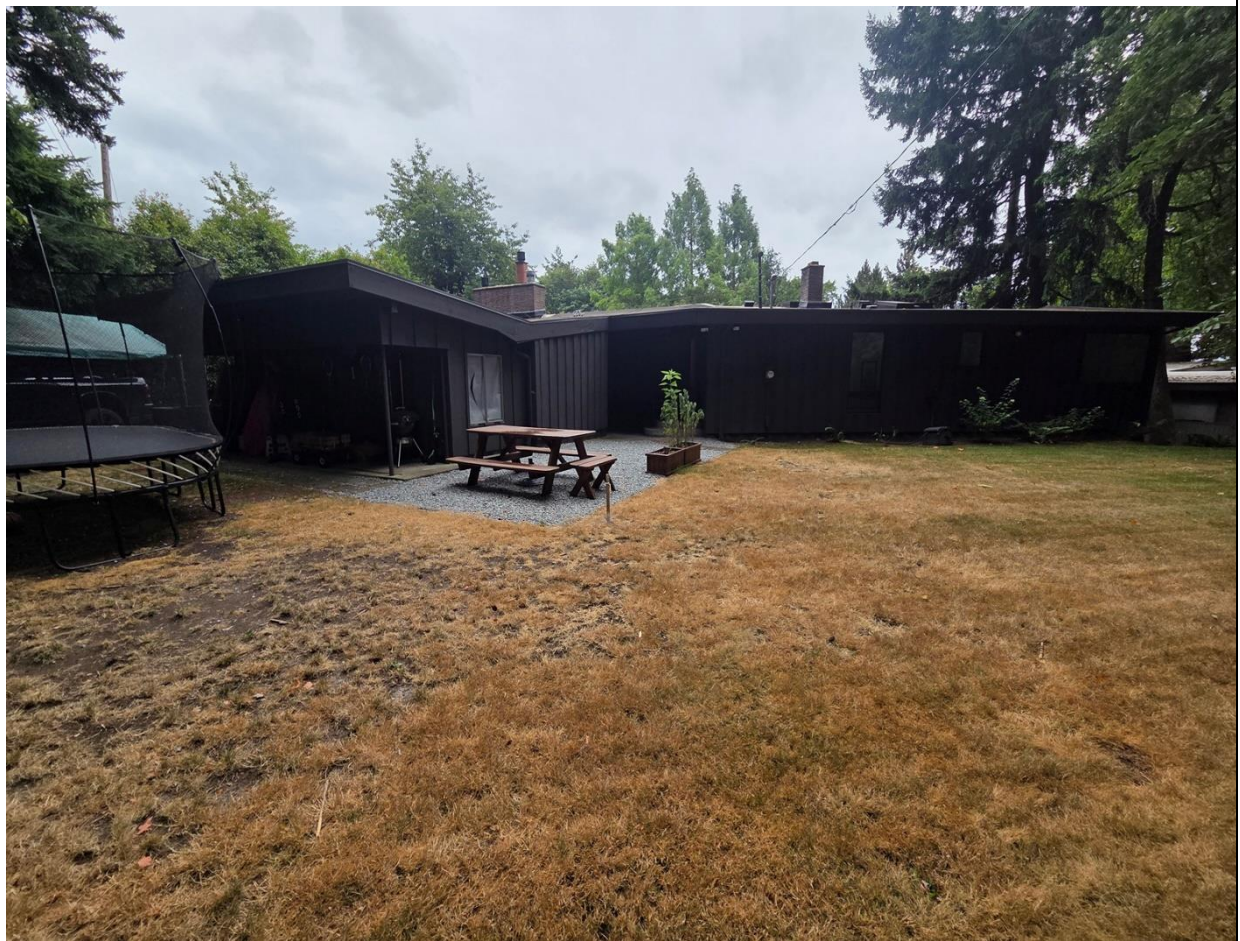
Plate 1. Proposed addition location, looking south (7/25/2025).
