August 6, 2025
Project No. 25-264

**Subject: Geotechnical Report
 Proposed Deck Replacement
 6511 82nd Avenue SE
 Mercer Island, Washington**

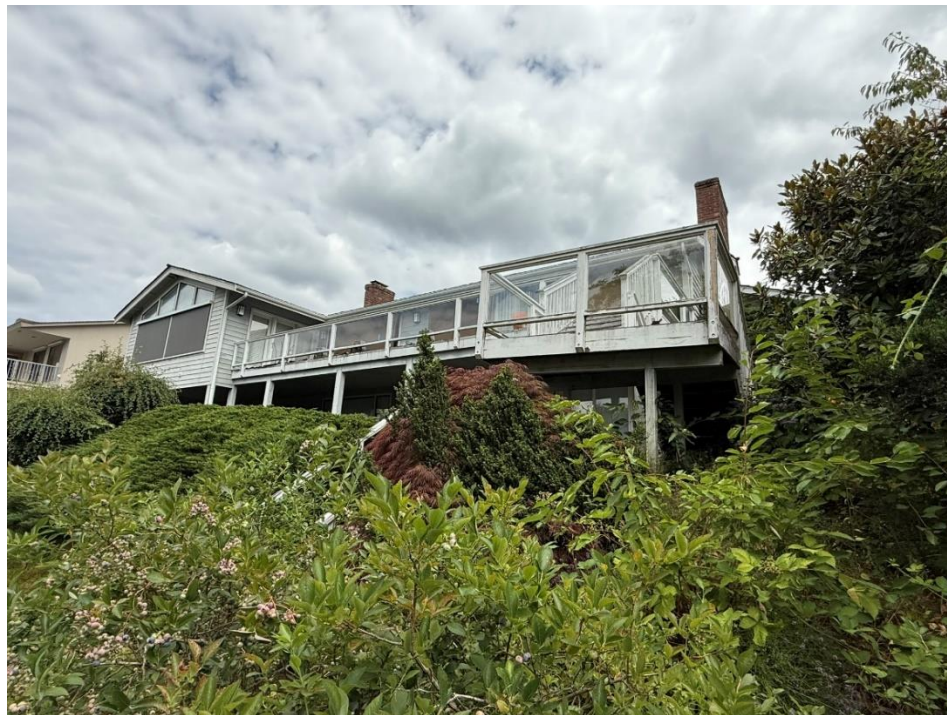
Plate 1. Existing house and proposed deck location, looking northeast (7/14/2025).

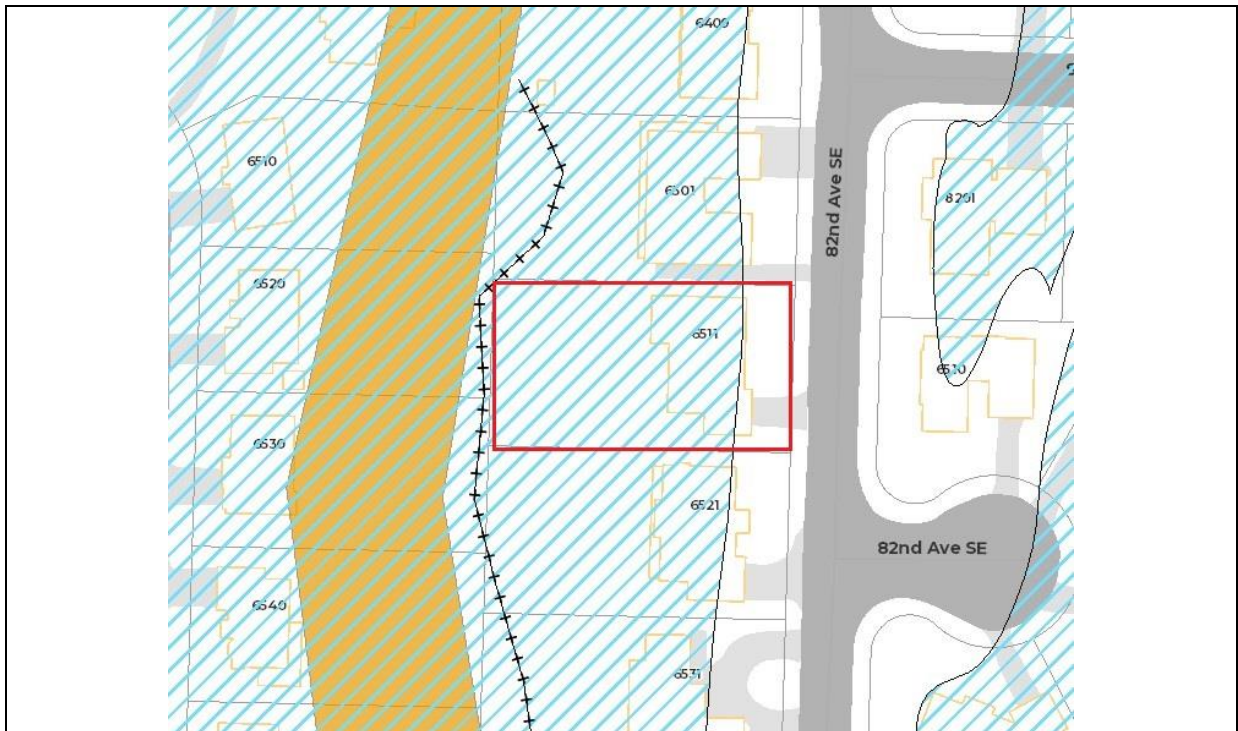
Plate 2. Steep slope area (shaded in orange), potential slide area (blue hashed area), and mapped landslide scarp (black line with tick marks) mapped on the subject property (Mercer Island GIS map).

The steep slope (40% or greater) area is located to the west of the site. The ground surface continues to slope down toward the west on the west neighboring property with an average gradient of about 50 percent. The majority of the site is mapped within a potential landslide hazard area according to the City of Mercer Island's Geologic Hazards Map. Additionally, a landslide scarp trending approximately north to south is mapped along the west property line (see plate 2 below).

A site reconnaissance of the subject property was conducted on July 14, 2025. According to GIS maps, the mapped landslide scarp is approximately 98 feet west of the proposed deck area. During our site reconnaissance, we did not observe the mapped landslide scarp along the top of slope on the west side of the site. The existing building foundations appear to be in relatively good condition and have performed well to date. Based on our field observations, the topography at the site and vicinity, and the subsurface conditions encountered in the hand borings, in our opinion, the subject site appears to be globally stable in its current configuration. It is our further opinion that the proposed deck as currently planned will not decrease the overall site stability or adversely affect the overall stability of the site or adjacent properties, provided the recommendations outlined herein are followed and the proposed development is properly design and constructed.

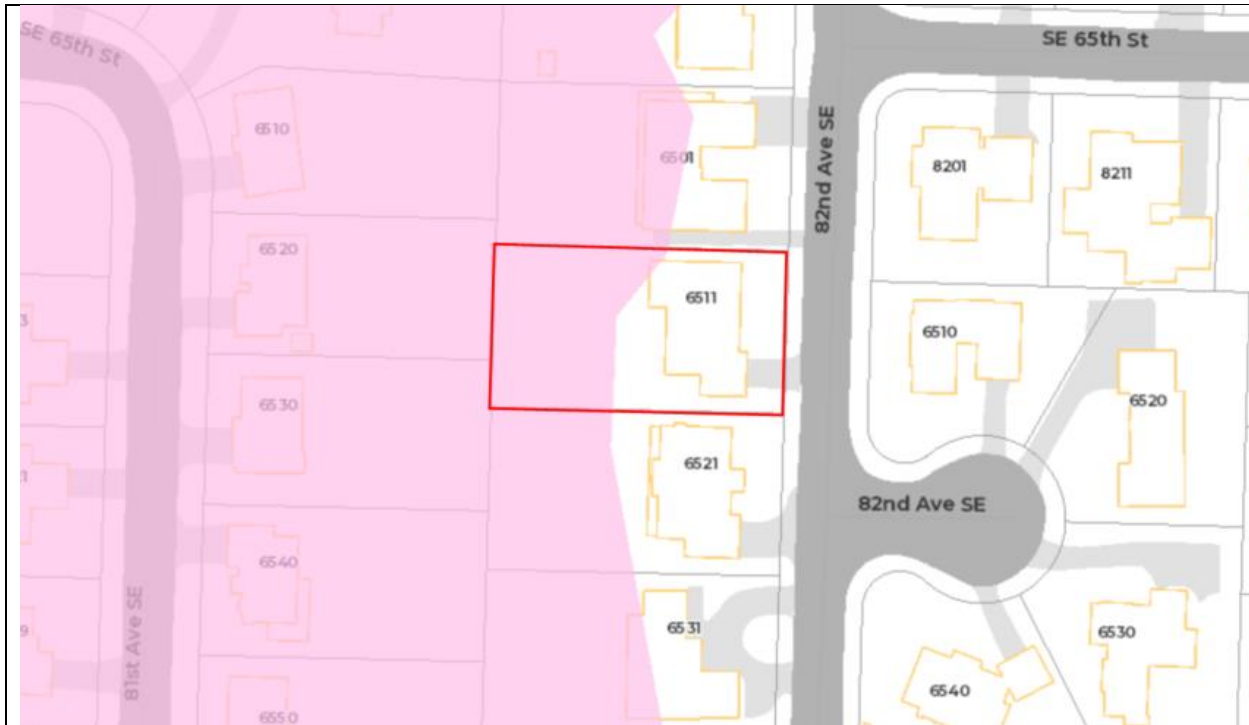
Plate 4. Seismic hazard area (shaded in pink) mapped on the subject property (outlined in red) (Mercer Island GIS map).

Based on review of the City of Mercer Island Parcel Map, the approximate western half of the site is mapped within a seismic/soil liquefaction hazard area (see Plate 4 on page 8).

Based on our subsurface explorations and the soil conditions in the previous borings in the vicinity, the project area is predominately underlain by silty sand at shallow depths without a well-defined water table (i.e. only limited perched groundwater seepage). Based on these conditions, in our opinion, the liquefaction potential of the soils underlying the site is negligible and design considerations related to soil liquefaction are not necessary for the deck project.

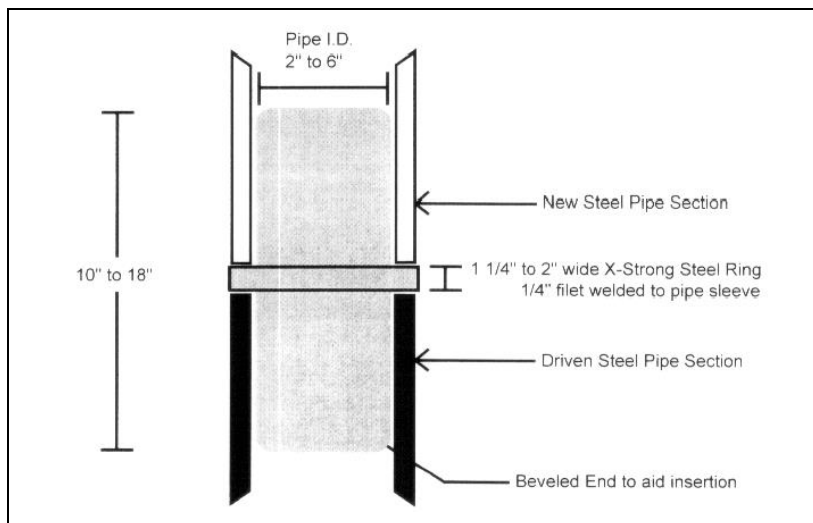
The number of pin piles needed, and pile layout should be determined by your structural engineer. Piles shall be driven in nominal sections and connected with compression fitted sleeve couplers (see detail below). We discourage welding of pipe joints, particularly when galvanized pipe is used, as we have frequently observed welds broken during driving.

3. Piles shall be driven in nominal sections and connected with compression fitted sleeve couplers (see typical detail below). We discourage welding of pipe joints, particularly when galvanized pipe is used, as we have frequently observed welds broken during driving.
4. At least 3 percent (one minimum but no more than 5) of the 3-inch pin piles should be load tested. All load tests shall be performed in accordance with the procedure outlined in ASTM D1143. The maximum test load shall be 2 times the design load. The objective of the testing program is to verify the adequacy of the driving criteria, and the efficiency of the hammer used for the project.
5. The geotechnical engineer of record or their representative shall provide full time observation of pile installation and testing.

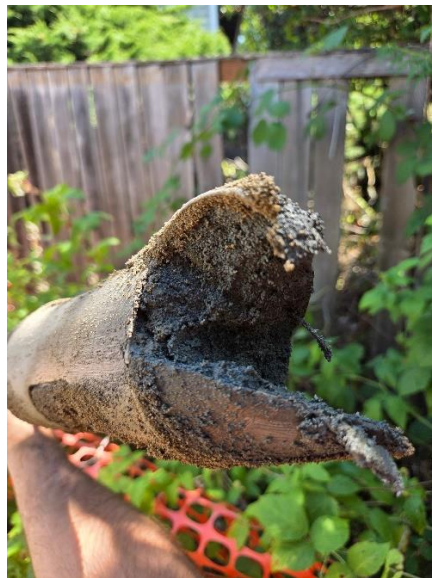
Image of soils at about 8 ½ feet below the ground surface. HB-1 was terminated approximately 8 ½ feet below ground surface. Minor perched groundwater was encountered at about 7 ½ below the existing ground surface at the time of exploration.

Hand Boring HB-1	
Approximate Location: Northing: 47.54465, Easting: -122.22972	
Approximate ground surface elevation: 286.6 ft	
<u>Depth (ft)</u>	<u>Material Description</u>
0 – ½	[Topsoil] Approximately 6 inches of topsoil overlain by landscaping mulch.
½ – 5	[Fill] Loose, orange-brown, fine SAND, trace organics (rootlets); moist
5 – 7 ½	Loose to medium dense, orange-brown, silty SAND, trace fine subrounded gravel, organics (rootlets and wood debris), silt content increases with depth; moist <ul style="list-style-type: none"> - Groundwater seepage encountered at 7 ½ feet below the ground surface
7½ – 8 ½	[Advance Outwash] Medium dense to dense, gray, silty SAND, few fine to coarse subrounded gravel; wet

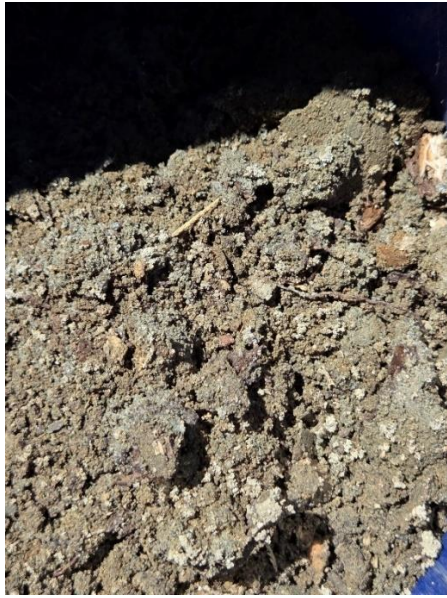
Image of soils from about 8 ½ feet below the ground surface. HB-1 was terminated approximately 9 feet below ground surface due to wood debris obstruction. Minor perched groundwater was encountered at about 7 ½ below the existing ground surface at the time of exploration.	
Logged by: T. Howitz

Hand Boring HB-2	
Approximate Location: Northing: 47.54475, Easting: -122.22973 Approximate ground surface elevation: 286.7 ft	
<u>Depth (ft)</u>	<u>Material Description</u>
0 – ½	[Topsoil] Approximately 6 inches of topsoil overlain by landscaping mulch.
½ – 8 ½	[Fill] Loose, orange-brown, silty SAND, trace fine subrounded gravel, trace organics (rootlets and wood debris); moist - Groundwater seepage encountered 7 ½ feet below the ground surface
8 ½ – 9	[Advance Outwash] Medium dense to dense, gray, silty SAND; wet - Advance outwash is inferred at this depth due to perched groundwater and appearance of gray sand

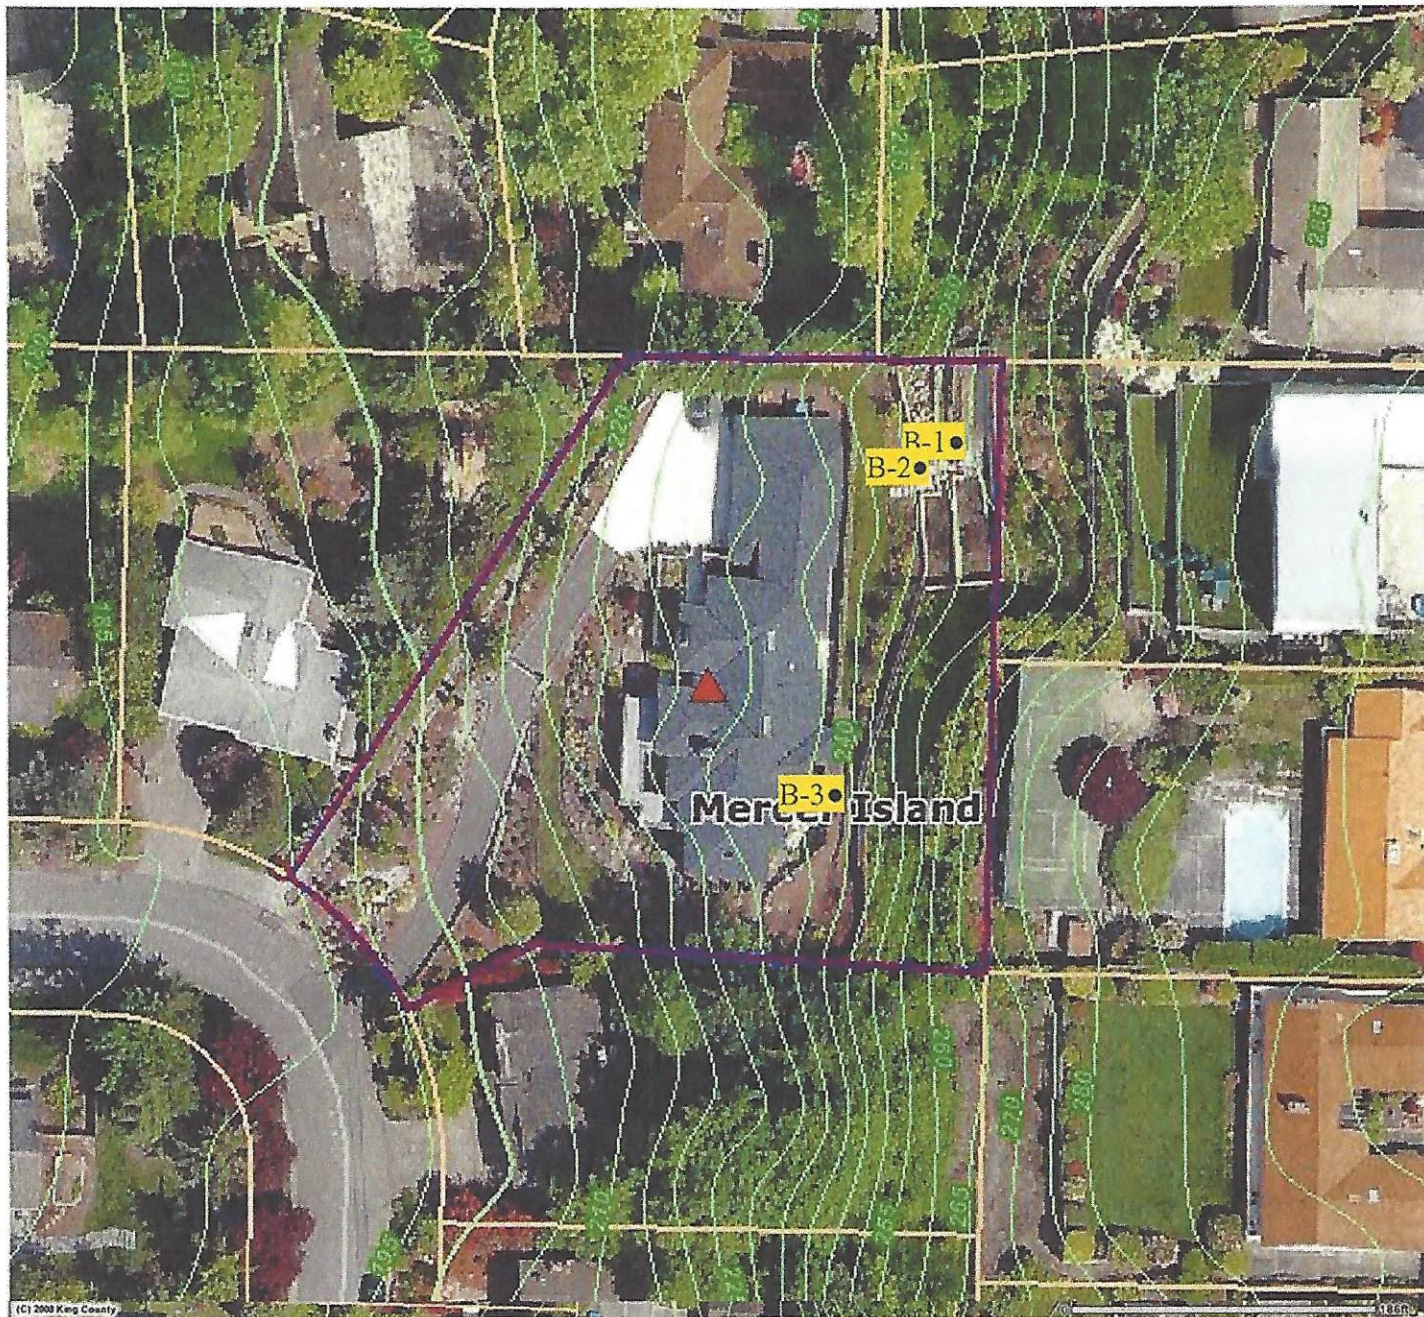
Figure 2

APPROXIMATE LOCATION OF BORINGS B-1●

The previous test borings located at 8040 SE 65th St (GeoResources, 2012) were directly downslope to the west of 6501 82nd Ave SE. The soils encountered in the borings generally consisted of loose sand and very soft to soft silt from the surface to depths of about 6 to 11 feet,
