**Stormwater Drainage Report  
2740 61<sup>st</sup> Avenue SE  
Mercer Island, Washington  
KC Tax Parcel #217450-3230  
Permit #: 25xx-xxx**

### **Section 1: Project Narrative:**

The project will be evaluated for storm water treatment and control using the Amended December 2014 SWMMWW (DOE Manual).

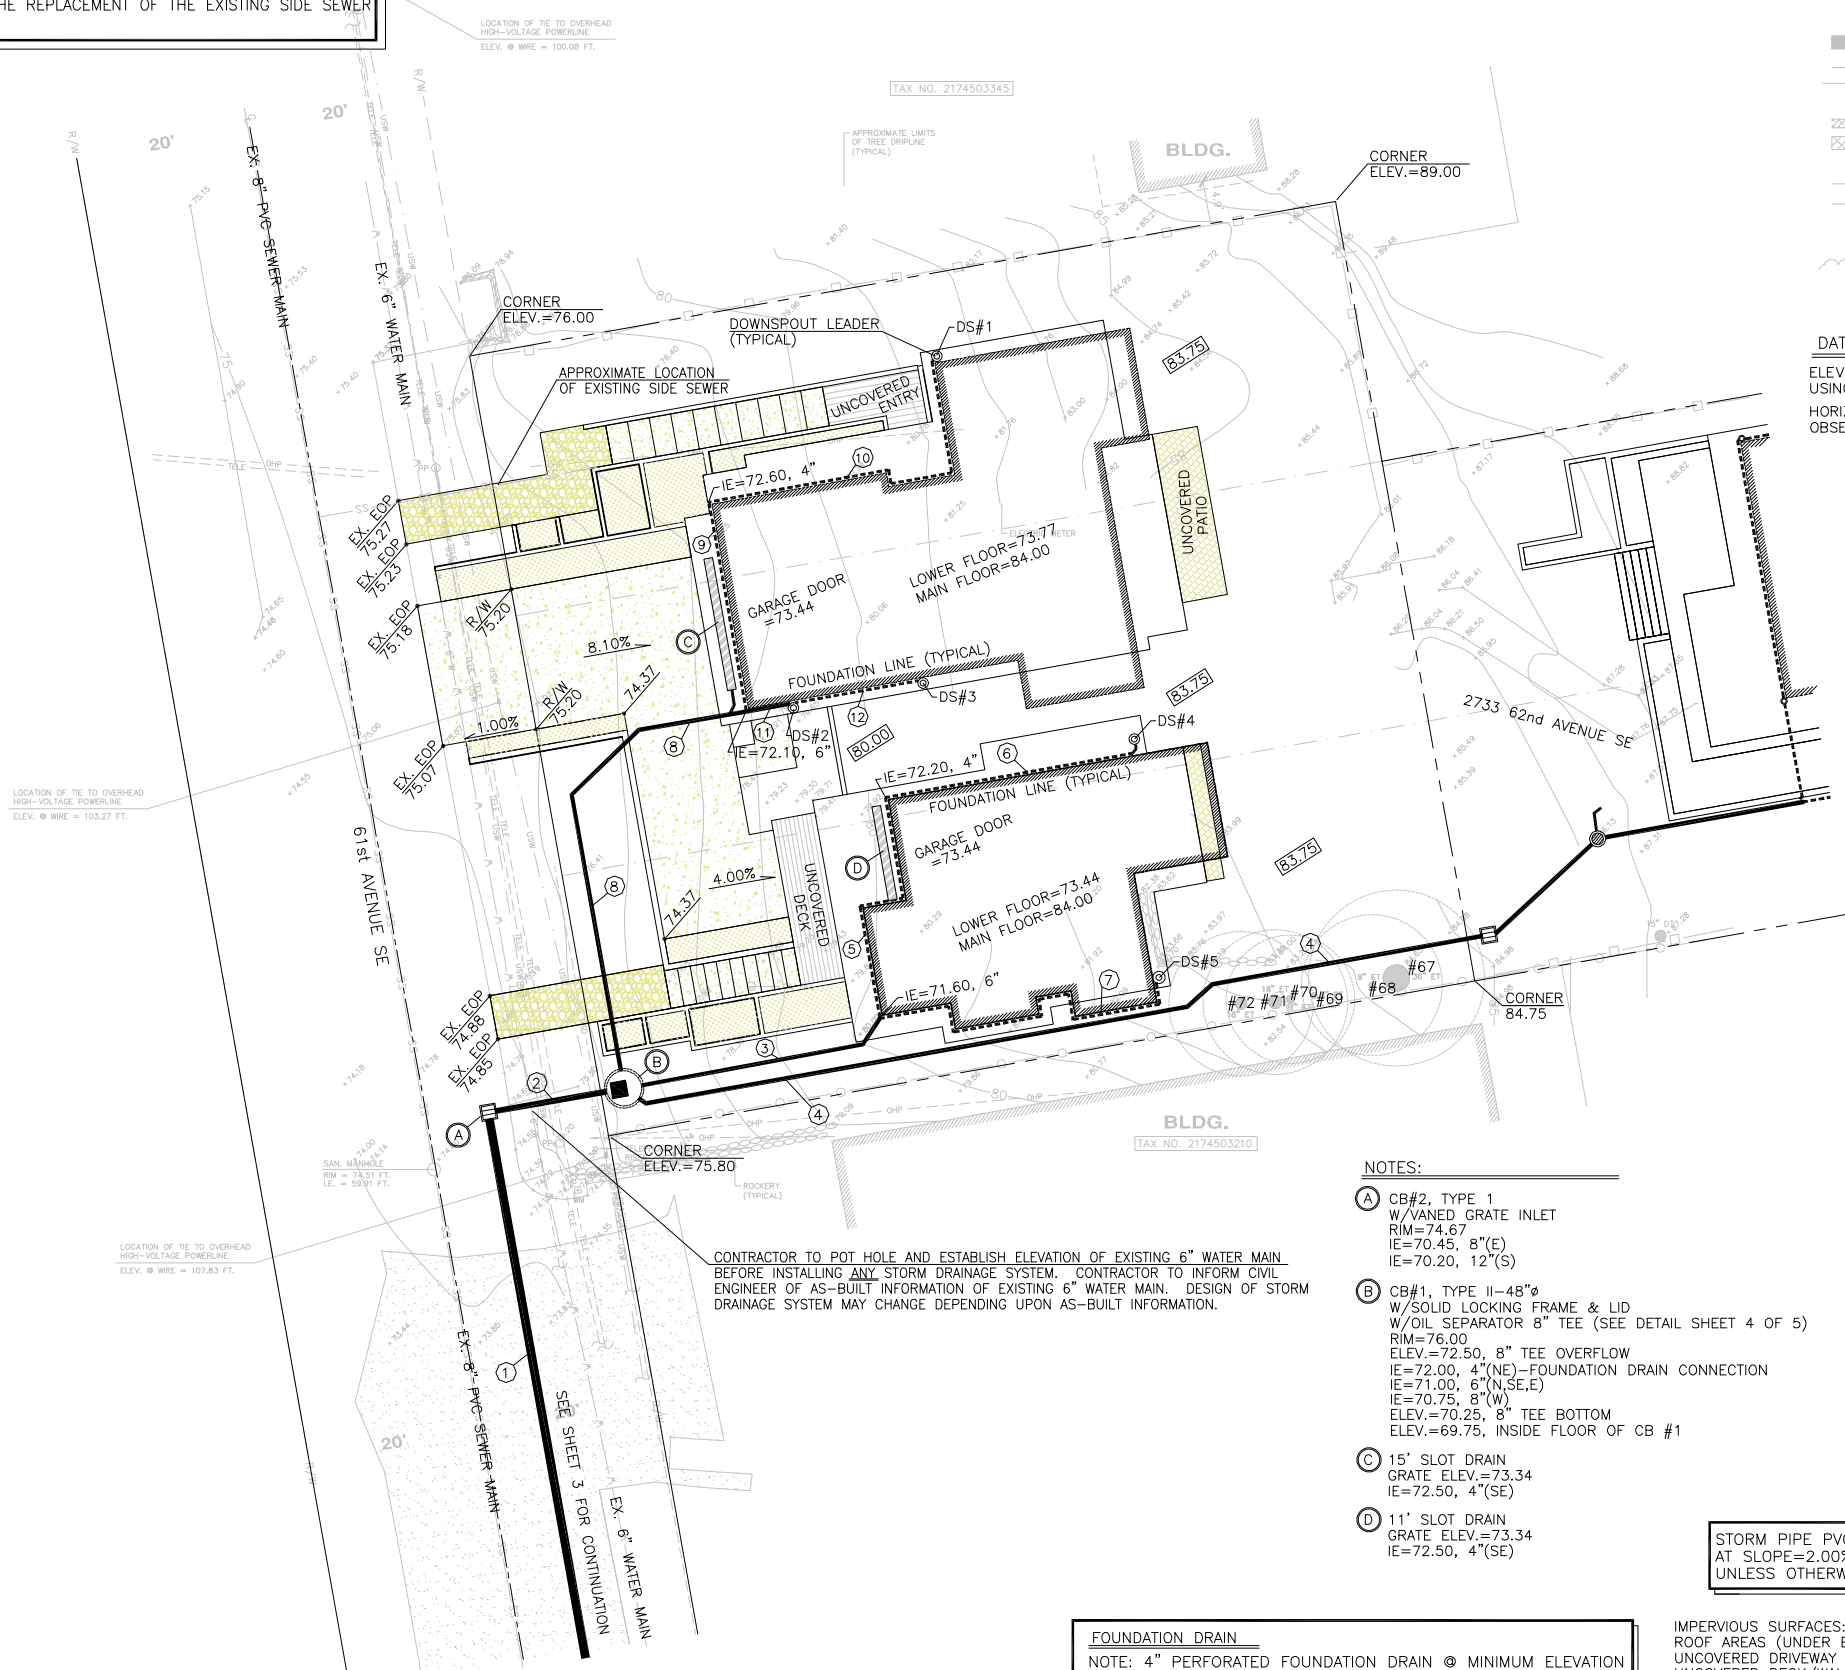
PROJECT		2740 61st Avenue SE	
CLIENT		Mercer Partners, LLC	
SHEET CONTENT		Stormwater Site Plan	
DATE	02/03/2025	CHECKED BY	DLO
JOB NO.		DRAWN BY	SLS
DWG NO.		DESIGNED BY	DLO
SHEET		2 OF 6	
PERMIT #:		25xx-xxx

- NOTES:**
- A CB#2, TYPE 1 W/VANED GRATE INLET  
RIM=74.67  
IE=70.45, 8"(E)  
IE=70.20, 12"(S)
  - B CB#1, TYPE II-48" W/SOLID LOCKING FRAME & LID W/OIL SEPARATOR 8" TEE (SEE DETAIL SHEET 4 OF 5)  
RIM=76.00  
ELEV.=72.50, 8" TEE OVERFLOW  
IE=72.00, 4"(NE)-FOUNDATION DRAIN CONNECTION  
IE=71.00, 6"(N,SE,E)  
IE=70.75, 8"(W)  
ELEV.=70.25, 8" TEE BOTTOM  
ELEV.=69.75, INSIDE FLOOR OF CB #1
  - C 15' SLOT DRAIN  
GRATE ELEV.=73.34  
IE=72.50, 4"(SE)
  - D 11' SLOT DRAIN  
GRATE ELEV.=73.34  
IE=72.50, 4"(SE)

**FOUNDATION DRAIN**  
NOTE: 4" PERFORATED FOUNDATION DRAIN @ MINIMUM ELEVATION OF 72.50 IS REQUIRED BUT NOT SHOWN ON PLAN, CONNECT INTO CB#1, WHERE SHOWN ON PLAN.

IMPERVIOUS SURFACES:  
ROOF AREAS (UNDER EAVES) = 2,854.10 SQ. FT.  
UNCOVERED DRIVEWAY AREA = 745.43 SQ. FT.  
UNCOVERED DECK/WALKWAY/WALLS = 605.10 SQ. FT.  
UNCOVERED PATIO AREA = 144.50 SQ. FT.  
TOTAL IMPERVIOUS AREAS = 4,349.12 SQ. FEET

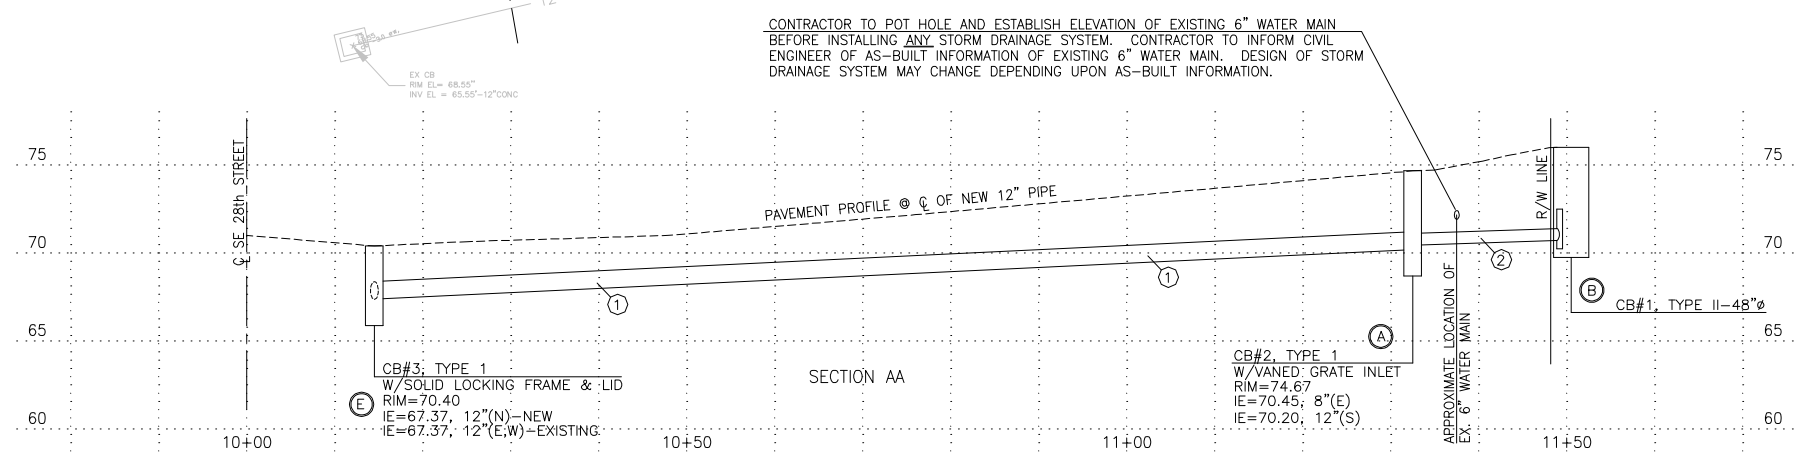
PROJECT: 2740 61st Avenue SE CLIENT: Mercer Partners, LLC SHEET CONTENT: Off Site Storm Plan & Profile		DESIGNED BY: DLO DRAWN BY: SLS CHECKED BY: DLO	REV. NO.: DATE: DESCRIPTION:
DATE: 01/28/2025 JOB NO.: DWG NO.:		SHEET: 3 OF 6 PERMIT #: 25xx-xxx

- NOTES:**
- A** CB#2, TYPE 1 W/VANED GRATE INLET  
RIM=74.67  
IE=70.45, 8"(E)  
IE=70.20, 12"(S)
  - B** CB#1, TYPE II-48"Ø W/SOLID LOCKING FRAME & LID W/OIL SEPARATOR 8" TEE (SEE DETAIL SHEET 4 OF 5)  
RIM=76.00  
ELEV.=72.50, 8" TEE OVERFLOW  
IE=72.00, 4"(NE)-FOUNDATION DRAIN CONNECTION  
IE=71.00, 6"(N,SE,E)  
IE=70.75, 8"(W)  
ELEV.=70.25, 8" TEE BOTTOM  
ELEV.=69.75, INSIDE FLOOR OF CB #1
  - E** CB#3, TYPE 1 W/SOLID LOCKING FRAME & LID  
RIM=70.40  
IE=67.37, 12"(N)-NEW  
IE=67.37, 12"(E,W)-EXISTING

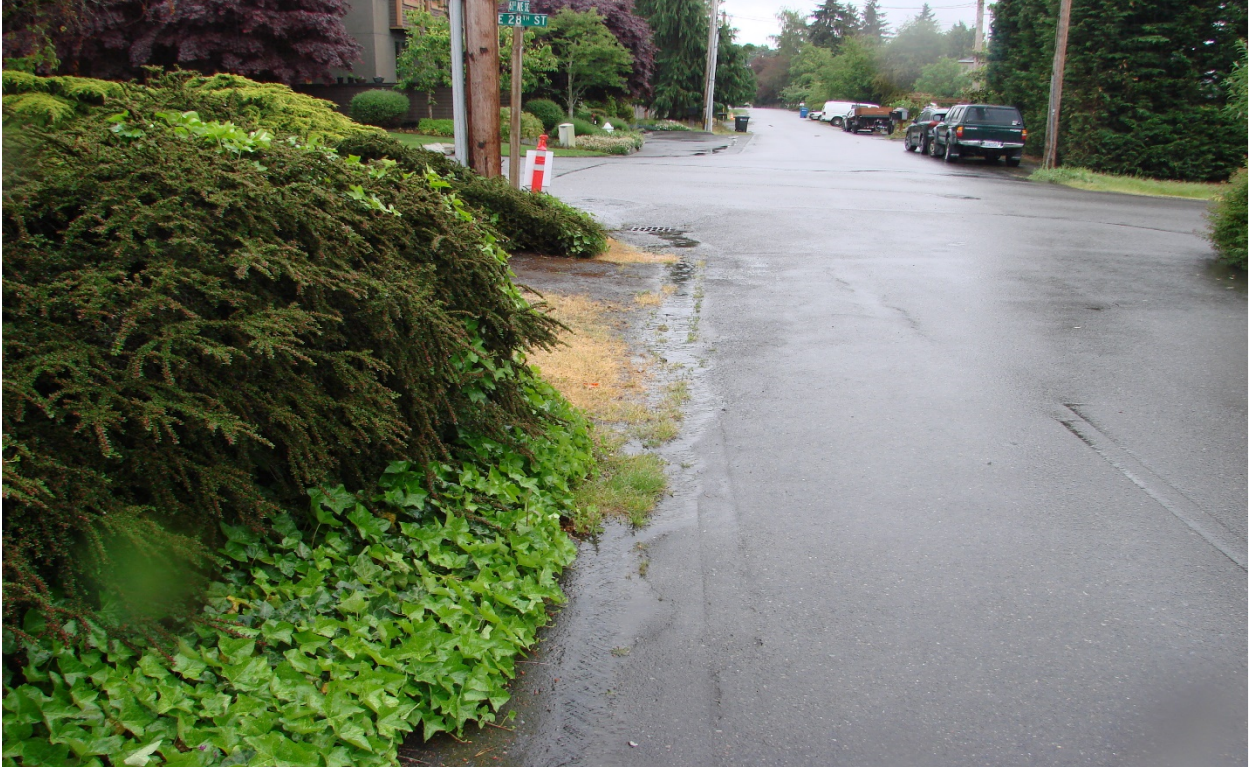
Photo #7 – Inlet City CB #16-16 at northeaasty corner of SE 28<sup>th</sup> Street & 60<sup>th</sup> Avenue SE

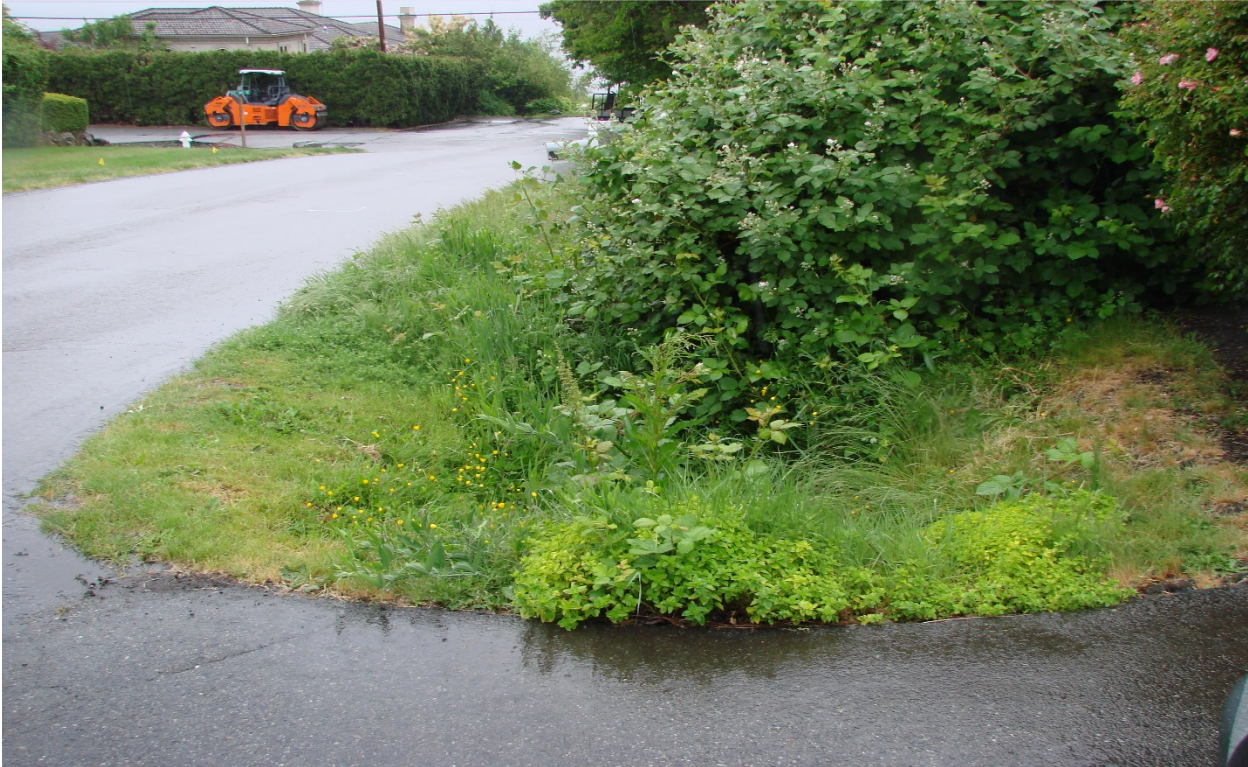
Photo #9 – Open ditch inlet at northeast corner of SE 28<sup>th</sup> Street & 60<sup>th</sup> Avenue SE
