**FACET**

# Drainage Report

**ADDRESS:** 4045 West Mercer Way, Mercer Island, WA 98040

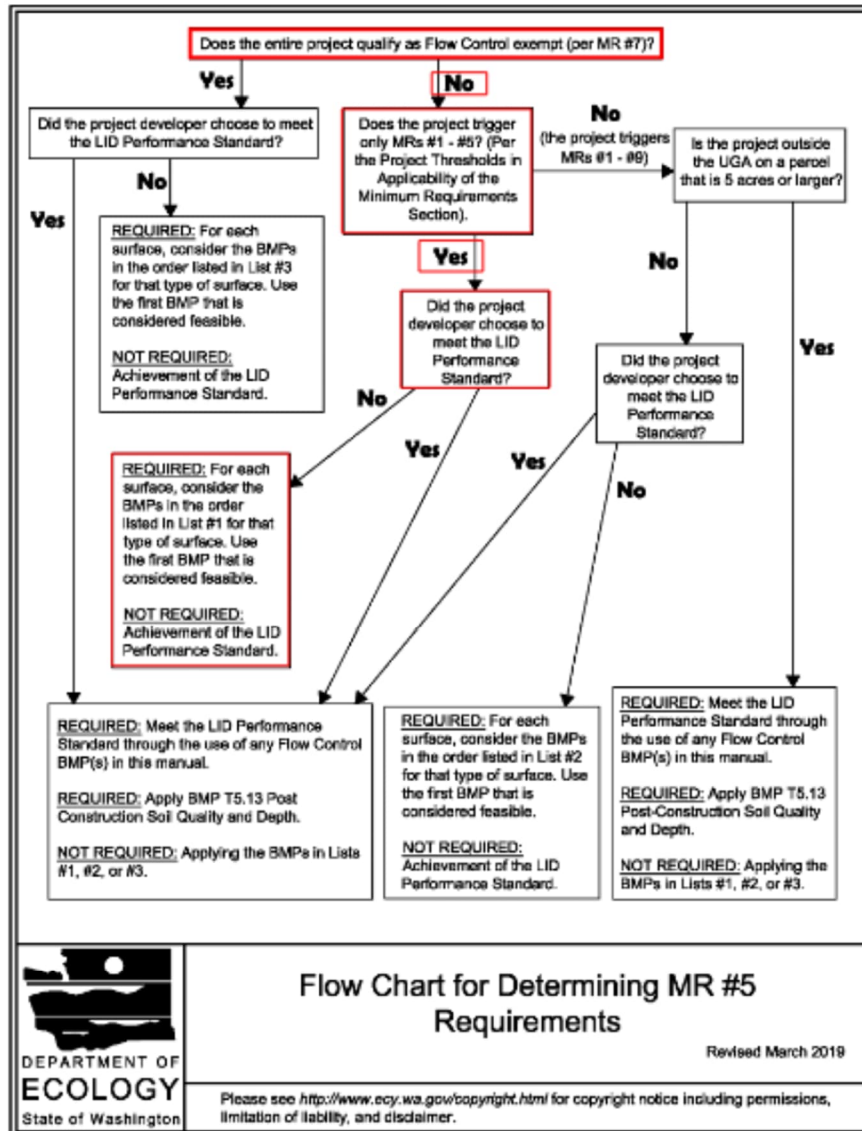
**Figure I-3.3: Flow Chart for Determining MR #5 Requirements**

As shown in Figure I-3.3, List #1 applies to this project. This project complies with List #1 as described below:

The On-Site Stormwater Management requirements applicable to this project were determined using *Figure I-3.3 – Flow Chart for Determining LID MR #5 Requirements* from the Stormwater Manual, as shown on the next sheet.

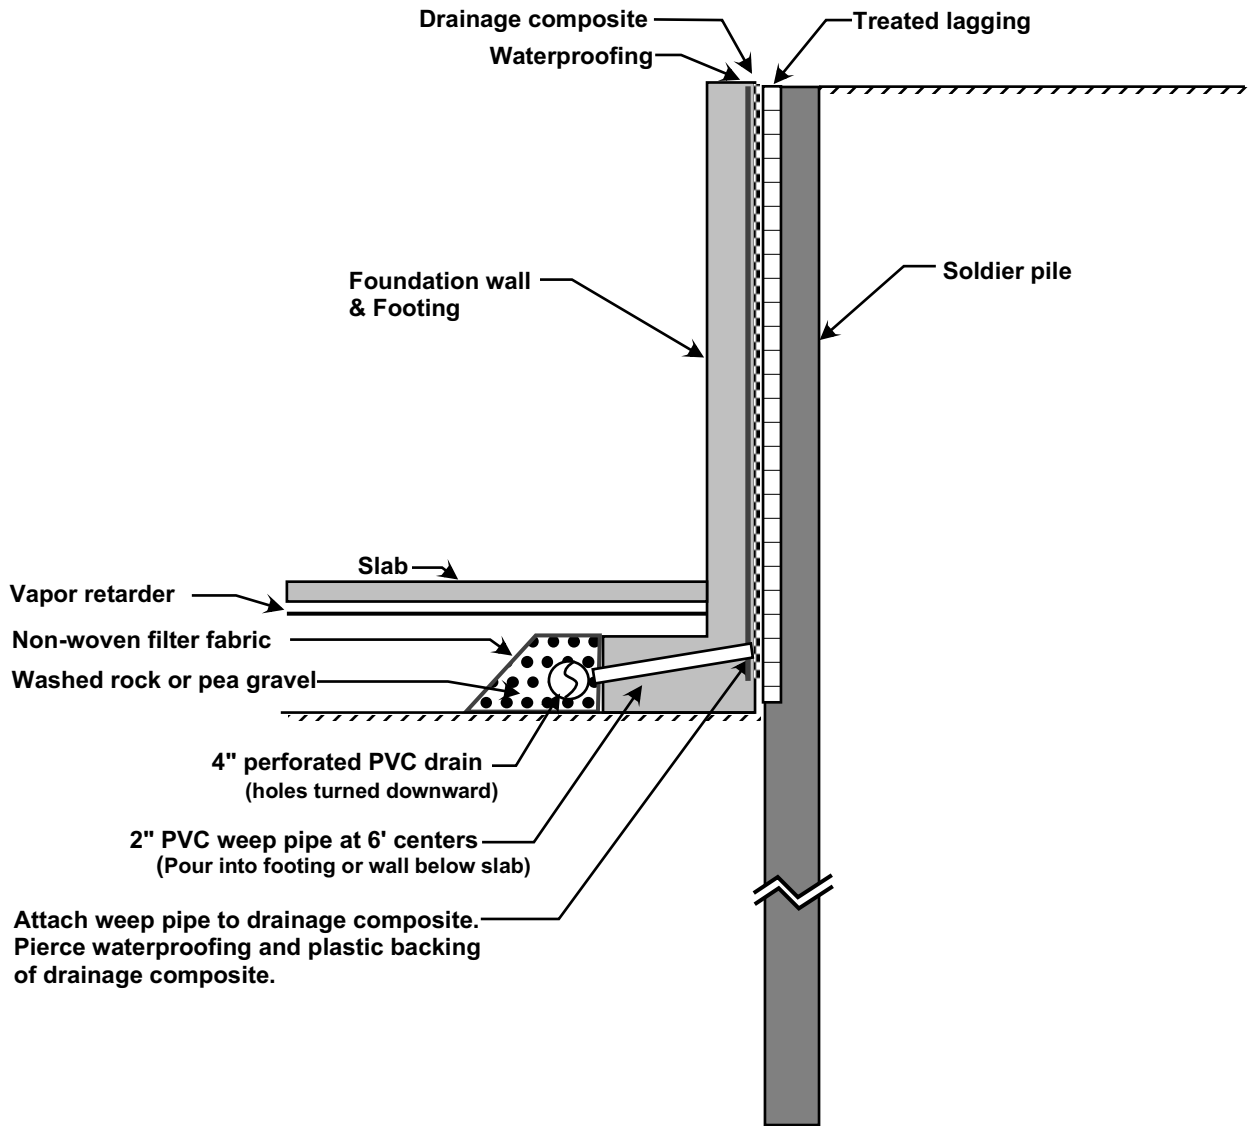
**SHORING DRAIN DETAIL**  
4045 West Mercer Way  
Mercer Island, Washington

Attach weep pipe to drainage composite.  
Pierce waterproofing and plastic backing  
of drainage composite.

Note - Refer to the report for additional considerations related to drainage and waterproofing.

We anticipate that permanent foundation walls may be constructed against the shoring walls. Where this occurs, a plastic-backed drainage composite, such as Miradrain, Battledrain, or similar, should be placed against the entire surface of the shoring prior to pouring the foundation wall. Weep pipes located no more than 6 feet on-center should be connected to the drainage composite and poured into the foundation walls or the perimeter footing. A footing drain installed along the inside of the perimeter footing will be used to collect and carry the water discharged by the weep pipes to the storm system. Isolated zones of moisture or seepage can still reach the permanent wall where groundwater finds leaks or joints in the drainage composite. This is often an acceptable risk in unoccupied below-grade spaces, such as parking garages. However, formal waterproofing is typically necessary in areas where wet conditions at the face of the permanent wall will not be tolerable. If this is a concern, the permanent drainage and waterproofing system should be designed by a specialty consultant familiar with the expected subsurface conditions and proposed construction. Plate 6 presents typical considerations for foundation drains at shoring walls.

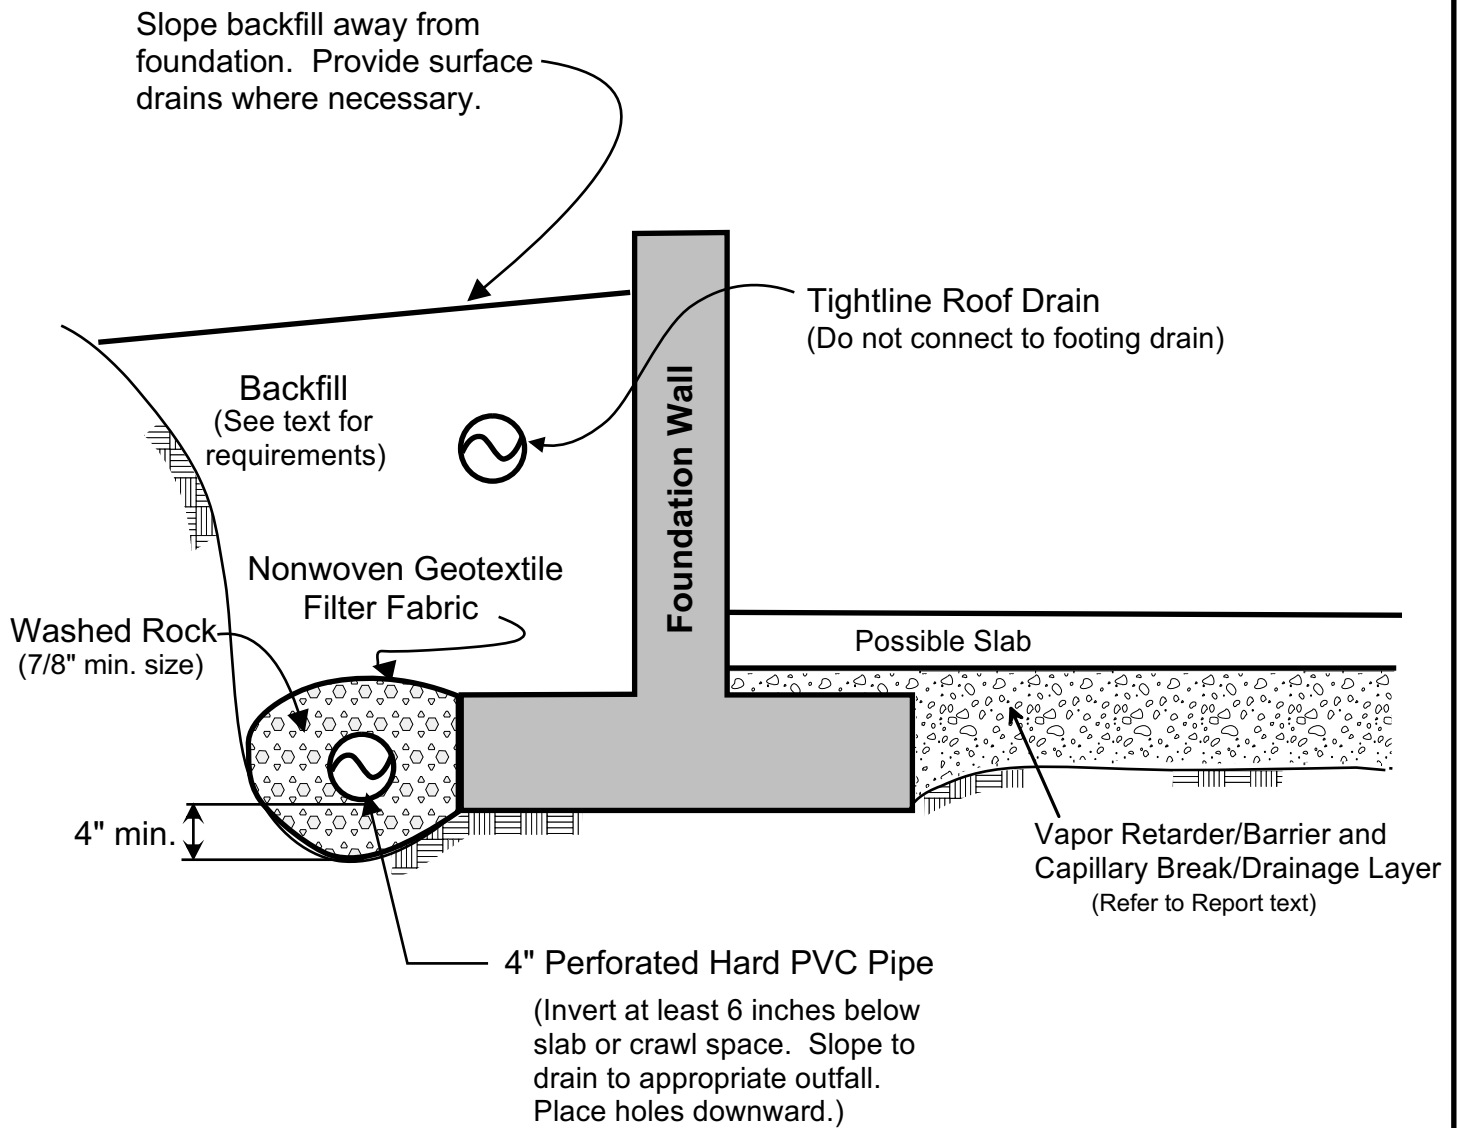
**FOOTING DRAIN DETAIL**  
4045 West Mercer Way  
Mercer Island, Washington

**NOTES:**

- (1) In crawl spaces, provide an outlet drain to prevent buildup of water that bypasses the perimeter footing drains.
- (2) Refer to report text for additional drainage, waterproofing, and slab considerations.

Footing drains should be placed inside the building for shored areas noted above, outside of the building in non-shored areas, or behind backfilled walls. Footing drains outside of the building should be used where: (1) crawl spaces or basements will be below a structure; (2) a slab is below the outside grade; or, (3) the outside grade does not slope downward from a building. The footing drains should consist of 4-inch, perforated PVC pipe surrounded by at least 6 inches of 1-inch-minus, washed rock wrapped in a non-woven, geotextile filter fabric (Mirafi 140N, Supac 4NP, or similar material). At its highest point, a perforated pipe invert should be at least 6 inches below the level of a crawl space or the bottom of a floor slab, and it should be sloped slightly for drainage. All roof and surface water drains must be kept separate from the foundation drain system. A typical footing drain detail is attached to this report as Plate 7. Clean-outs should be provided for potential future flushing or cleaning of footing drains.

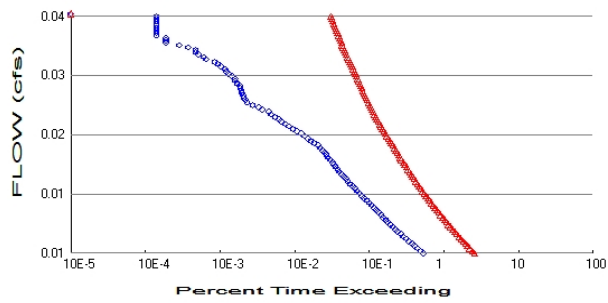
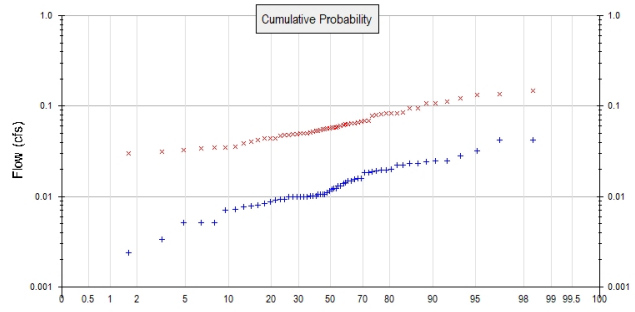
## POC 1

+ Predeveloped    x Mitigated

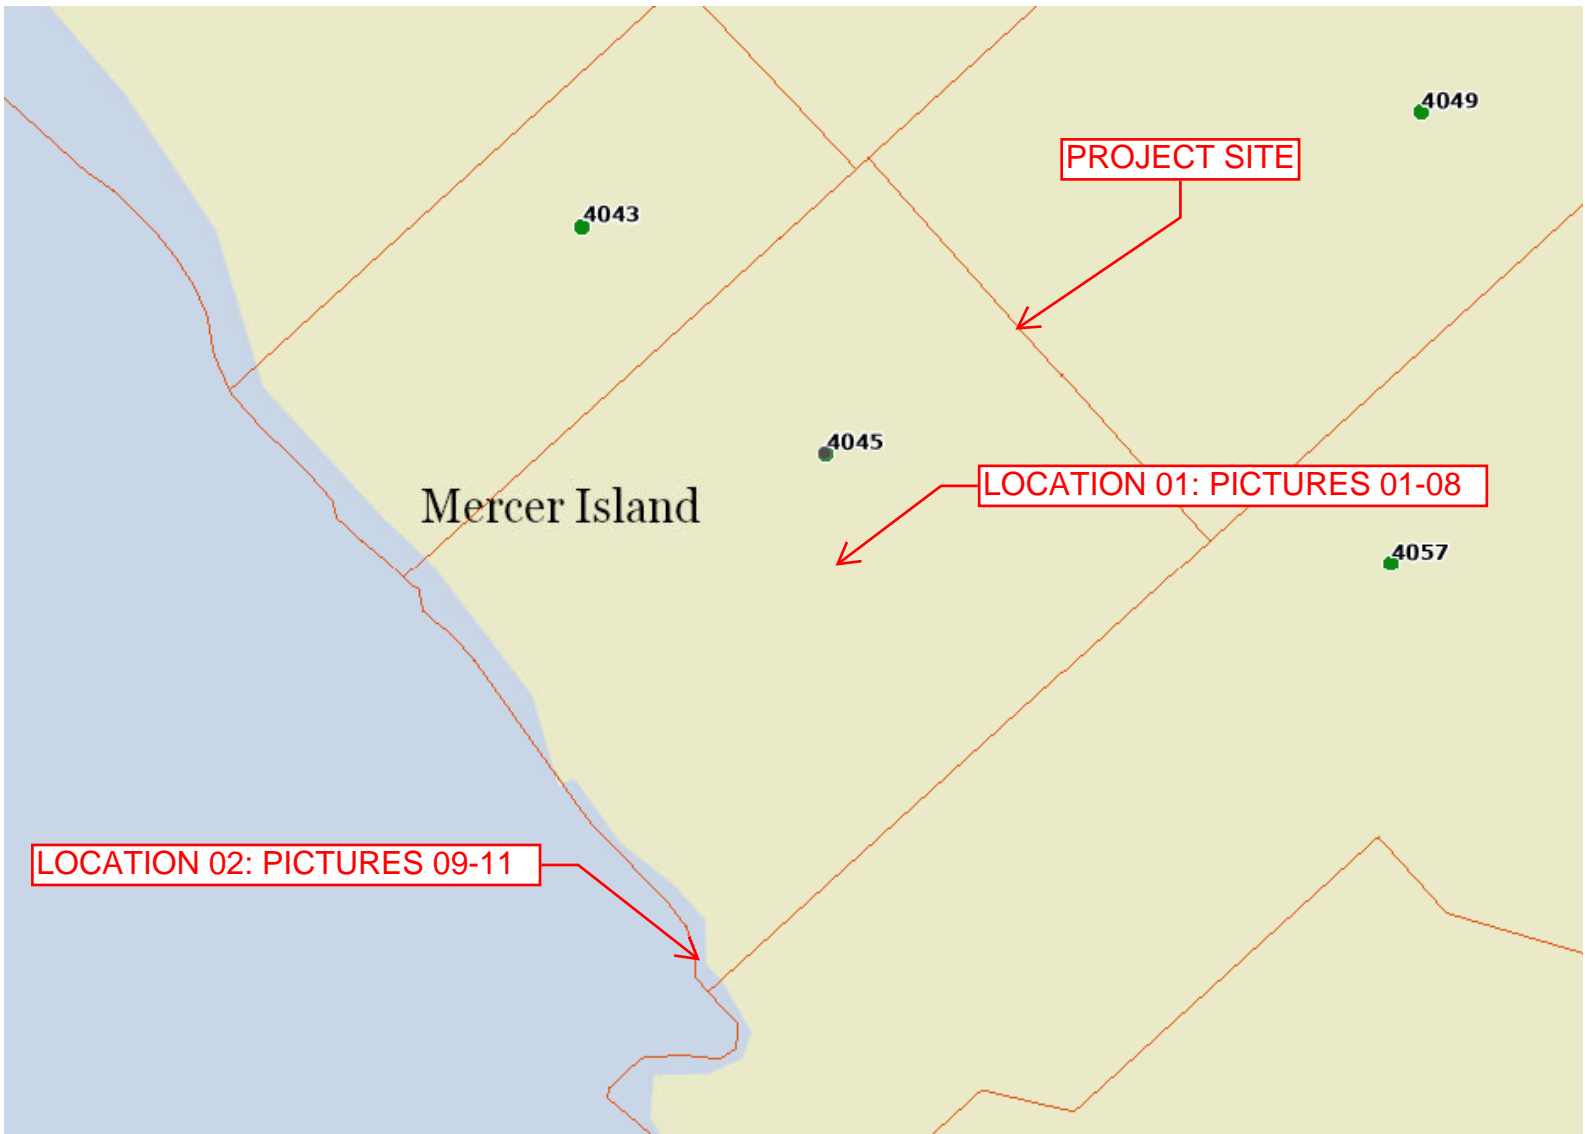
# JOB ADDRESS Downstream Analysis

General Note - Red Arrow on all sheets represents flow path

There was no visual indication of conveyance system capacity problems, localized flooding, erosion impacts, or violations of surface water quality standards. Additionally, there was no evidence of any damage to the drainage system. See Appendix E of this report for the Downstream Drainage Exhibit and Downstream Analysis Photos.

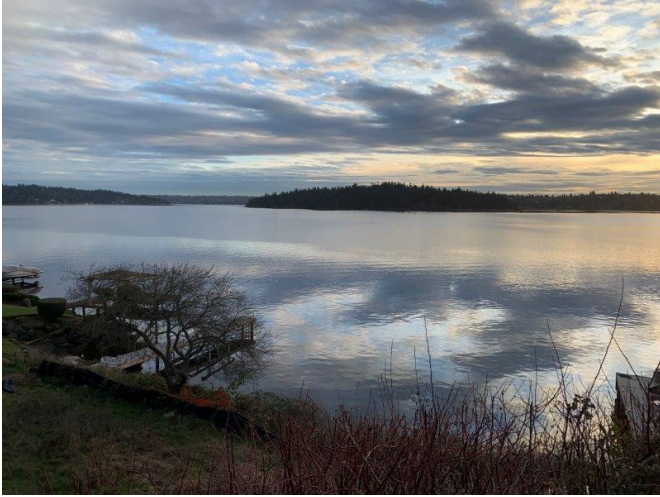
Photo 01 - Location 01  
Picture from project site. Looking at Lake Washington.

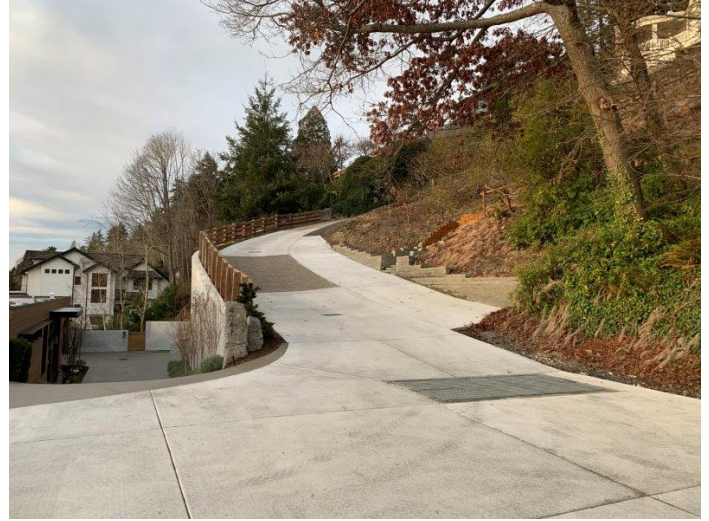
Photo 02 - Location 01  
Picture from project site. Looking Northwest at driveway easement/tract to access property.

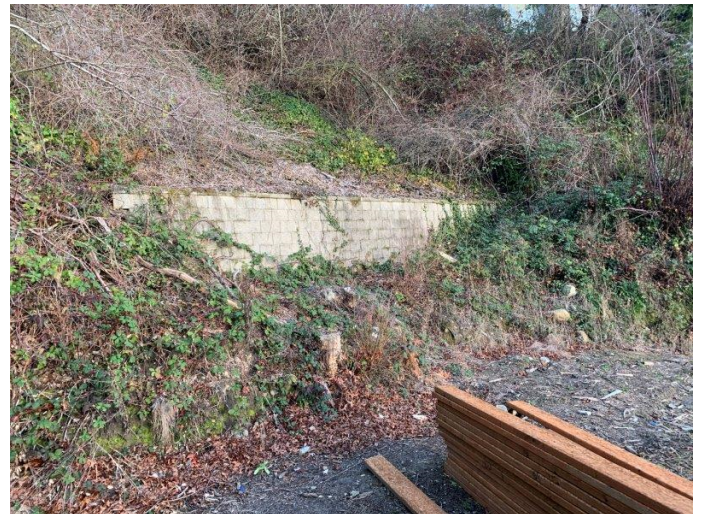
Photo 03 - Location 01  
Picture from project site. Looking East at foundation of old house.

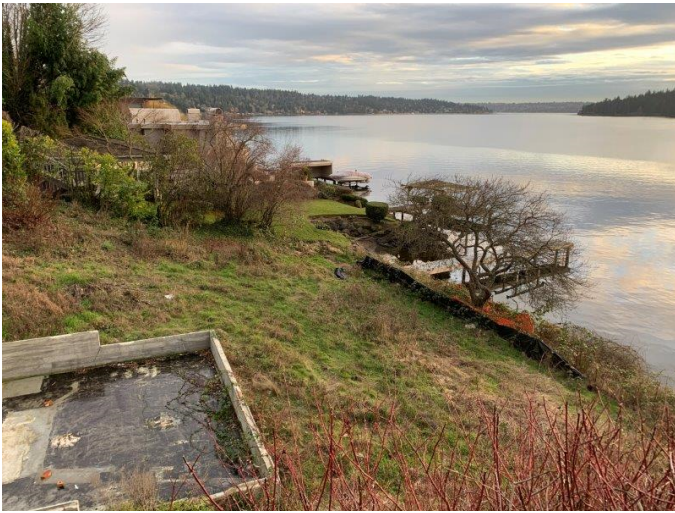
Photo 04 - Location 01  
Picture from project site. Looking East at existing block wall.

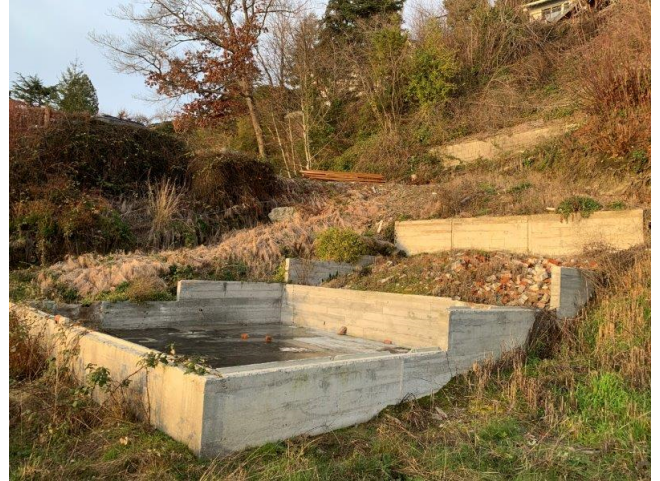
Photo 05 - Location 01  
Picture from project site. Looking East at  
foundation of old house.

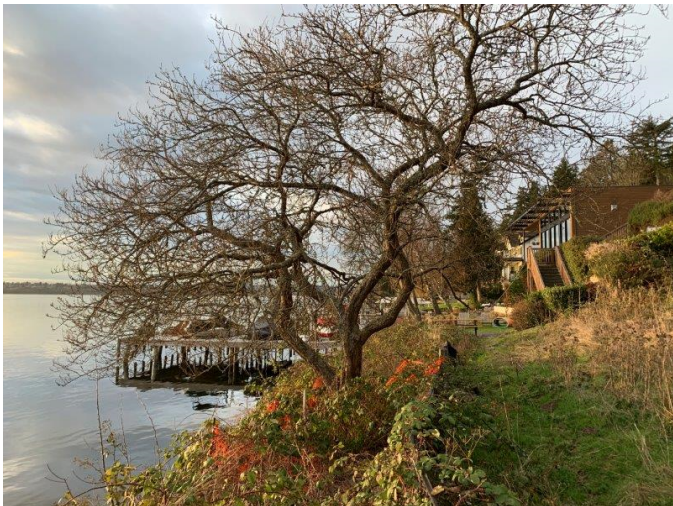
Photo 06 - Location 01  
Picture from project site. Looking North at  
foundation of old house.

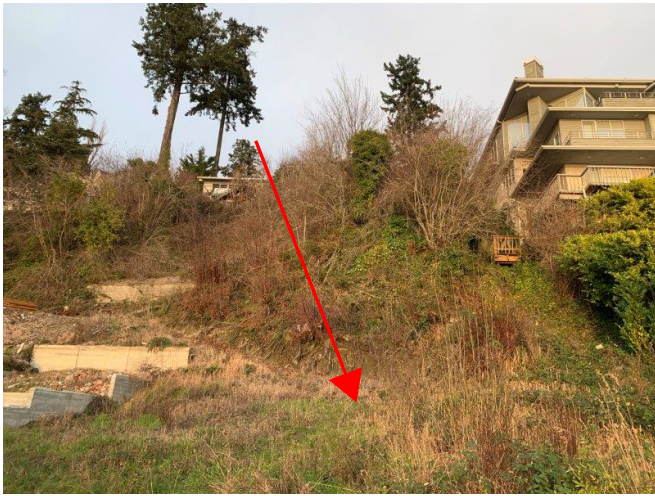
Photo 08 - Location 01  
Picture from project site. Looking Southeast at  
existing driveway.

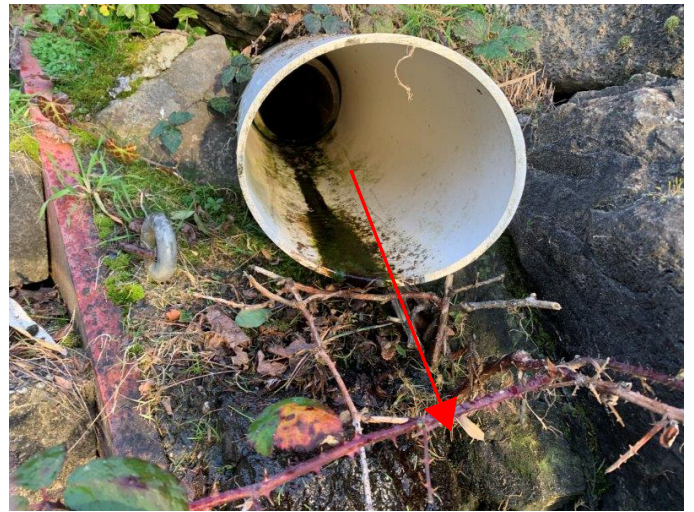
Photo 09 - Location 02

Looking North from the direct discharge pipe. Storm water will make its way from site, to this pipe, and directly discharge into Lake Washington.

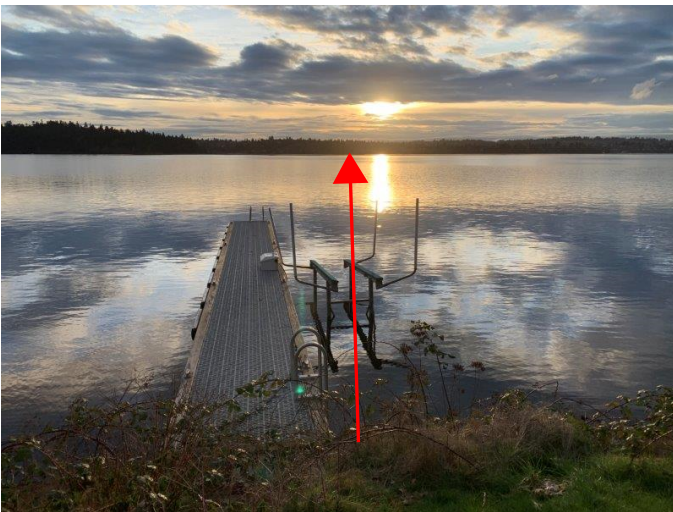
Photo 10 - Location 02

Water from site will make its way to the existing direct discharge pipe and make its way into Lake Washington.
