GEOTECHNICAL ENGINEERING REPORT PROPOSED SINGLE-FAMILY RESIDENCE 9191 SE 64th Street Mercer Island, Washington

PROJECT NO. 25-036.200
AUGUST 27, 2025

**Subject: Geotechnical Engineering Report
Proposed Single-Family Residence
9191 SE 64th Street, Mercer Island, Washington**

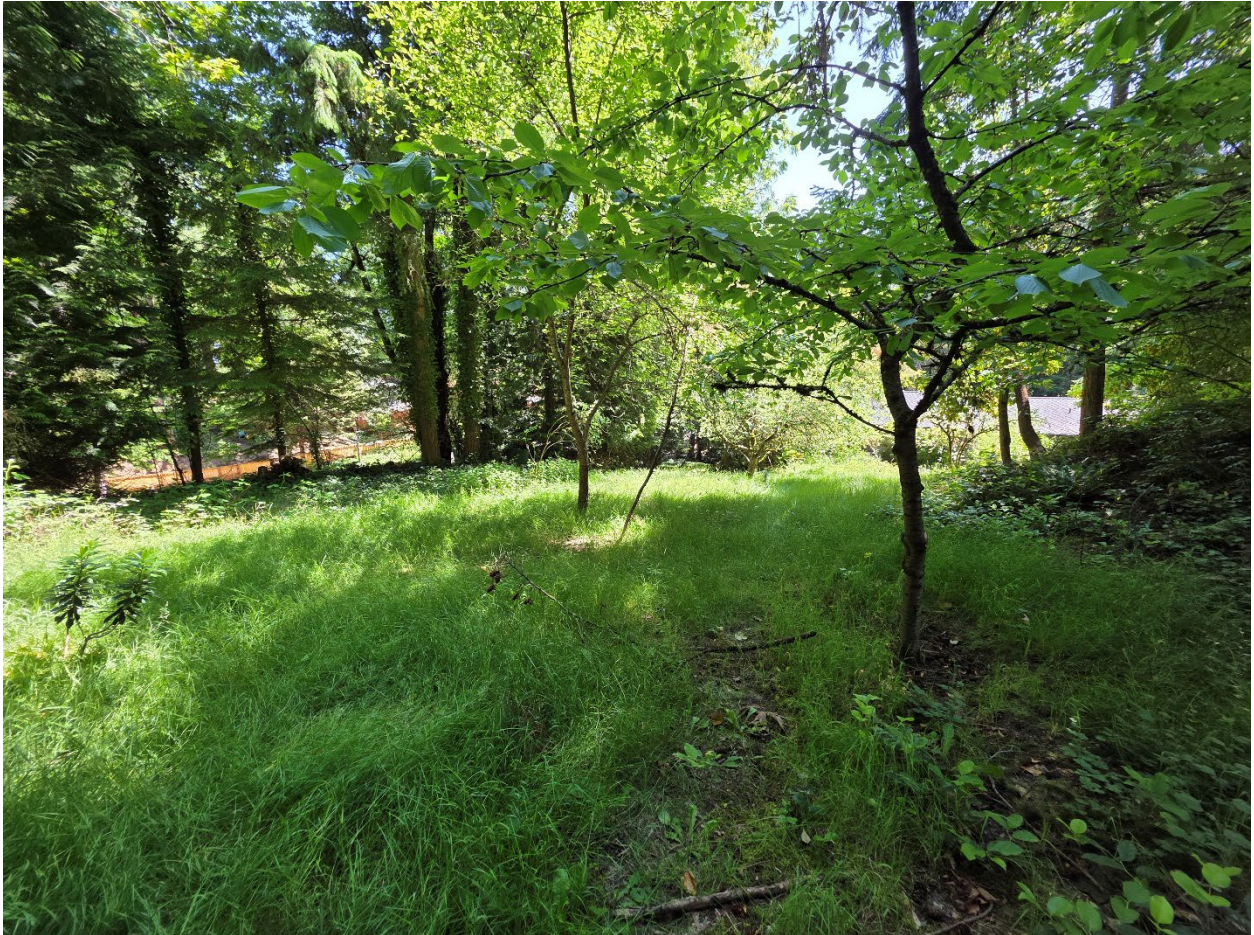
Plate 1 – General conditions of the property, looking downslope to the east from the approximate location of the currently proposed house, where the ridge crest broadens. (6/18/2025)

As described above, the site morphology consists of a descending ridge running southeast from a saddle or bench area along the west property line as shown in Figure 2. The upper portion of the ridge is relatively narrow, but widens below elevation 198 feet (see Plate 1). During our site visits, we did not observe evidence of recent slope instability such as slide scarps or tension cracks within the subject property. In addition, no recent or historical slides have been mapped on or directly adjacent to the subject property. Review of the recent Lidar image of the area shows the site grading work fairly readily, and the road cut to the bench, but shows no features that may suggest slope instability in the subject area.

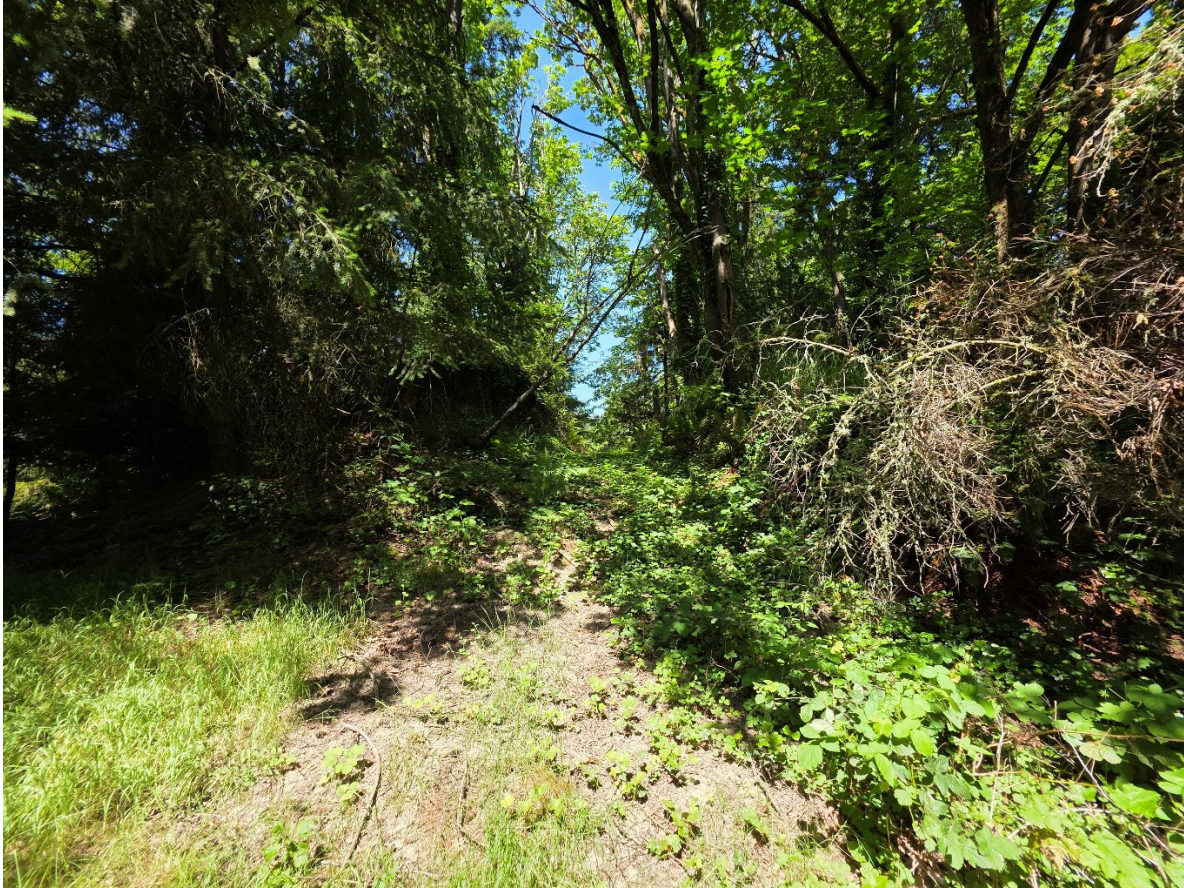
Plate 2 – “Road” cut, looking uphill to the west along the ridge crest. Note vertical slope in shadow on left. (6/18/2025)

The western property line contains a topographic saddle or upper bench area, near the top of the property, around elevation 201 feet (see Figure 2). From here a ridgeline with moderately steep slopes reaches down to the southeast toward the existing house at 6423 East Mercer Way. From a relatively sharp crest below the upper bench, the ridge crest broadens out, especially below elevation 198 feet (see Plate 1, following page). An access driveway or dirt road has been graded up the spine of the ridge to the upper bench area, and the upper part of the ridge appears to have been undercut by past grading work. This has created areas of vertical and near vertical slopes and road cuts where the access road has been excavated through the crest of the ridge (see Plate 2,

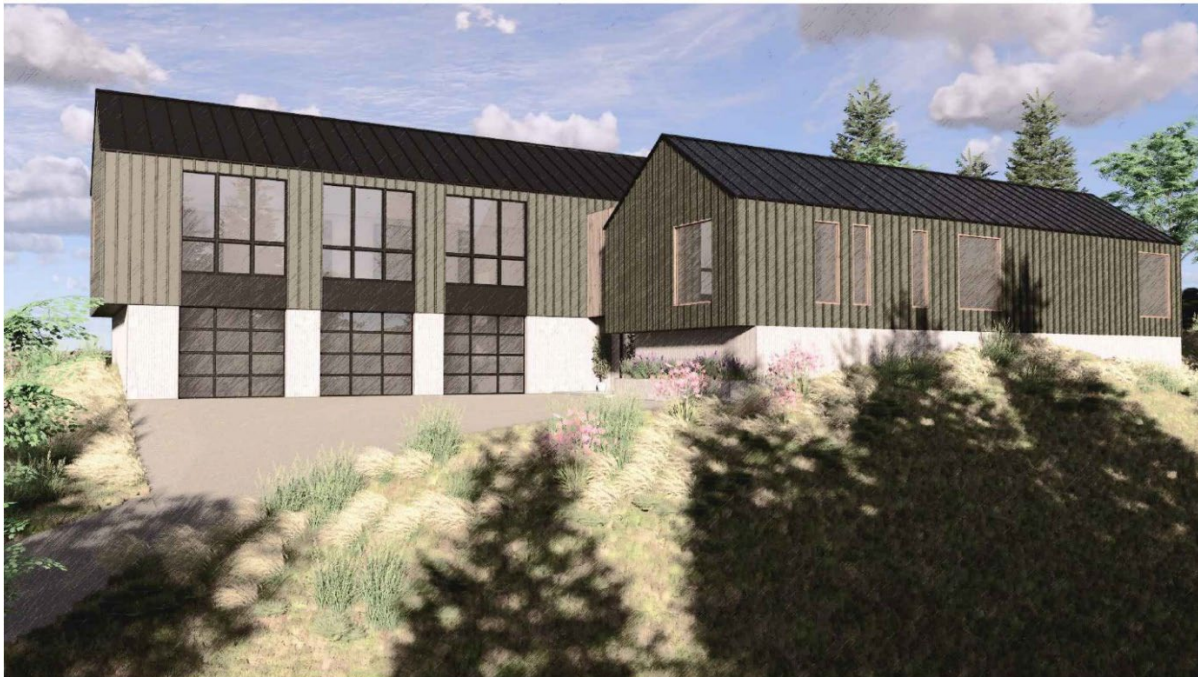
Plate 3 –Schematic View from the East, dated 5/23/25, by Citizen Design.

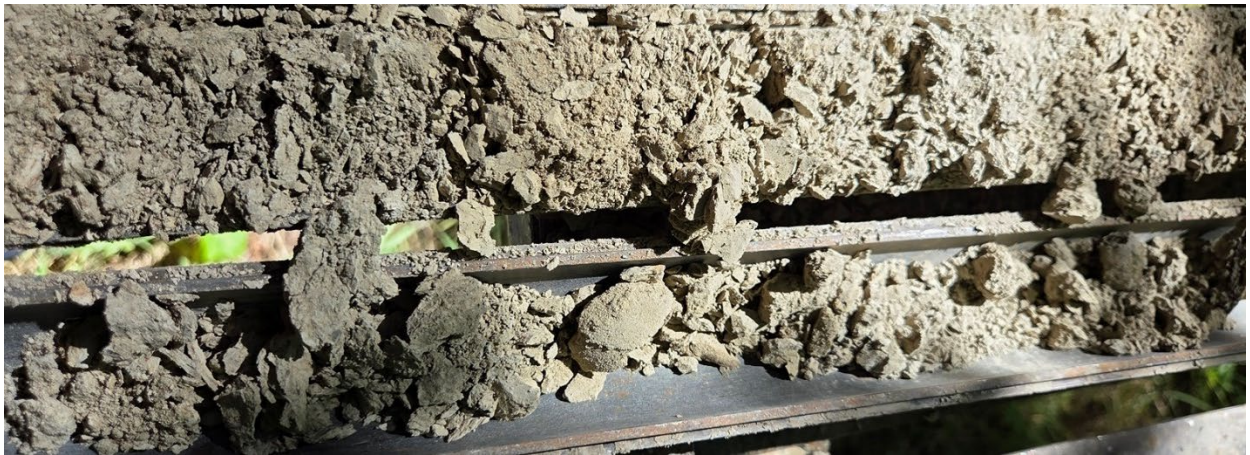
Plate 4 – Pre-Olympia, Non-glacial Fine Grained: Hard, sandy SILT (Qponf) | PG-1-25, S-4 @ 7½ – 9 feet.

Selected Sample Photos: Plates 4 through 6 below depict select soil samples obtained from our recent test borings. For reference purposes, the split-soon samplers pictured below have an outside diameter of 2 inches.

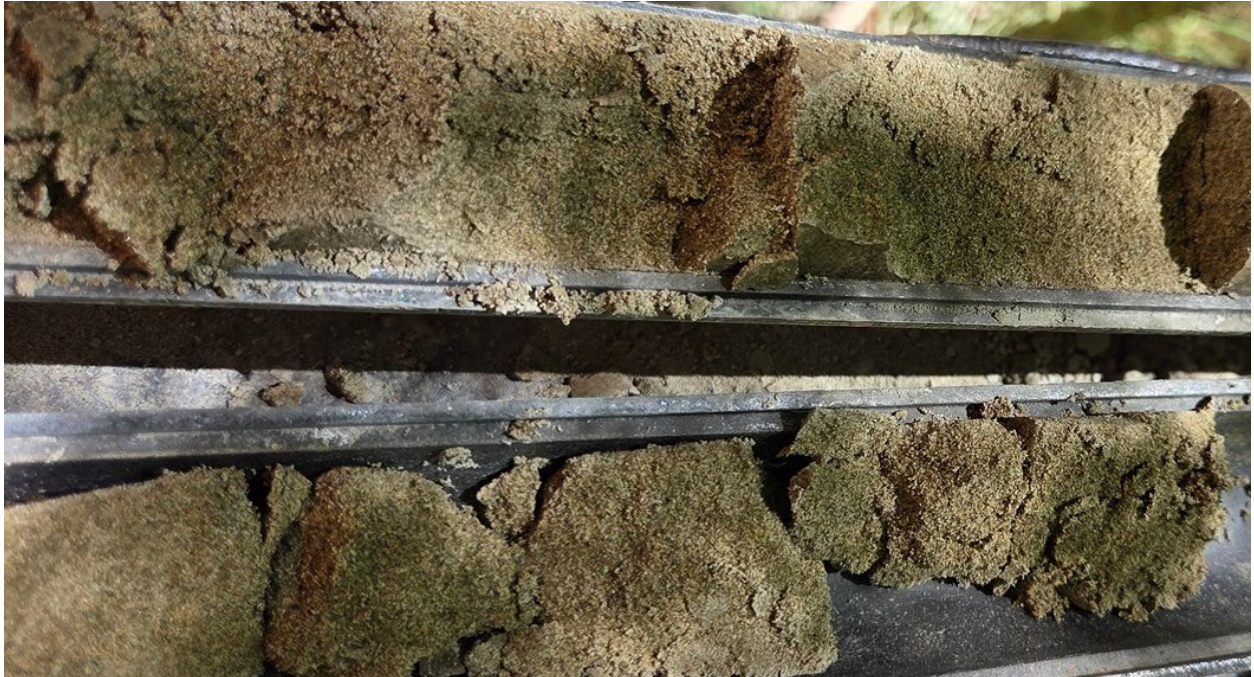
Plate 5 – Pre-Olympia, Non-glacial Coarse Grained: Very dense fine SAND with silt (Qponc) | PG-1-25, S-9 @ 25-26½ feet.

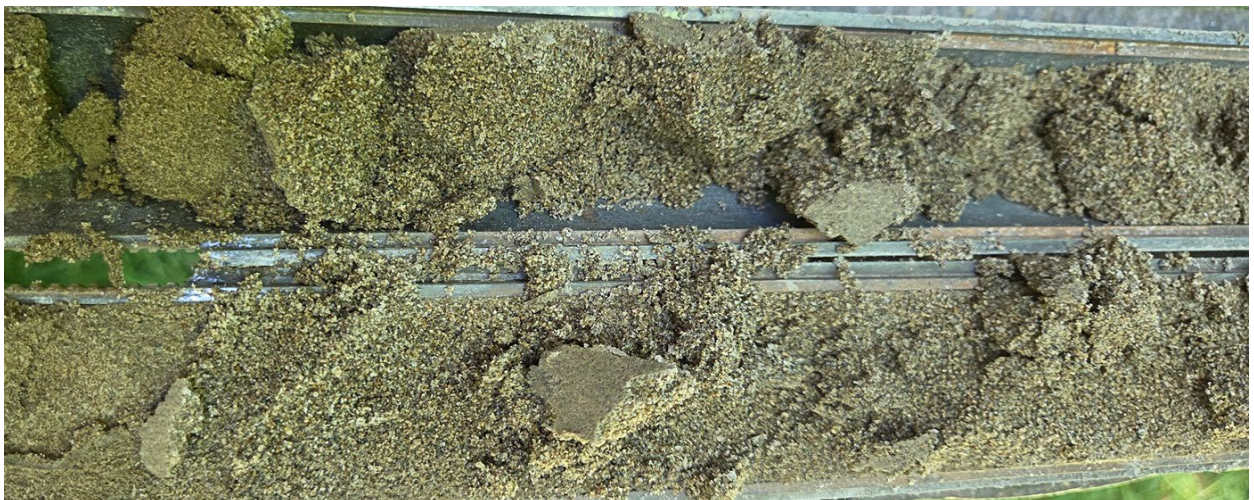
Plate 6 – Pre-Olympia, Non-glacial Coarse Grained: Medium Dense to Very dense, SAND, with silt | PG-2-25, S-4 @ 7½-9 feet.

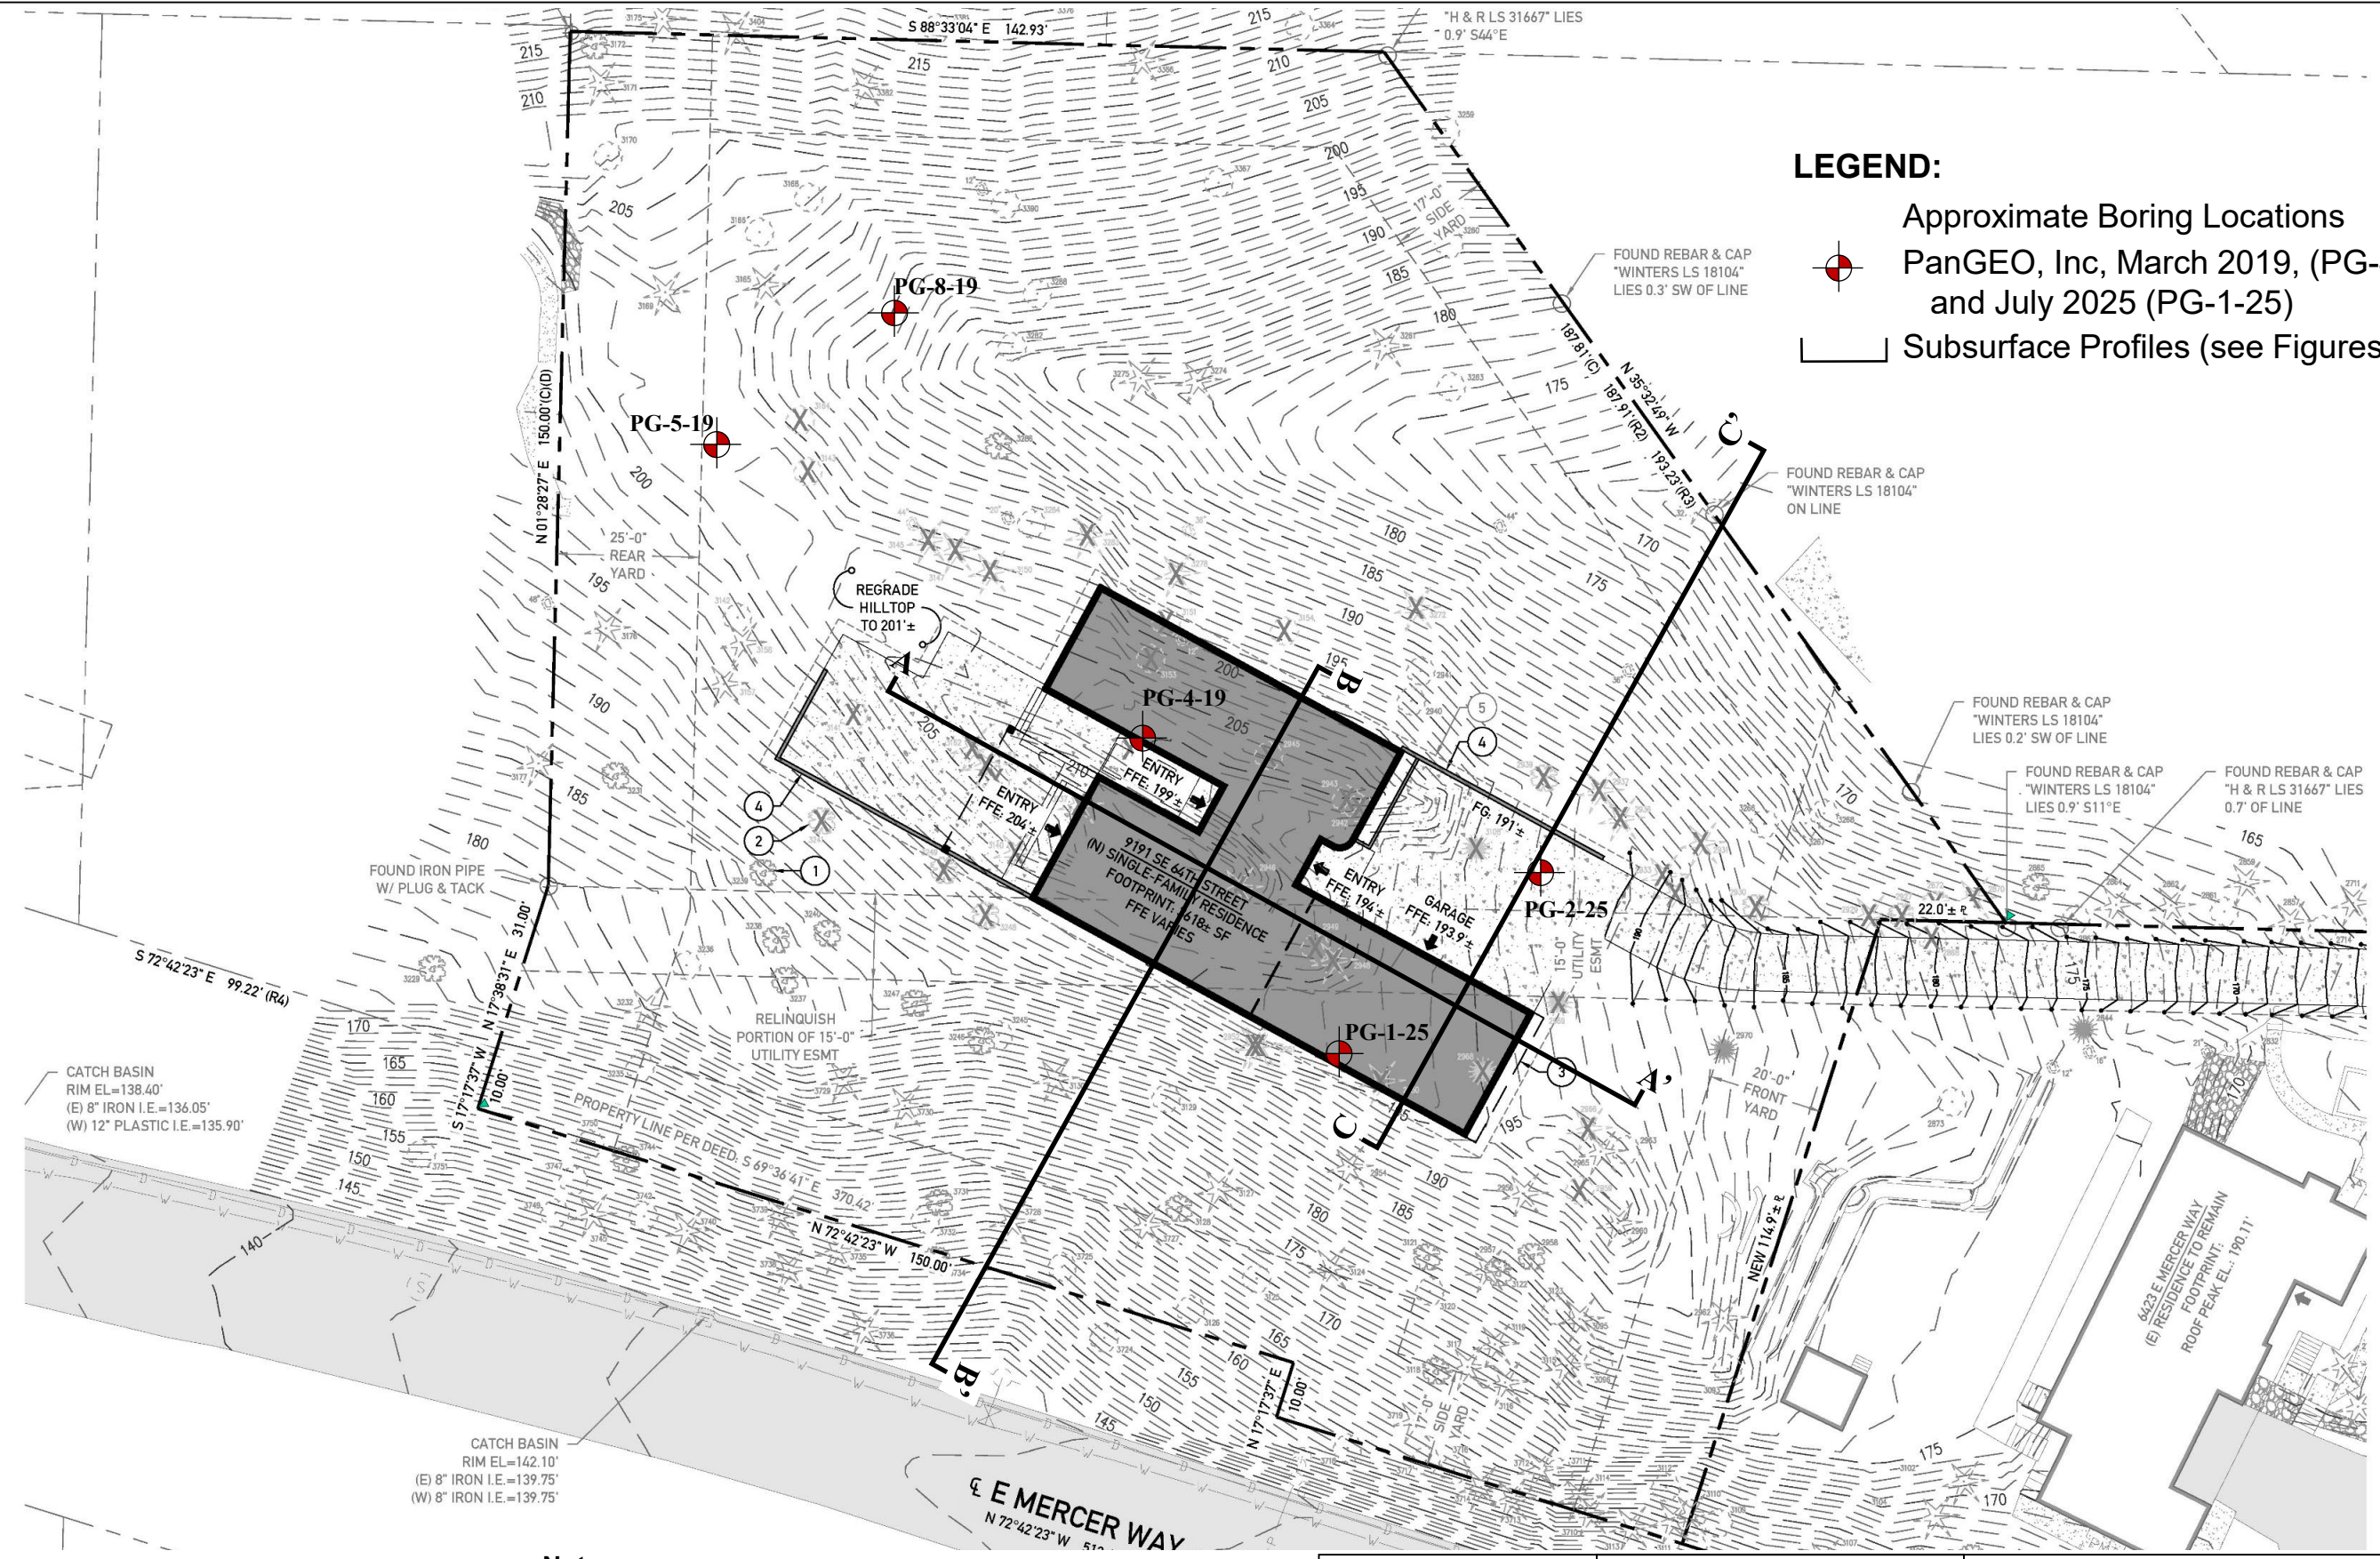
Project No.	Figure No.
25-036.200	2

Subsurface Profiles (see Figures 3 to 5)

The project site consists of an irregularly shaped, undeveloped parcel located at 9191 SE 64th Street, on the east side of Mercer Island, Washington (see Figure 1, *Vicinity Map*). The current property includes an original parcel identified by the parcel number 302405-9001 (address 9191 SE 64th Street, per City of Mercer Island), a 25,125 square-foot parcel. As the original property line ran down the center of the ridgeline (topography discussed below), the portion of the property at 6423 East Mercer Way south of the original lot, down to East Mercer Way, was added to the present site (see Figure 2, *Site and Exploration Plan*) to yield the current 47,398 square-foot property.

North of the ridgeline, between the house site and the steep slope rising the SE 64th Street, there is an open, incised drainage swale. Moderate to steep slopes descending into this swale form the north flank of the ridgeline (see Figure 2).

Current plans call for developing the house footprint on the central portion of the ridgeline discussed above (see Figure 2). We understand that the house will be multi-level, with the garage level at approximately elevation 194 feet, the main level on the north portion of the house at elevation 199 feet, and the main living area on the south section of the house at elevation 201 feet. All elevations are assumed to be NAVD88. The preliminary plans call for a complex, multilevel excavation, with cuts up to 20 feet in some locations. However, since the cuts are removing the ridge crest, resulting open cuts are generally less than 8 to 10 feet.

PanGEO completed five test borings at the subject site. Three of the borings (PG-4-19, PG-5-19 and PG-8-19) were completed during our previous exploration program on March 7, 2019 and March 21, 2019. Two additional borings (PG-1-25 and PG-2-25) were drilled on the revised house footprint on July 1, 2025. The 2019 borings were advanced to between 14 and 41½ feet below the existing ground surface using an EC-95 track mounted drill owned and operated by Borettec, Inc. The 2025 borings were advanced to depths of 41½ and 36½ feet below ground surface, respectively. They were drilled using a track-mounted Acker Recon drill rig owned and operated by Geologic Drill Partners of Fall City, Washington. The approximate boring locations are shown on the attached Figure 2.

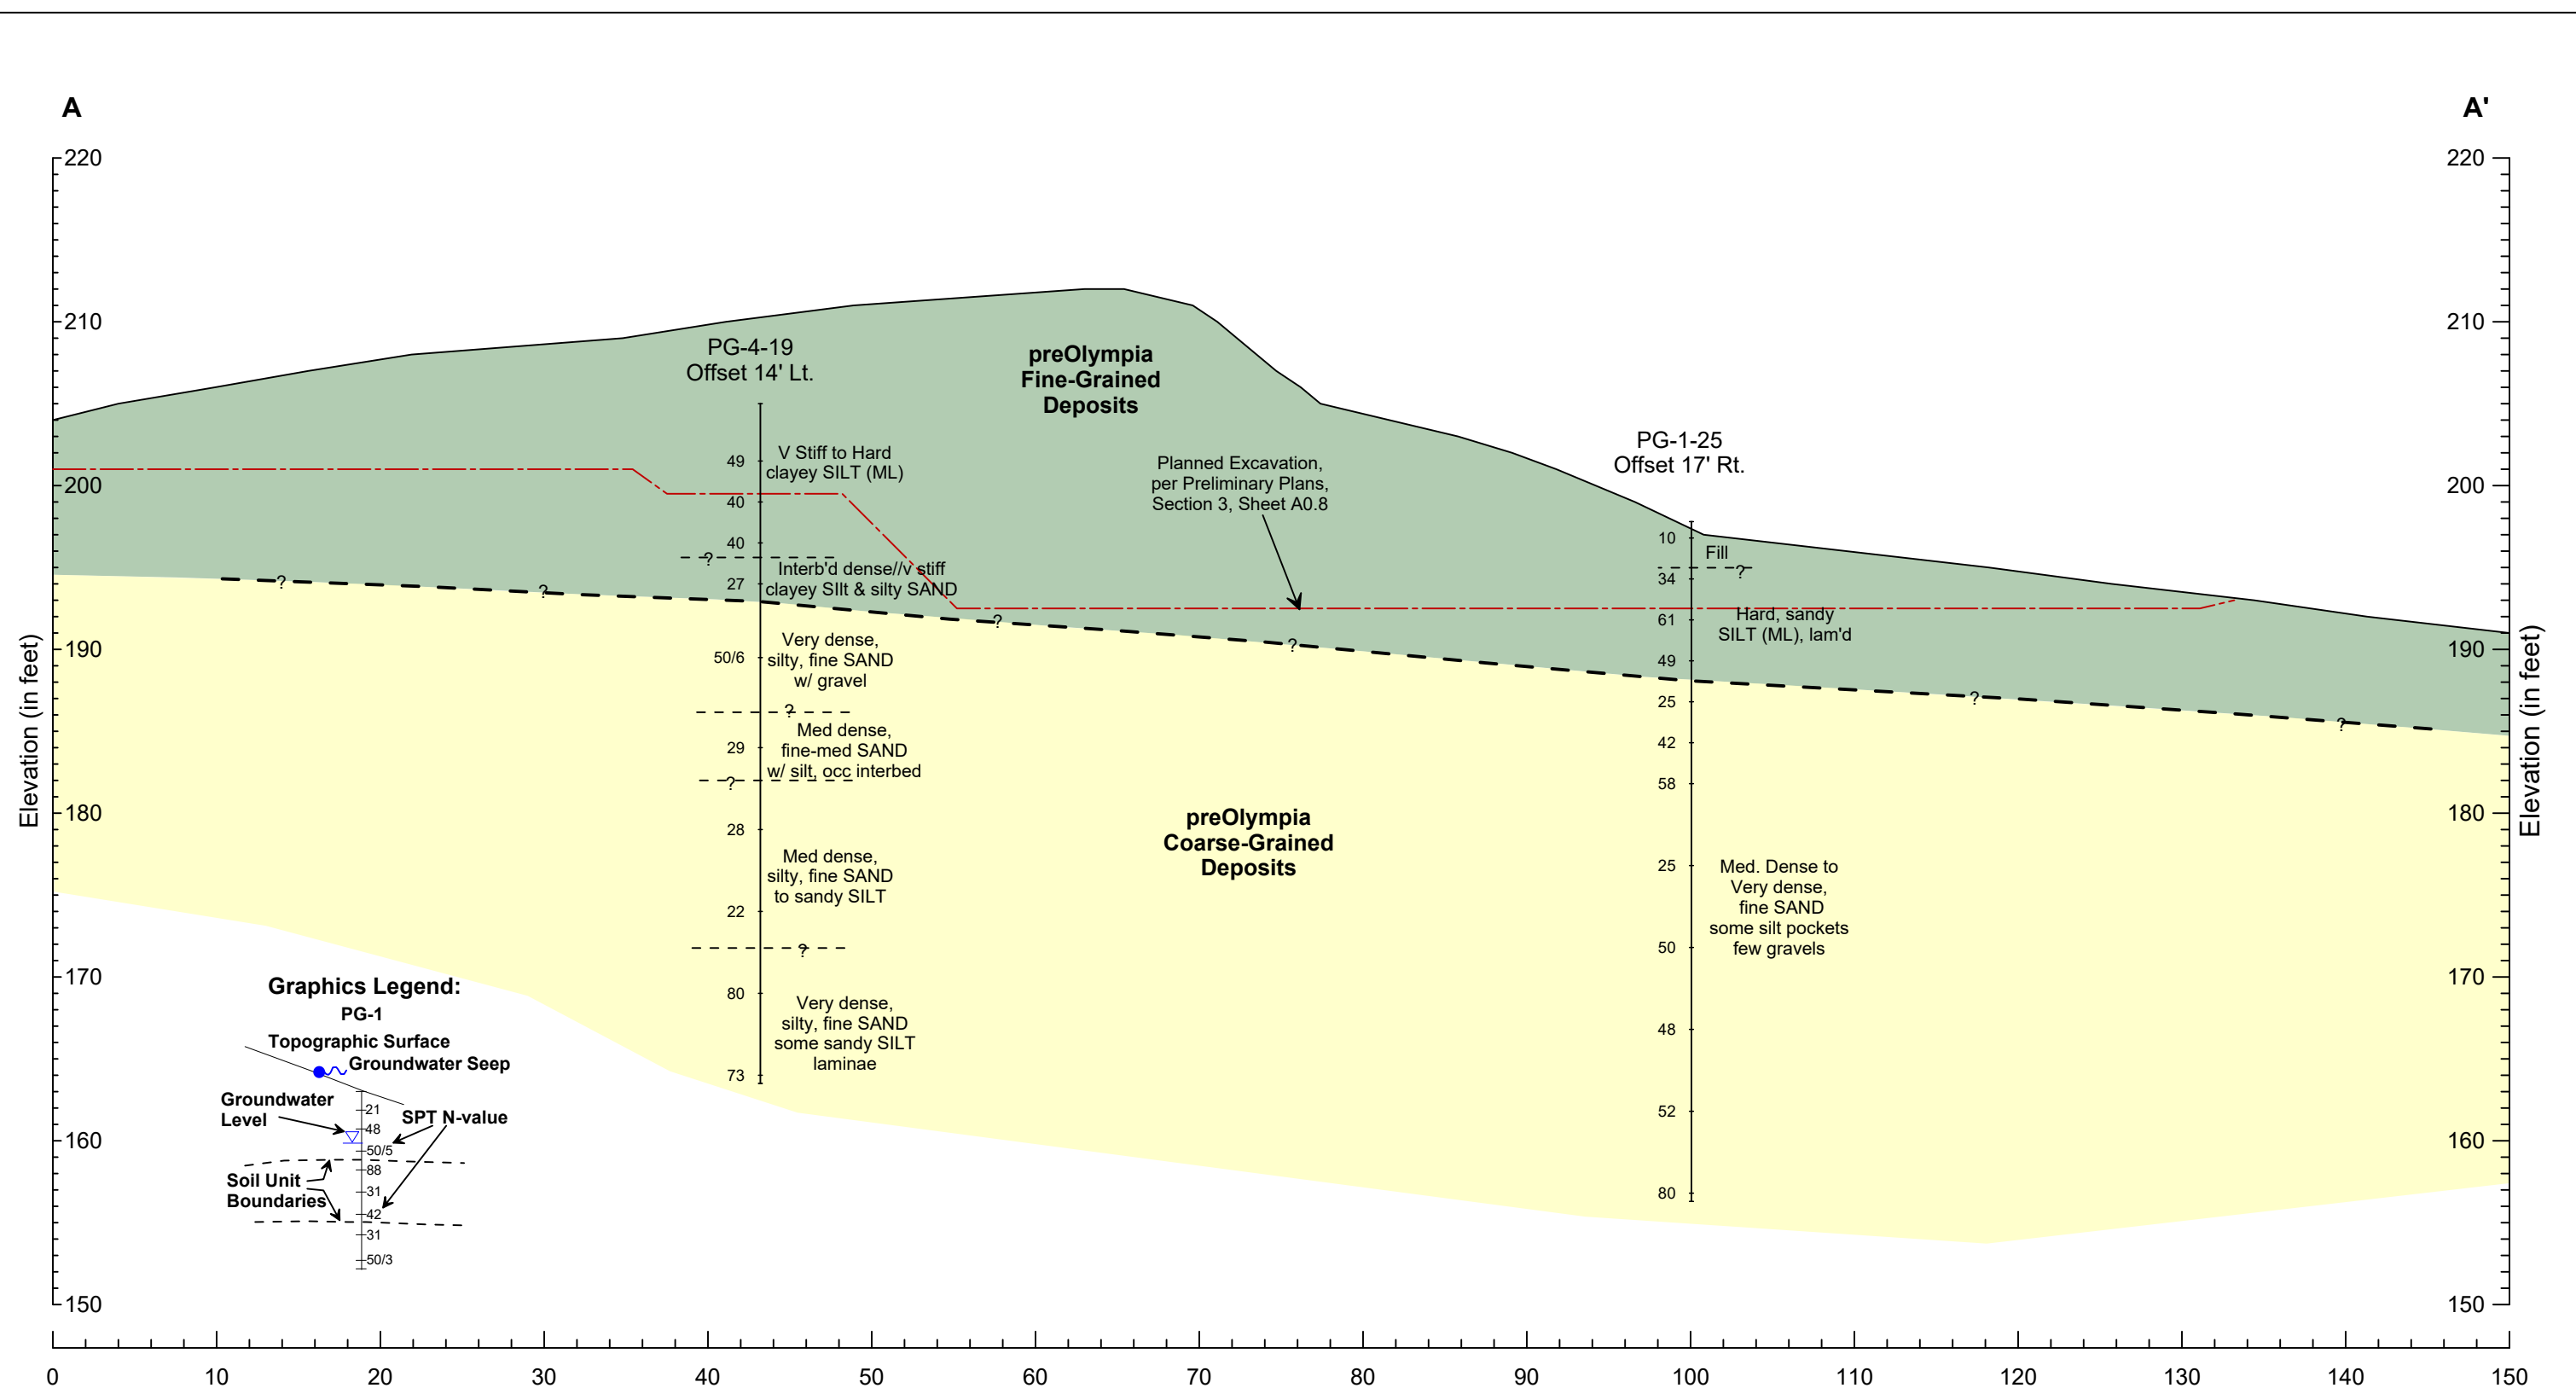
- Notes:**
- Existing ground profile based on topographic survey by Informed Land Survey.
 - Transitions between soil units and in between explorations are best estimates and may vary from the actual soil conditions.
 - See report text for detailed descriptions of subsurface conditions across site.
 - See Appendix A for detailed exploration logs.
 - See Figure 2 for Site Plan with approximate profile location.
 - Planned Cut Elevations from Sheets A0.7 and A0.8, MI 6429 Lot A Schematic 25.0523.pdf design drawing.
 - Vertical Datum assumed to be NAVD88.

Proposed Single Family Residence 9191 SE 64th Street Mercer Island, Washington	GENERALIZED SUBSURFACE PROFILE - SECTION A-A'	
		Project No. 25-036.200	Figure No. 3

The interpreted subsurface conditions are depicted in Figures 3, 4 and 5 – *Generalized Subsurface Profiles A-A', B-B' and C-C'*, respectively, and brief descriptions of the generalized soil conditions encountered at the locations of the test borings advanced at the site are presented below. Please refer to the summary boring logs in *Appendix A* for more details. A layer of colluvium (mass wasting deposit) was encountered in PG-8-19, but as this boring was not located near the proposed house footprint, the soil unit is not included in the descriptions below.

The stability of a slope depends on a variety of factors, including the geometry of the slope, the subsurface stratigraphy, material properties of the soils, the location of groundwater, and the effects of surface loads. Based on our understanding of the subsurface conditions at the site, the topography shown on Figure 2, and site features observed during our site reconnaissance, we developed generalized subsurface profiles through the site as shown on Figure 2, and presented in Figures 3, 4 and 5. We selected subsurface profile B-B' as the most critical section for our analyses.

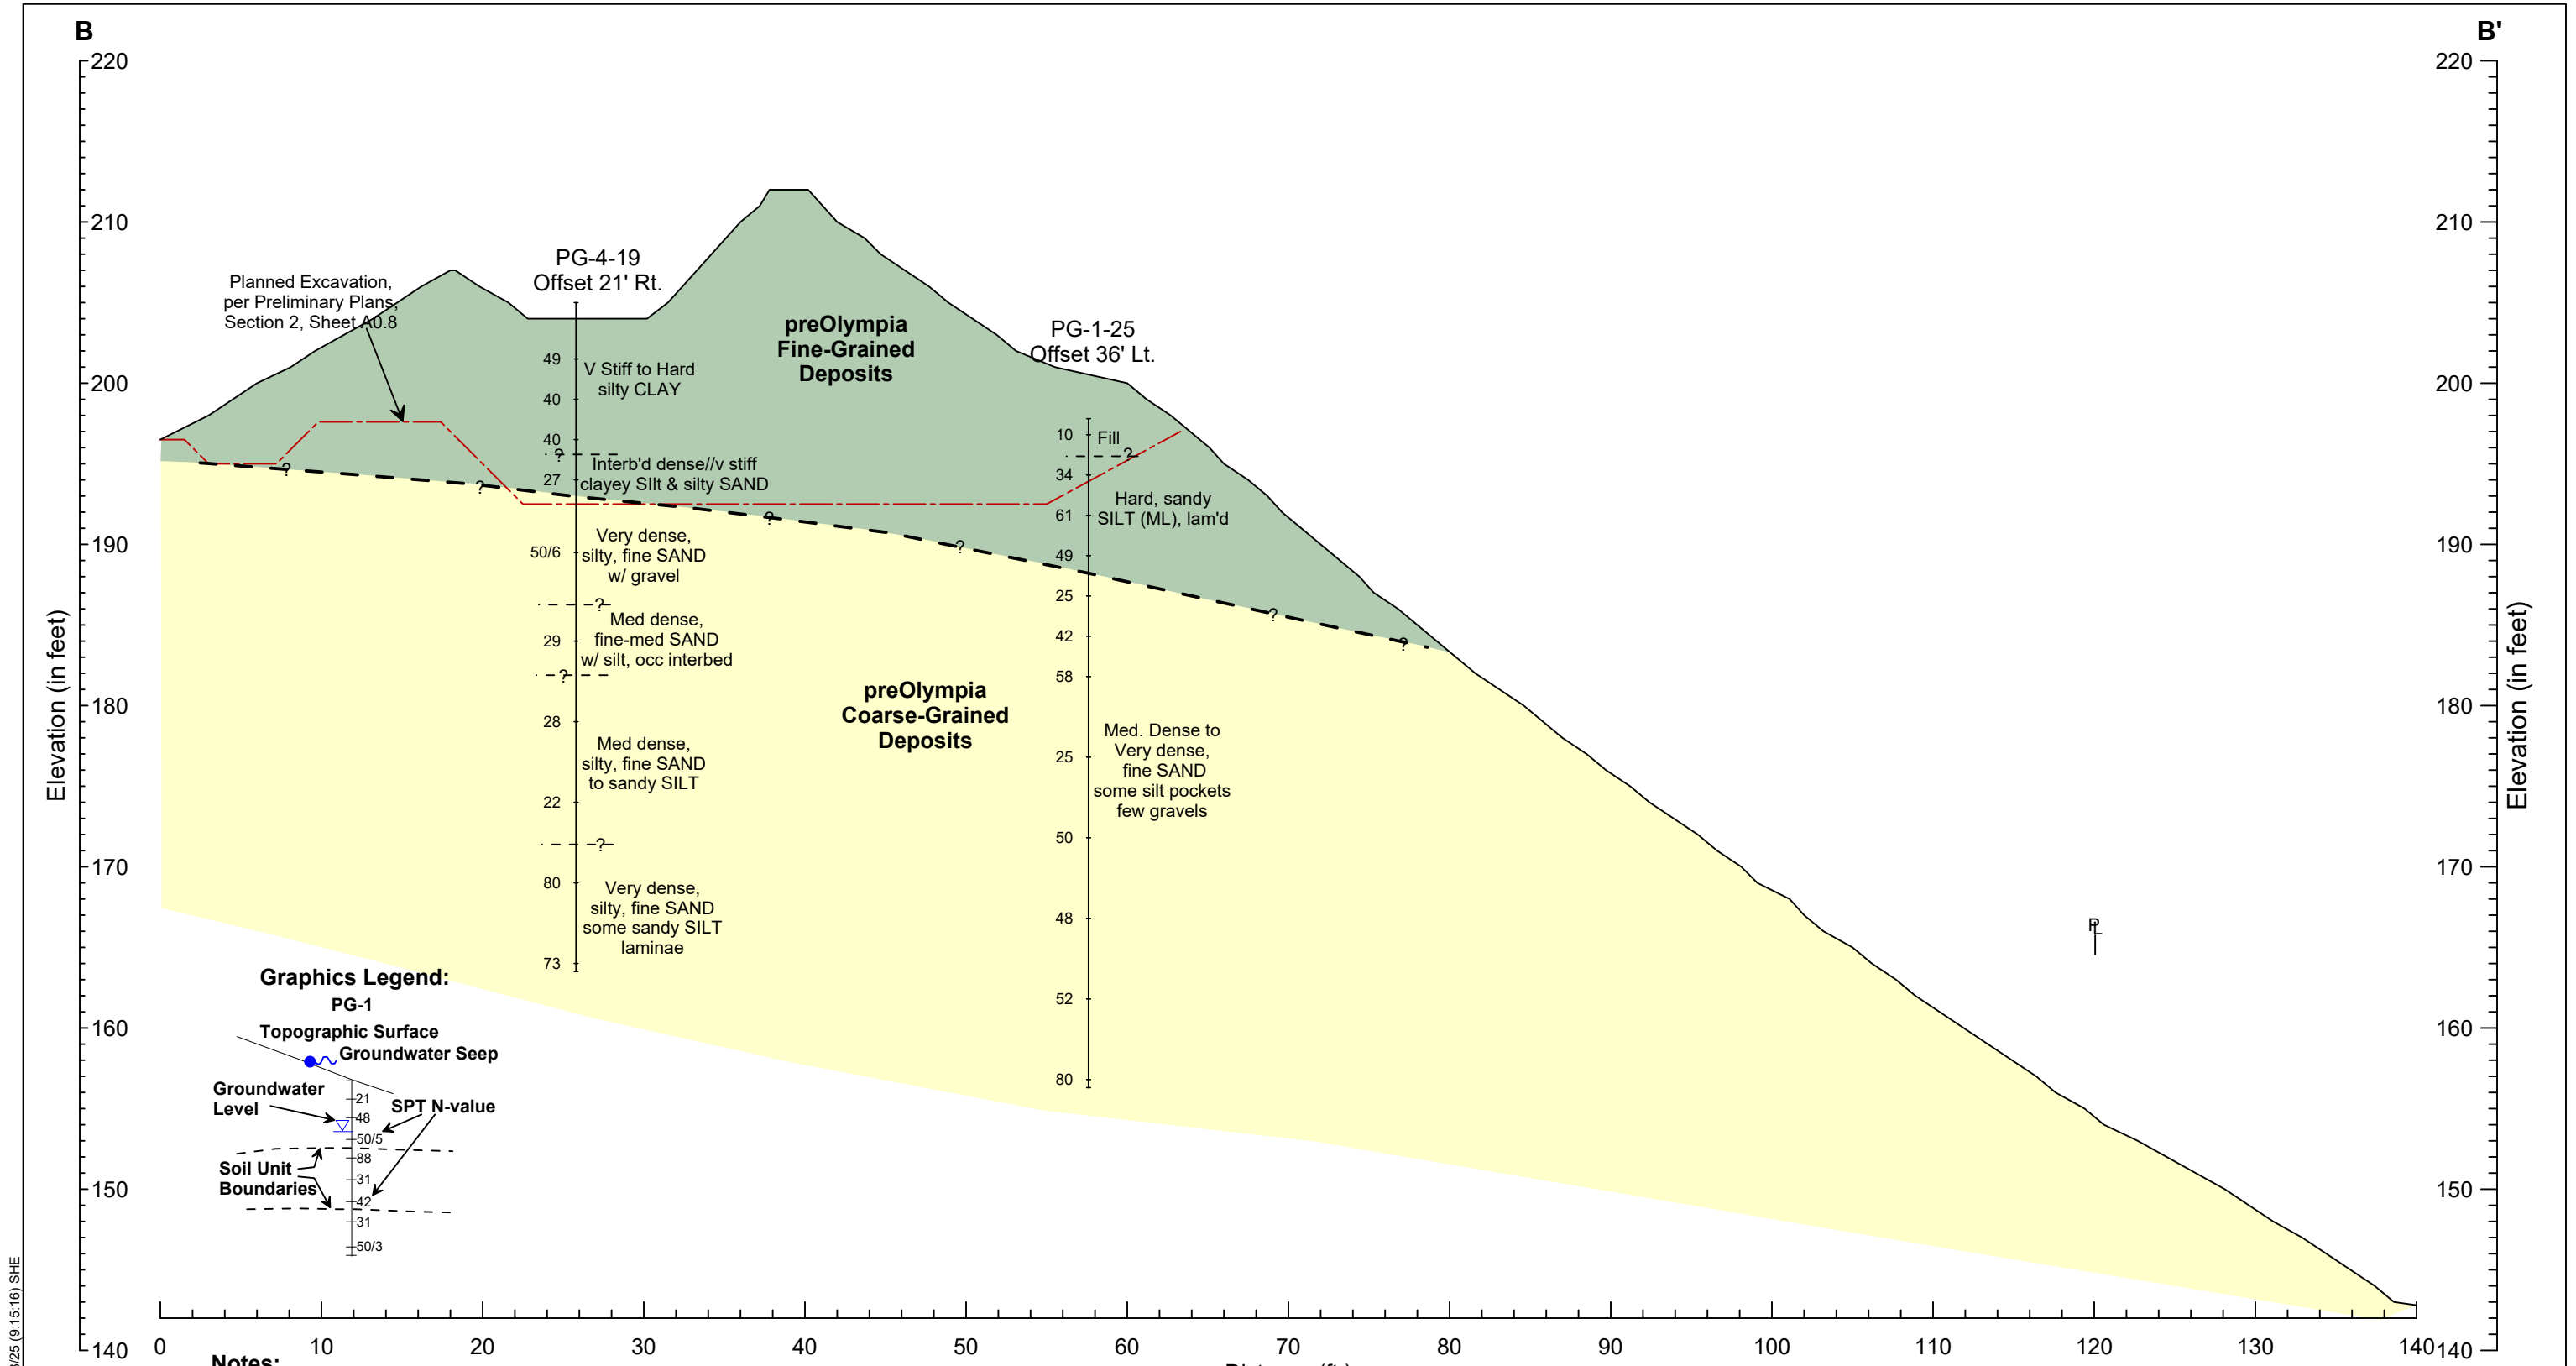
- Notes:**
- Existing ground profile based on topographic survey by Informed Land Survey.
 - Transitions between soil units and in between explorations are best estimates and may vary from the actual soil conditions.
 - See report text for detailed descriptions of subsurface conditions across site.
 - See Appendix A for detailed exploration logs.
 - See Figure 2 for Site Plan with approximate profile location.
 - Planned Cut Elevations from Sheets A0.7 and A0.8, MI 6429 Lot A Schematic 25.0523.pdf design drawing.
 - Vertical Datum assumed to be NAVD88.

Proposed Single Family Residence 9191 SE 64th Street Mercer Island, Washington	GENERALIZED SUBSURFACE PROFILE SECTION B-B'	
		Project No. 25-036.200	Figure No. 4

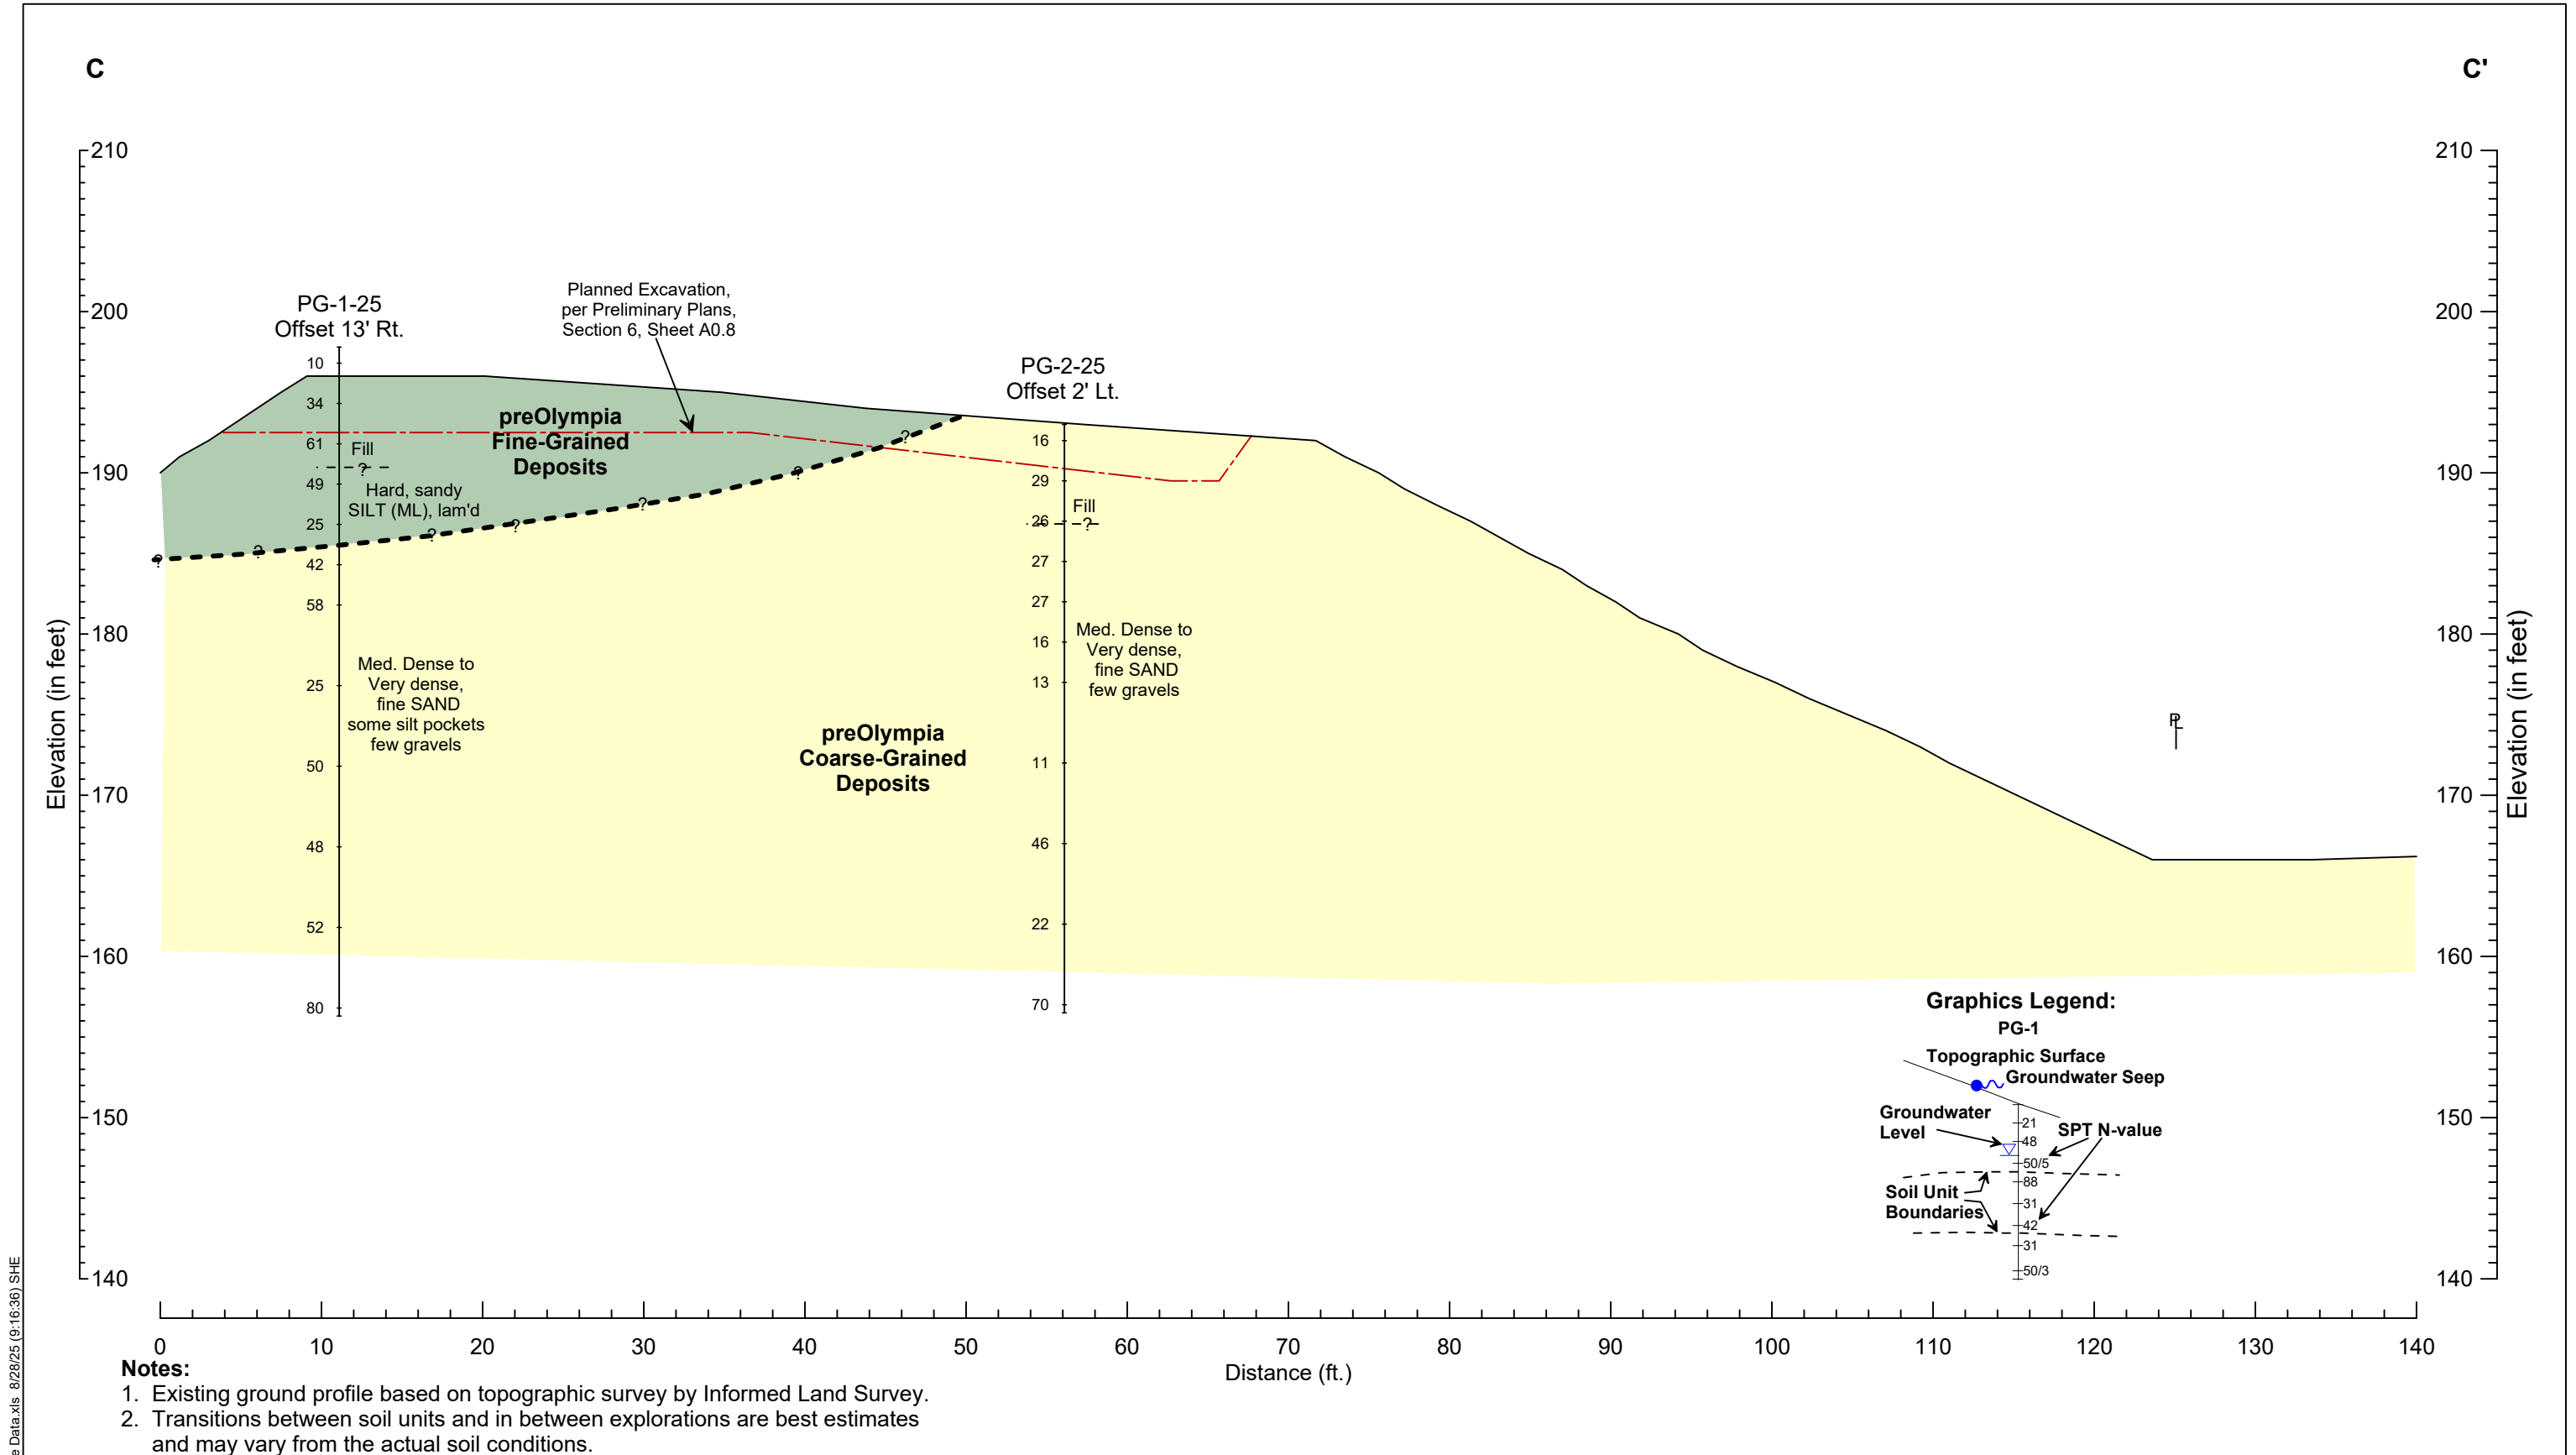
- Notes:**
- Existing ground profile based on topographic survey by Informed Land Survey.
 - Transitions between soil units and in between explorations are best estimates and may vary from the actual soil conditions.
 - See report text for detailed descriptions of subsurface conditions across site.
 - See Appendix A for detailed exploration logs.
 - See Figure 2 for Site Plan with approximate profile location.
 - Planned Cut Elevations from Sheets A0.7 and A0.8, MI 6429 Lot A Schematic 25.0523.pdf design drawing.
 - Vertical Datum assumed to be NAVD88.

Proposed Single Family Residence 9191 SE 64th Street Mercer Island, Washington	GENERALIZED SUBSURFACE PROFILE SECTION C-C'	
		Project No. 25-036.200	Figure No. 5
