GEOTECHNICAL ENGINEERING REPORT PROPOSED SINGLE-FAMILY RESIDENCE 9191 SE 64th Street Mercer Island, Washington

PROJECT NO. 25-036.200
AUGUST 27, 2025

**Subject: Geotechnical Engineering Report
Proposed Single-Family Residence
9191 SE 64th Street, Mercer Island, Washington**

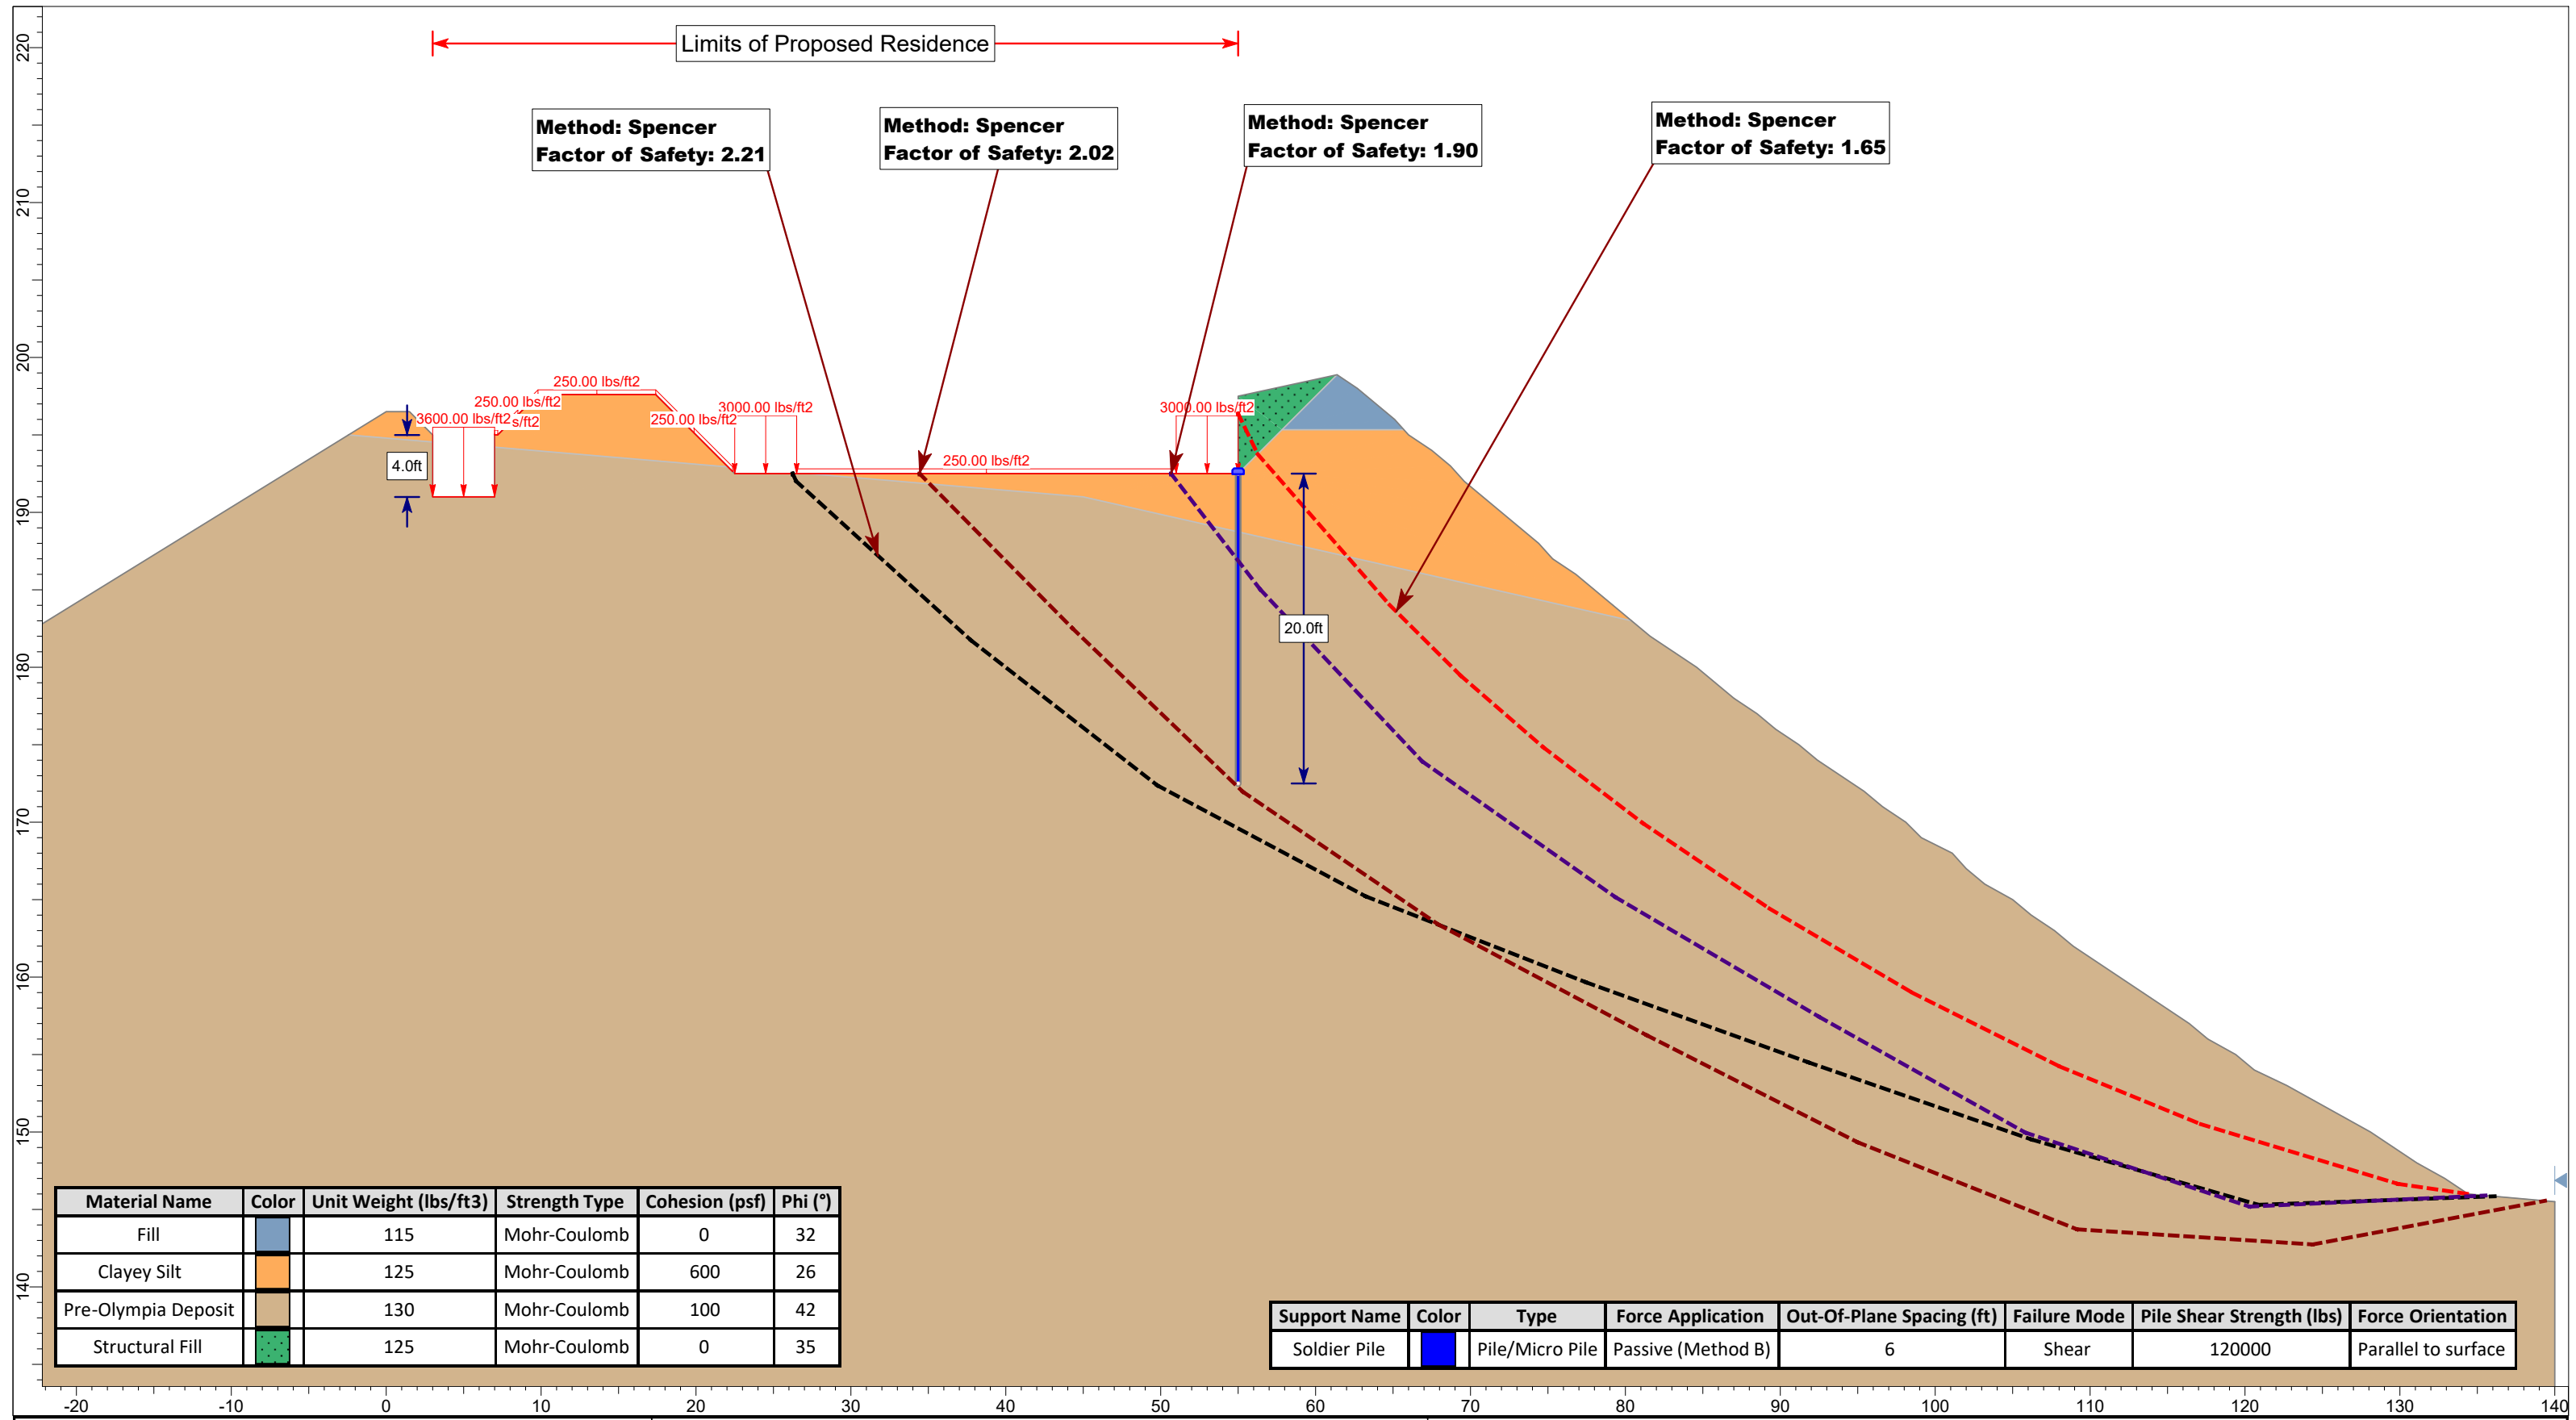
Figure No. **6A**

Static Slope Stability Analysis (right)

Soil & Groundwater Parameters - Soil parameters utilized in the stability analyses are shown on the attached Figures 6 and 7. Soil parameters were selected based on observed soil types, the results of standard penetration tests performed in the test borings, the results of laboratory testing, published correlations for soil units in the Puget Sound Area, and our experience.

Surcharge Loads – Estimated foundation surcharge loads were included in the model, as noted on Figures 6 and 7. The added mass of the recommended 4-foot-thick concrete bearing pad below the northern footings were also included as a surcharge load.

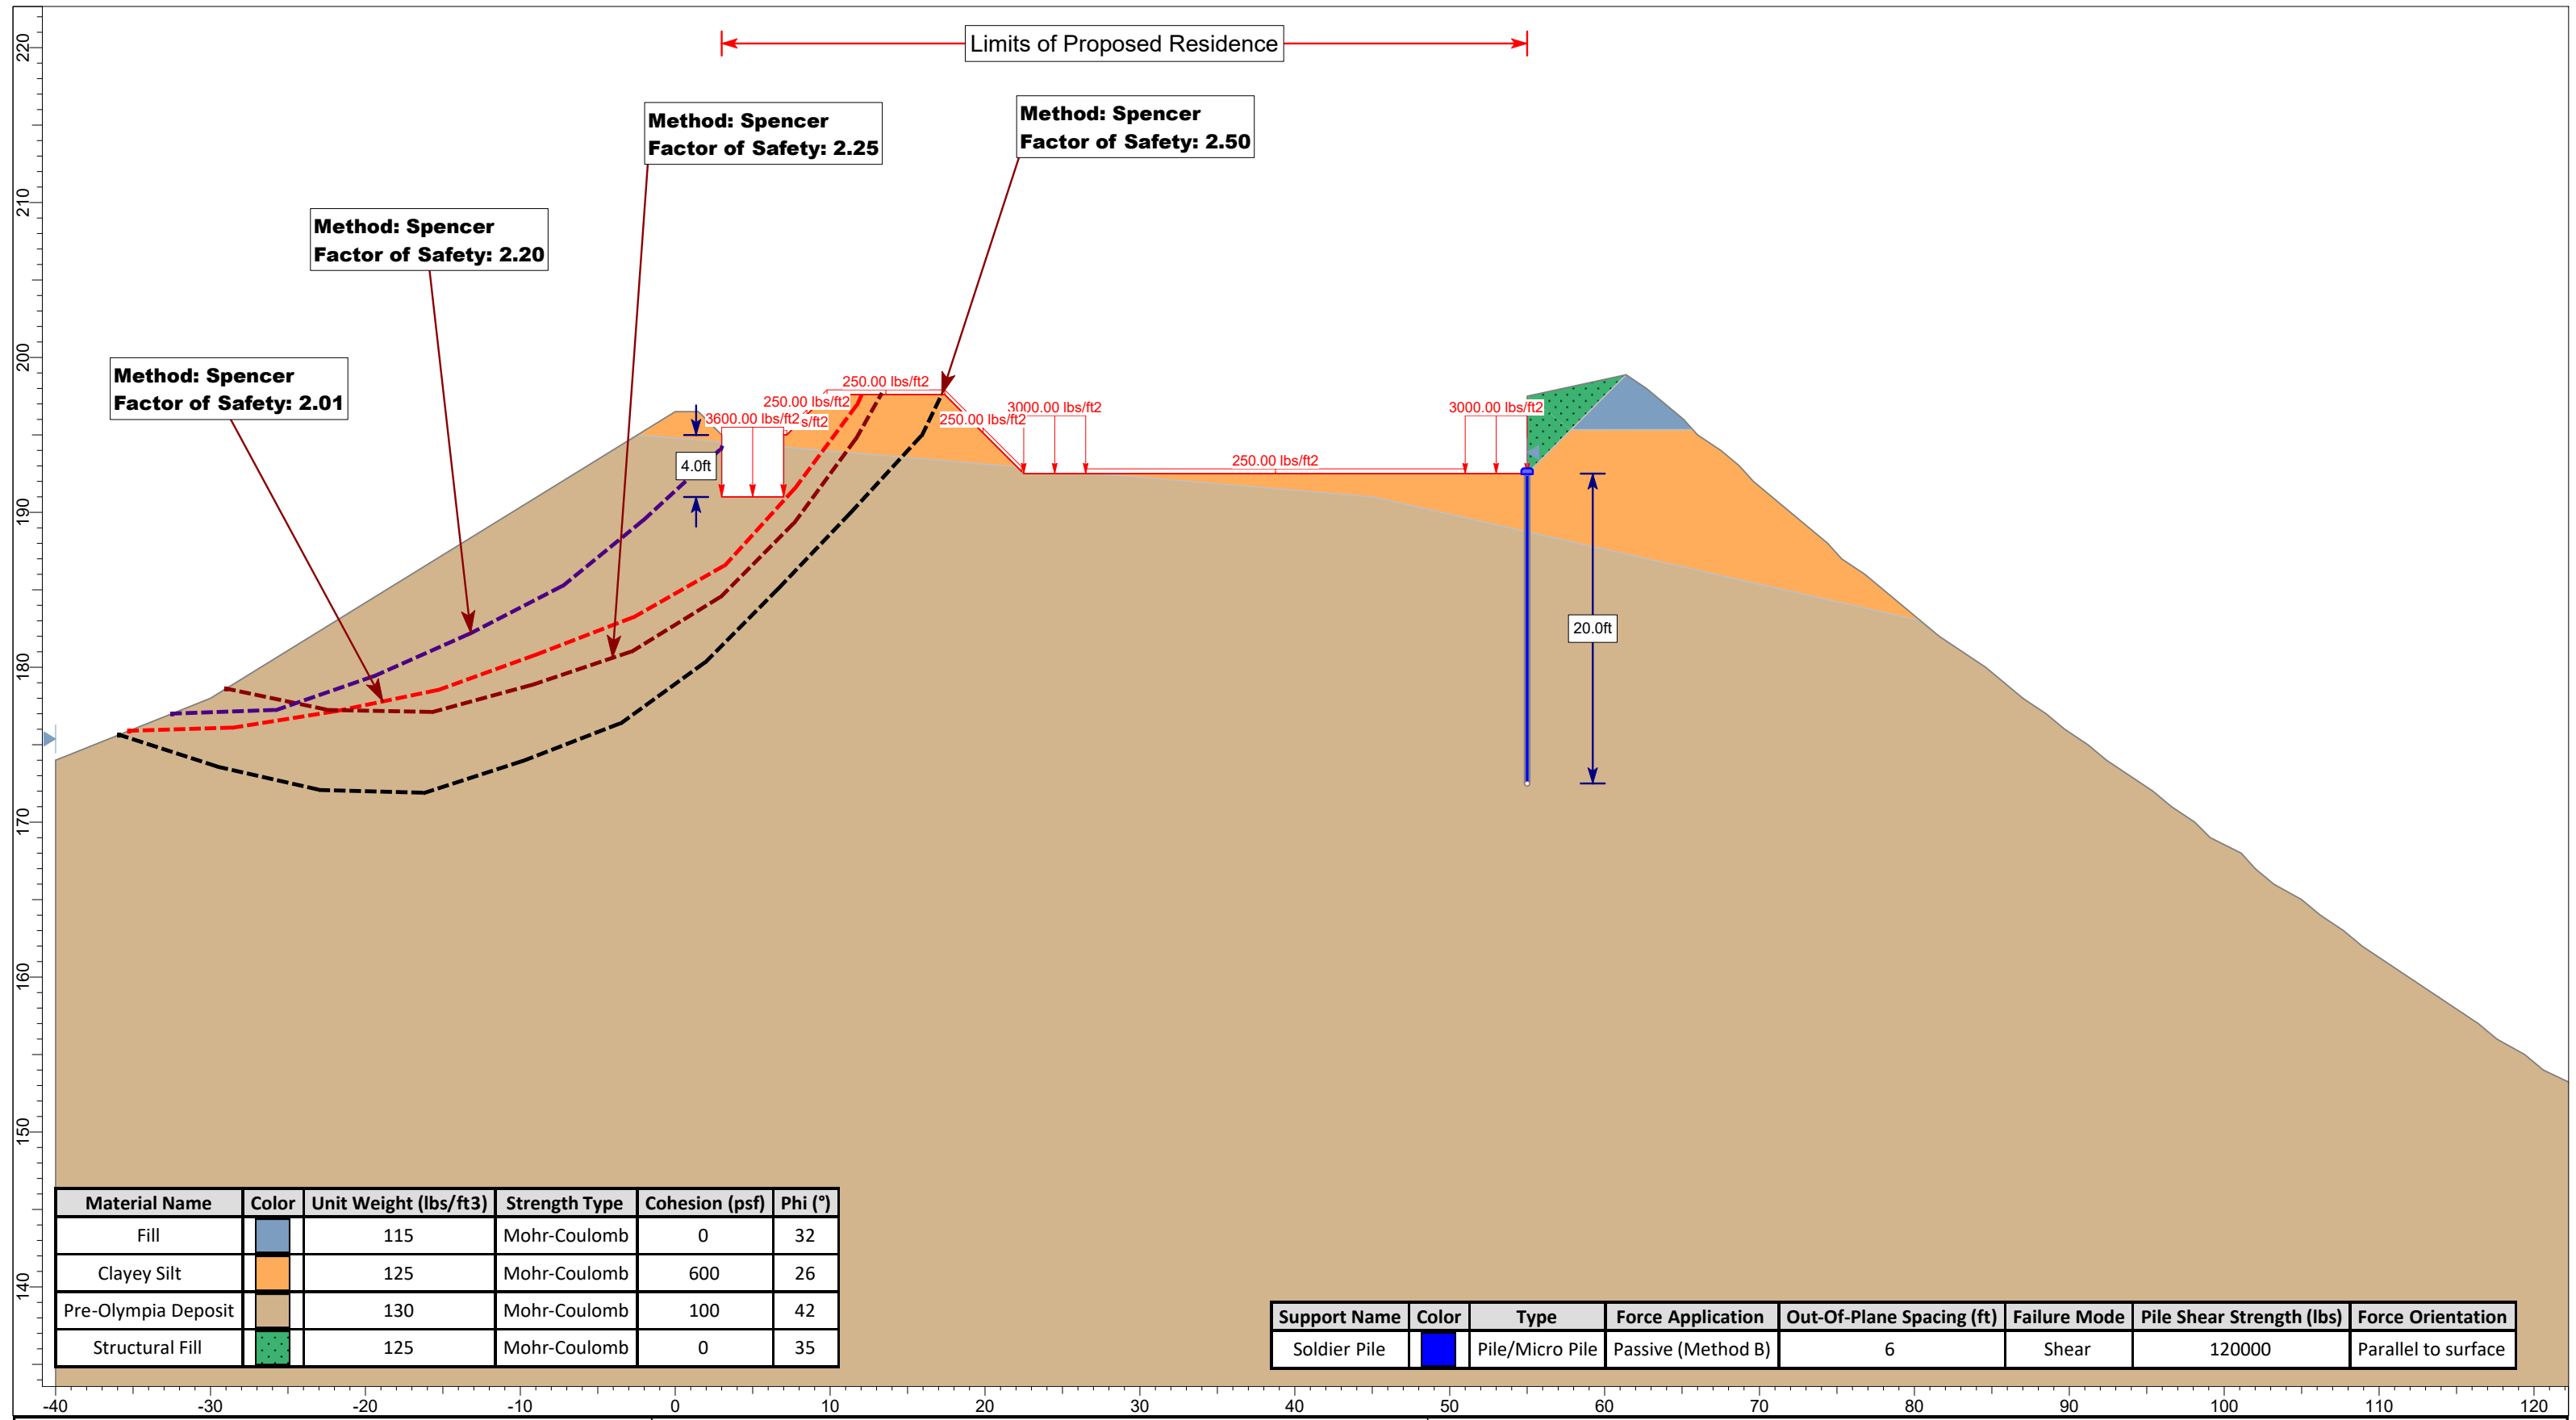
Material Name	Color	Unit Weight (lbs/ft ³)	Strength Type	Cohesion (psf)	Phi (°)
Fill	Blue	115	Mohr-Coulomb	0	32
Clayey Silt	Orange	125	Mohr-Coulomb	600	26
Pre-Olympia Deposit	Brown	130	Mohr-Coulomb	100	42
Structural Fill	Green Dotted	125	Mohr-Coulomb	0	35

Support Name	Color	Type	Force Application	Out-Of-Plane Spacing (ft)	Failure Mode	Pile Shear Strength (lbs)	Force Orientation
Soldier Pile	Blue	Pile/Micro Pile	Passive (Method B)	6	Shear	120000	Parallel to surface

Static Slope Stability Analysis (left)			
Section B-B'			
Scale:	Project No.	Figure No.	
1:120	25-036.200	7A

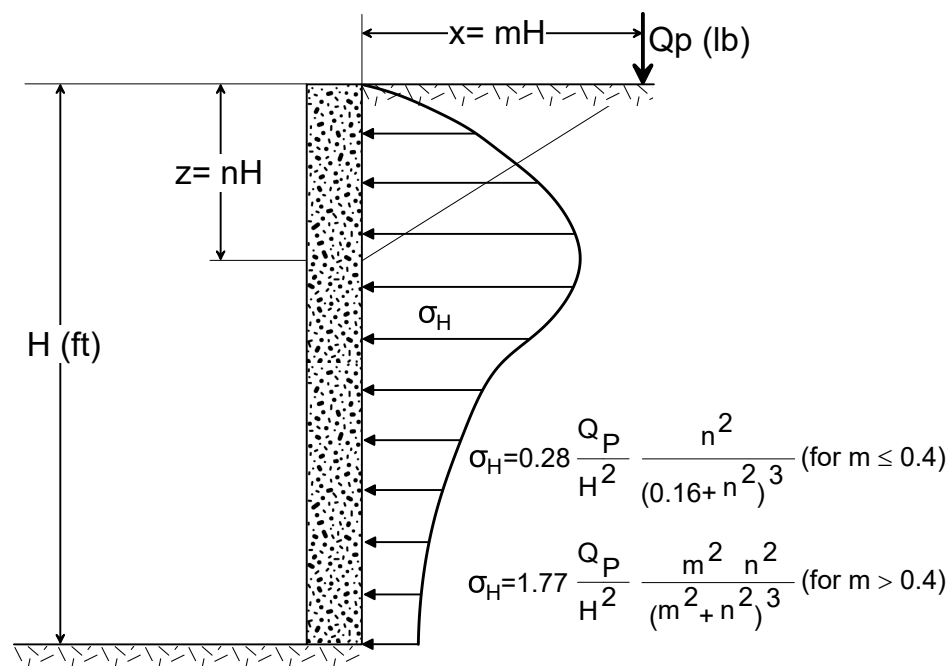
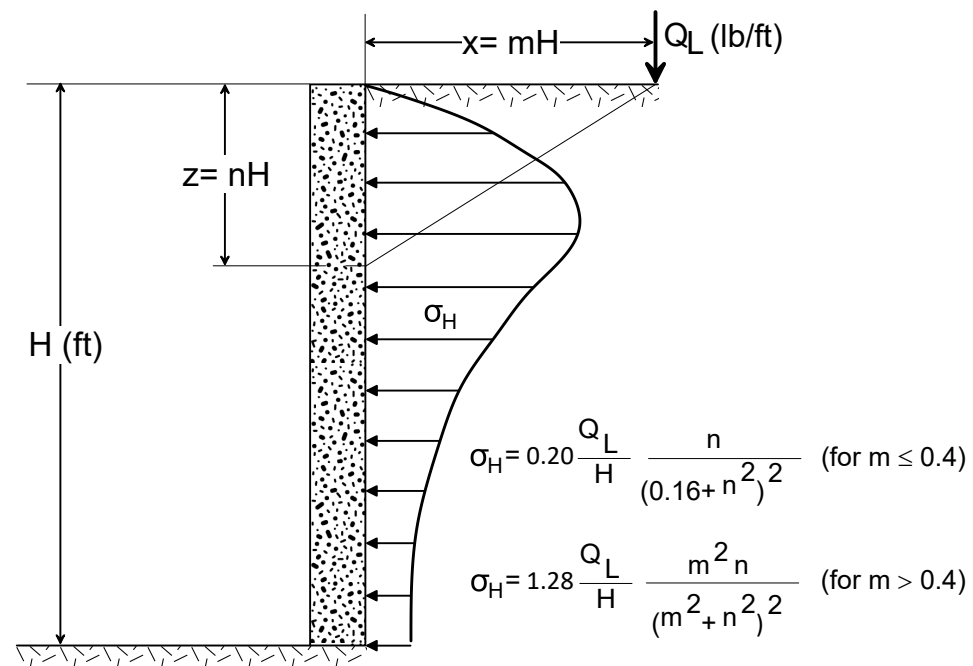
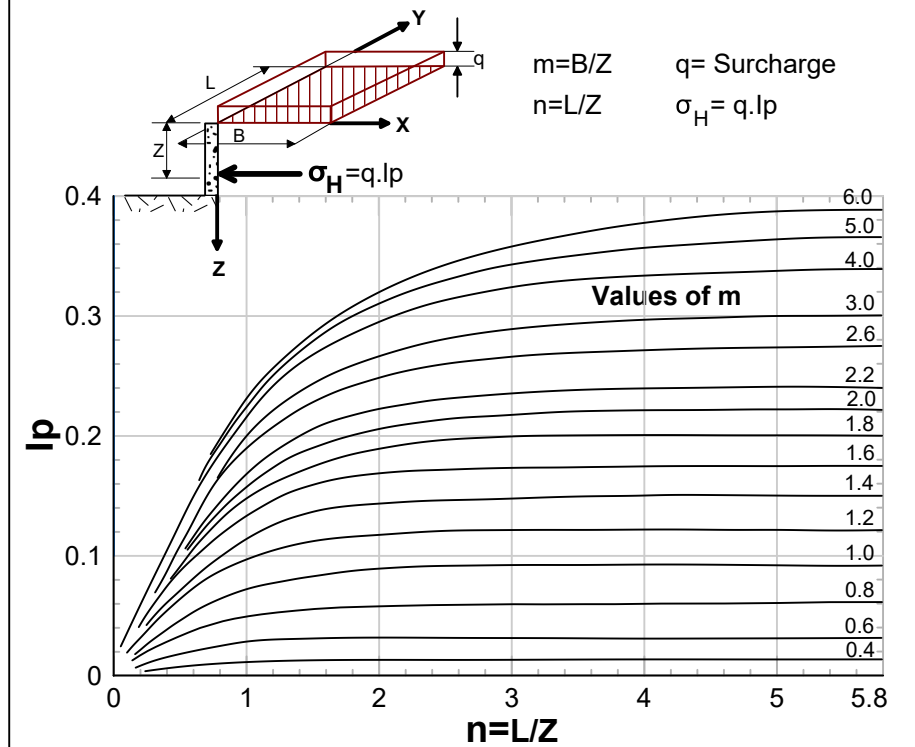
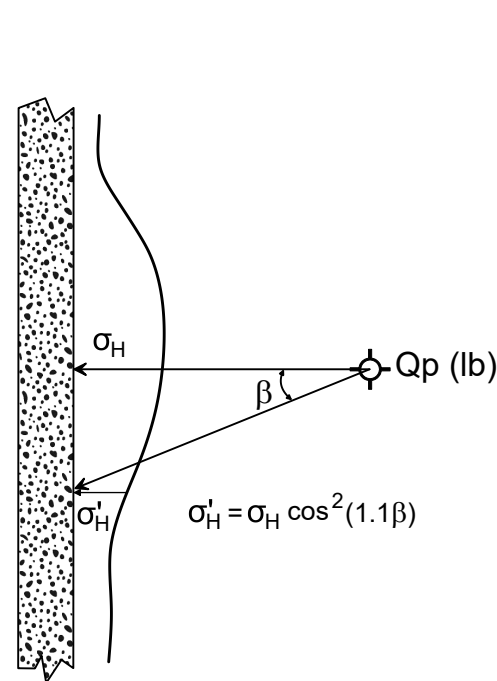
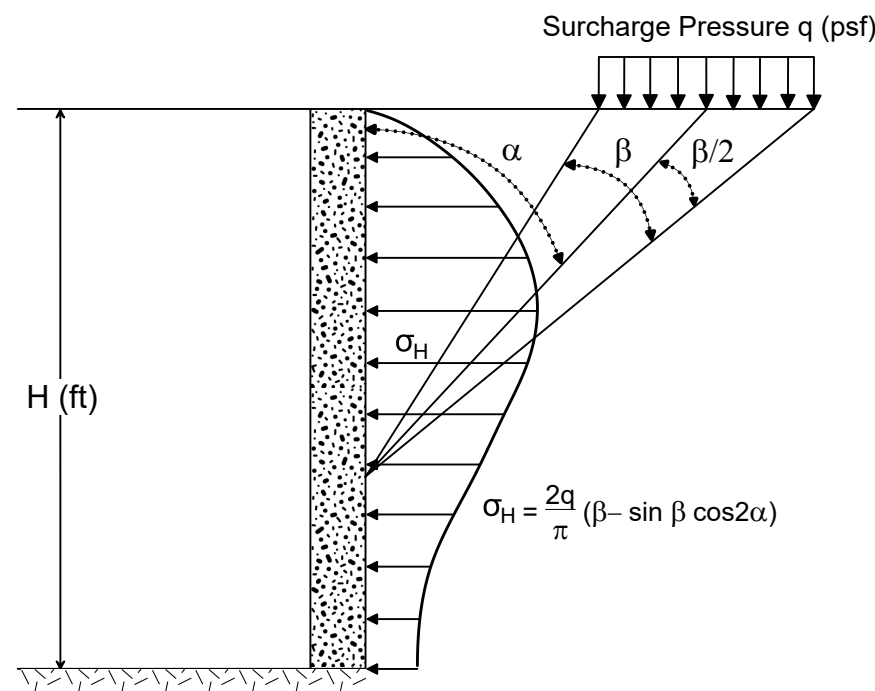
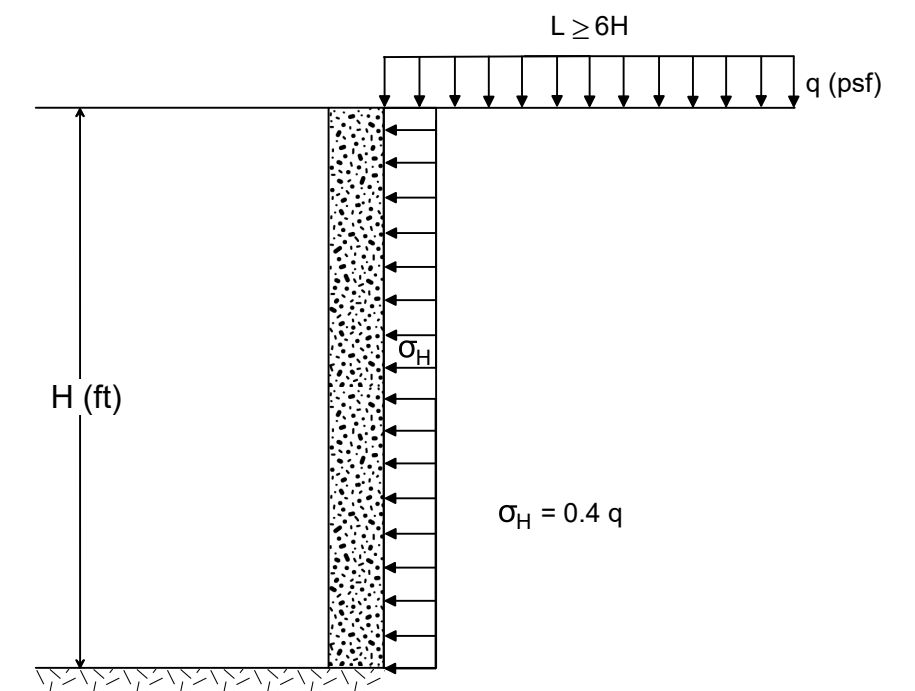
A-1) Lateral Pressure Due to Point Load- Elevation View

B) Lateral Pressure Due to Line Load-Parallel to the Wall

D) Lateral Pressure Due to Adjacent Footing

A-2) Lateral Pressure Due to Point Load- Plan View

C) Lateral Pressure Due to Strip Load-Perpendicular to the Wall

E) Lateral Pressure Due to Uniform Surcharge.
(For $L \leq 6H$ Use Chart D Above)

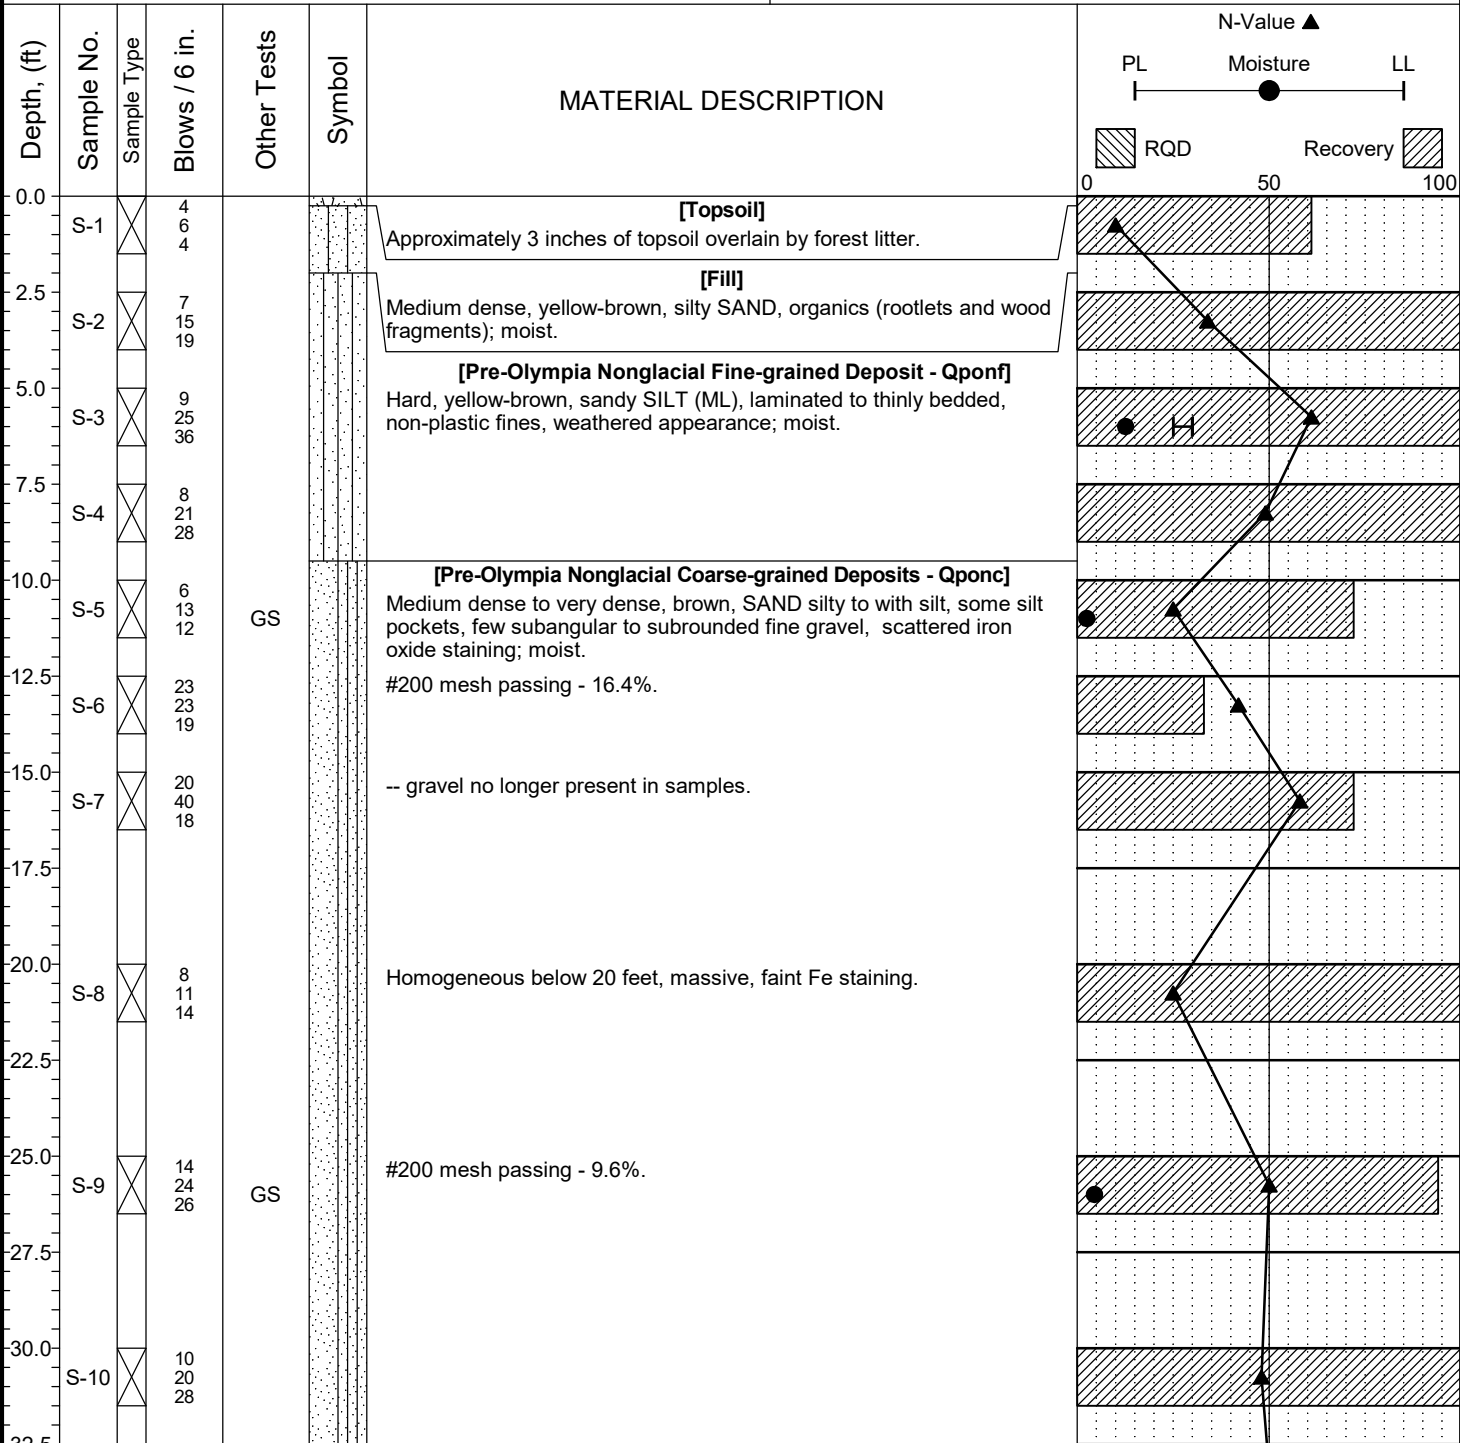
Project:	Proposed Single-Family Residence	Surface Elevation:	197.8ft
Job Number:	25-036.200	Top of Casing Elev.:	N/A
Location:	9191 SE 64th Street, Mercer Island, WA	Drilling Method:	HSA
Coordinates:	Northing: 47.54521, Easting: -122.2134	Sampling Method:	SPT

Completion Depth:	41.5ft	Remarks: Borings drilled using tracked drill rig. Standard Penetration Test (SPT) sampler driven with a 140 lb. safety hammer w/ 30" drop. Hammer operated by hydraulic mechanism. Samples were collected using a 2-inch OD split-spoon. Coordinates and elevation are approximate and based on their relative location to known site features. This surface elevation is estimated from the topographic survey provided by Informed Land Survey dated May 23, 2025.
Date Borehole Started:	7/1/25	
Date Borehole Completed:	7/1/25	
Logged By:	T. Howitz	
Drilling Company:	Geologic Drill Partners, Inc.

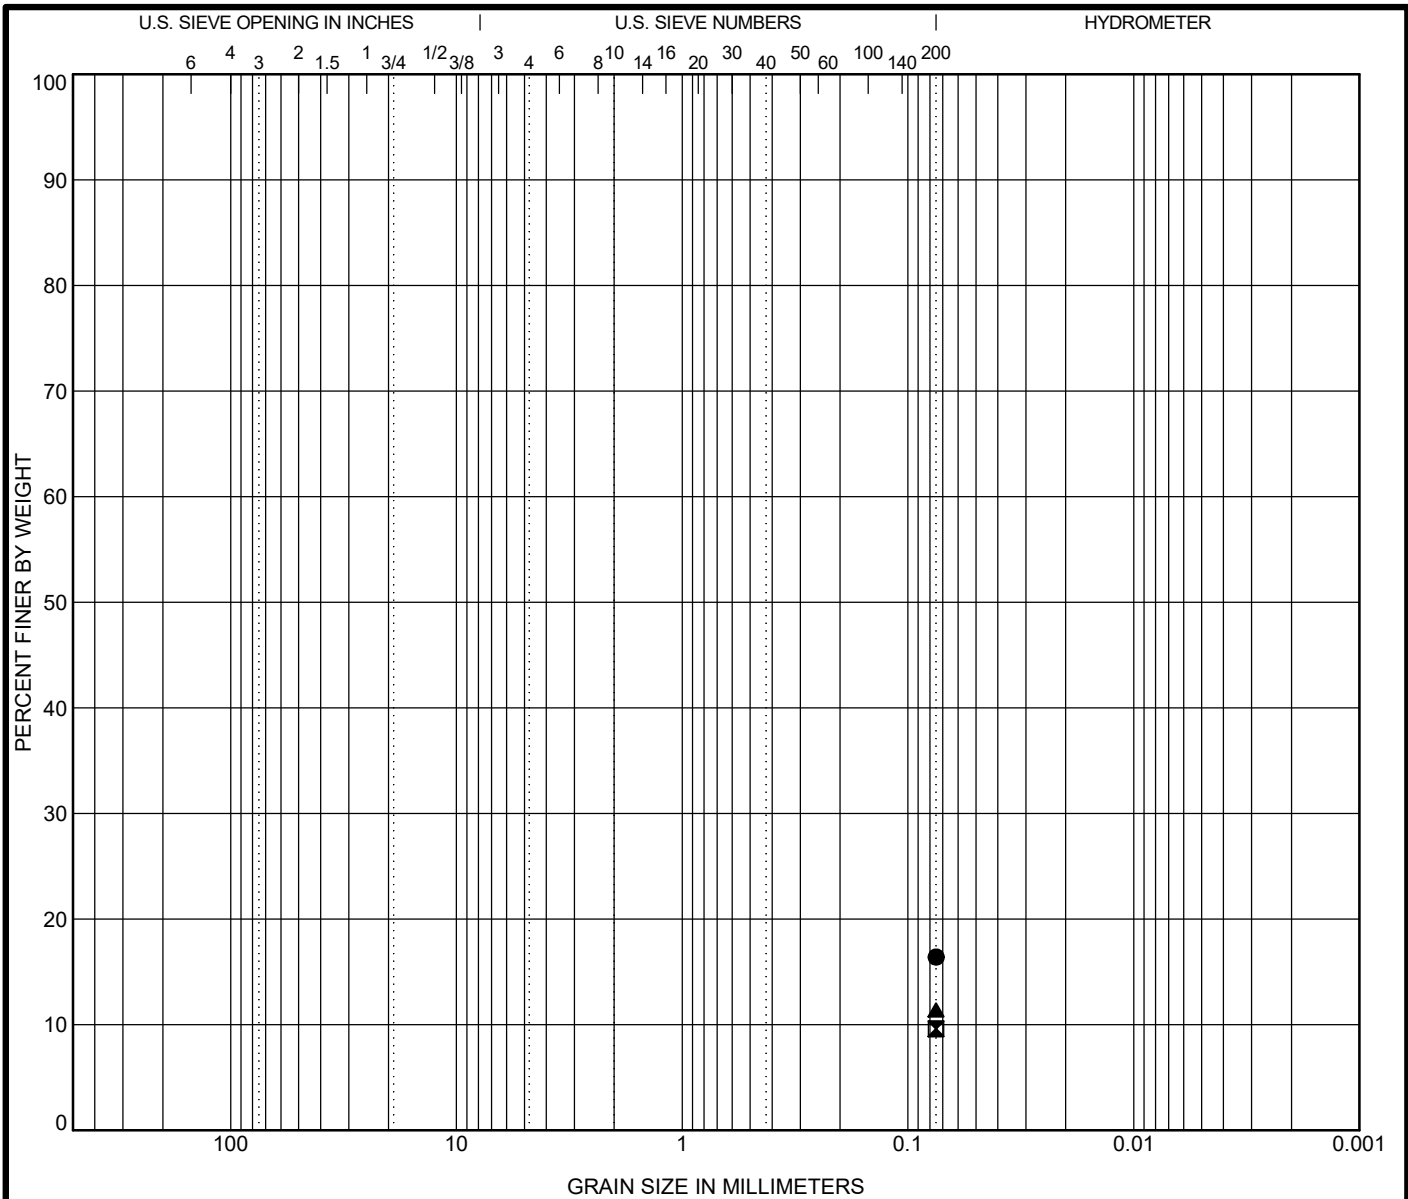
LABORATORY TEST RESULTS

Specimen Identification	Classification	LL	PL	PI	Cc	Cu
● PG-1-25 @ 11.0 ft.	SILTY SAND					
☒ PG-1-25 @ 26.0 ft.	SAND, SOME SILT					
▲ PG-2-25 @ 16.0 ft.	SAND, SOME SILT
