MILLER RESIDENCE ELEVATION X-SECTION

7709 W. MERCER WAY
 PARCEL NO. 5451300045
 SCALE 1" = 2'
 OWNER: SHANE MILLER
 DATE: NOVEMBER 26, 2019

MILLER RESIDENCE SITE PLAN

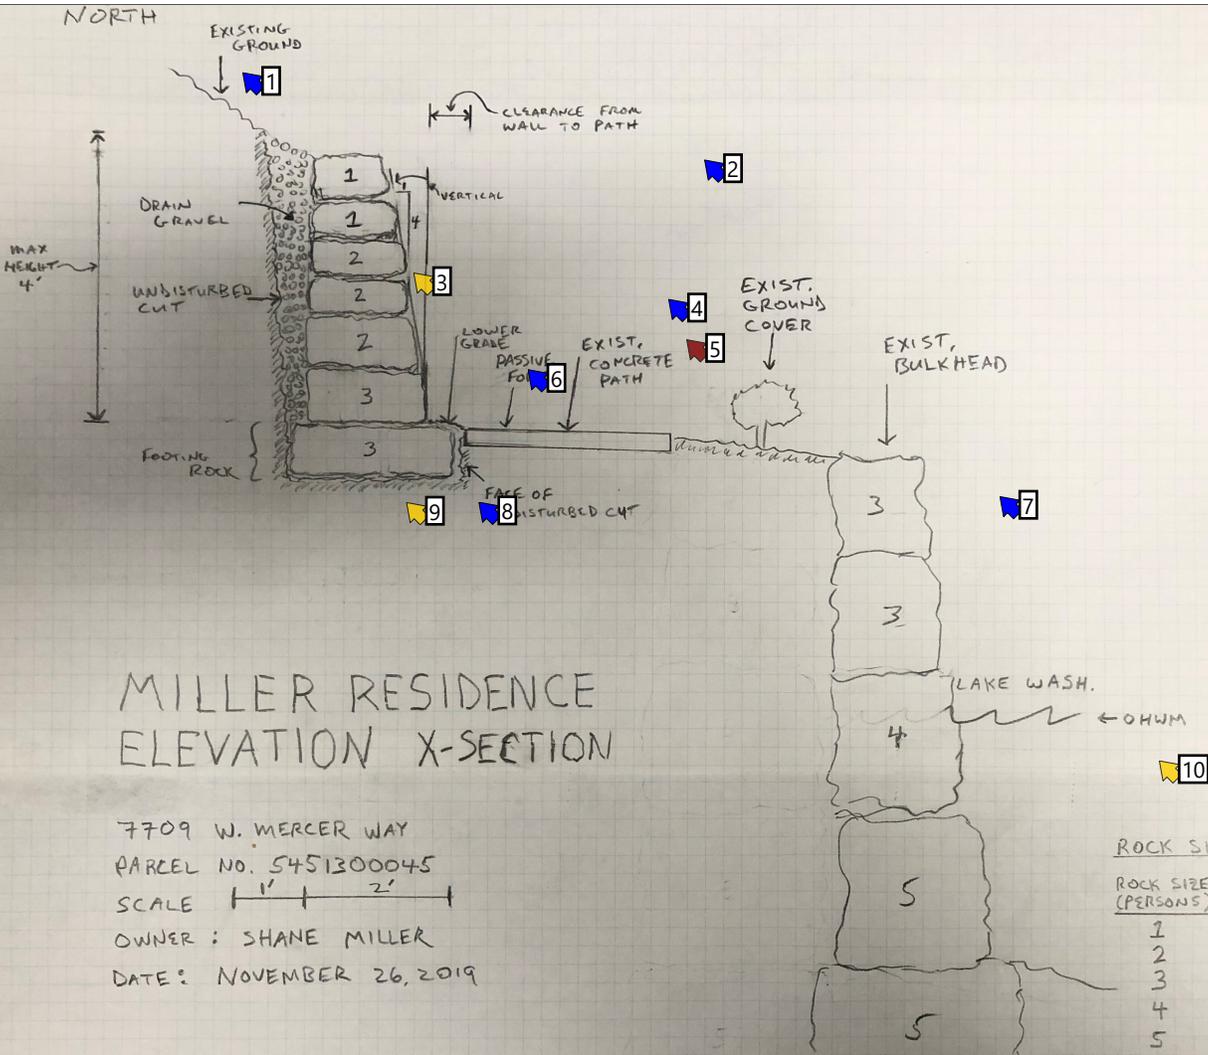
ROCK SIZE DESIGNATION

ROCK SIZE (PERSONS)	ROCK WT. (LBS)	AVG DIA. (INCHES)
1	50-200	12-18"
2	200-700	18-28"
3	700-2000	28-36"
4	2000-4000	36-48"
5	4000-6000	48-54"

Number: 1 Author: Building Review (paul.skidmore@mercergov.org) Subject: Comment #1 Date: 12/30/2019 5:47:53 PM
-08'00'
- Maximum allowable permanent backslope, per 2002 geotechnical report, is limited to 2H:1V, and recommended at 3H:1V. This is typical for colluvium soil and shall be confirmed by topographical survey.
-

Number: 4 Author: Building Review (paul.skidmore@mercergov.org) Subject: Comment #1 Date: 12/30/2019 5:47:14 PM
-08'00'
- Provide dimensions locating nearest distance of new rockery from existing bulkhead. Will new retaining wall surcharge the existing bulkhead?
-

Number: 5 Author: Geotechnical Peer Review (michele.lorilla@mercergov.org) Subject: Comment Date: 1/2/2020 9:59:00 AM -08'00'
- If the new retaining wall is surcharging the existing bulkhead, the geotechnical engineer shall determine the impact on the bulkhead and provide mitigation and repair recommendations, if necessary.
-

Number: 6 Author: Building Review (paul.skidmore@mercergov.org) Subject: Comment #1 Date: 12/30/2019 5:16:27 PM
-08'00'
- How does concrete path provide passive resistance? Note minimum embedment depth of rockery. Indicate how vertical cut in colluvium is achieved. 2002 geotechnical report recommends a maximum temporary cut of 1.5H:1V. Show extent of excavation on the site plan. Note that the cut will be "chasing" the existing slope up the hill.
-

Number: 8 Author: Building Review (paul.skidmore@mercergov.org) Subject: Comment #1 Date: 12/30/2019 5:23:28 PM
-08'00'
- Provide engineered design of rockery retaining wall, including all surcharges. Provide slope stability analysis for this condition. ARC recommendations are not appropriate in critical areas.
-

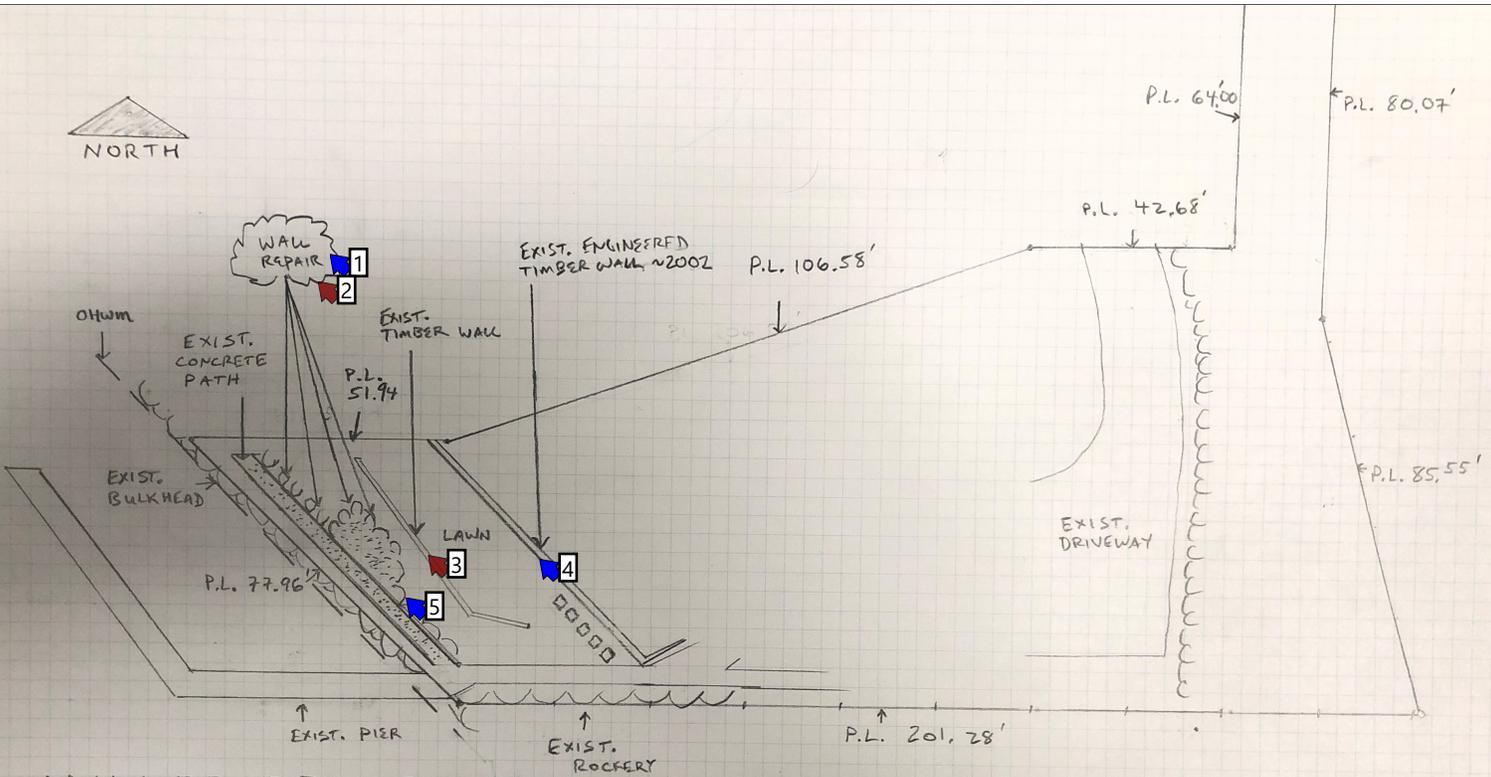
7709 W. MERCER WAY

SCALE: | 20' | | 40' |

Clarify what is meant by wall repair. There is no record of a permit being issued for a rockery retaining wall. This will be considered as and reviewed as new construction.

Geotechnical engineer to determine cause of wall failure and provide recommendations for stabilization and repair. New soil explorations will be required at the location of the wall to assess the wall failure as well as provide subsurface information for the stabilization and repair. Geotechnical engineer shall specifically address the appropriateness of wall type to retain loose soil conditions as identified in boring B-1 of the 2002 AMEC report if similar soil conditions are encountered in the new soil explorations. Wall design calculations shall be included in the resubmittal as well as stability analyses to verify the stability of the wall. Stability analyses should also assess impact of this lower wall on the stability of the existing features upslope of the wall.

Geotechnical engineer to assess potential undermining of existing timber wall due to lower wall failure and repair activities and provide recommendations for mitigation of impact to existing timber wall or repair recommendations as needed.

Based on aerial mapping, tree(s) have been removed for the construction of non-permitted work. Please note location, species, caliper size of all trees

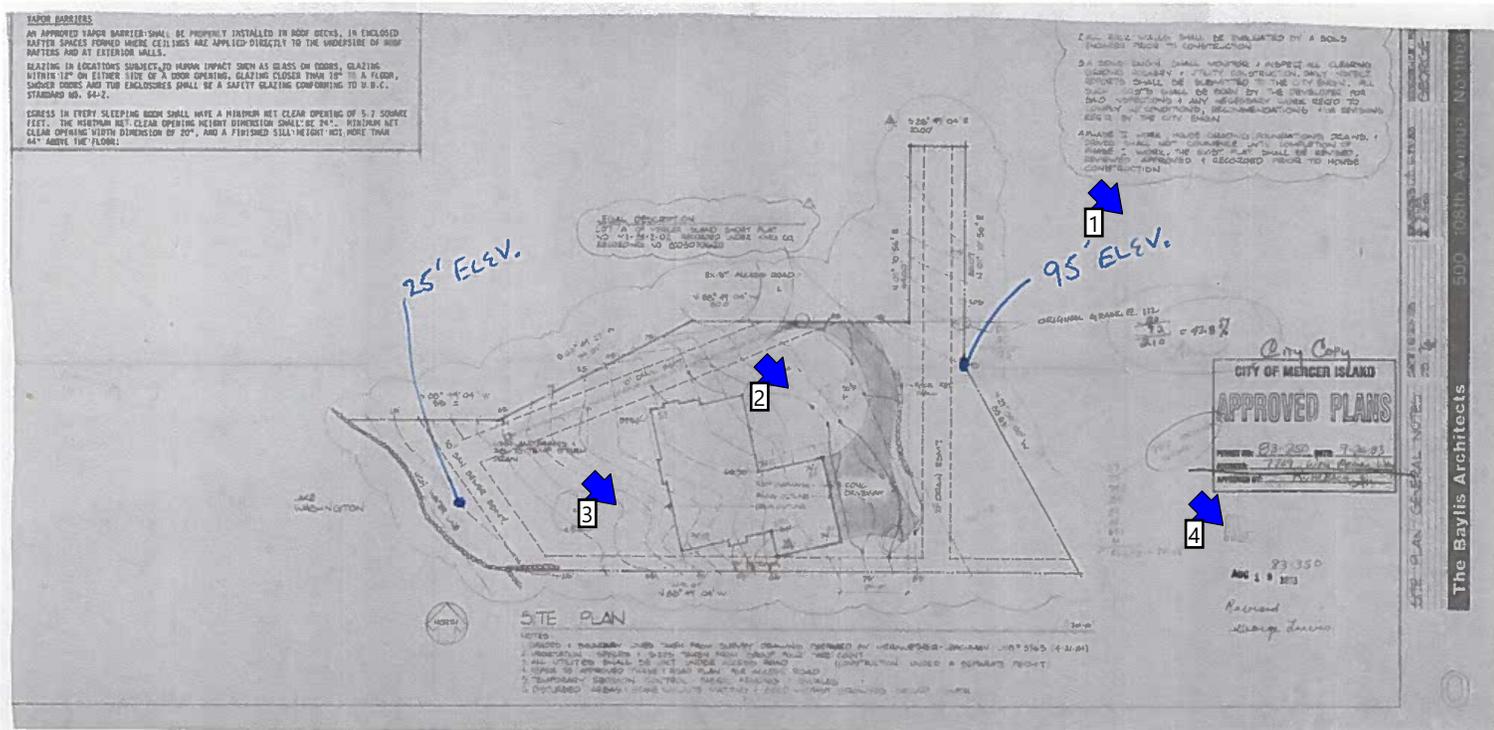
An updated geotechnical engineering report is required, and shall address the existing soil conditions, all work done within the critical area that was done without permit, and all proposed work, i.e. the rockery retaining wall. A Geotechnical Statement of Risk that addresses all of these issues is required. Additionally, an applicant paid geotechnical peer review will be required.

A steep slope is defined as "Any slope of 40 percent or greater calculated by measuring the vertical rise over any 30-foot horizontal run". Based on GIS information, the slope over 30 feet exceeds 60 percent, and would be considered a steep slope. Also note there have been identified landslides on the property and is mapped as a potential slide, erosion and seismic hazard. Any work within a critical area shall not be exempt from permit requirements.
