## GEOTECHNICAL ENGINEERING INVESTIGATION

Proposed Single Family House  
5425 96th Ave SE  
Mercer Island, Washington  
Parcel#: 1438700145

November 19, 2024  
Project No. 2DF0422984

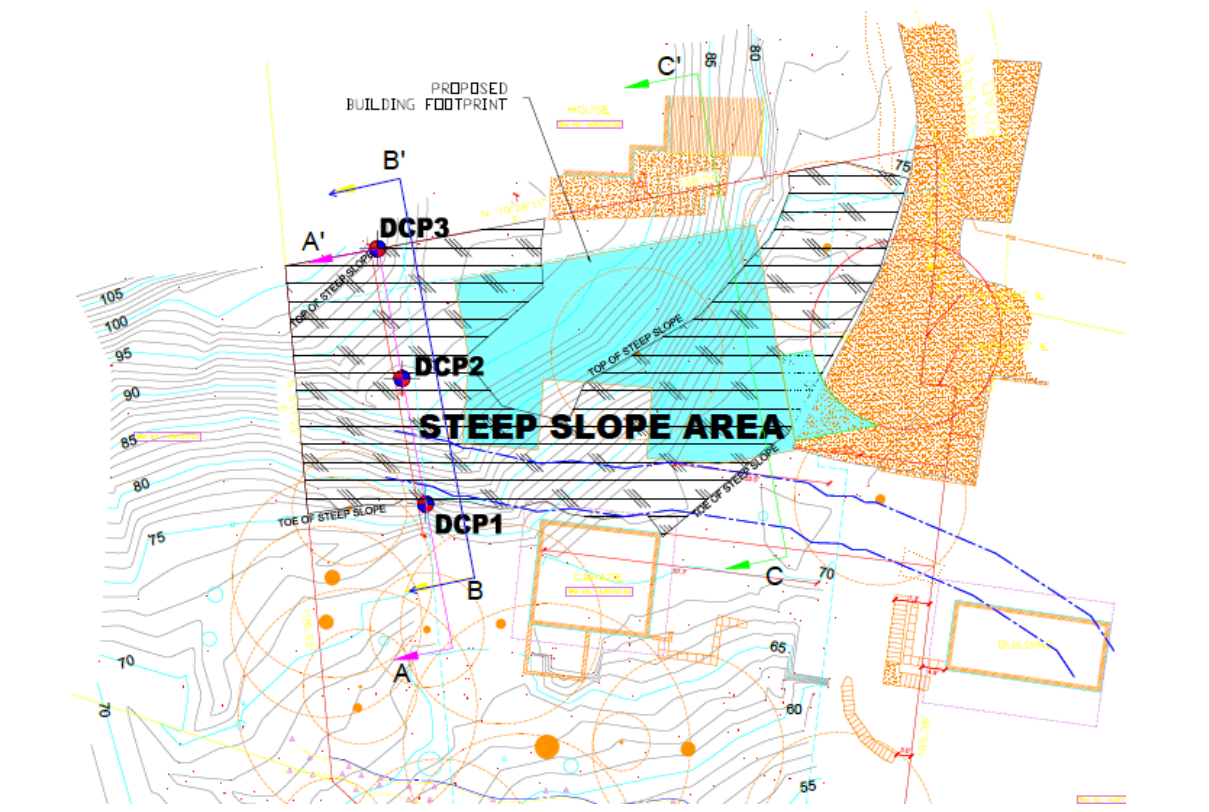
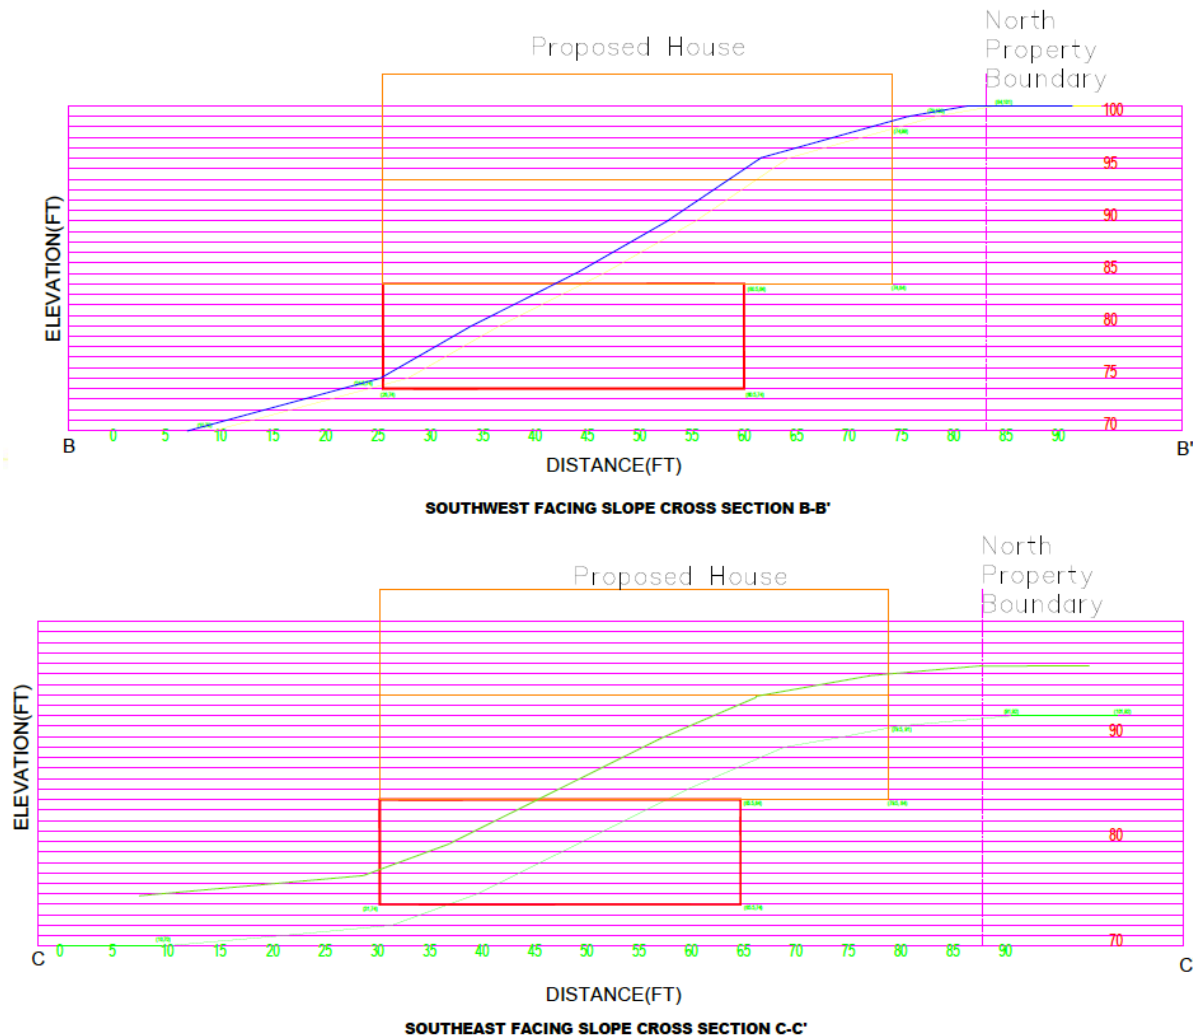
SITE PLAN

The project site is a rectangular-shaped parcel of land with an area of approximately 21,665sf. The site is at the end of SE 54th St and surrounded by single-family houses to east, south, and north. Topography at property general slopes to south with two steep slopes close to north and south property boundaries. A detached garage is situated on a relatively flat area between two steep slopes. The proposed house will be on the steep slope to the north of garage. (See Site Plan and Slopes Cross-sections below)

The steep slope to the north generally faces southeast and southwest. For southwest facing steep slope, the upper portion has a steep slope approximately 1.4H:1V (~70%) with local elevation loss ~14ft, roughly 35° following up with approximately 2H:1V (~51%) steep slope with local elevation loss ~9ft, roughly 27°. The lower portion has a gentle slope approximately 5.1H:1V (~20%) to the 96th Ave SE at east.

For southeast facing steep slope, the upper portion has a mild slope approximately 5.5H:1V (18%) with local elevation loss ~12ft, roughly 10° following up with approximately 1.7H:1V (~59%) steep slope with local elevation loss ~18ft, roughly 31°. Both slopes ultimately reach to the Lake of Washington.

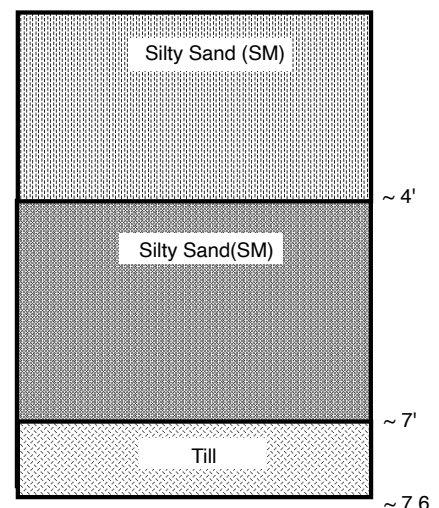
Descriptions of soil symbols and classifications used in this report are also presented in the Appendix (Figure 3). Site soils are generalized in the schematic and summarized as follows:

- a. Silty Sand (SM)
- b. Silty Sand with gravel (SM)
- c. Silty Sand with gravel (Glacial Till)

A layer of loose silty which varies in thickness from 0" - 4' generally blankets the slope. The more closer to the top of slope, the shallower of this loose silty sand is. The soil was damp, crumbly when disturbed, and loose in situ.

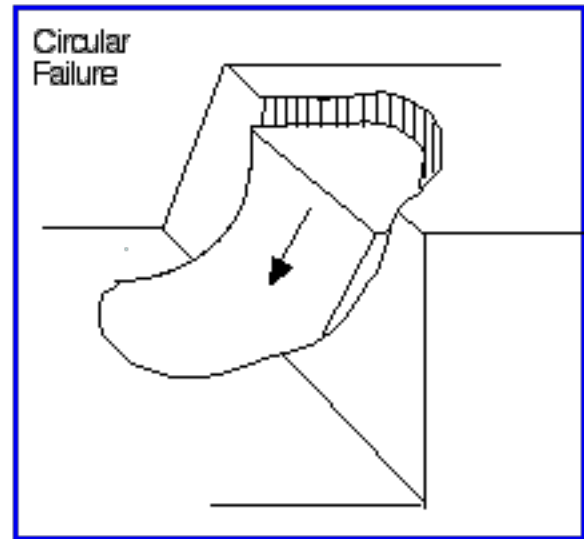
The possible mode of slope failure at this site has to be considered for the slope stability analysis. Modes of slope failure are best categorized according to controlling geological structures. For instance, such structures can be bedrock, faults, or high strength soil layers interbedded with low strength layers. As discussed above, for this

analysis we are considering the failure of the sand unit itself. Therefore, there is no significant controlling structure and the material is assumed as homogeneous soil with the internal parameters listed in Table 1. Soil slope failures are characterized to fail in a circular

mode according to Hoek and Bray (1981). This will be the assumed failure mode for this site, depicted here.

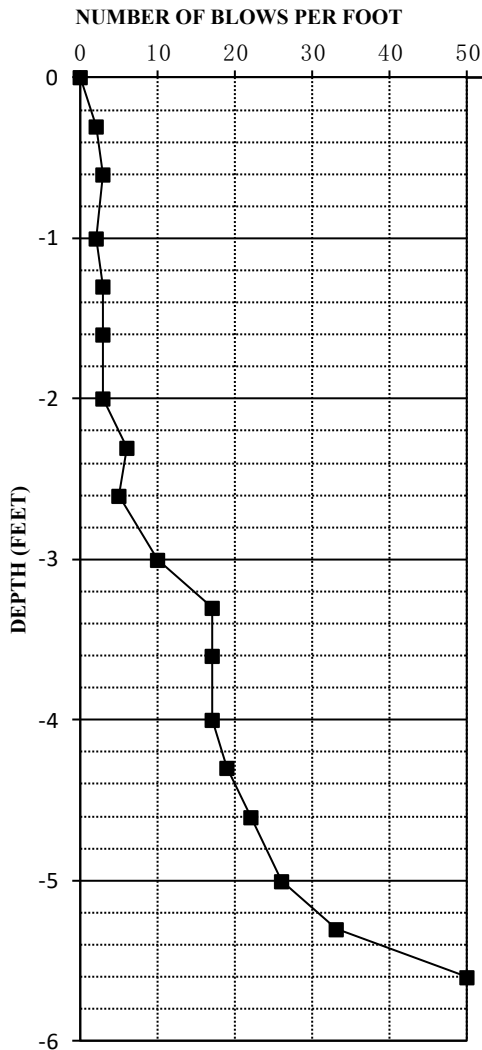
Figure 4

Surface Elevation = 62'

Surface Conditions = Ground Cover

**LOOSE SILTY SANDS****SILTY SANDS WITH GRAVEL (SM)****SILTY SANDS WITH GRAVEL (TILL)**

refusal 50/3"

Subsurface soil and ground water conditions were investigated by conducting three (3) DCP tests to maximum 7.6' depth on June 29, 2022. Test locations are shown on the site plan (Figure 2). Test logs are presented in the Appendix of this report as Figures 4 through 6.

Descriptions of subsurface conditions are based on observations made at the site at the time of the field investigation. DCP test logs are presented in Figures 4 through 6. The soils observed at the site were classified using the USCS (Unified Soils Classification System ) in accordance with ASTM D-2488-69 and ASTM D 2487. This classification system is also presented in the Appendix (Figure 3).

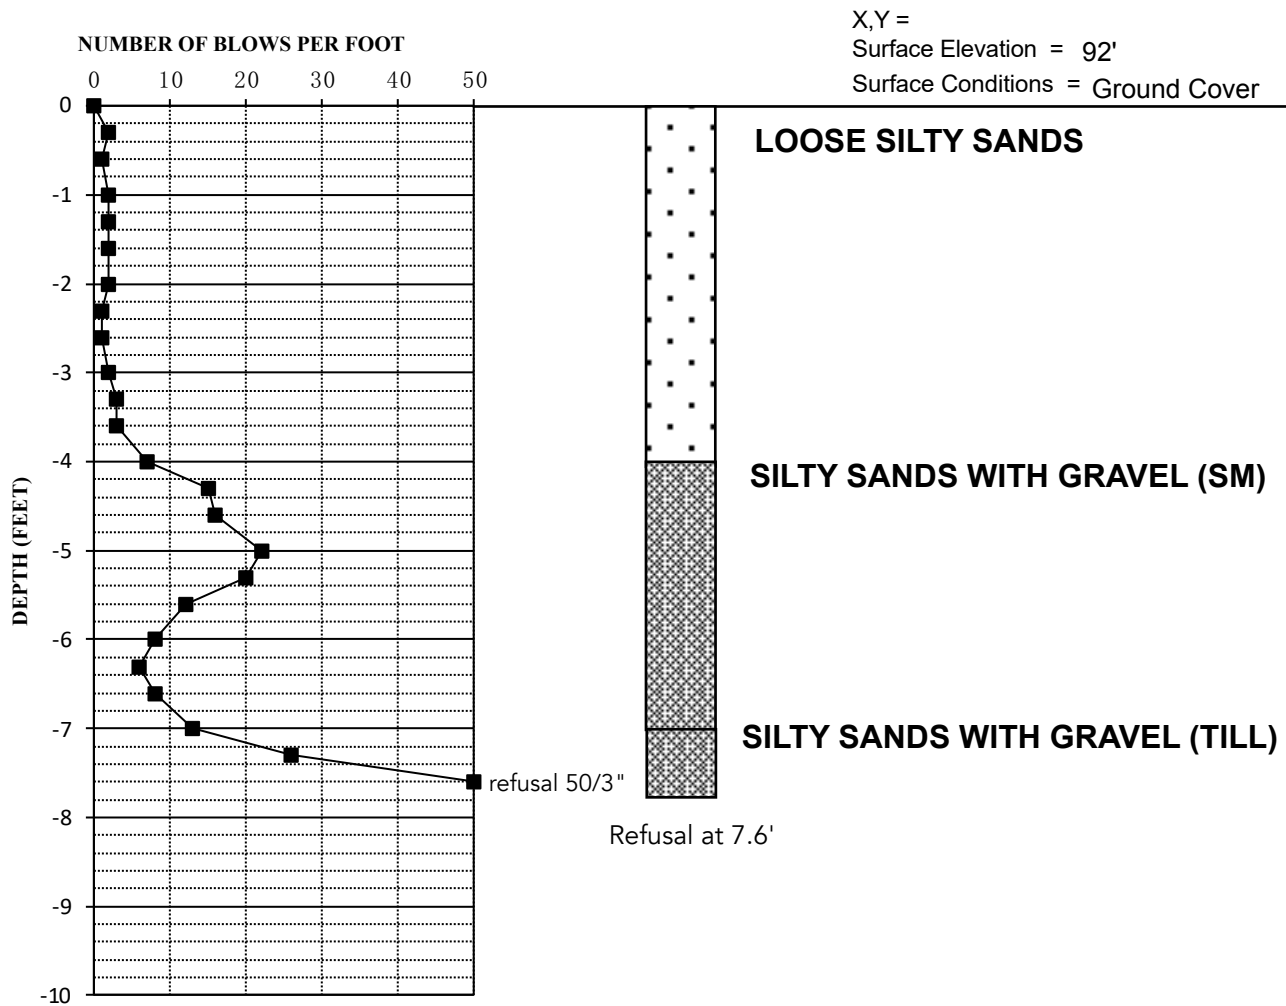
**DCP-2** DYNAMIC CONE PENETRATION TEST

Note: Soil profile is inferred from CPT results. Subsurface conditions were not observed directly during DCP testing.

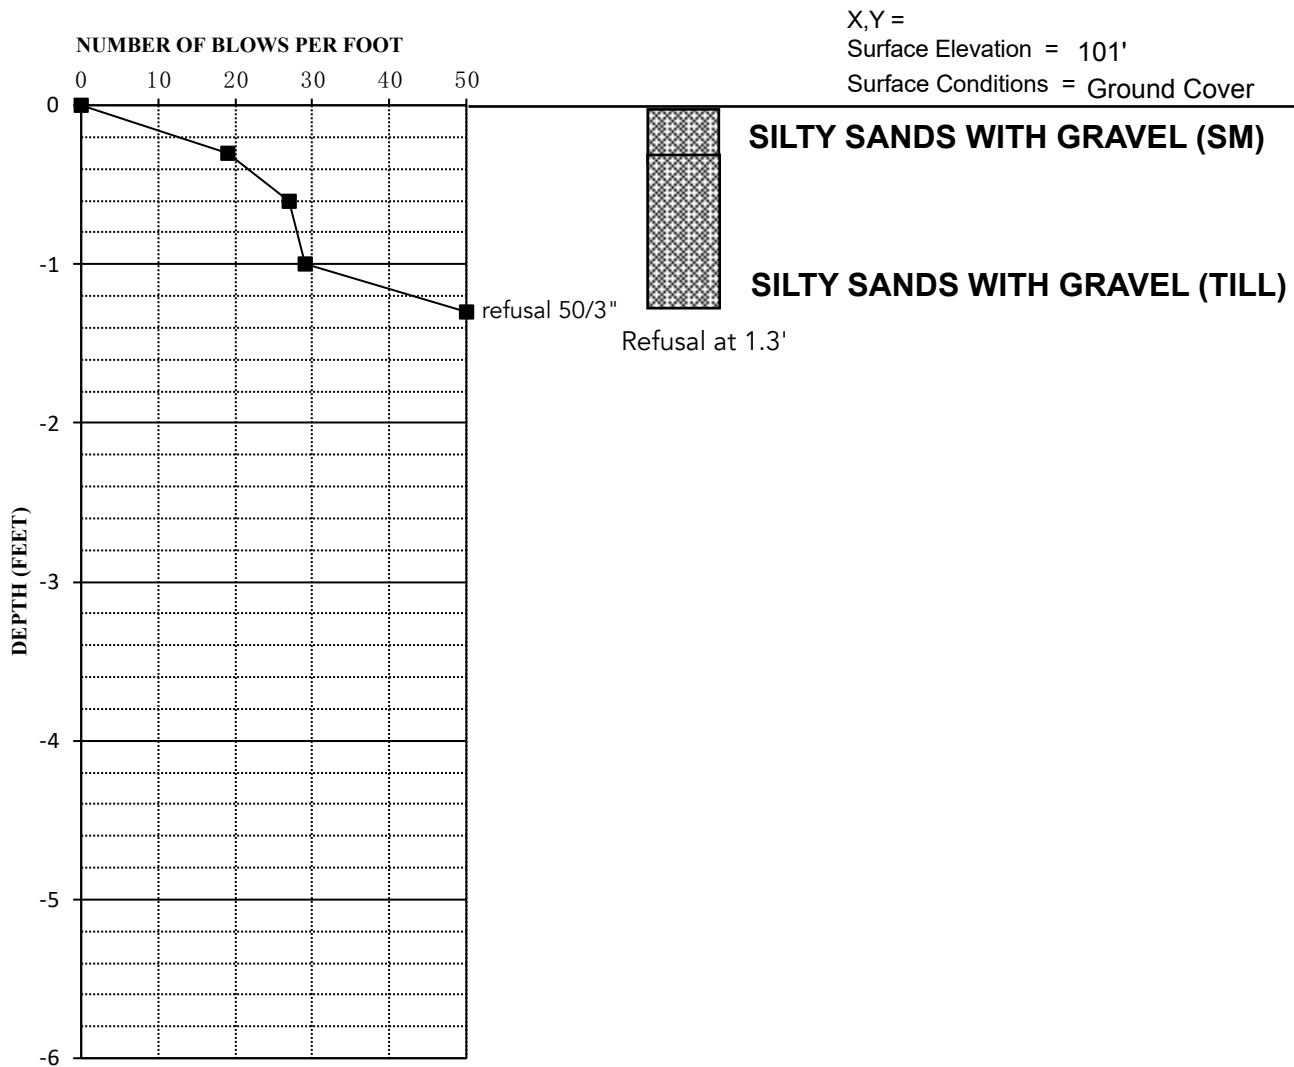
**DCP-3****DYNAMIC CONE PENETRATION TEST****SOIL DESCRIPTION AND CLASSIFICATION**

Note: Soil profile is inferred from CPT results. Subsurface conditions were not observed directly during DCP testing.

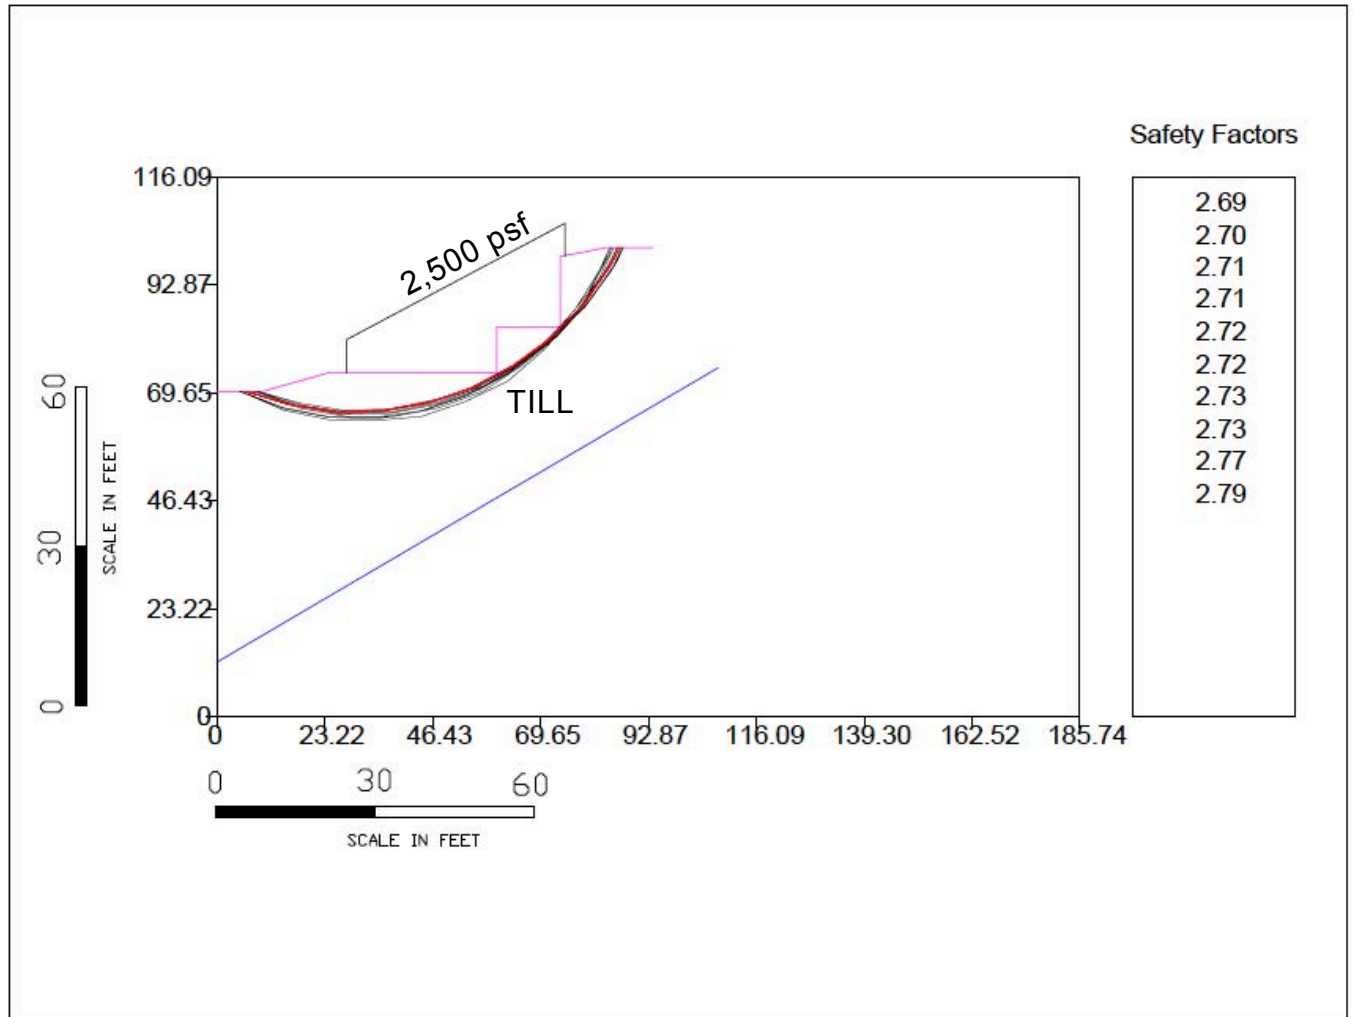
# STATIC CONDITION

TILL  
Friction Angle $\phi$ : 34°  
Cohesion (psf) : 410

Results of analysis incorporating the full-scale slope condition are shown in Figure 7 through Figure 10. For curves originating past the base of the slope and extending to the top of slope, Factor of Safety values are well above target values. Recorded static values are FS = 2.69; seismic values are FS = 1.47. The high FS values despite the slope size are attributed to the presence of the resistance upper soil unit of hardpan glacial deposits.

Based on our derived soil properties and site parameters, shown on the Table 1 for the entire southwest facing slope from top to the toe, the ten (10) most critical surfaces were created, shown in Figure 7. The factor of safety for the critical surfaces range from 2.69 to 2.79,

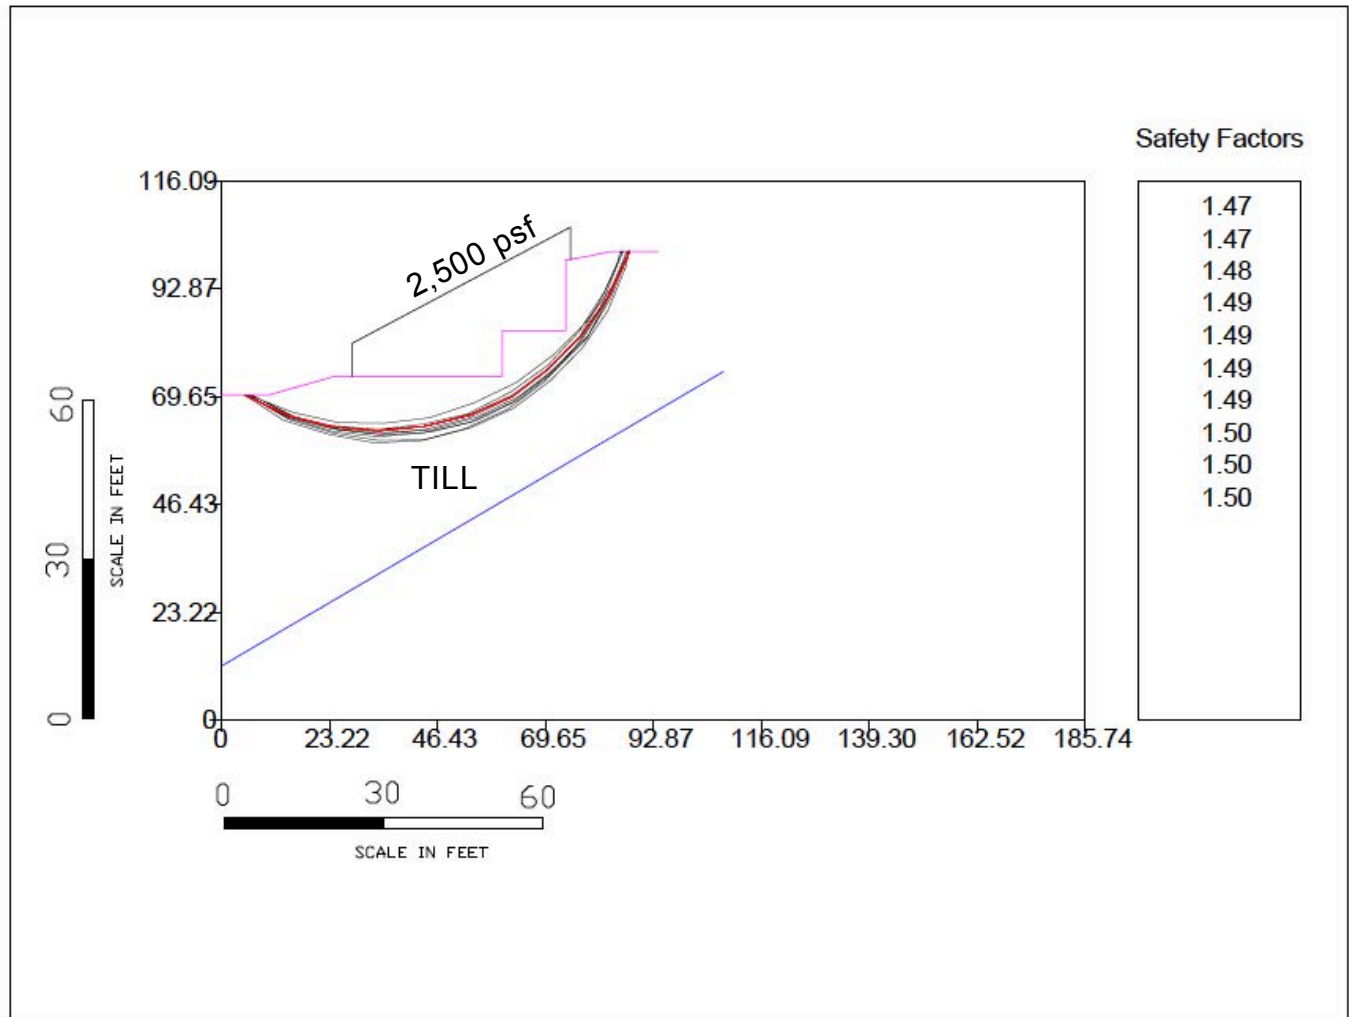
TILL  
Friction Angle  $\phi$ :  $34^\circ$   
Cohesion (psf) : 410

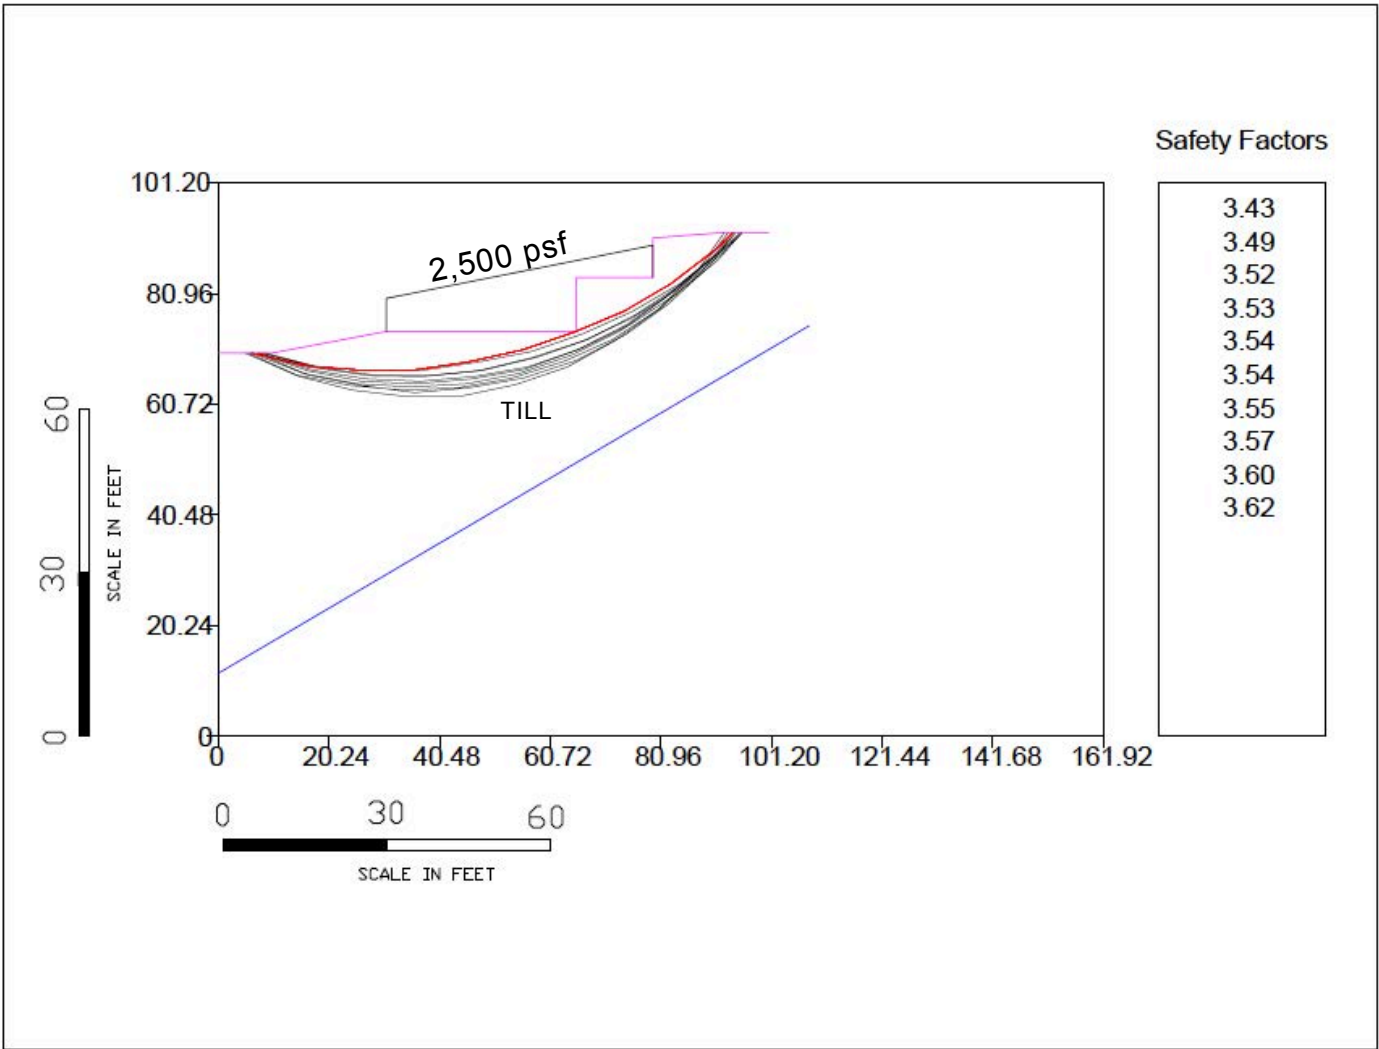
Figure 9

STATIC CONDITION

TILL  
Friction Angle $\phi$ : 34°  
Cohesion (psf) : 410

During this study, we considered local slope conditions and focused on the specific slope area in order to evaluate the critical areas identified above and assess project feasibility. Cross-section profile (Figure 9) was constructed through locations of interest based on survey data and subsurface testing.

which is over 1.5 for representative cross-section B-B'. For the entire southeast facing slope from top to the toe, the ten (10) most critical surfaces were created, shown in Figure 9. The factor of safety for the critical surfaces range from 3.43 to 3.62, which is also over 1.5 for representative cross-section C-C'. This gives us that on subject steep slope with proposed house may be satisfactory.

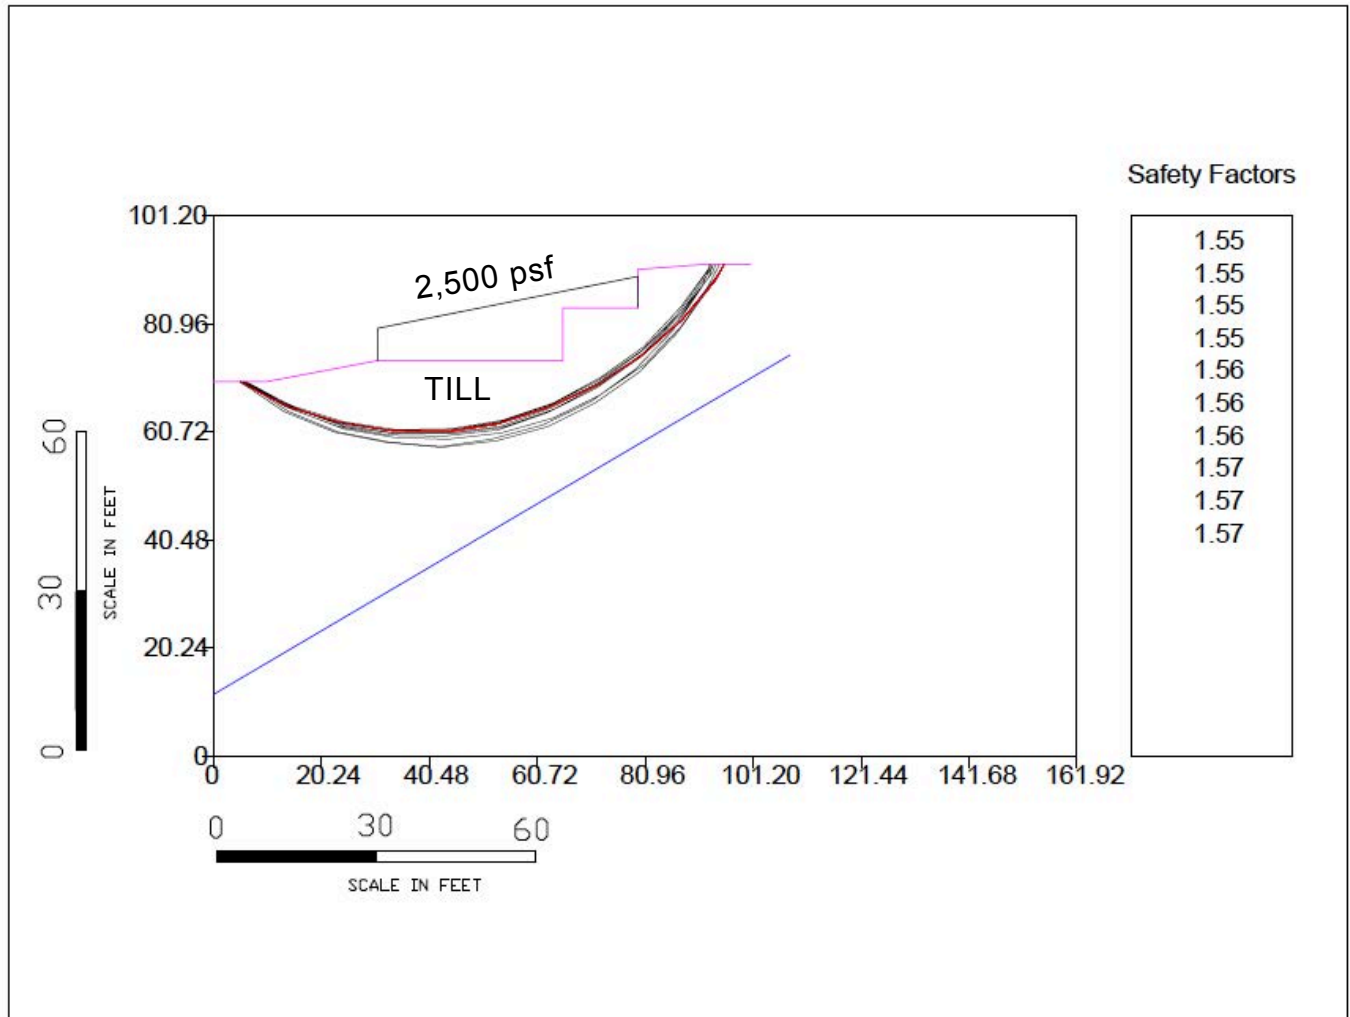
TILL  
Friction Angle  $\phi$ :  $34^\circ$   
Cohesion (psf) : 410

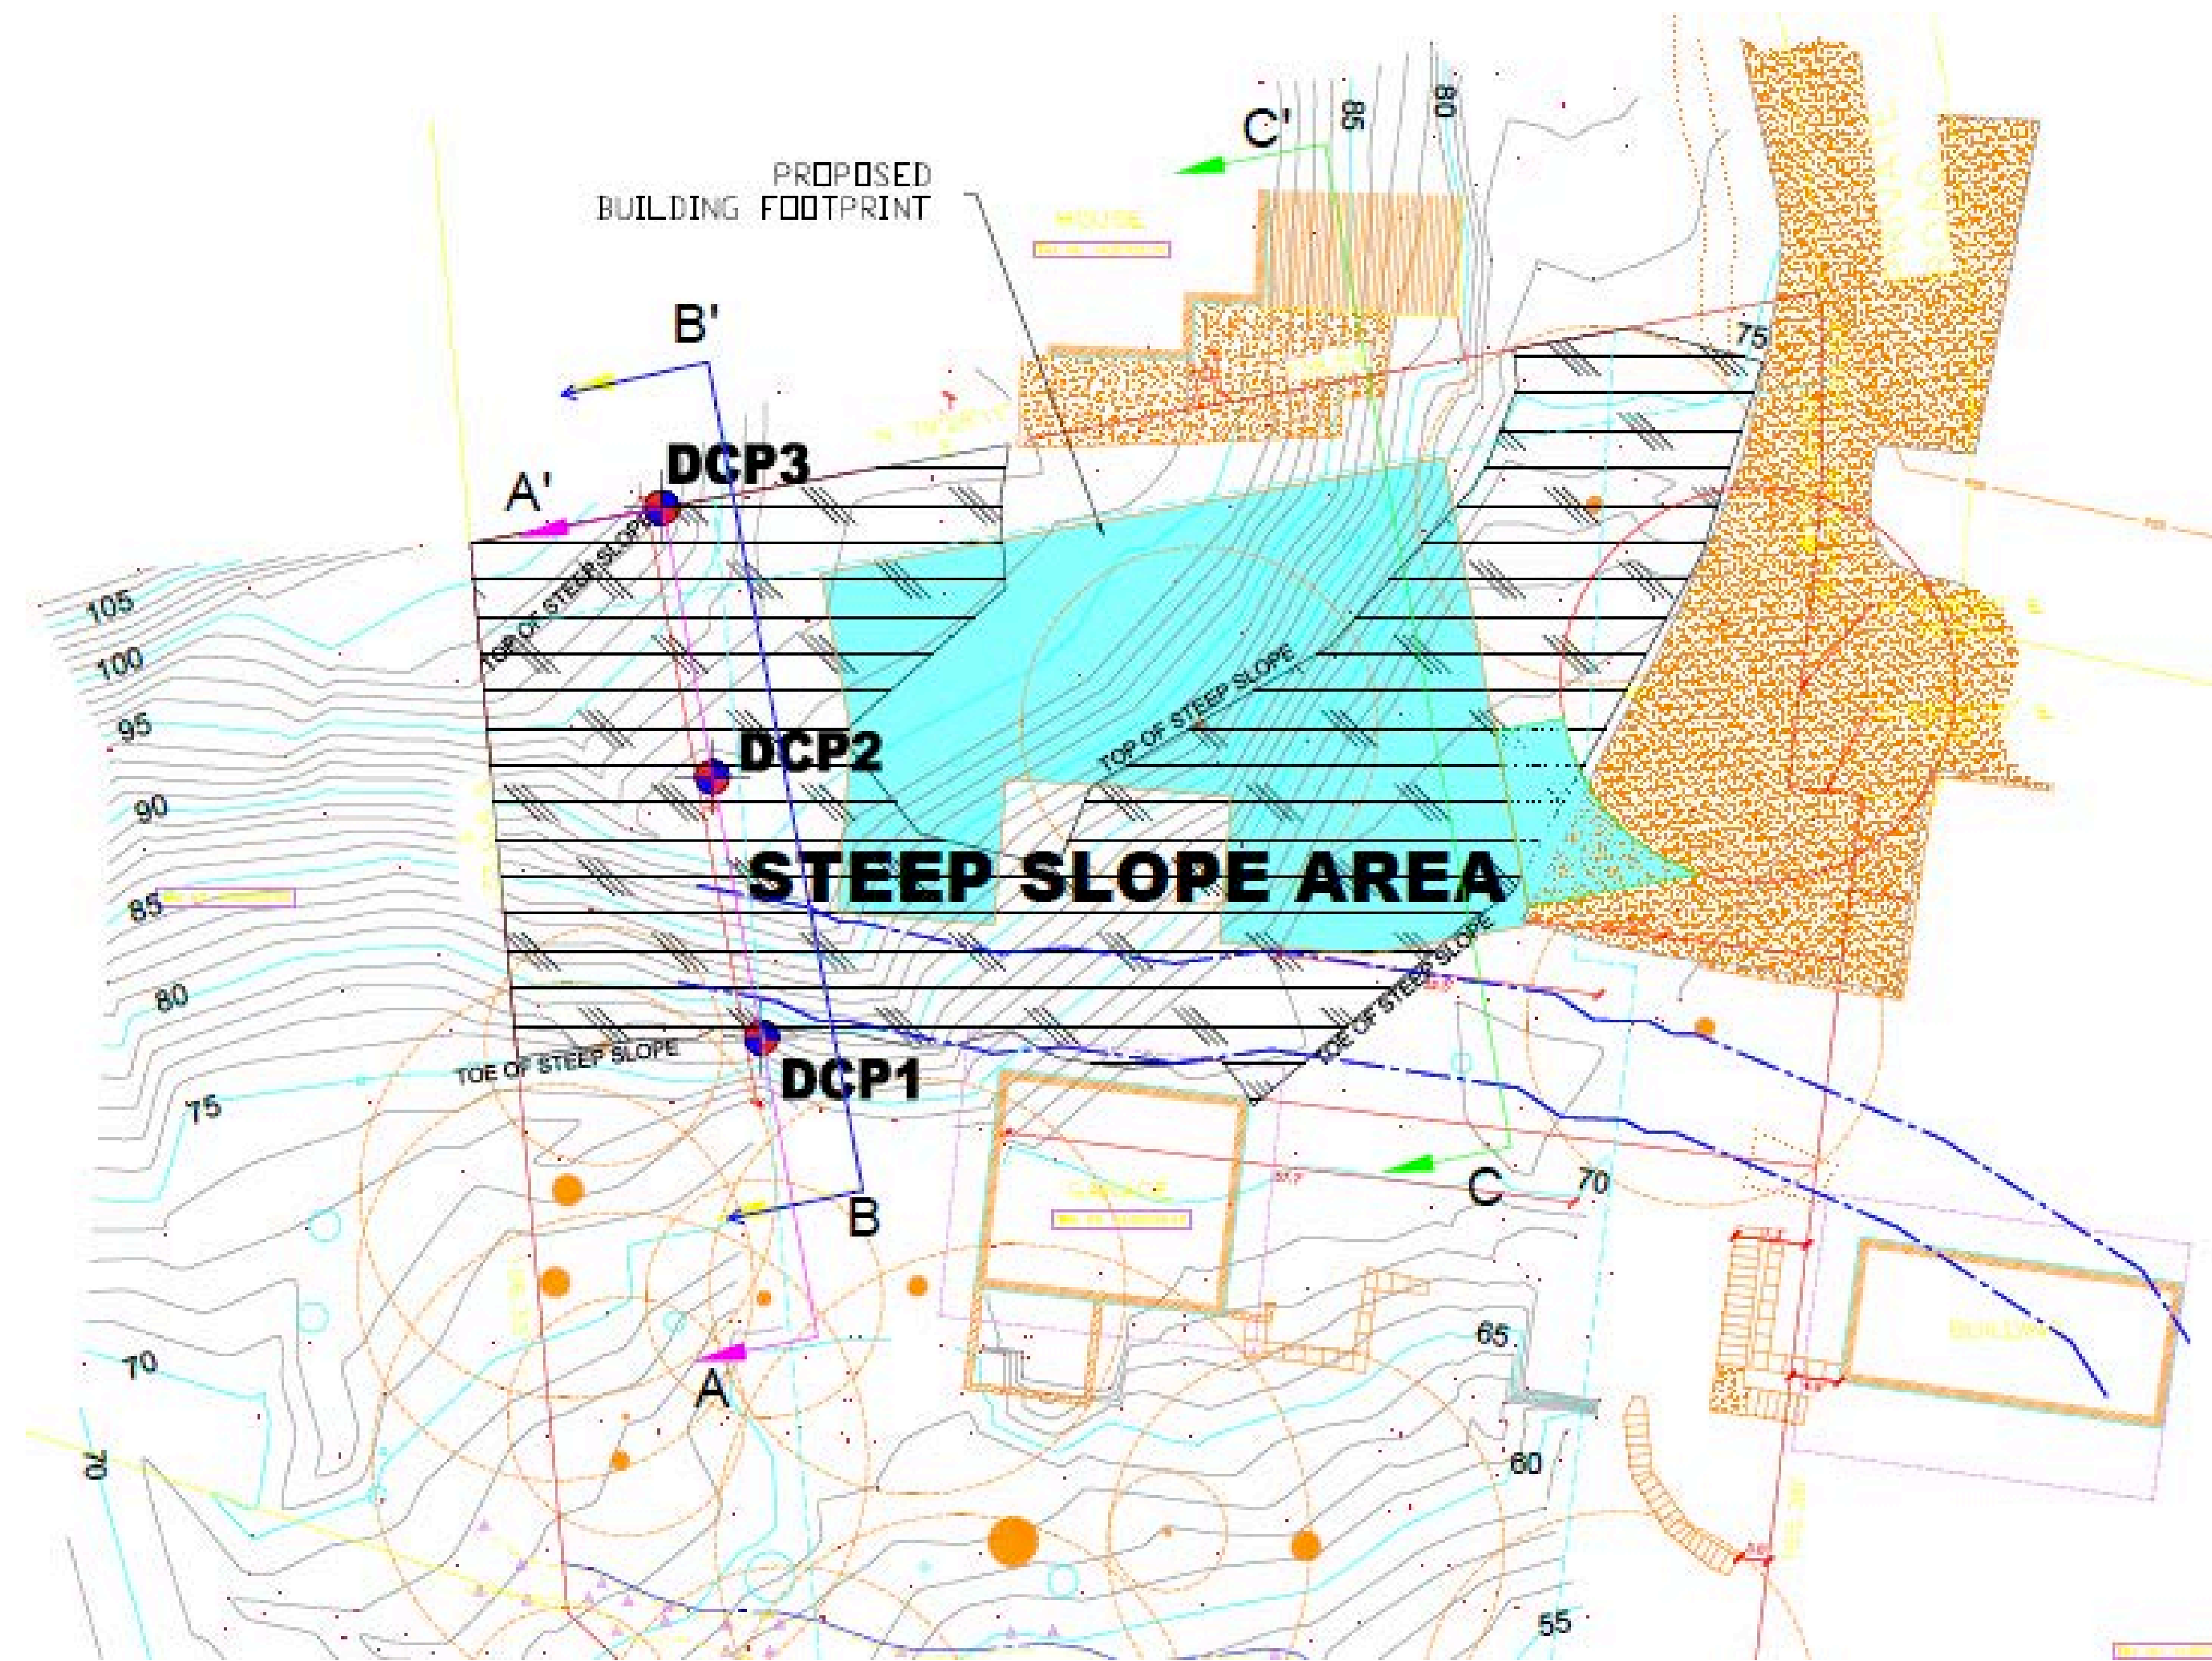
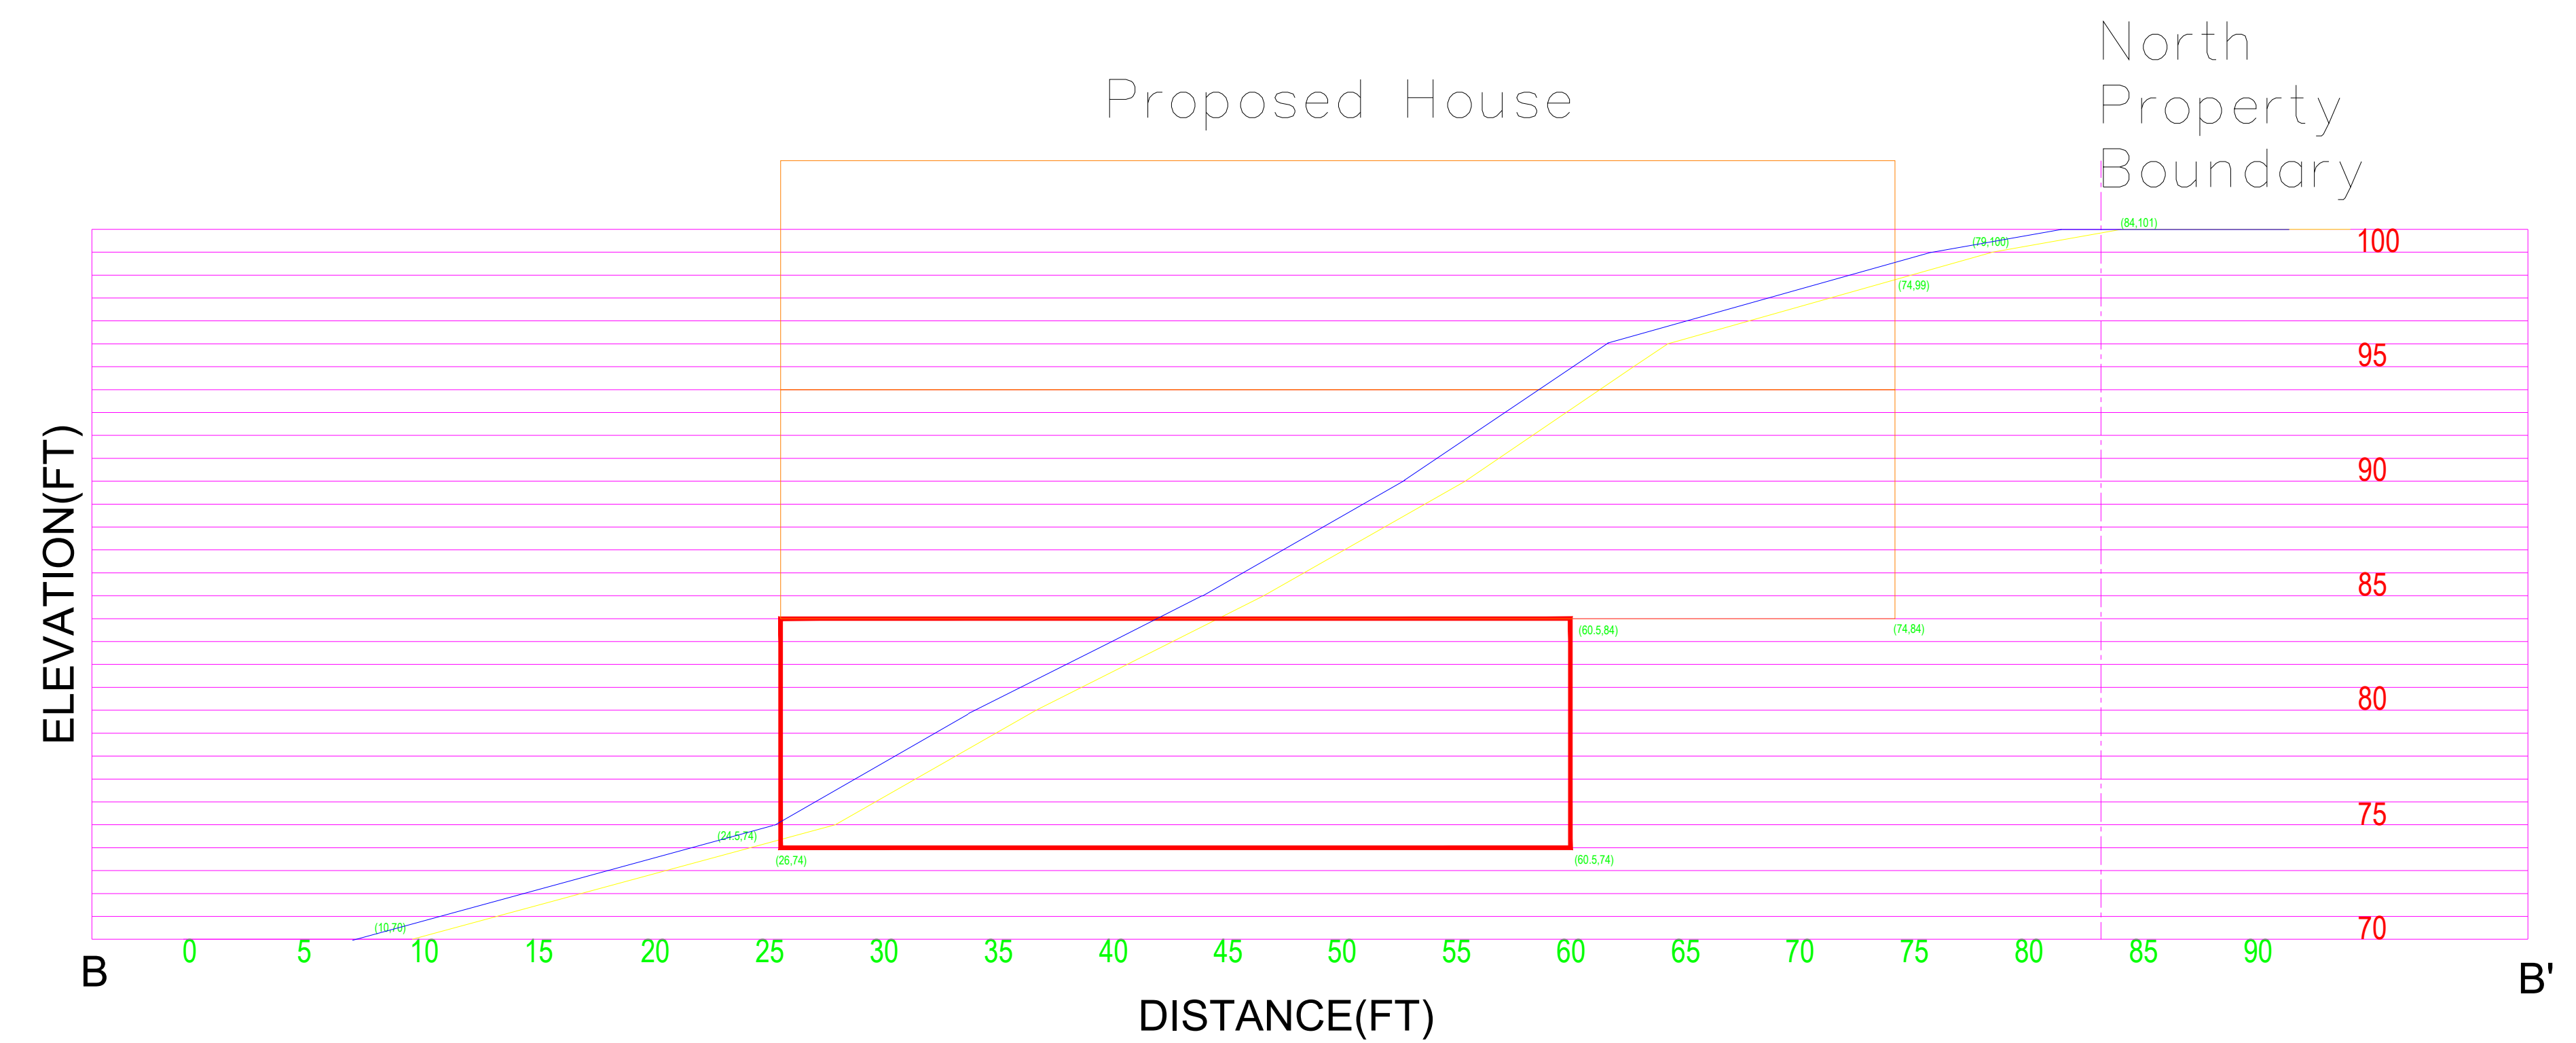
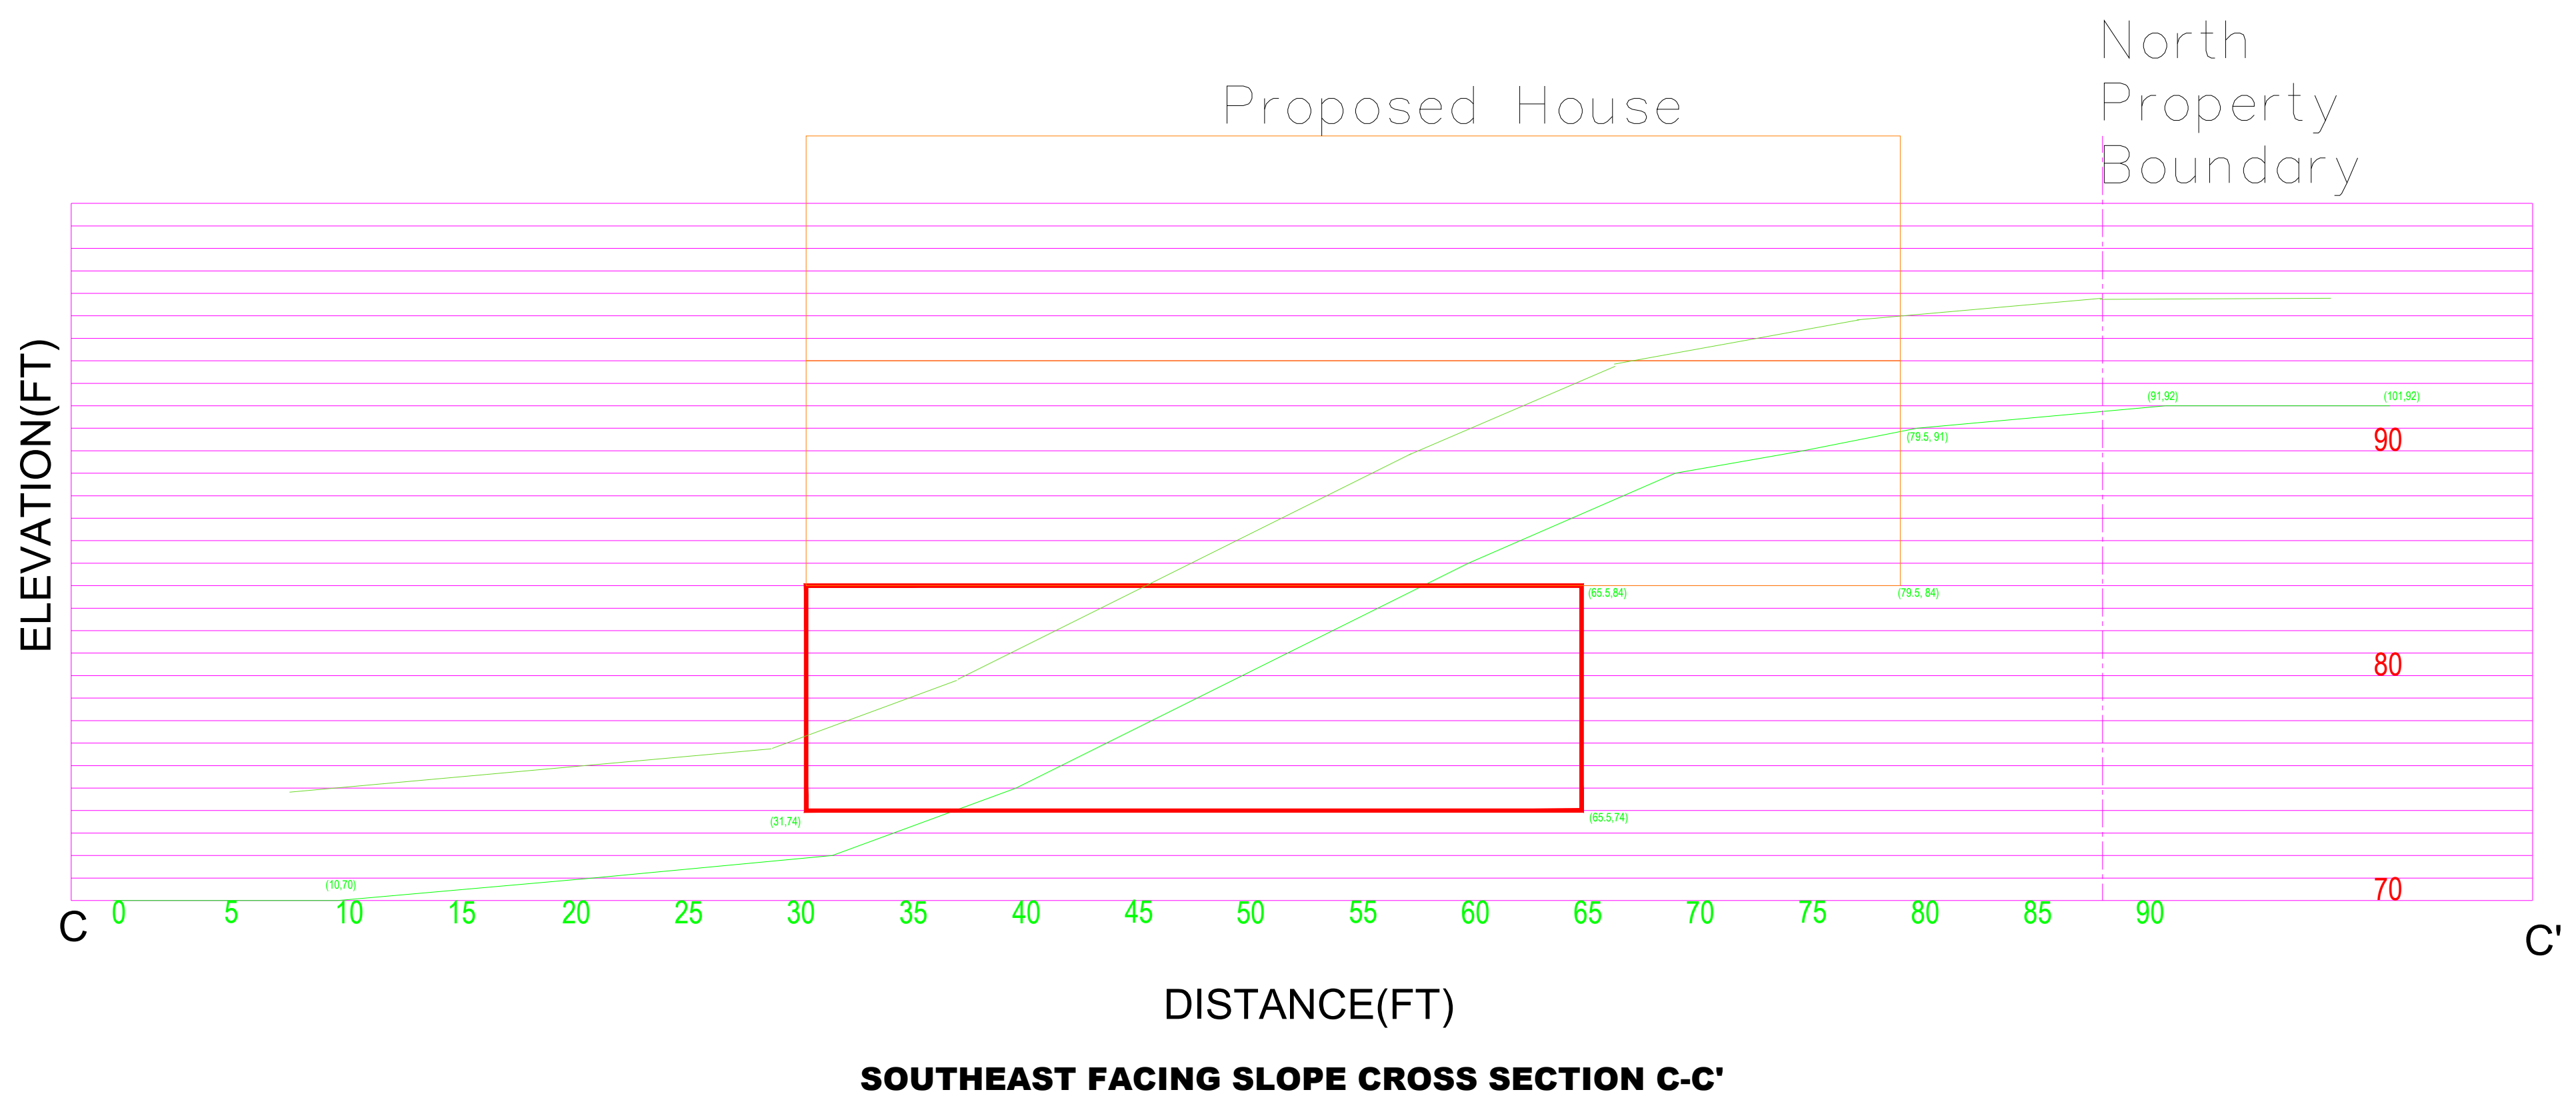
| <p>Note: Property Lines and Topogrphy based on the Survey From CHADWICK and WINTERS LAND SURVEYING and MAPPING</p> | <p>Single Family House Development<br/>5425 96th Ave SE<br/>Mercer Island, WA<br/>Parcel Number: 1438700145</p> | CROSS-SECTIONS B-B' AND C-C' | | | <div><b>MERIT ENGINEERING INC.</b><br/>10129 Main Street, #201<br/>Bellevue, Washington 98004<br/>Telephone: (425) 454-2133<br/><a href="http://www.MeritEngineering.com">http://www.MeritEngineering.com</a></div> |
