## GEOTECHNICAL ENGINEERING INVESTIGATION

Proposed Single Family House  
5425 96th Ave SE  
Mercer Island, Washington  
Parcel#: 1438700145

November 19, 2024  
Project No. 2DF0422984

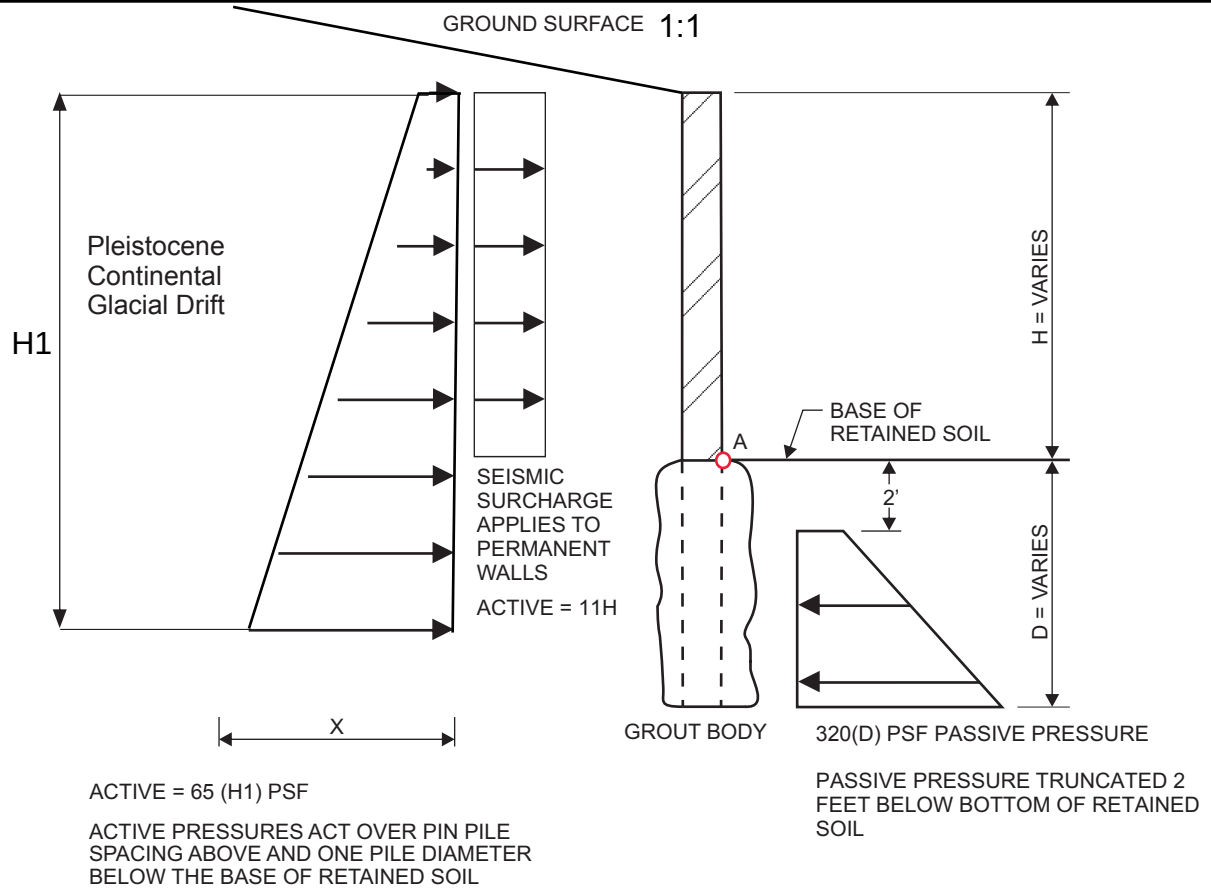
1. SOLDIER PILE EMBEDMENT DEPTH "D" SHOULD CONSIDER NECESSARY VERTICAL CAPACITY, KICKOUT, AND OVERTURNING RESISTANCE.
2. PASSIVE PRESSURE INCLUDES A FACTOR OF SAFETY OF 1.5.
