## GEOTECHNICAL ENGINEERING INVESTIGATION AND CRITICAL AREA STUDY

Proposed Residential Development  
3804 E Mercer Way  
Mercer Island, Washington 98040  
Parcel#: 2107000100

February 06, 2025  
Project No. 2DK0233995

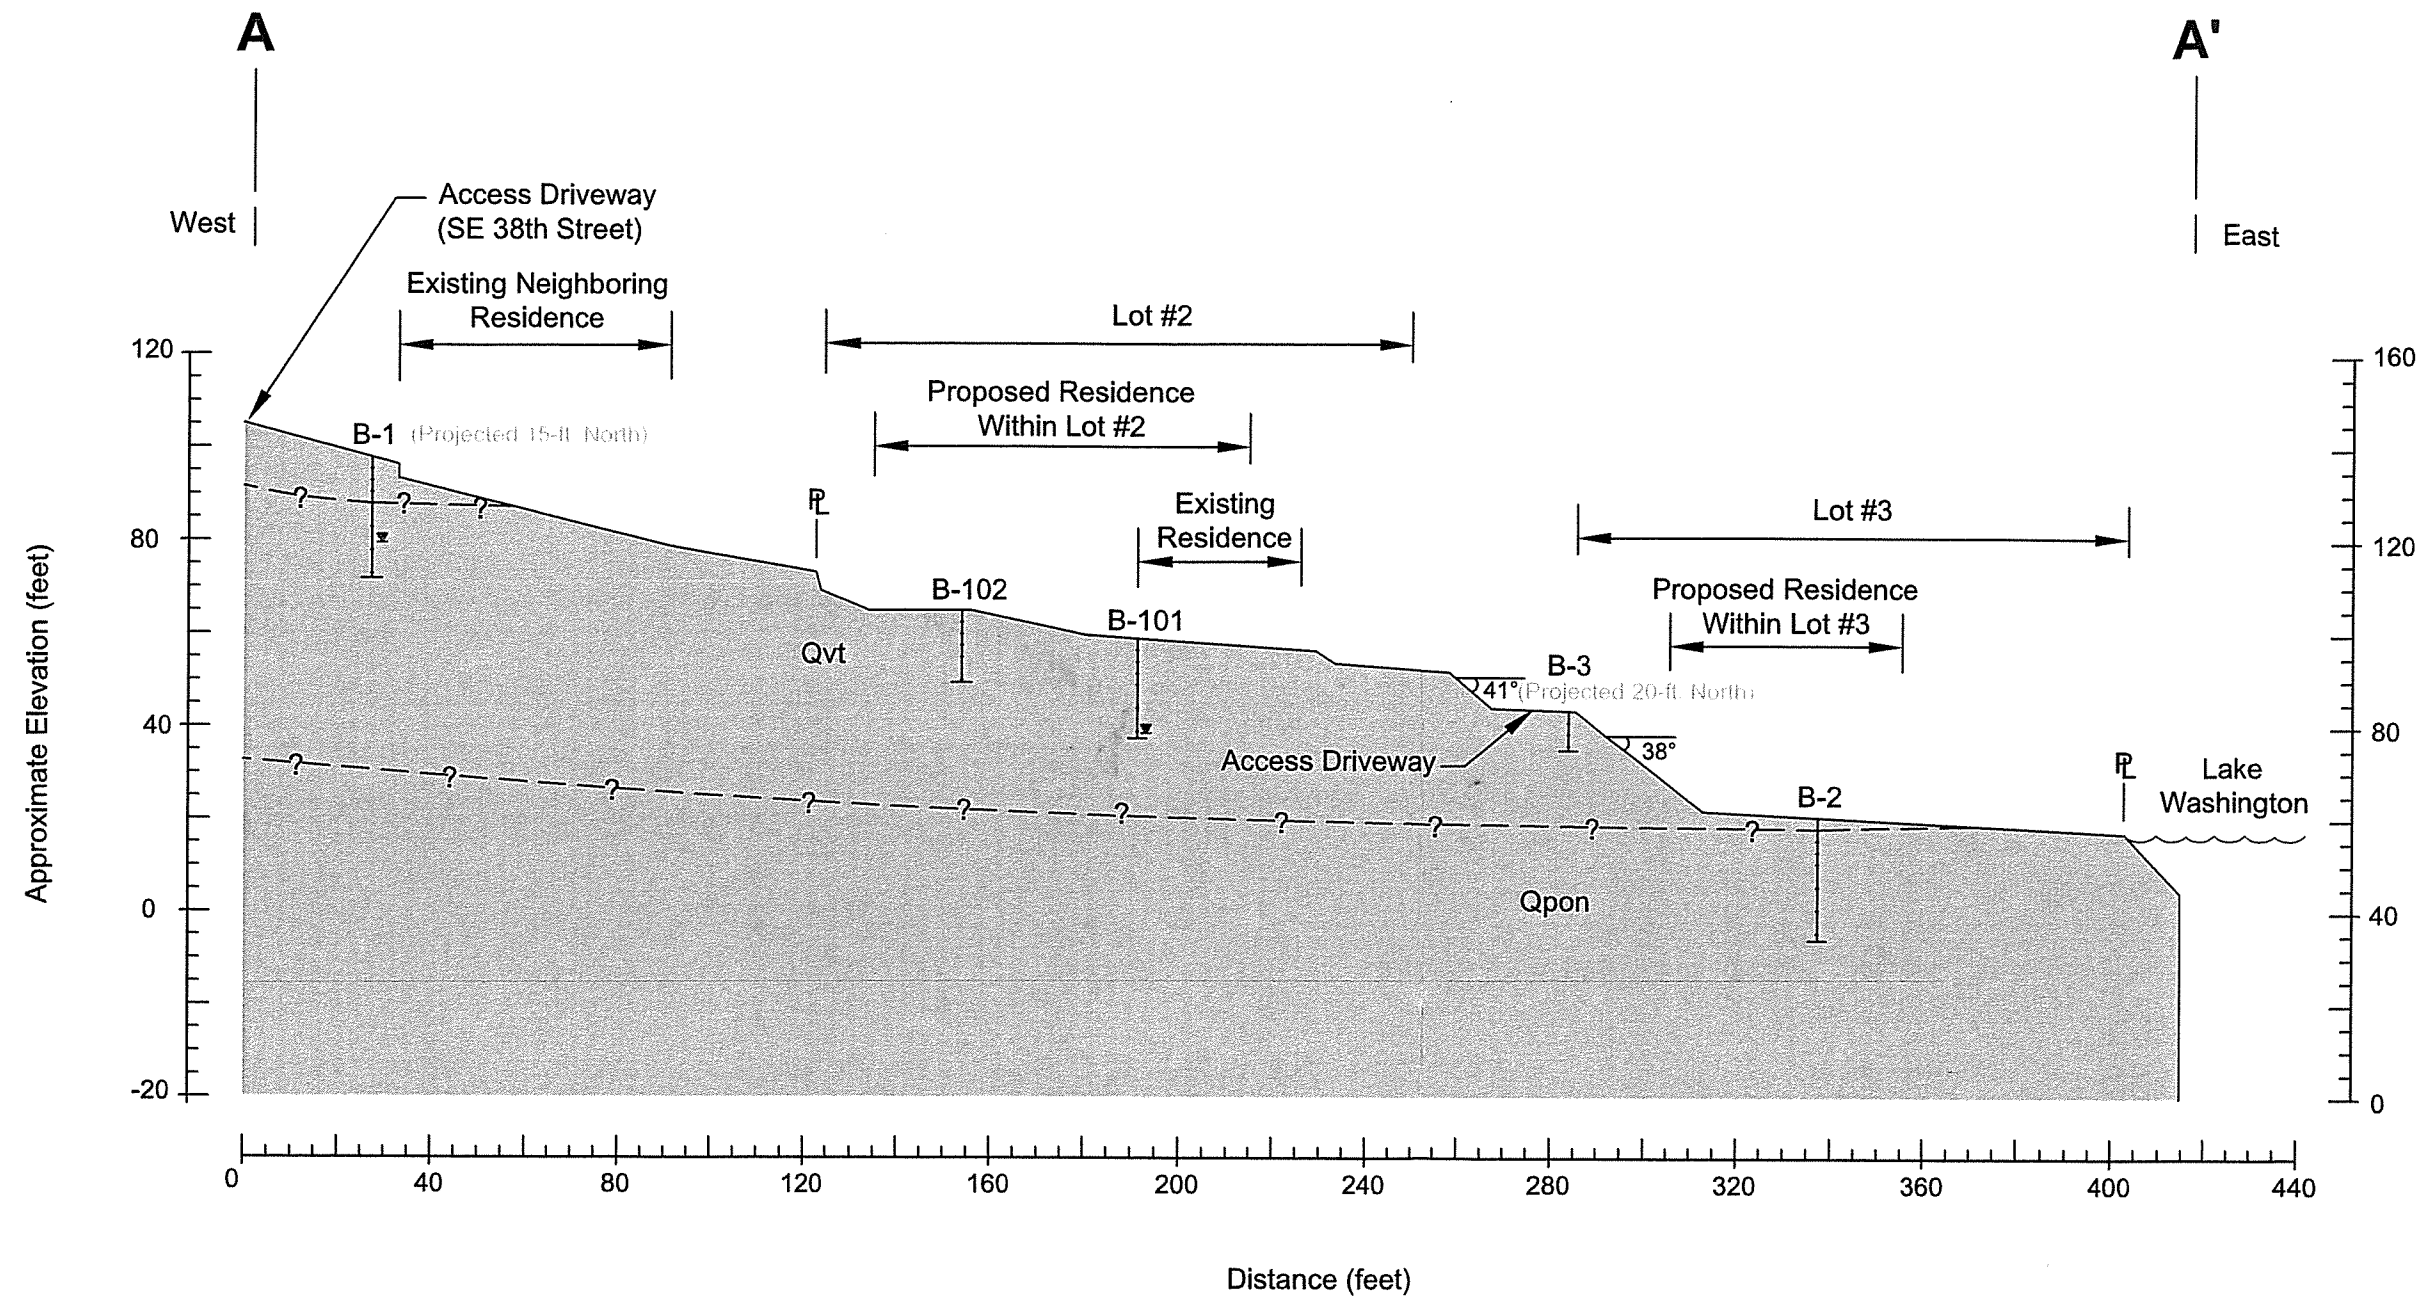
**Exploration**

- NOTES:**
- 1) Stratigraphic conditions are interpolated between the explorations. Actual conditions may vary.
  - 2) Elevations are approximate.

Reference: Cross Section is based on field measurements using a hand-held clinometer and 100-ft tape measure.
