Geotechnical Engineering Evaluation  
**Rudd Residential Addition**  
**8032 SE 57<sup>th</sup> Street**  
**Mercer Island, Washington**  
NGA File No. 1482723

We are pleased to submit the attached report titled ***“Geotechnical Engineering Evaluation – Rudd Residential Addition – 8032 SE 57<sup>th</sup> Street – Mercer Island, Washington.”*** This report summarizes our observations of the existing surface and subsurface conditions within the site, our observations and provides general recommendations for the proposed site development. Our services were completed in general accordance with the proposal signed by you on January 26, 2024.

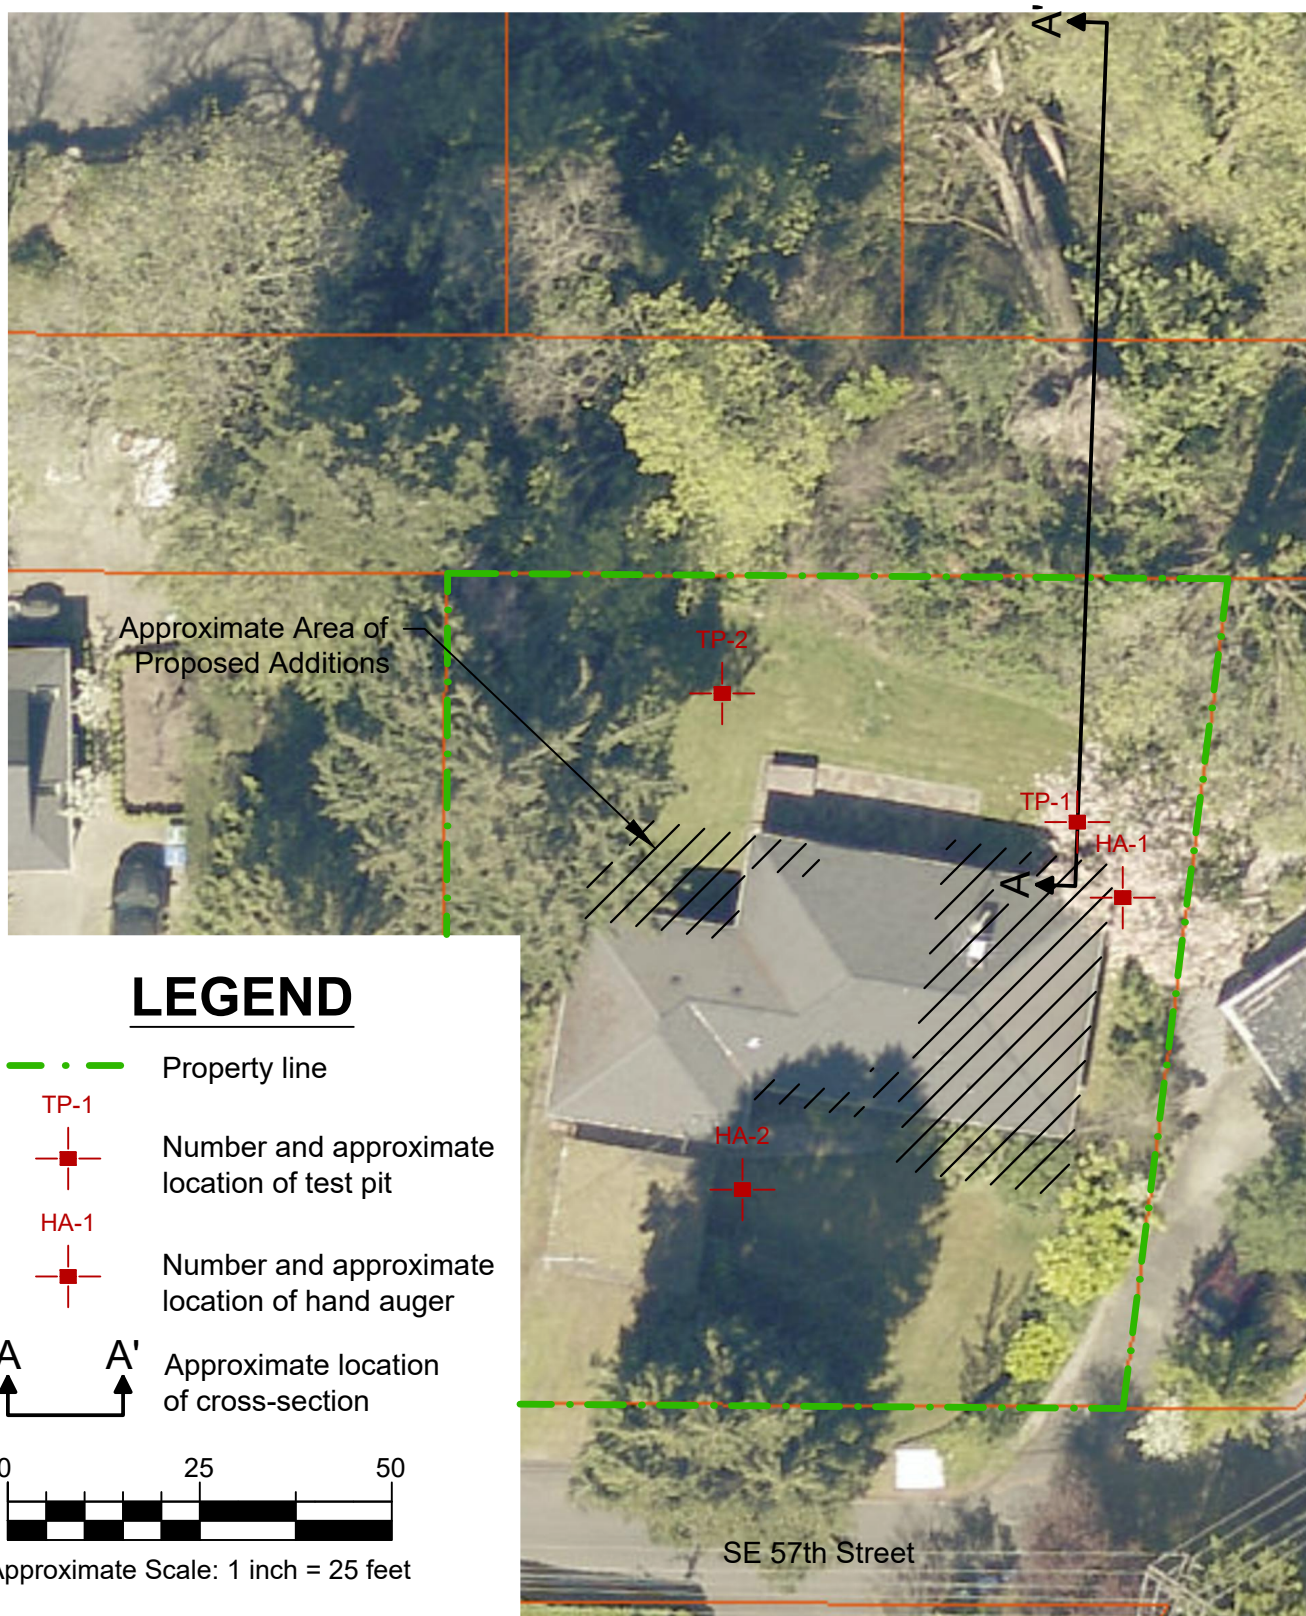
# Site Plan

- Property line
- TP-1  
Number and approximate location of test pit
- HA-1  
Number and approximate location of hand auger
- A-A'  
Approximate location of cross-section

The site is vegetated with grass, landscaping plants, bamboo, shrubs, and few young to mature trees. The site is bordered by SE 57<sup>th</sup> Street to the south, an undeveloped strip of land to the north, and residential properties to the west and east. We did not observe any standing water within the site or groundwater seepage within the site slopes during our site visit on February 5, 2024. We also did not observe significant signs of recent slope movement within the site slopes during our site visit. The existing site conditions and proposed development areas are shown on the Site Plan in Figure 2.

**Explorations:** We visited the site on February 5, 2024, to explore the subsurface conditions within the proposed development area with two test pits and two hand auger explorations. The approximate locations of our explorations are shown on the Schematic Site Plan in Figure 2. A geologist from Nelson Geotechnical Associates, Inc. (NGA) was present during the explorations, examined the soils and geologic conditions encountered, and maintained logs of the explorations. The soils were visually classified in general accordance with the Unified Soil Classification System, presented in Figure 4. The logs of our explorations are presented as Figures 5 and 6. The following paragraph contains a brief description of the subsurface conditions encountered in the explorations. For a detailed description of the subsurface conditions, the test pit and hand auger logs should be reviewed.

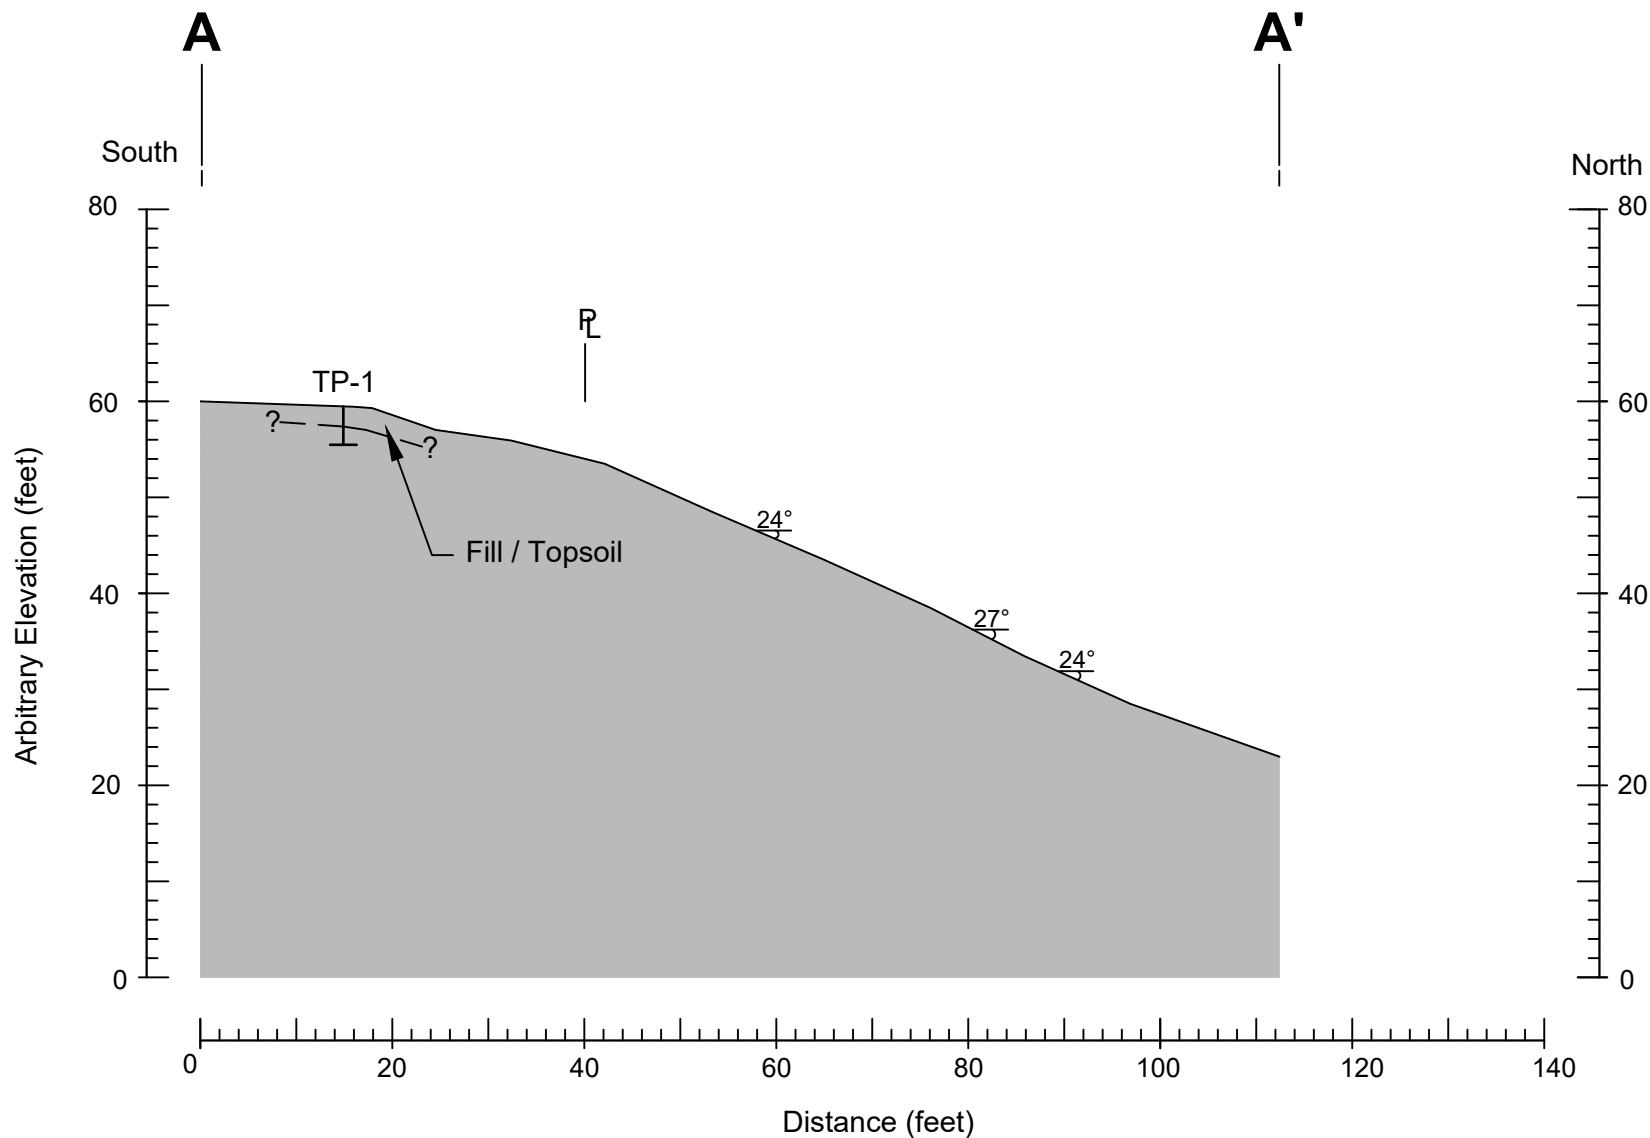
- NOTES:
- 1) Stratigraphic conditions are interpolated between the explorations. Actual conditions may vary.
  - 2) Elevations are arbitrary.

Reference: Cross Section is based on field measurements using a hand-held clinometer and 100-ft tape measure.
