Subject: **Transmittal Letter – Geotechnical Engineering Study**  
Proposed Four Lot Short-Plat  
5224 Forest Avenue Southeast  
Mercer Island, Washington

**GEOTECHNICAL ENGINEERING STUDY**  
**Proposed Four Lot Short-Plat**  
**5224 Forest Avenue Southeast**  
**Mercer Island, Washington**

5224 Forest Avenue Southeast  
Mercer Island, Washington

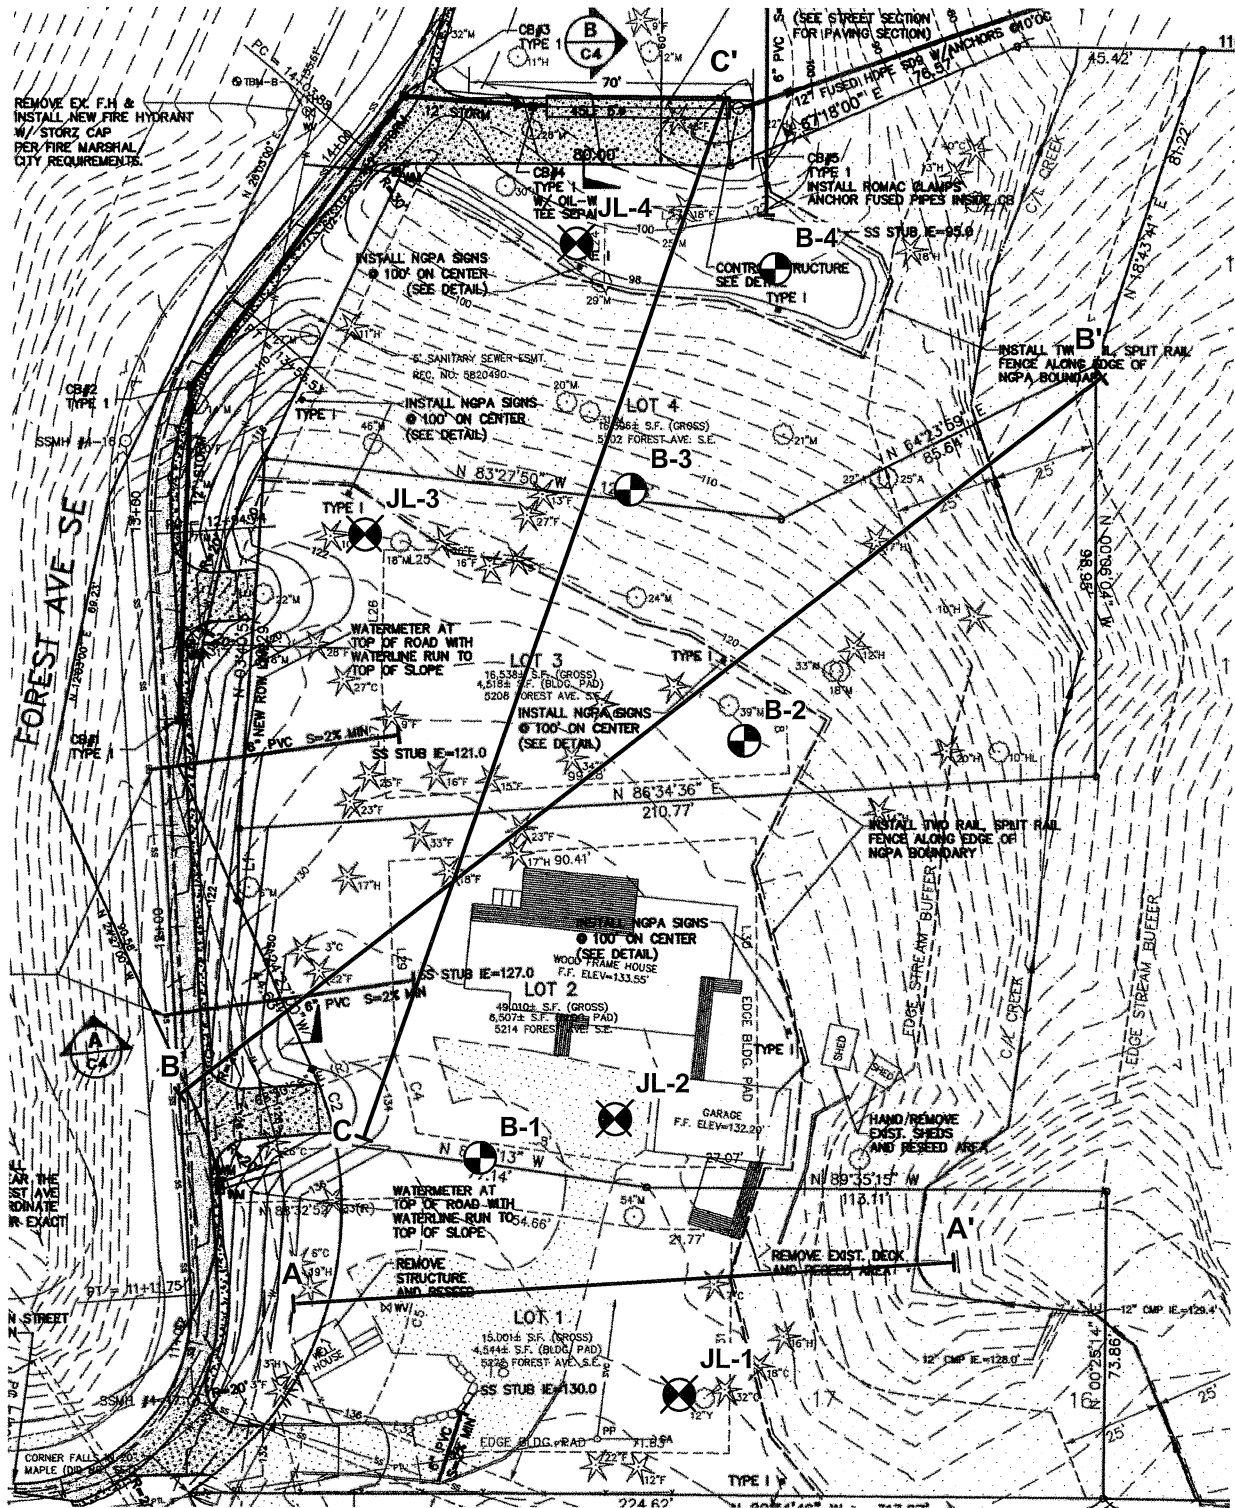
**SITE EXPLORATION PLAN**

Previous Test Boring Location - Liu and Associates, September, 2002

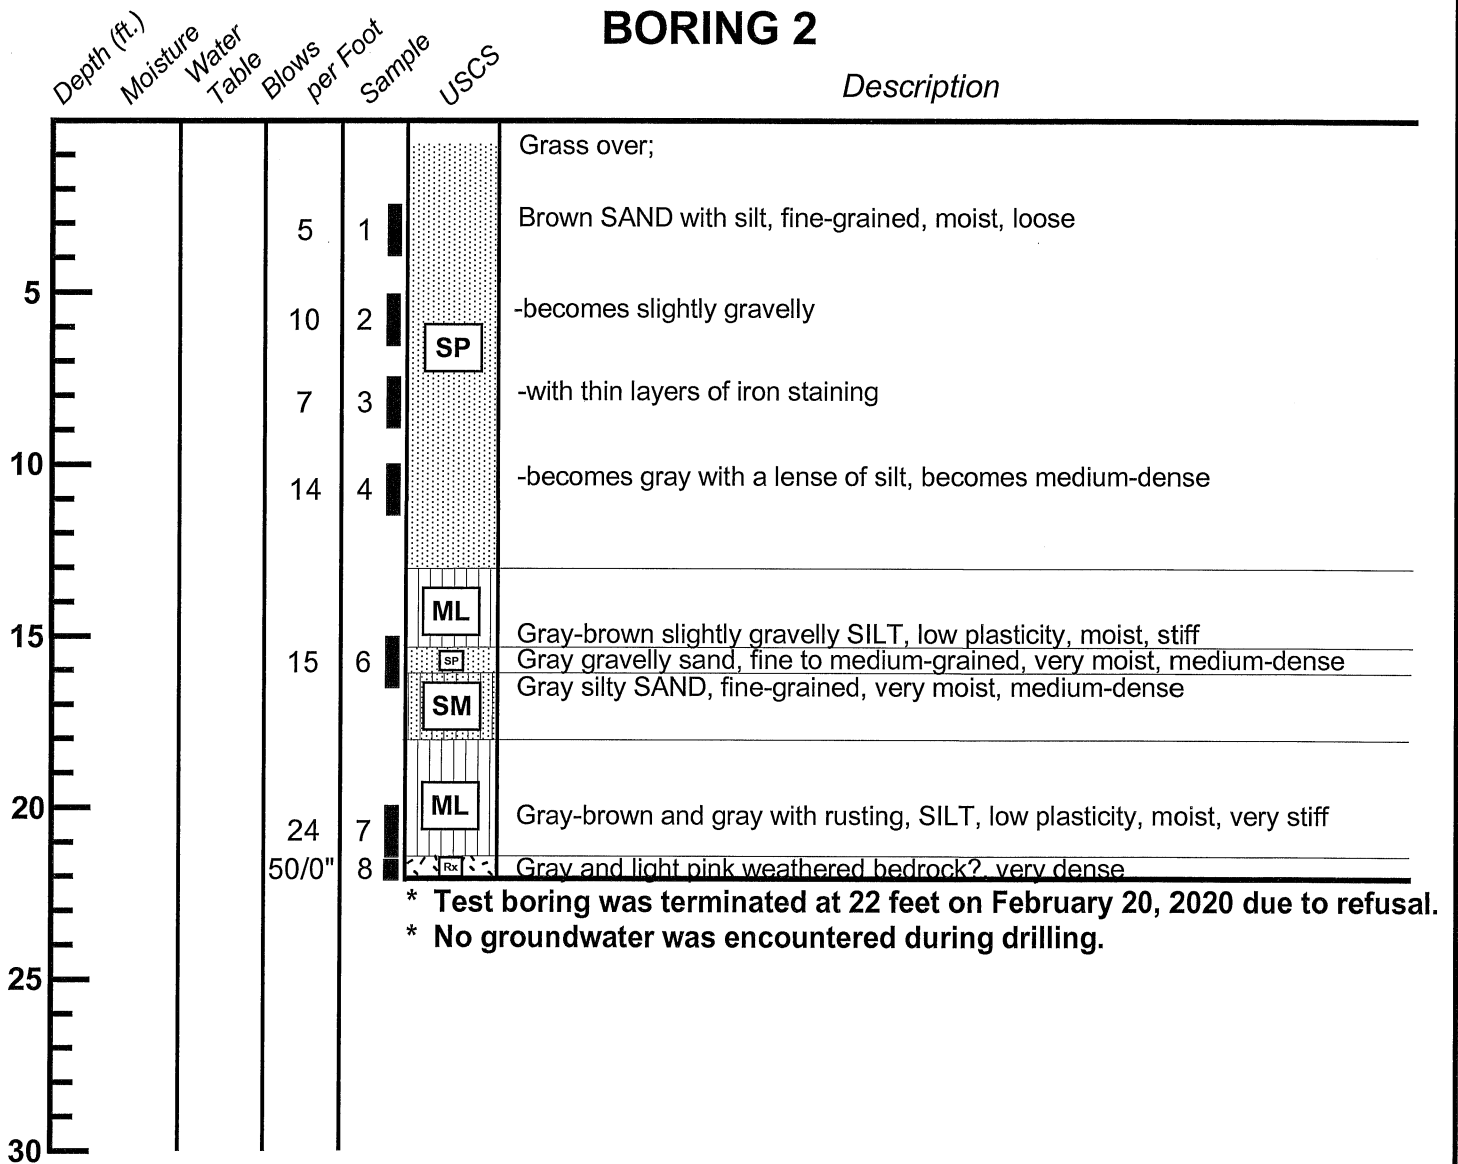
# BORING 2

## TEST BORING LOG

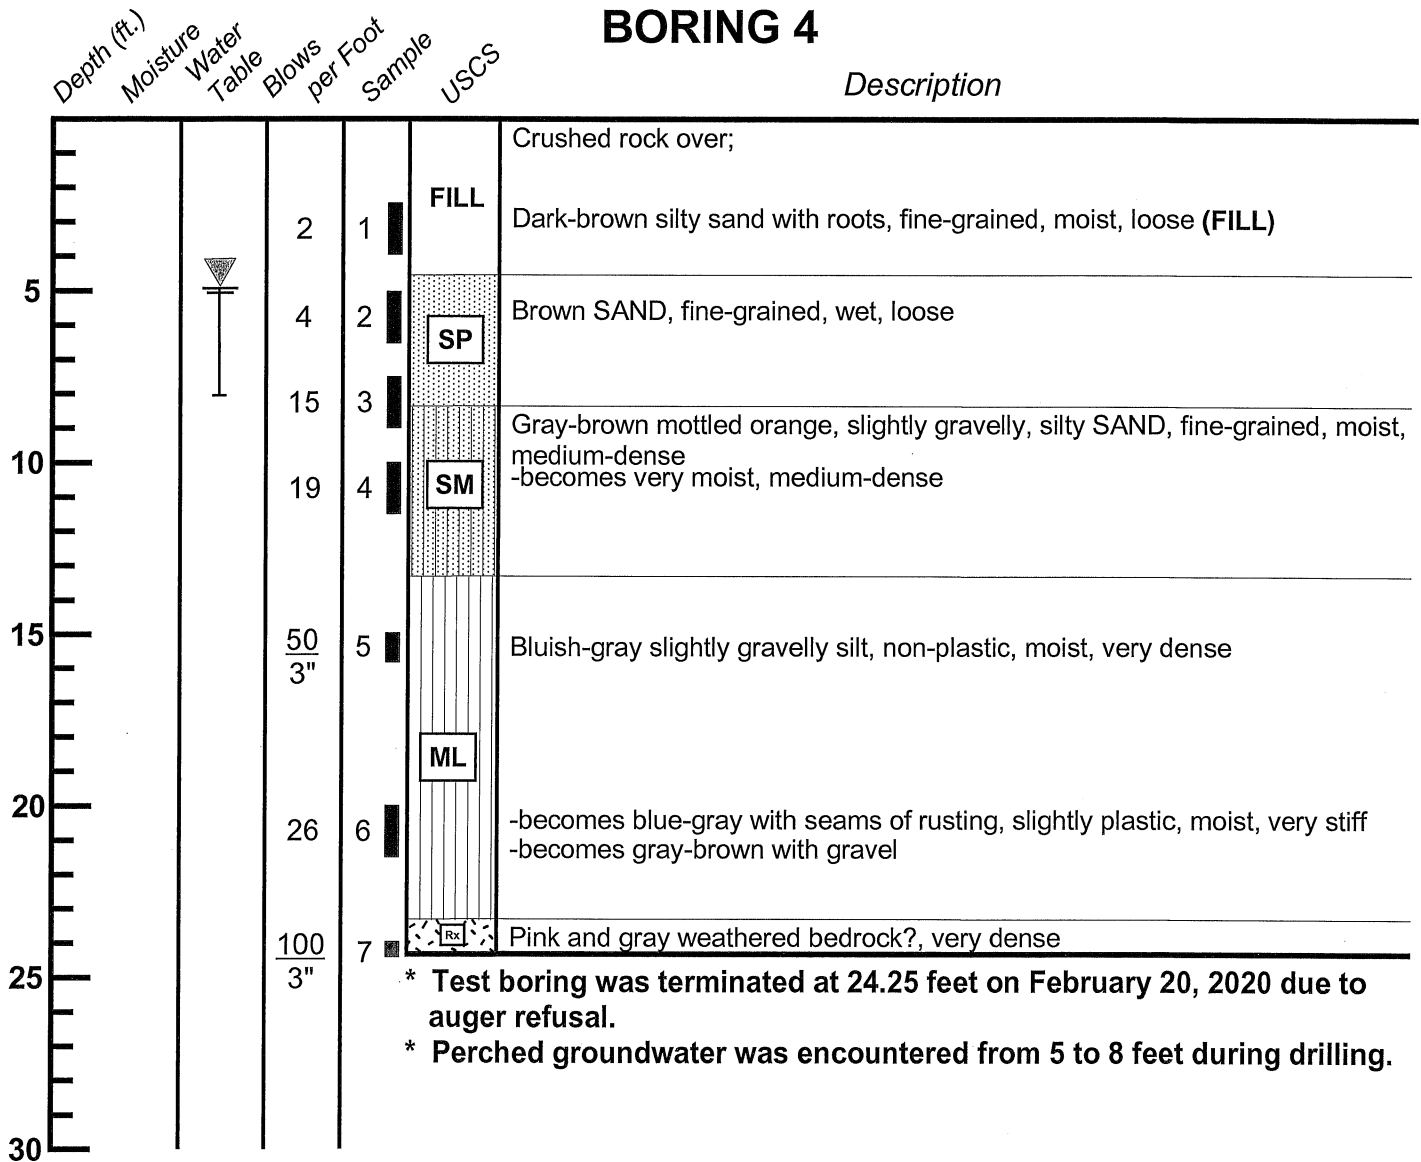
# BORING 4

## TEST BORING LOG

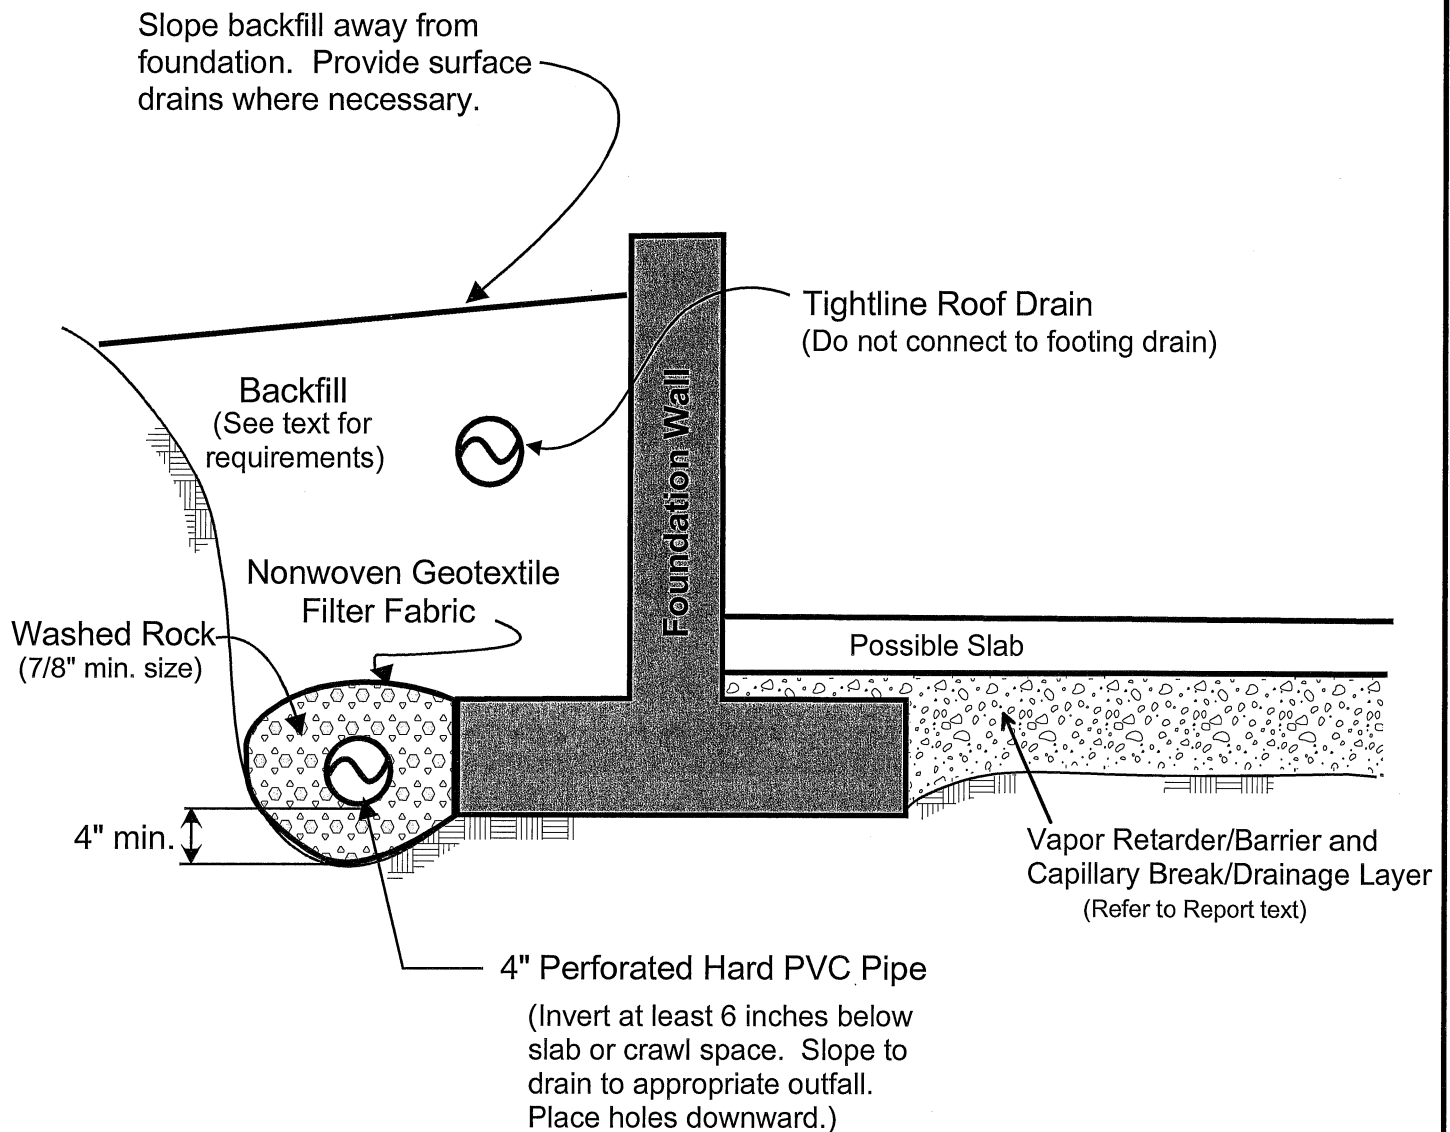
**FOOTING DRAIN DETAIL**

- (1) In crawl spaces, provide an outlet drain to prevent buildup of water that bypasses the perimeter footing drains.
- (2) Refer to report text for additional drainage, waterproofing, and slab considerations.

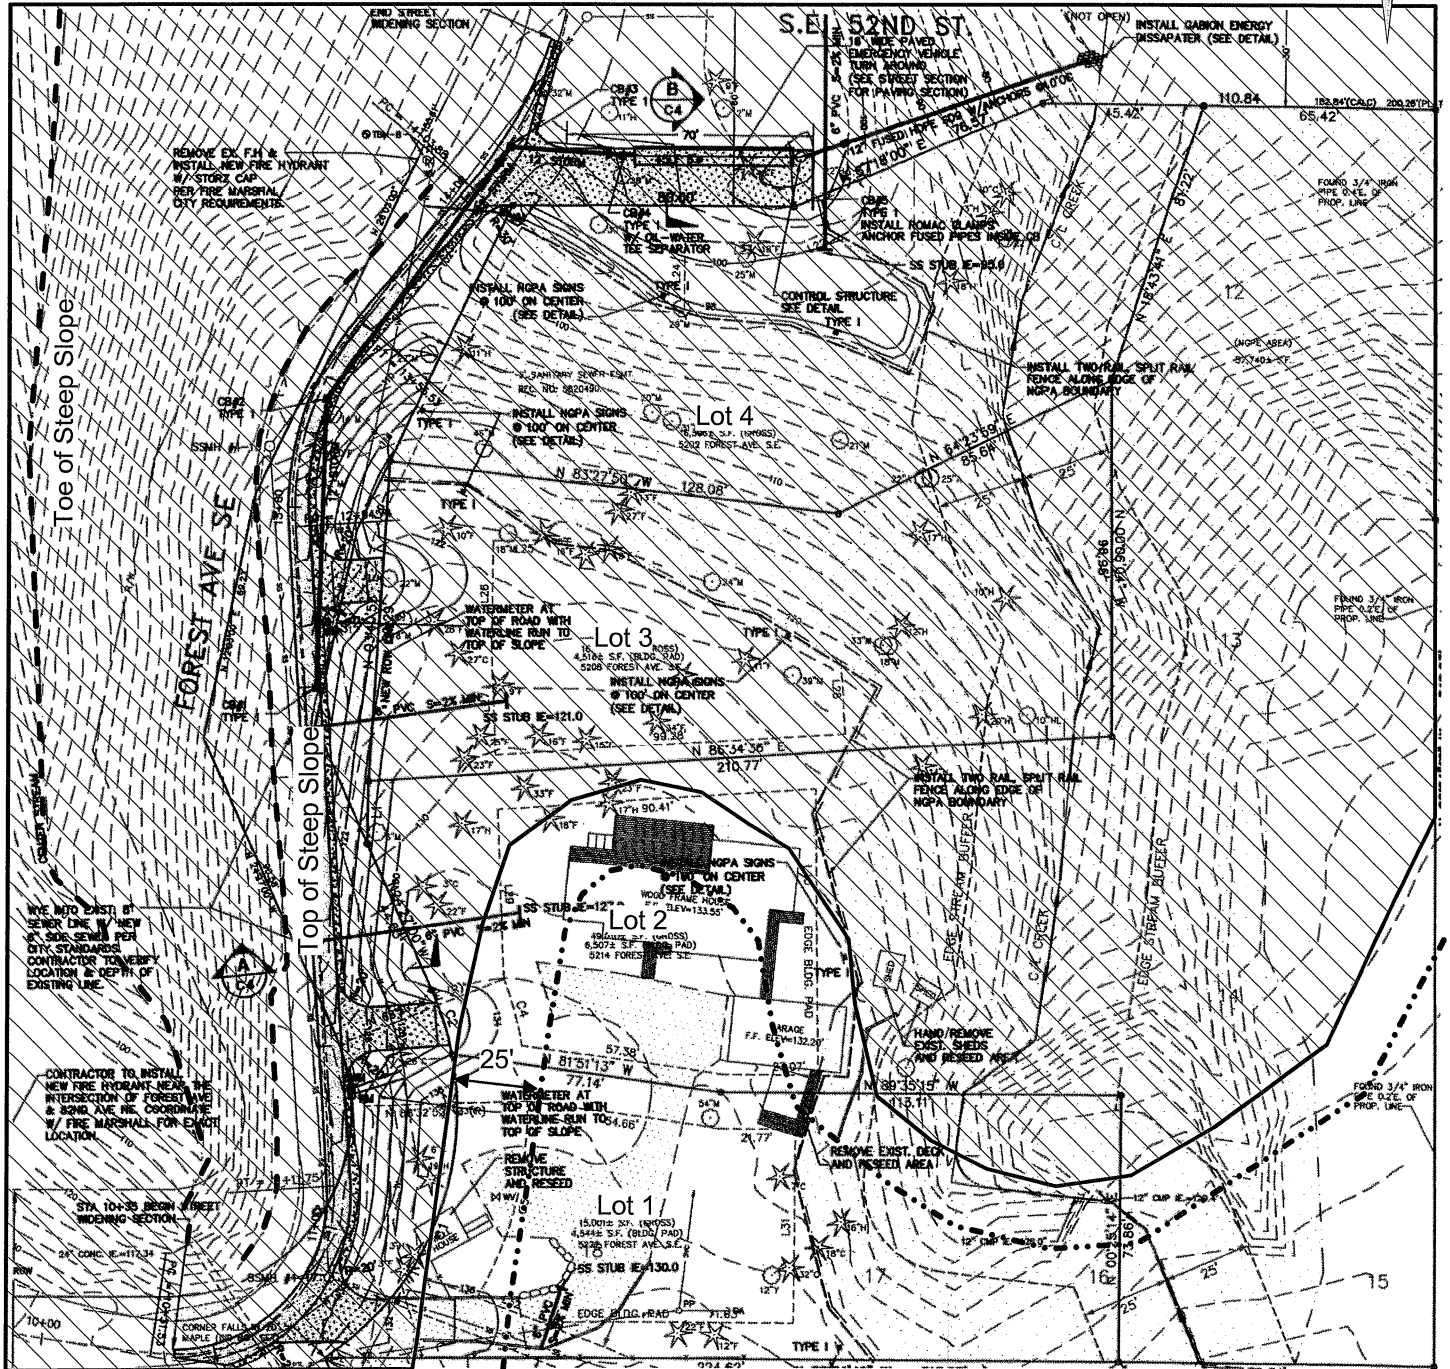
Potential Landslide Hazard & Erosion Hazard Area (Based on Mercer Island Mapping)

..... Approximate 25-Foot Potential Landslide Hazard Area Buffer

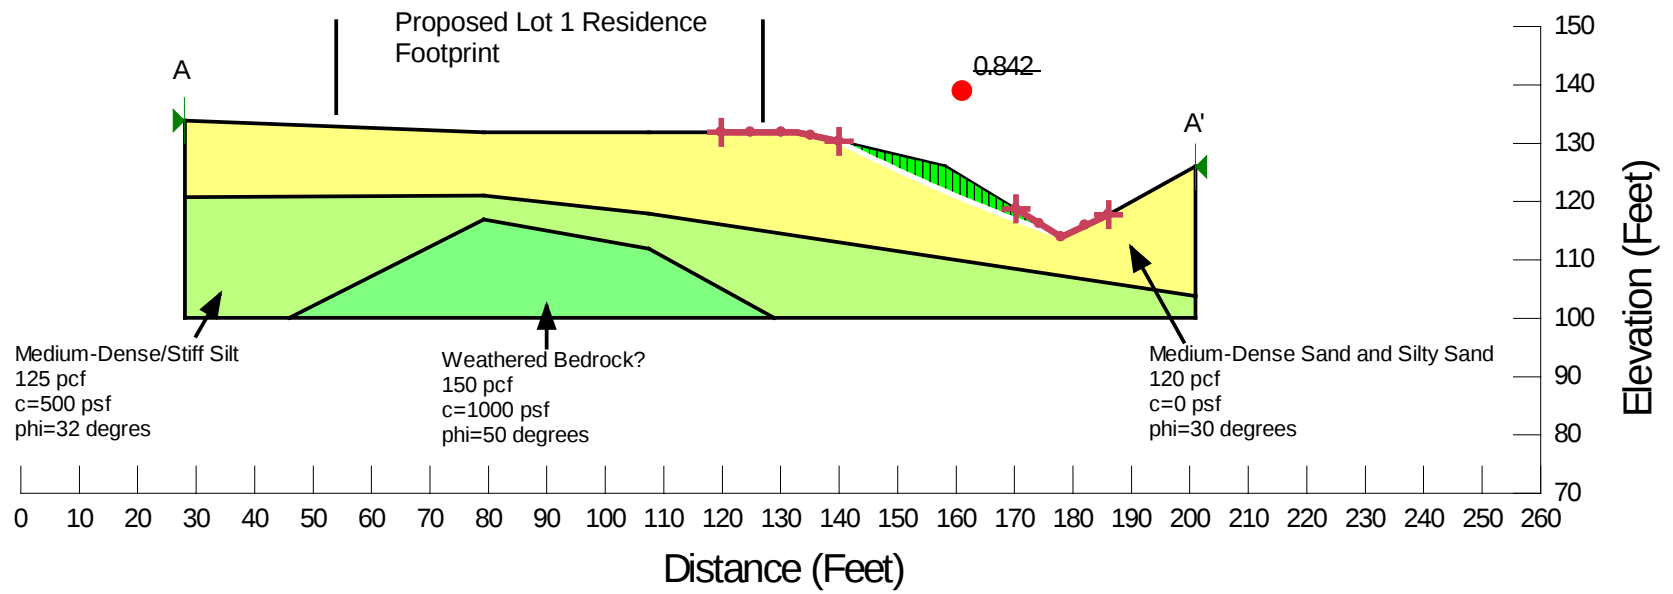
20046 - Seascape Homes  
Seismic

## **Slope Stability Sections**
