GEOTECHNICAL REPORT PROPOSED REMODEL 8109 Southeast 71st Street Mercer Island, Washington

PROJECT NO. 24-093
March 2024

**Subject: Geotechnical Engineering Report
Proposed Remodel
8109 SE 71st Street, Mercer Island, WA**

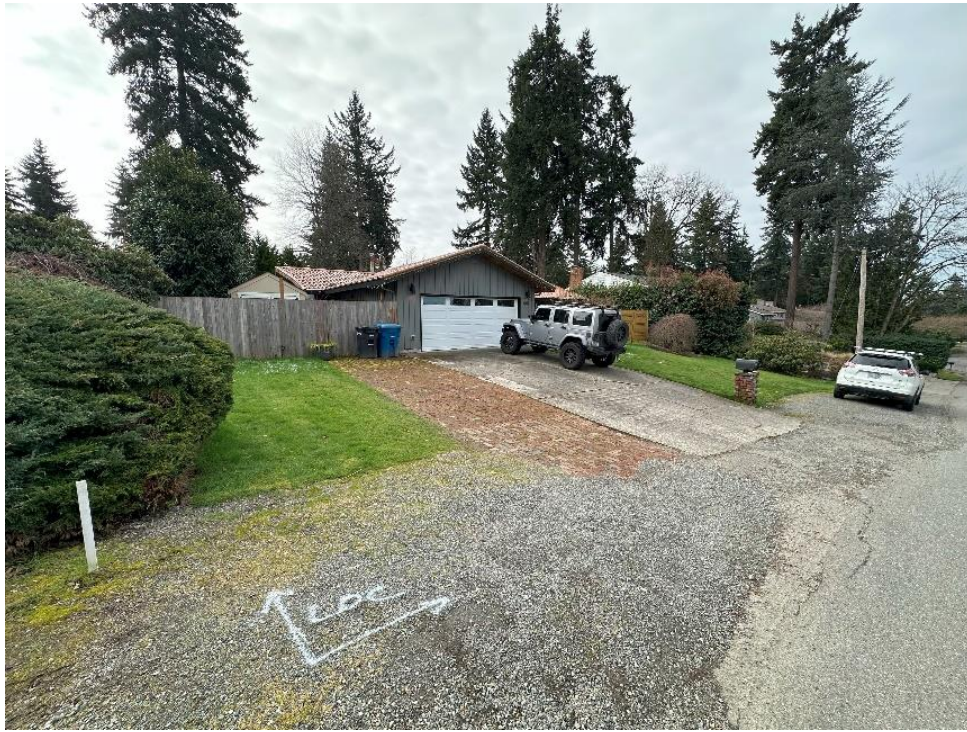
Plate 1. View of the front of subject property, looking southwest from Southwest 71st Street.

Based on our review of the project topographic survey, the site generally slopes down from southeast to northwest with a total vertical relief of about 12 feet, from about Elevation 307 to Elevation 295. The site is generally level in the middle of the site around the house and pool, at approximate Elevation 300 feet. Site conditions at the time of our site visits are shown on Plates 1 through 3, following.

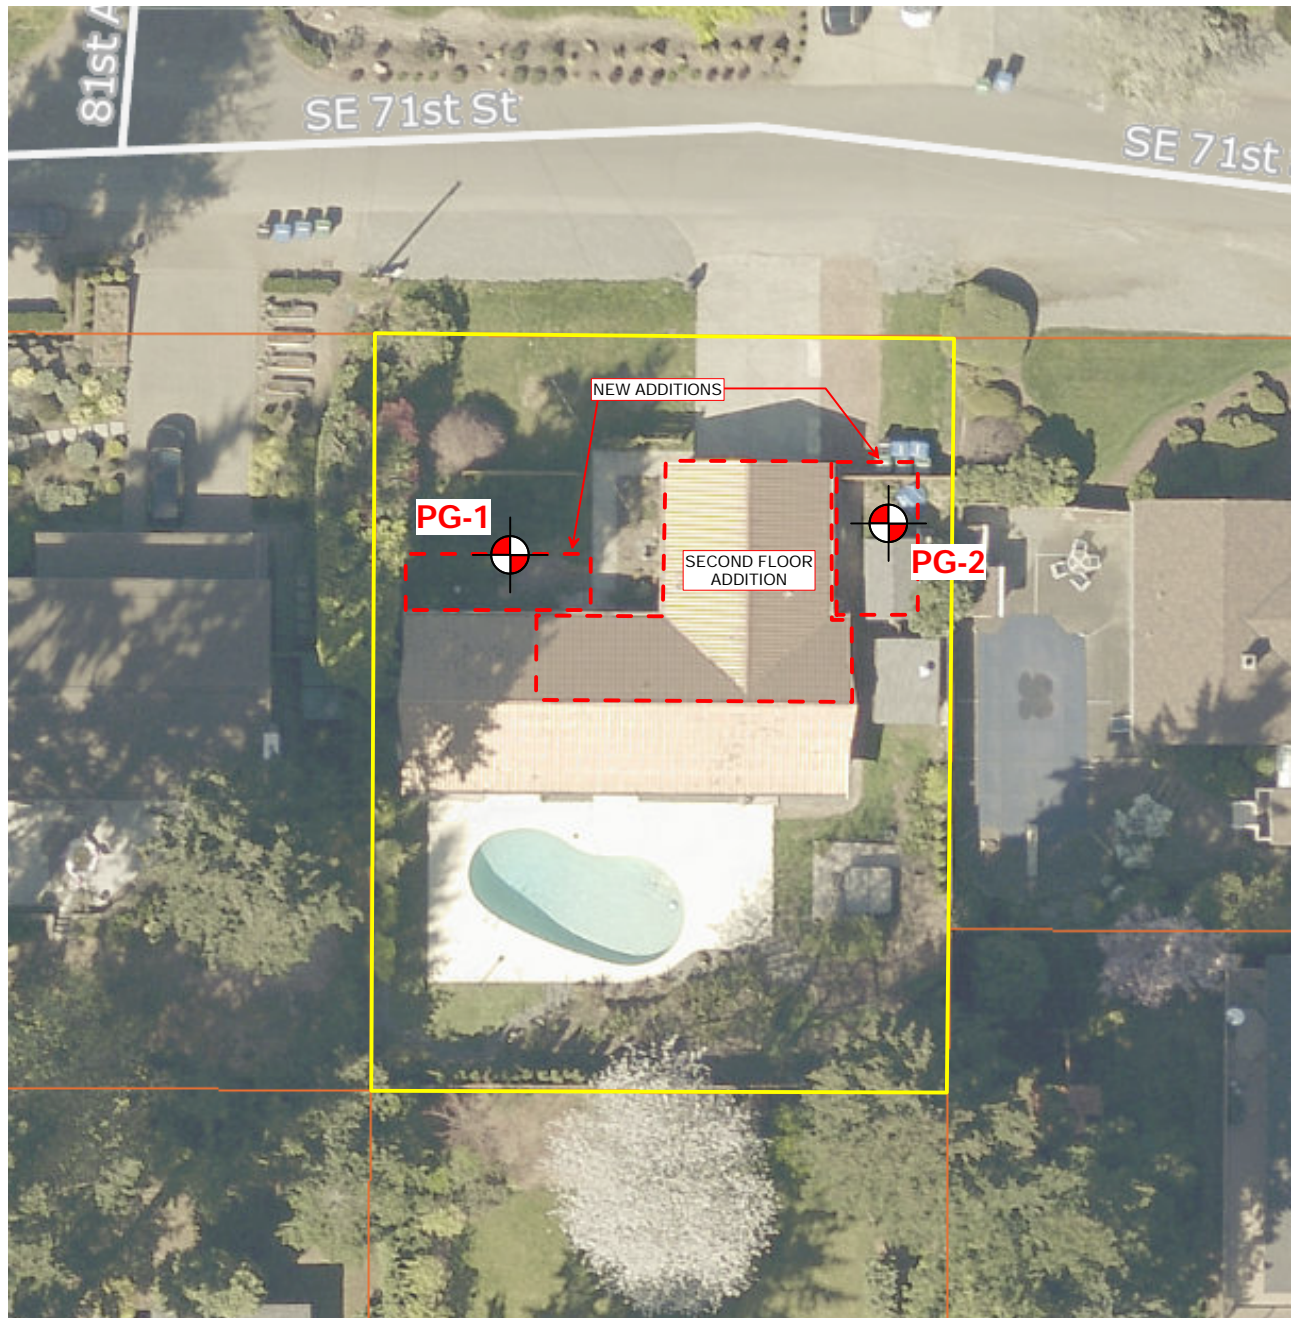
Note: Base map modified from King County iMap, 2021 Aerial Photography.

We understand that you plan to remodel the current house with the addition of a second floor over the north portion of the house. There are also additions planned on the north side of the living room (northwest corner of the house) and on the east side of the garage (northeast corner of the house). Figure 2 shows the approximate locations of the proposed additions and second floor. We understand that the existing footings will be utilized to support the second floor over the existing house footprint and that new foundations will be needed for the living room and garage additions.

The approximate boring locations are shown on the attached Figure 2 – Site and Exploration Plan.
