# GEOTECHNICAL REPORT PROPOSED REMODEL 8109 Southeast 71<sup>st</sup> Street Mercer Island, Washington

PROJECT NO. 24-093  
March 2024

**Subject: Geotechnical Engineering Report  
Proposed Remodel  
8109 SE 71<sup>st</sup> Street, Mercer Island, WA**

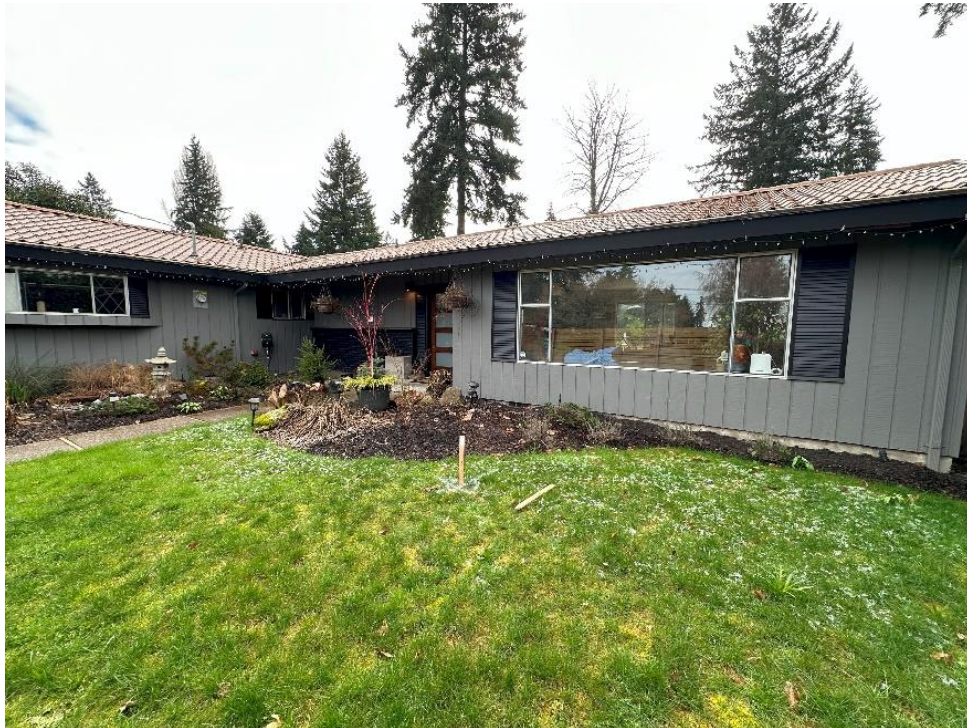
*Plate 2. View of the proposed north side improvement area, looking southeast.*

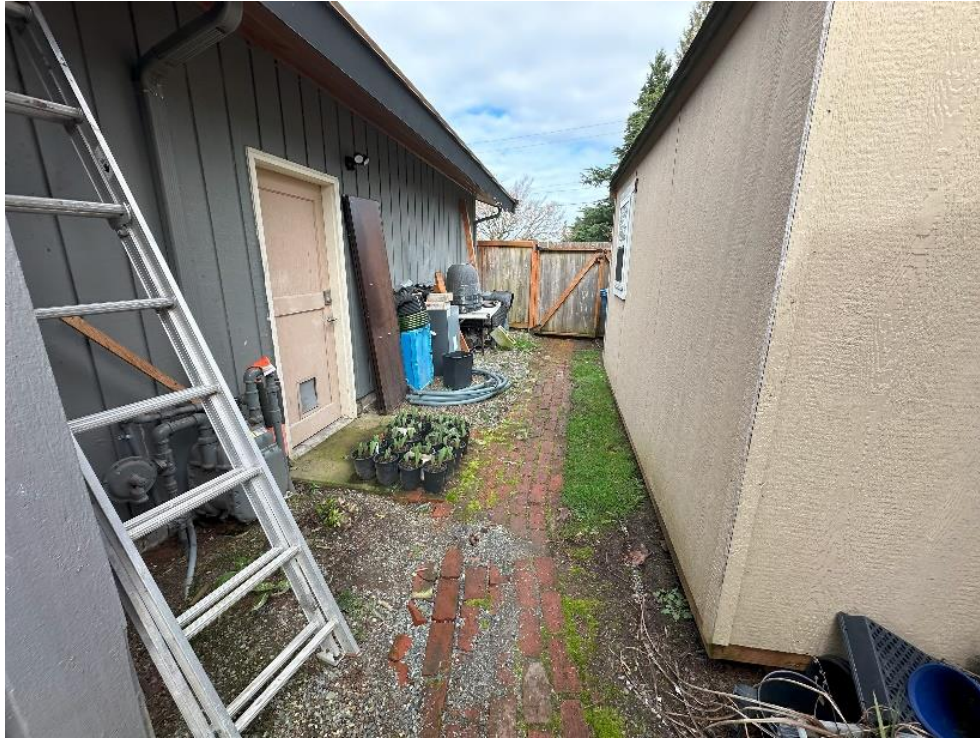
*Plate 3. View of the proposed northeast improvement area, looking north.*

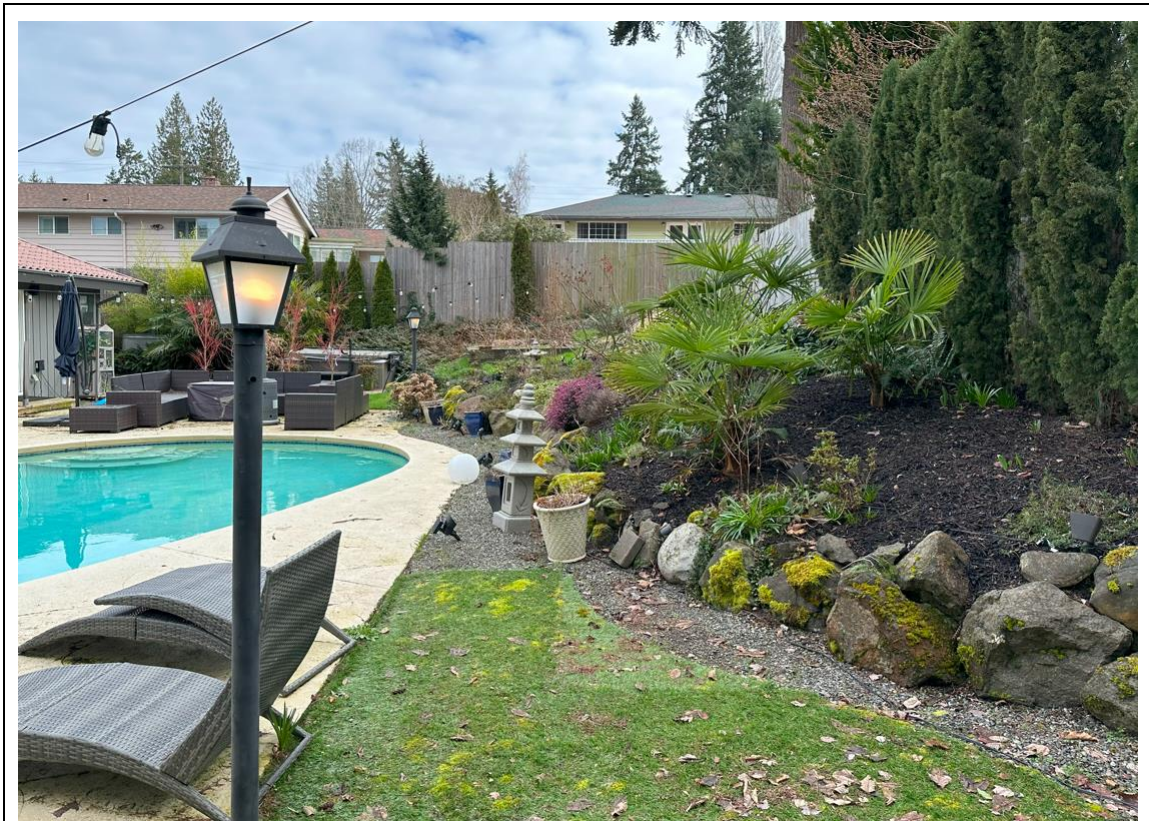
*Plate 5. View of the existing landscaped area mapped as a potential landslide area on the south side of the property.*

movement at the site. The site gently slopes down from the southeast corner of the backyard to the northeast corner of the front yard next to Southeast 71<sup>st</sup> Street and is relatively level through the center area of the main house and pool. The mapped hazard crosses through a 1-foot-tall rockery and shallowly sloped landscaping at the southwest corner of the site (see Plate 5 below). The sloped area is about 6 feet tall with no signs of slope movement or instability noted. The area around the proposed developments on the north side of the site is generally level.

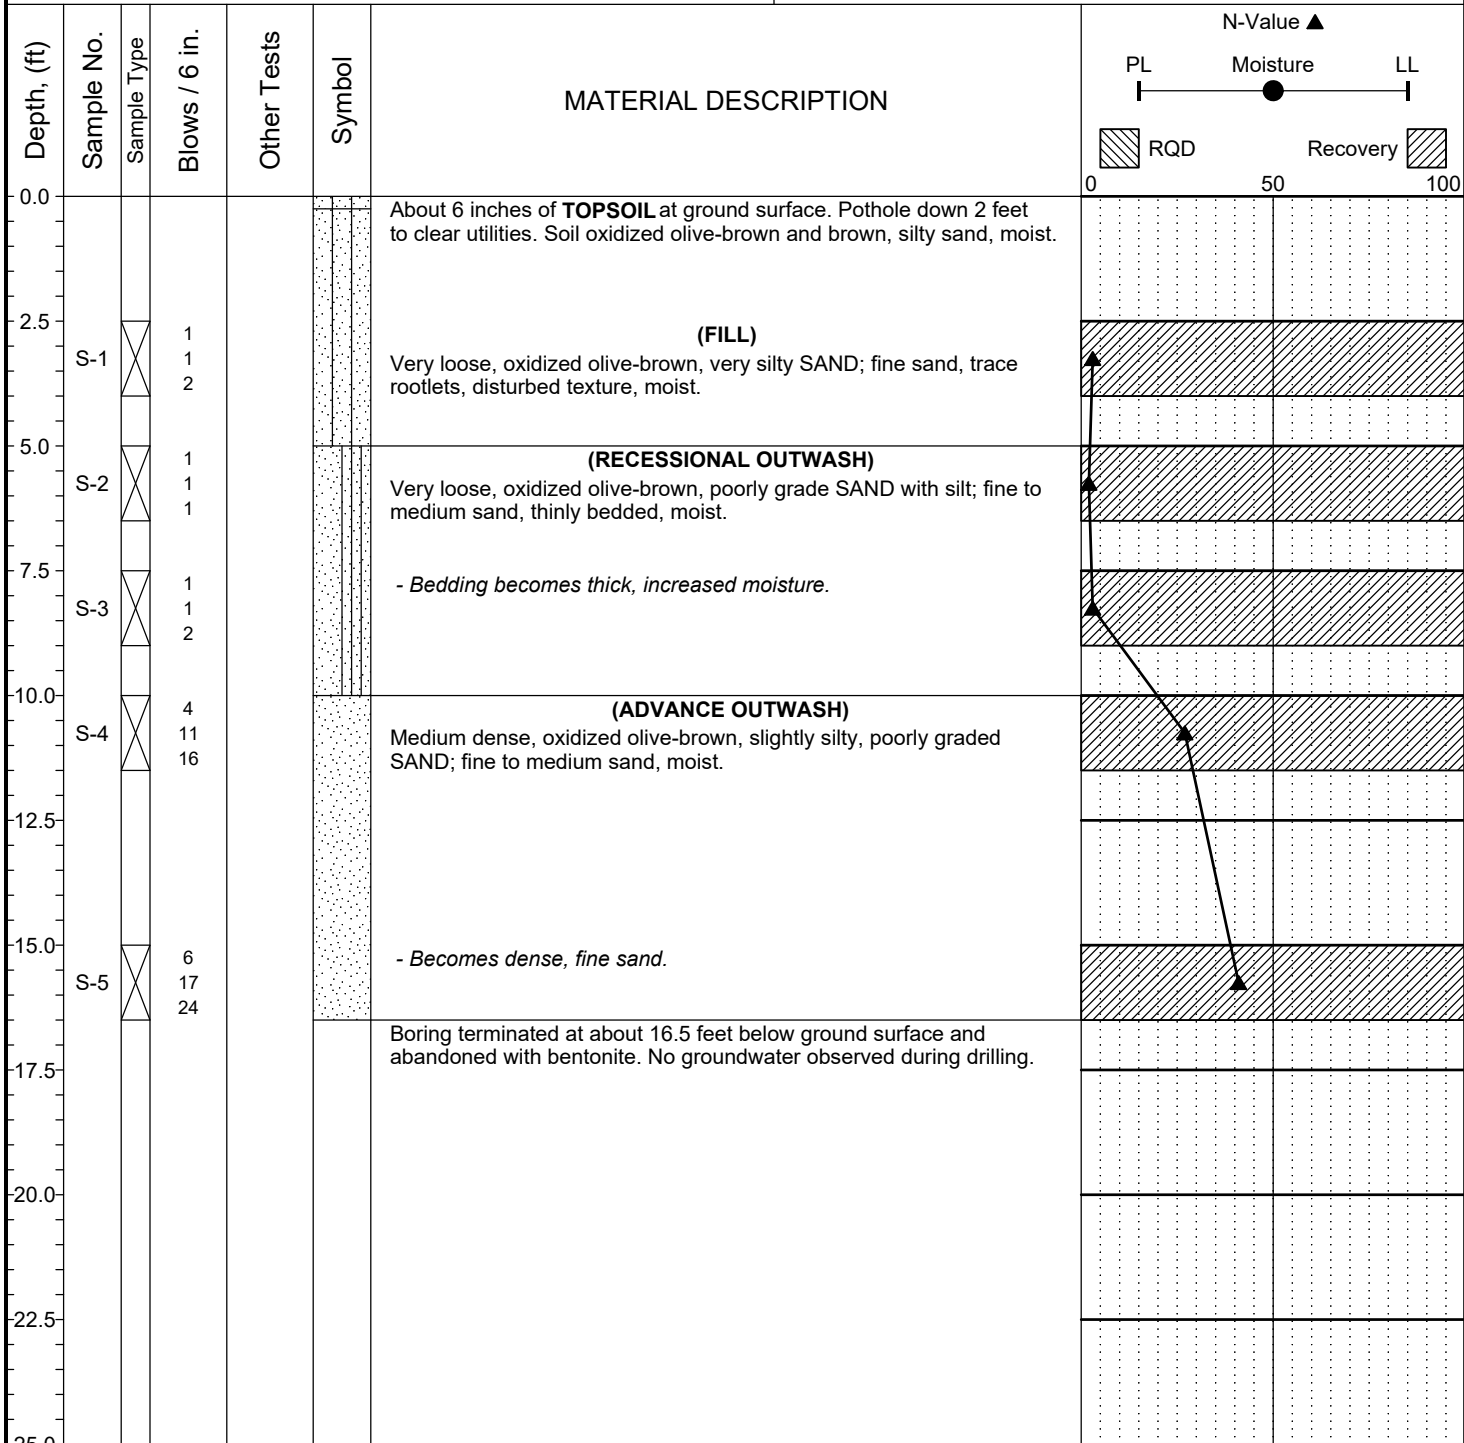
Project:	Proposed Remodel	Surface Elevation:	~301 ft
Job Number:	24-093	Top of Casing Elev.:	n/a
Location:	8109 Southeast 71st Street, Mercer Island, WA	Drilling Method:	HSA
Coordinates:	Northing: 47.53918, Easting: -122.23012	Sampling Method:	SPT, Rope and Cathead

Completion Depth:	16.5ft	Remarks: Borings drilled using limited-access Acker drill rig. Standard penetration test (SPT) sampler driven with a 140 lb. safety hammer. Hammer operated with a rope and cathead mechanism. Elevations are approximate from site survey by Terrane, dated 10/31/2019. <b>Vertical datum: NAVD88</b>
Date Borehole Started:	3/13/24	
Date Borehole Completed:	3/13/24	
Logged By:	A. Ong	
Drilling Company:	CN Drilling, Inc.

**Fill:** In both PG-1 and PG-2, we encountered a surficial soil unit of very loose, fine sand with variable silt and organic content. This soil unit had a generally disturbed and nonuniform texture with traces of charcoal. We interpret this soil unit as fill, which extended to about 5 feet deep in both test borings.

**Recessional Outwash Deposits (Qvr):** Below the fill in both borings, we encountered very loose to medium dense, thinly bedded, slightly silty to silty, poorly graded, fine sand. We interpret this soil unit as recessional outwash based on the loose consistency and presence of bedding. The recessional outwash extended to about 10 feet deep in both borings.
