June 12, 2025
Updated June 17, 2025
ES-9607.02

**Subject: Response to Review Comments
Cheshire Property
7615 East Mercer Way
Mercer Island, Washington**

As requested, Earth Solutions NW, LLC (ESNW) has prepared this response to review comments letter for the subject project. This response letter addresses city of a city of Mercer Island review comments in the referenced review letter. This update includes a review of the latest submittal plans.

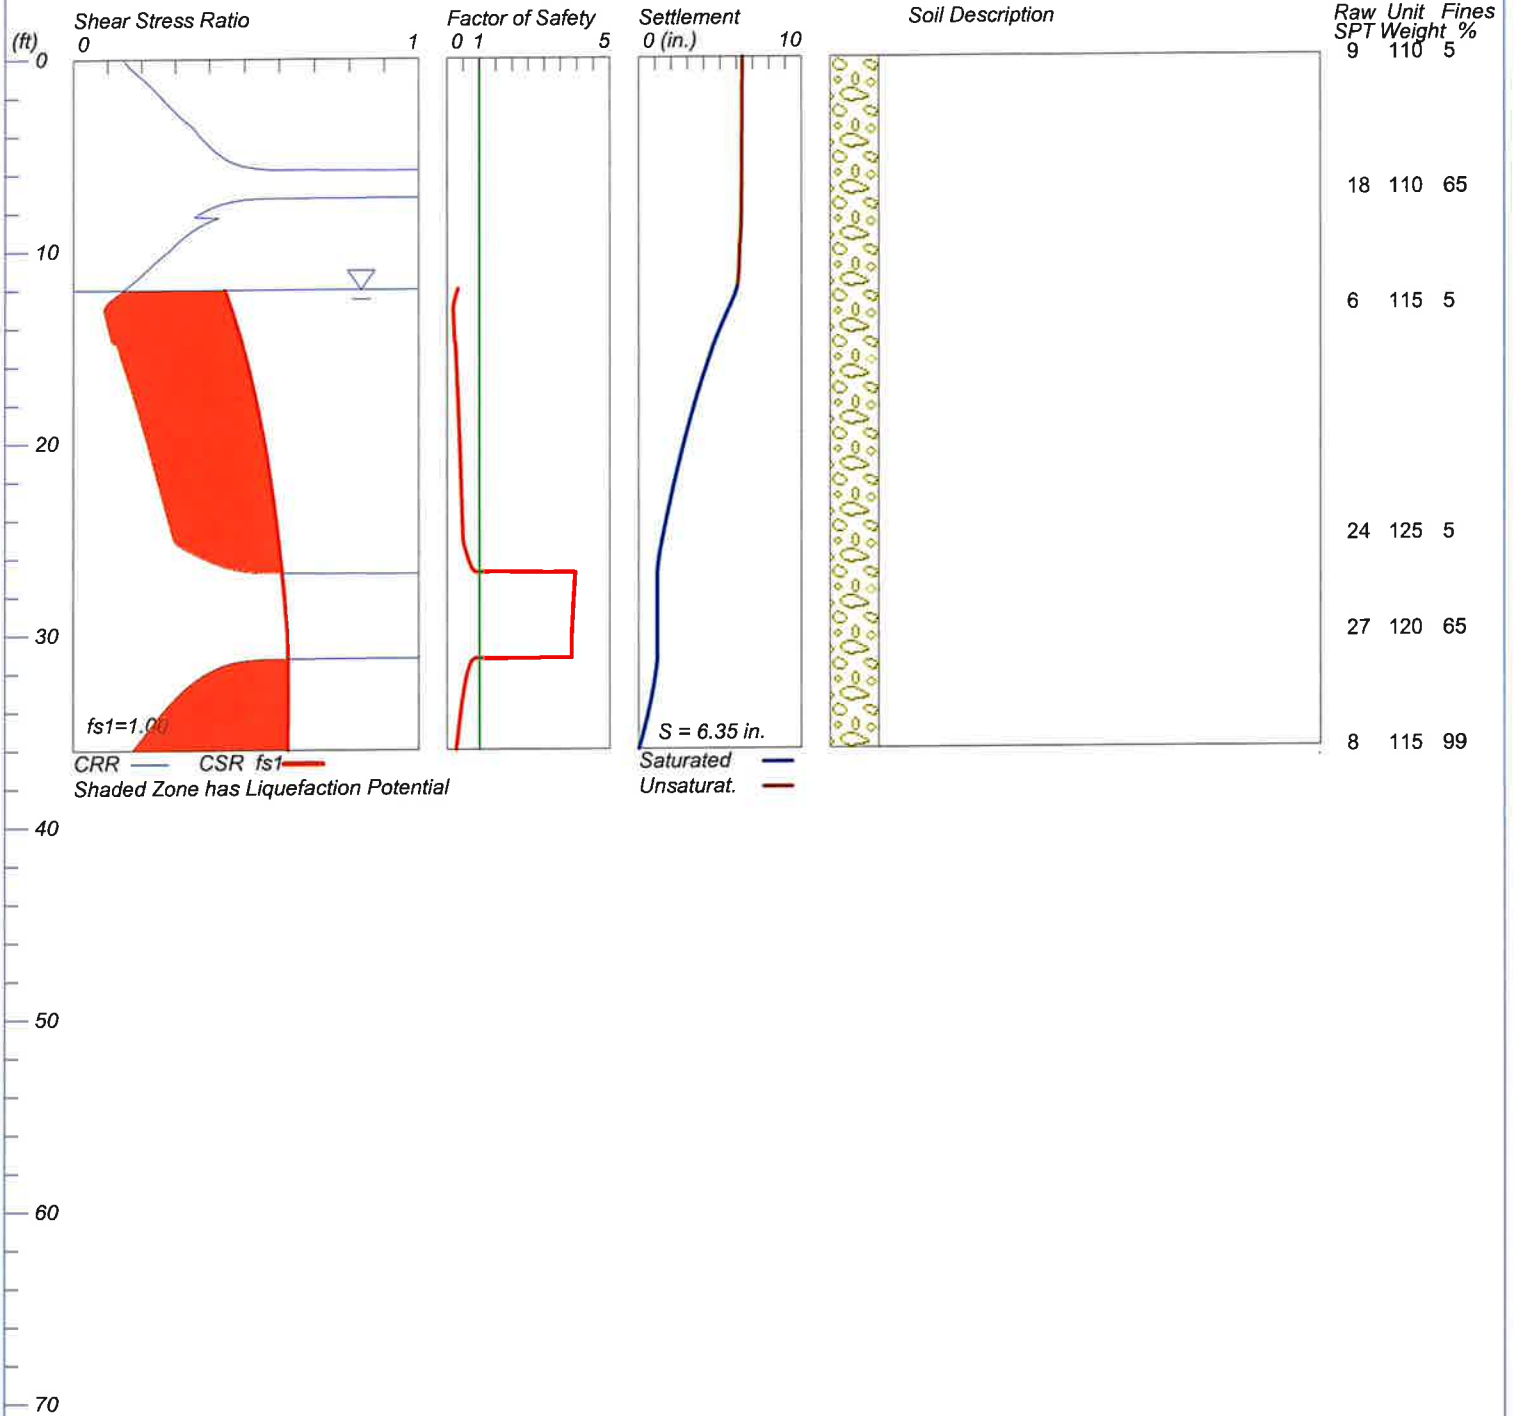
Hole No.=B-7 Water Depth=12 ft

Magnitude=7
Acceleration=0.7g

LiquefyPro CivilTech Software USA www.civilttech.com
