# Cheshire Residence

7165 E Mercer Way

## Stormwater Site Plan

June 27, 2025

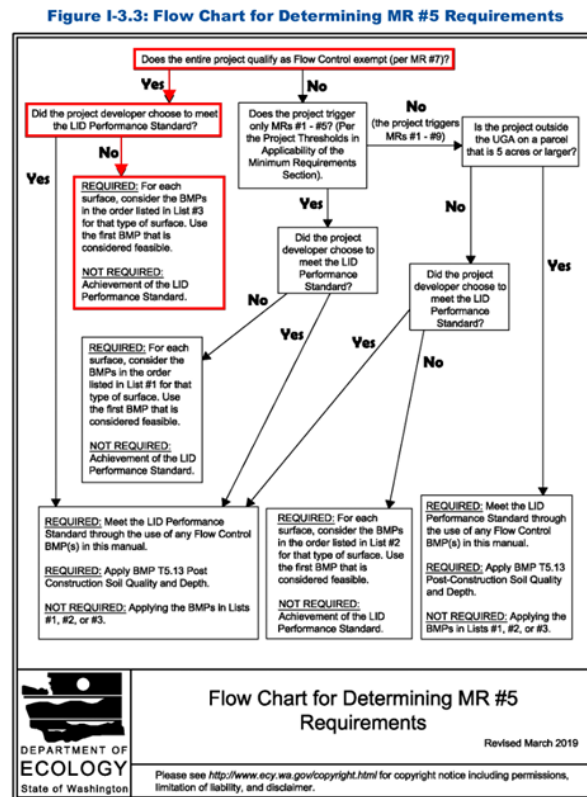
Since the project triggers Minimum Requirements #1-9, the project must provide on-site stormwater management in accordance with Section I-3.4.5 of Volume I of the 2019 DOE Manual. Figure I-3.3 requires BMPs in List #3 to be evaluated for feasibility, included in the following table. See Table 2 below the figure for a feasibility evaluation of the on-site stormwater management BMPs.

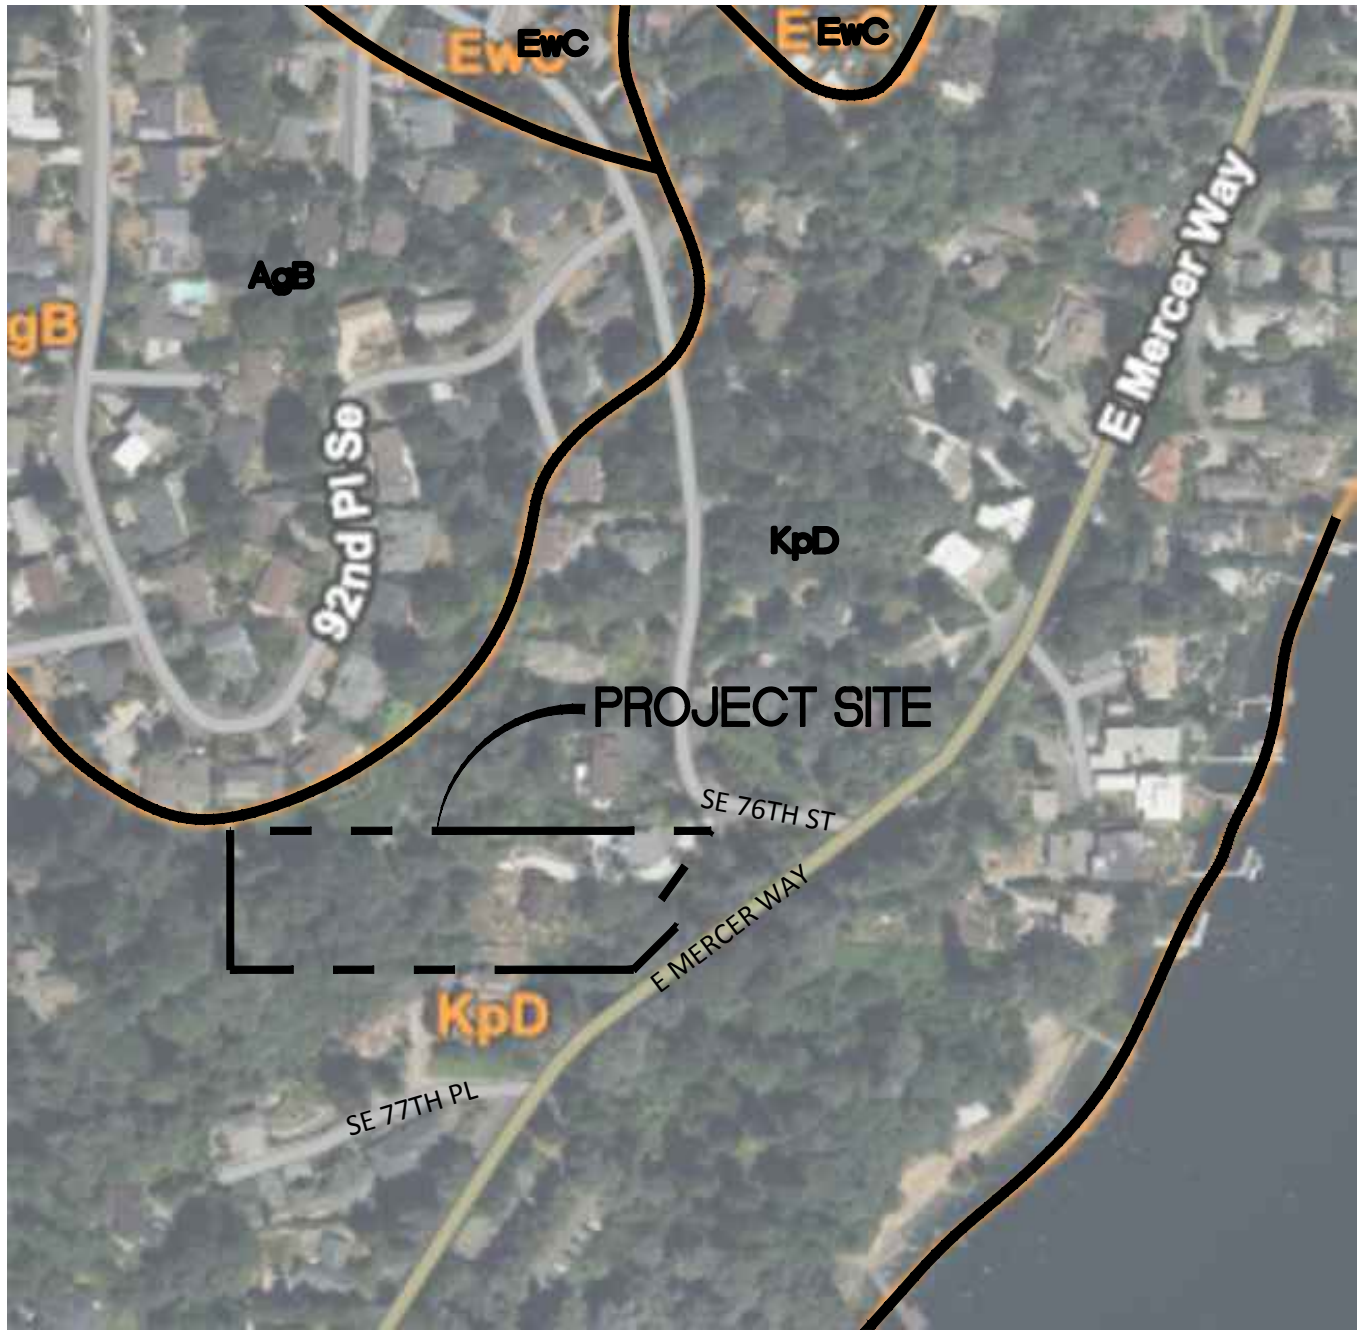
KING COUNTY AREA, WASHINGTON (WA633)

Per the Natural Resources Conservation Service Web Soil Survey, the entire site is underlain with Kitsap silt loam, 15 to 30 percent slopes (KpD). Refer to Figure 3 – Soils Map. A geotechnical report was previously prepared by Geotech Consultants Inc., dated May 2, 2016, for the construction of the DADU located on the site. The report indicates that the site soils near the existing residence consists of medium-stiff to medium dense native soils. Also based upon the mature, straight, evergreen trees and no signs of distress in the existing foundation, Geotech Consultants Inc. concluded that there was no evidence of significant slope movement within the last 50 years. Groundwater seepage was observed in three borings along the north side of the property, ranging in depths from 7.5 to 10 feet. The geotechnical report is included in Appendix D. The City of Mercer Island Infiltration Feasibility Map shows as located in “Basin 38”, in an area where both infiltration is infeasible and infiltration facilities are not permitted. As a result of this, drainage BMPs such as on-site infiltration and dispersion were determined to be infeasible. This will be further discussed in the Permanent Stormwater Control Plan section of this report.

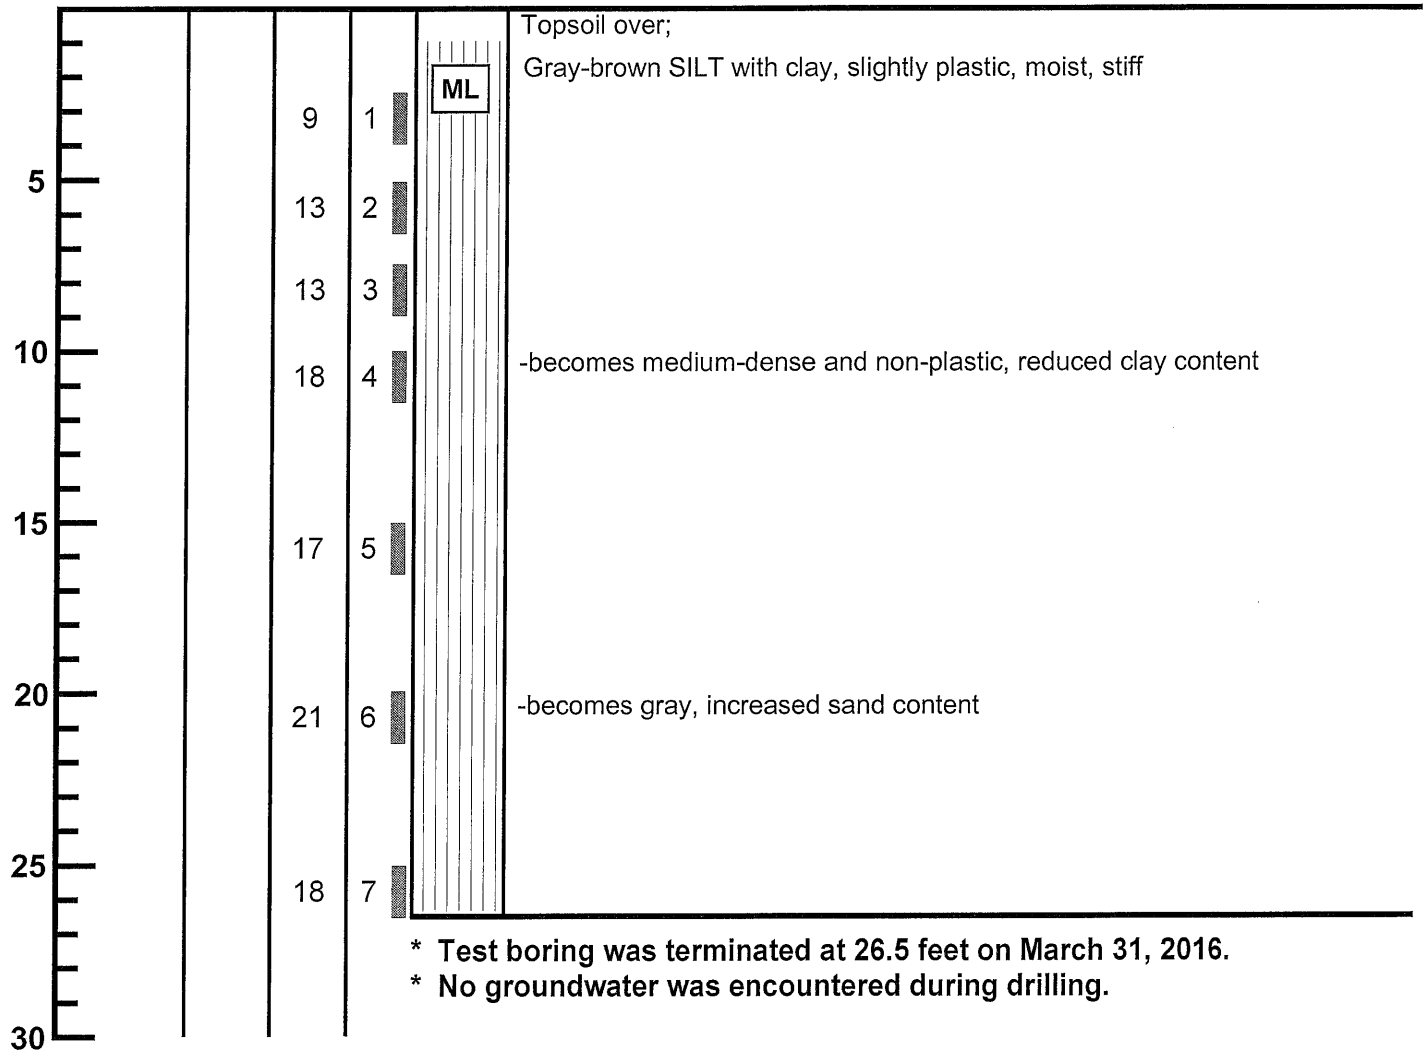
<b>Job</b> 16095	<b>Date:</b> March 2016	<b>Logged by:</b> TRC	<b>Plate:</b> 3
---------------------	----------------------------	--------------------------	--------------------

**TEST BORING LOG**  
7615 East Mercer Way  
Mercer Island, Washington

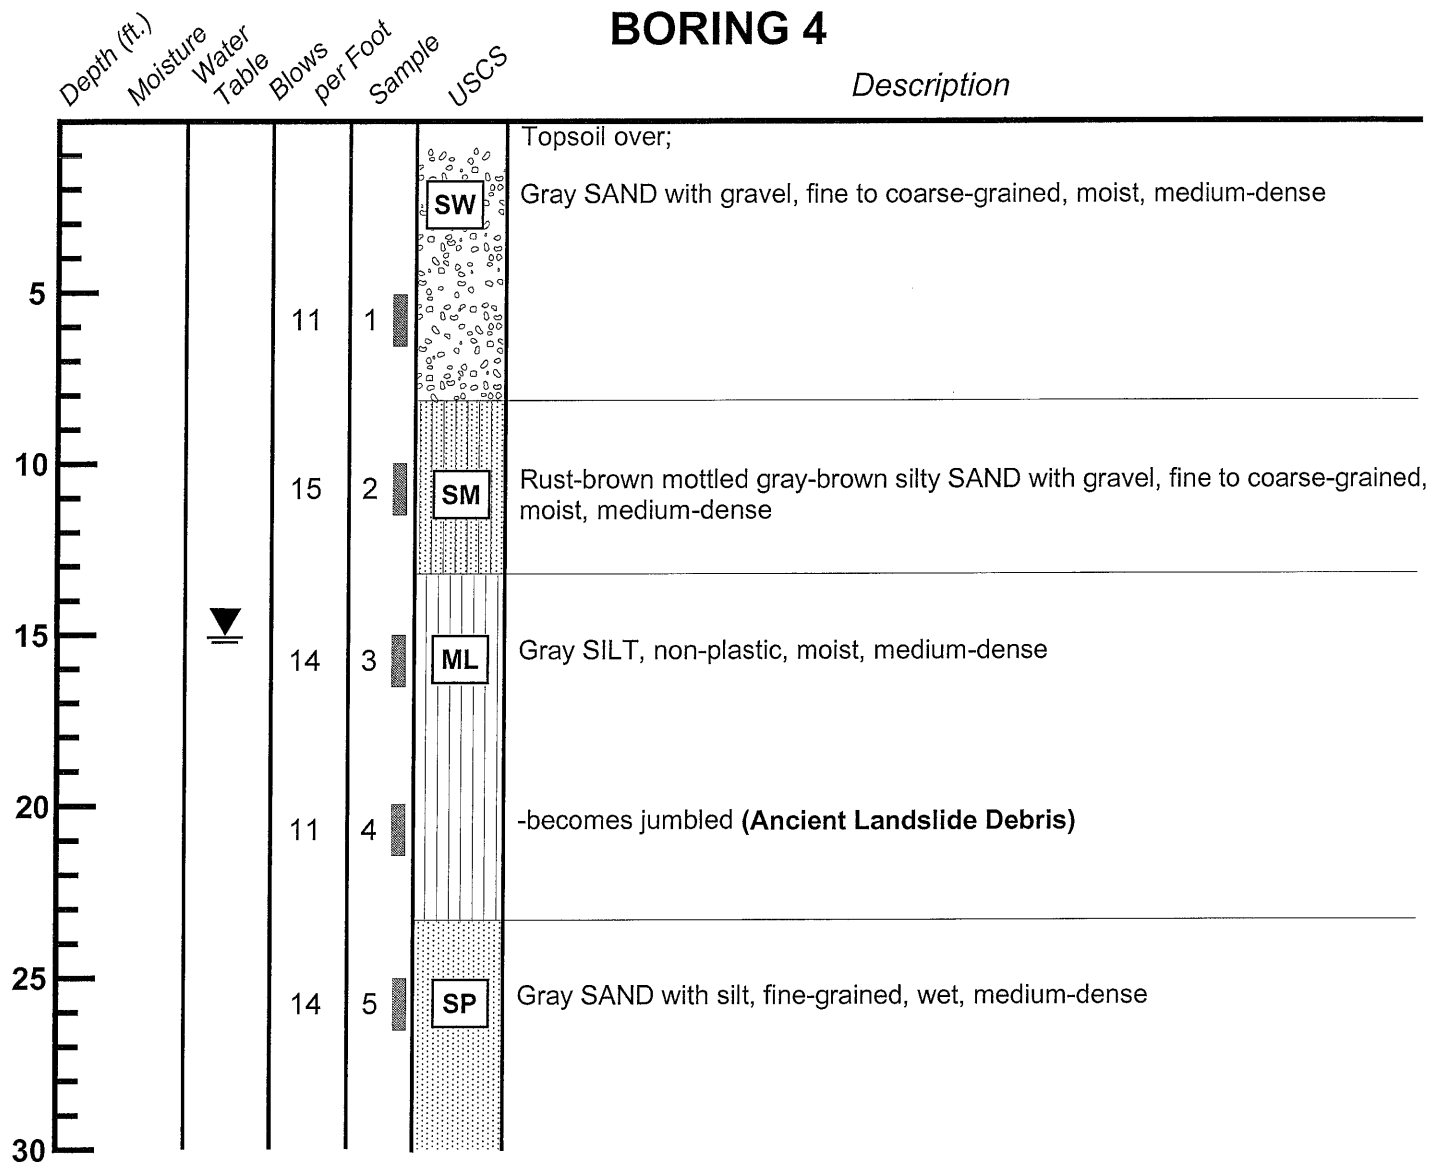
<b>Job</b> 16095	<b>Date:</b> March 2016	<b>Logged by:</b> TRC	<b>Plate:</b> 7
---------------------	----------------------------	--------------------------	--------------------

# BORING 4

\* Continued on Plate 8.

**TEST BORING LOG**  
7615 East Mercer Way  
Mercer Island, Washington

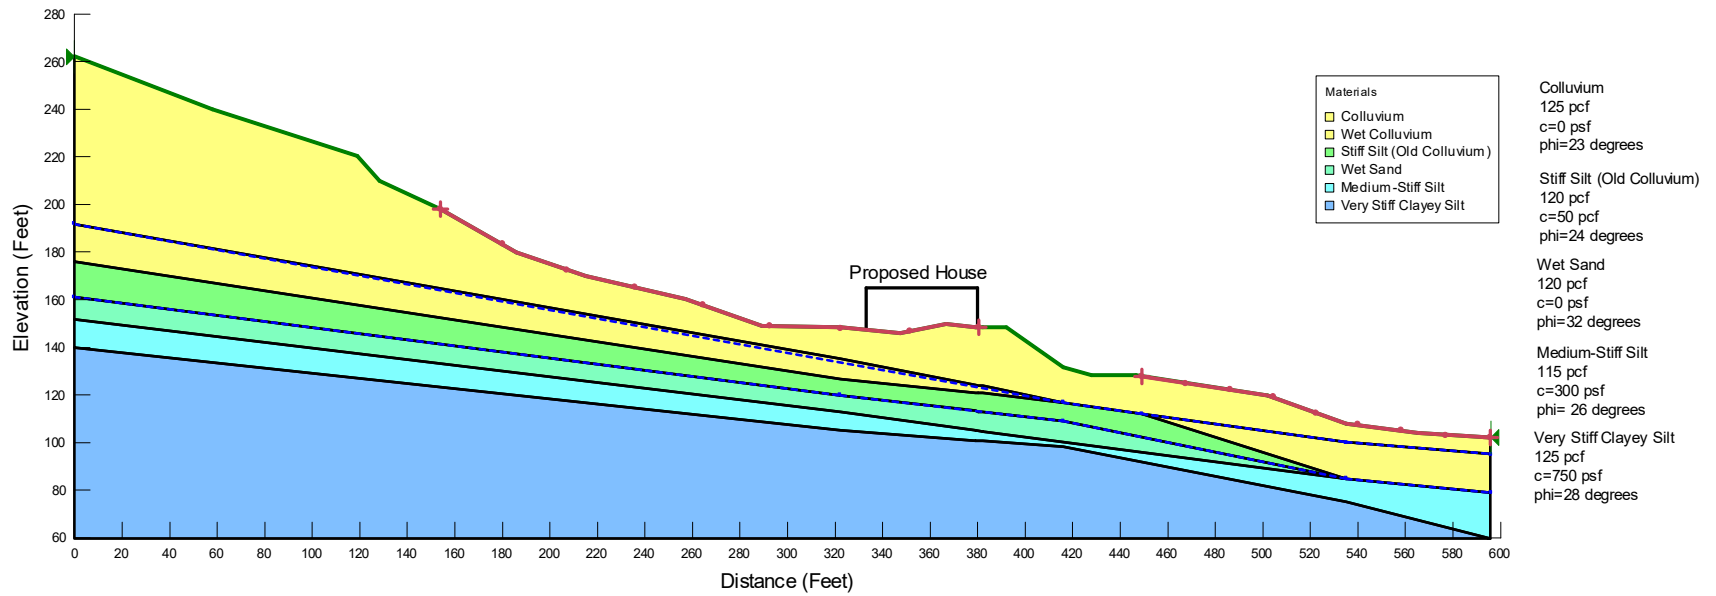
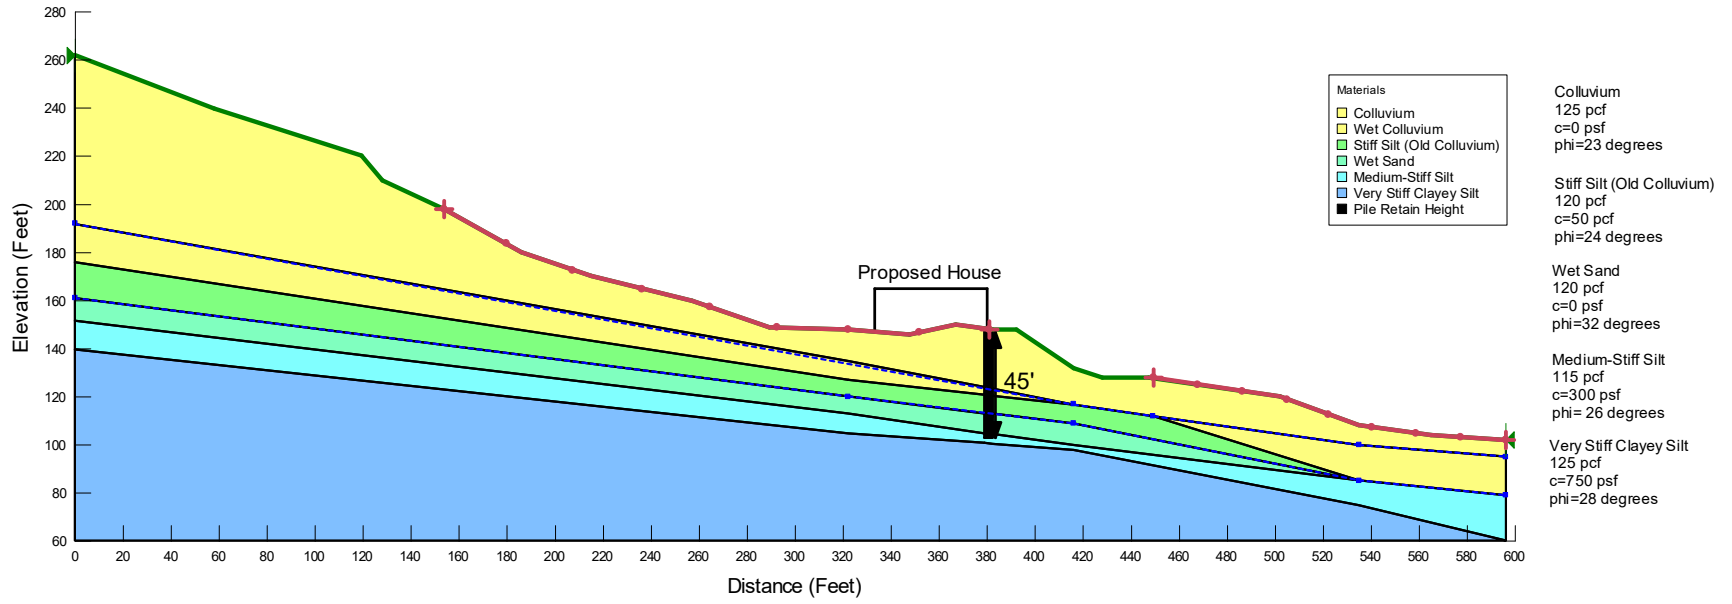
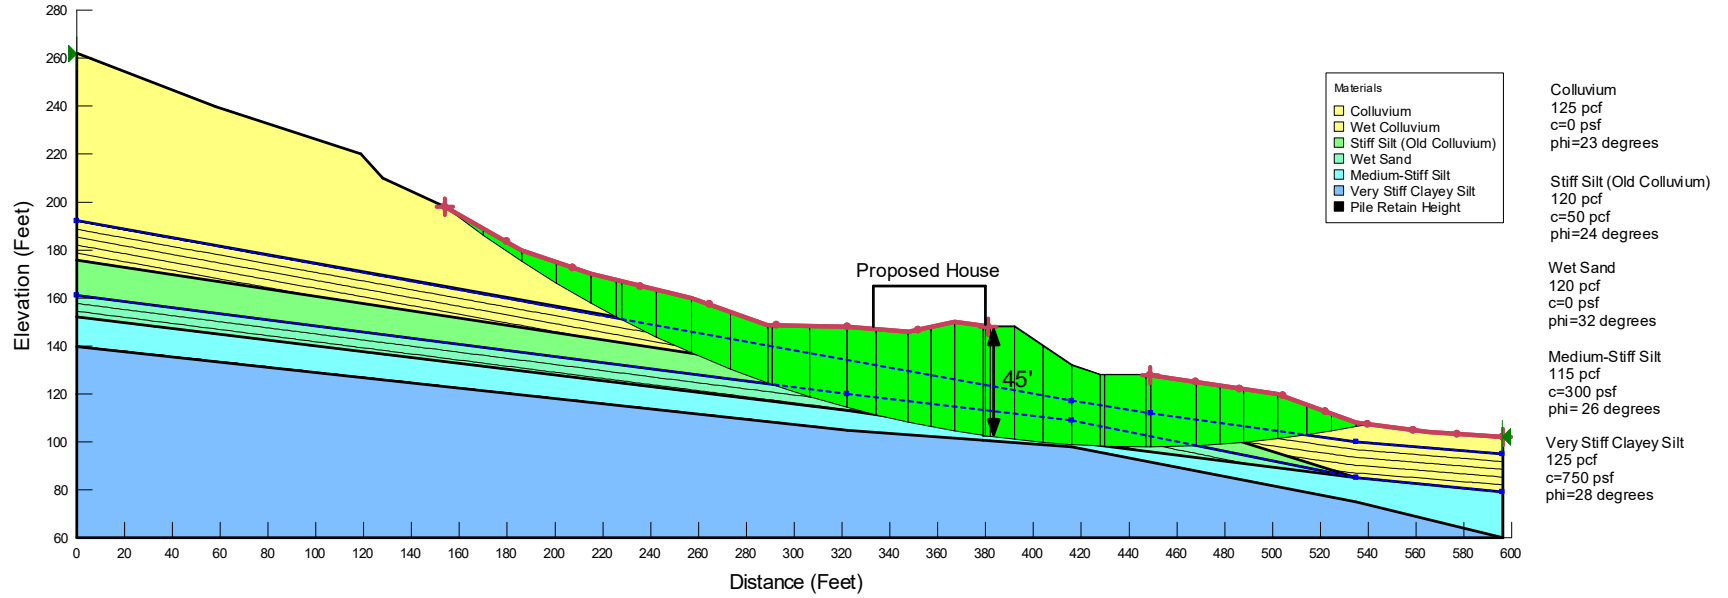
23177 - Cheshire  
 Static

# Static

Kind: SLOPE/W  
Method: Morgenstern-Price  
Settings  
Side Function  
Interslice force function option: Half-Sine  
PWP Conditions Source: Piezometric Line  
Apply Phreatic Correction: Yes  
Use Staged Rapid Drawdown: No  
Slip Surface  
Direction of movement: Left to Right  
Use Passive Mode: No  
Slip Surface Option: Entry and Exit  
Critical slip surfaces saved: 1  
Resisting Side Maximum Convex Angle: 1 °  
Driving Side Maximum Convex Angle: 5 °  
Optimize Critical Slip Surface Location: No  
Tension Crack
