June 12, 2025
Updated June 17, 2025
ES-9607.02

**Subject: Response to Review Comments
 Cheshire Property
 7615 East Mercer Way
 Mercer Island, Washington**

As requested, Earth Solutions NW, LLC (ESNW) has prepared this response to review comments letter for the subject project. This response letter addresses city of a city of Mercer Island review comments in the referenced review letter. This update includes a review of the latest submittal plans.

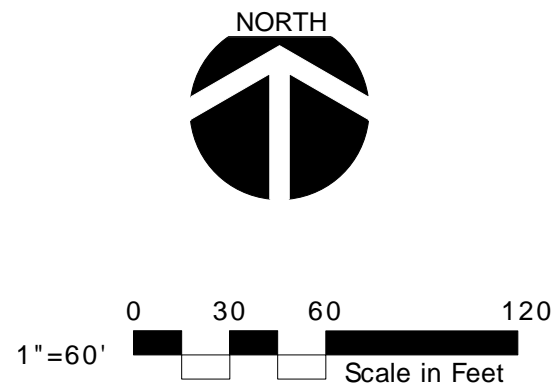
Drawn CAM
Checked SSR
Date 06/11/2025
Proj. No. 9607.02
Plate 2

- HA-101 | Approximate Location of ESNW Hand Auger Boring, Proj. No. ES-9607.02, June 2025
- HA-1 | Approximate Location of ESNW Hand Auger Boring, Proj. No. ES-9607.02, May 2025
- B-1 | Approximate Location of Geotech Consultants, Inc. Boring, Job 16095, March 2016
- B-6 | Approximate Location of Geotech Consultants, Inc. Boring, Job 23177, June 2023
- Subject Site
- Proposed Building
- Existing Building
- Cross-Section
- Approximate Location of Steep Slope Hazard Area

2. *Please provide a scaled site plan with elevation contours showing the boring locations.*

Attached.

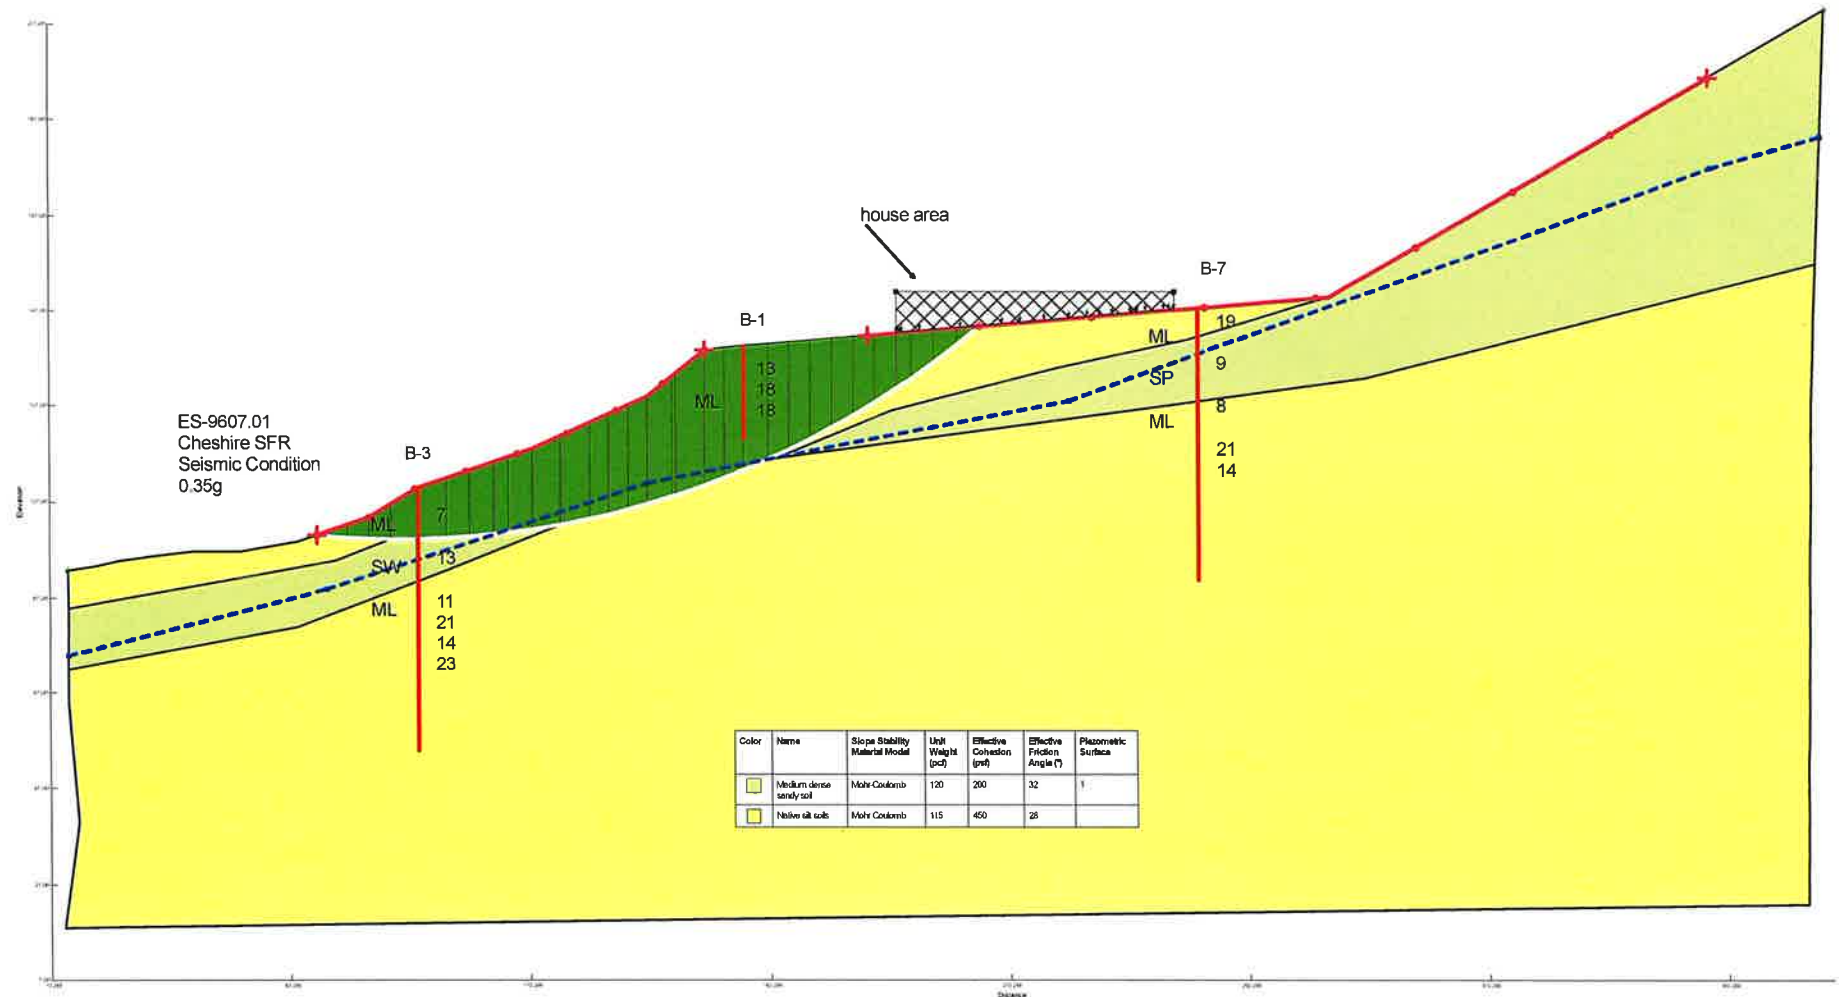
1.16

ES-9607.01
Cheshire SFR
Static Condition

4. *Please provide a slope stability assessment of the entire site (including the slope west of the residence) under static and seismic loading conditions.*

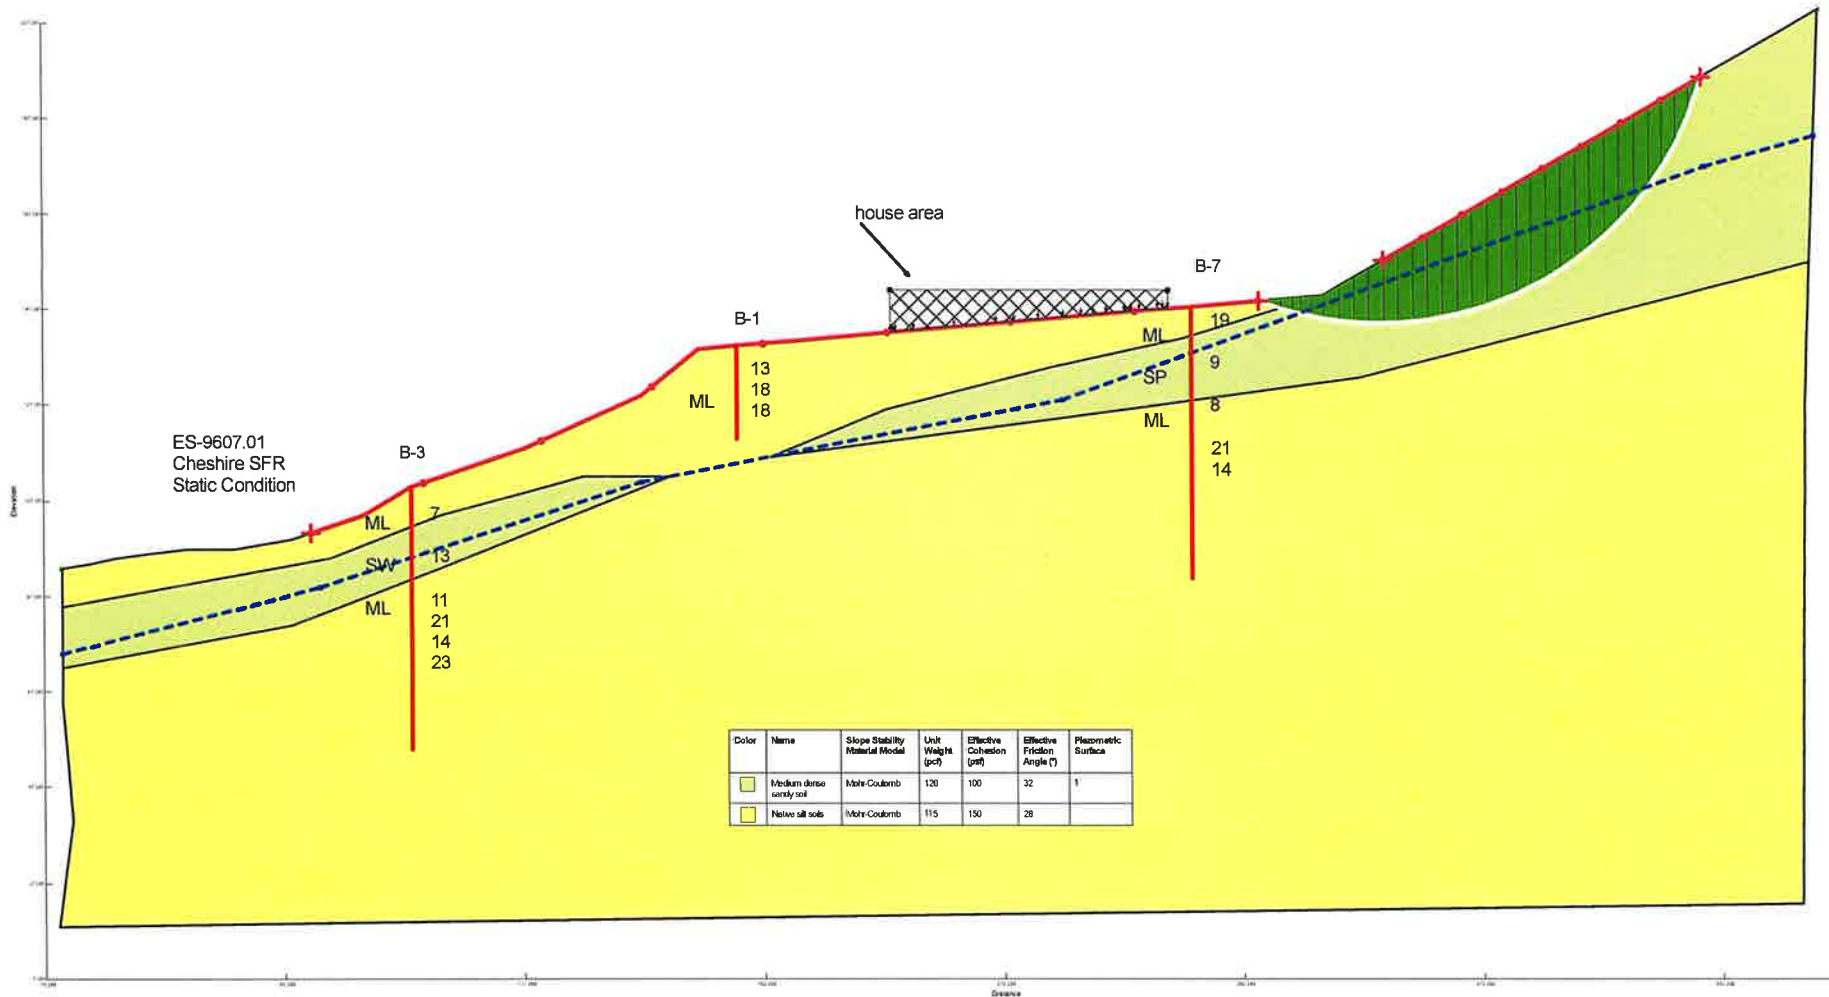
1.29

house area

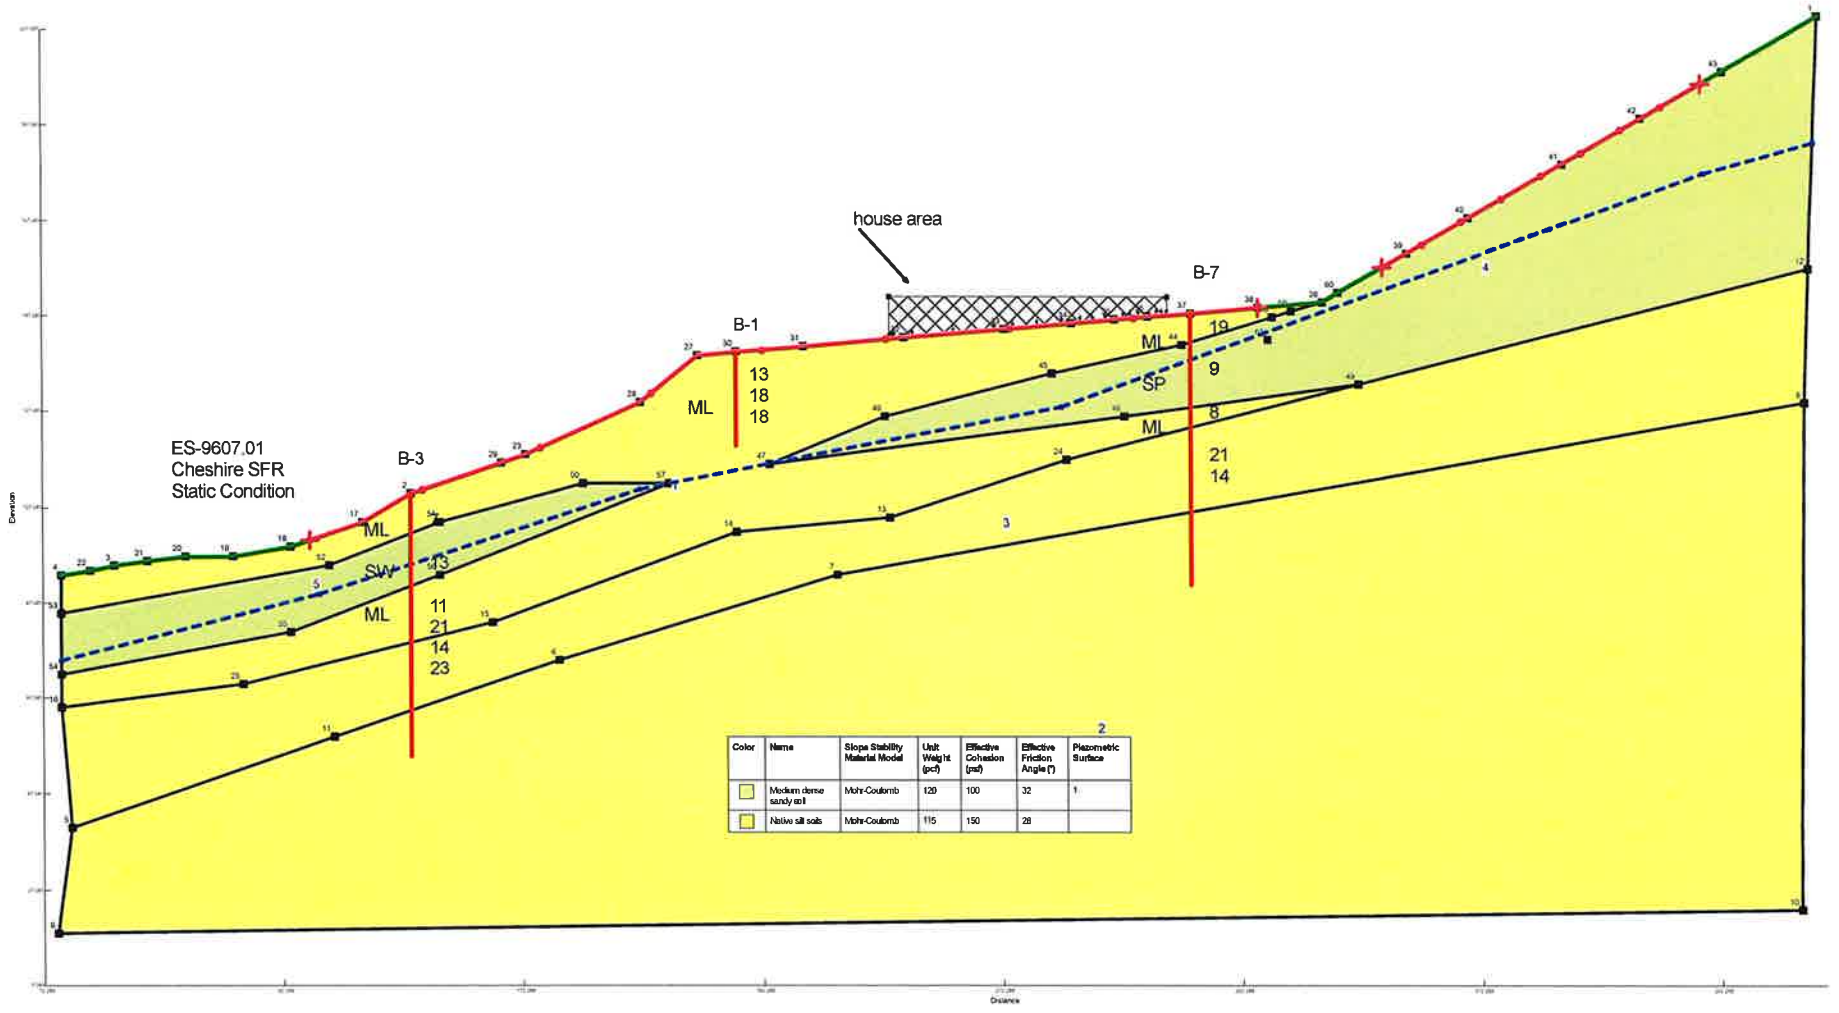
SLOPE/W Analysis

Kind: SLOPE/W
Analysis Type: Morgenstern-Price
Settings
Side Function
Intercolumn force function option: Half-Sine
PWP Conditions from: Piezometric Surfaces
Apply Phreatic Correction: No
Use Staged Rapid Drawdown: No
Unit Weight of Water: 62.4 pcf
Slip Surface
Direction of movement: Right to Left
Use Passive Mode: No
Slip Surface Option: Entry and Exit
Critical slip surfaces saved: 1
Optimize Critical Slip Surface Location: No
Tension Crack Option: (none)
Distribution
F of S Calculation Option: Constant
Convergence
Geometry Settings
Minimum Slip Surface Depth: 3 ft
Number of Columns: 30
Factor of Safety Convergence Settings
Maximum Number of Iterations: 100
Tolerable difference in F of S: 0.001
Solution Settings
Search Method: Root Finder
Tolerable difference between starting and converged F of S: 3
Maximum iterations to calculate converged lambda: 20
Max Absolute Lambda: 2
