# GEOTECHNICAL ENGINEERING REPORT

**Proposed Remodel  
3424 76<sup>th</sup> Place Southeast  
Mercer Island, WA 98040**

**Project No. 24-472  
January, 2025**

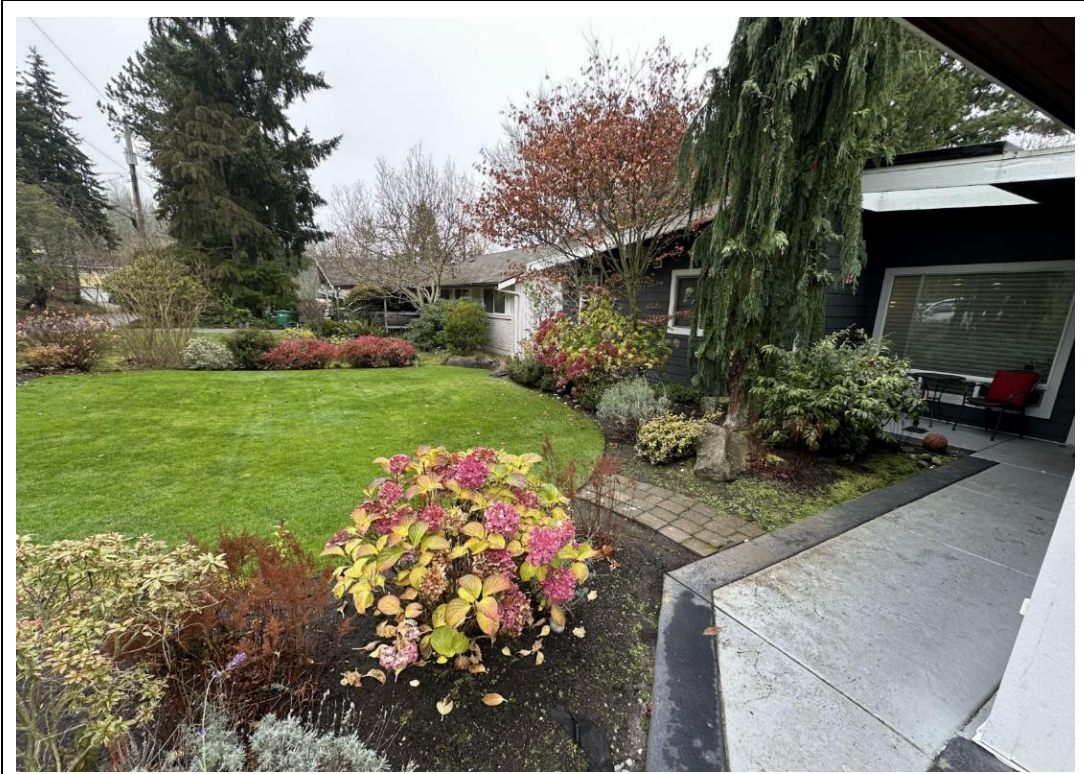
*Plate 1. View of the front yard of subject property near the proposed new entryway, looking northeast from the driveway.*

(descending from first floor to daylit basement level) and on the east side of the backyard. Site conditions at the time of our site visits are shown on Plates 1 and 2 below.

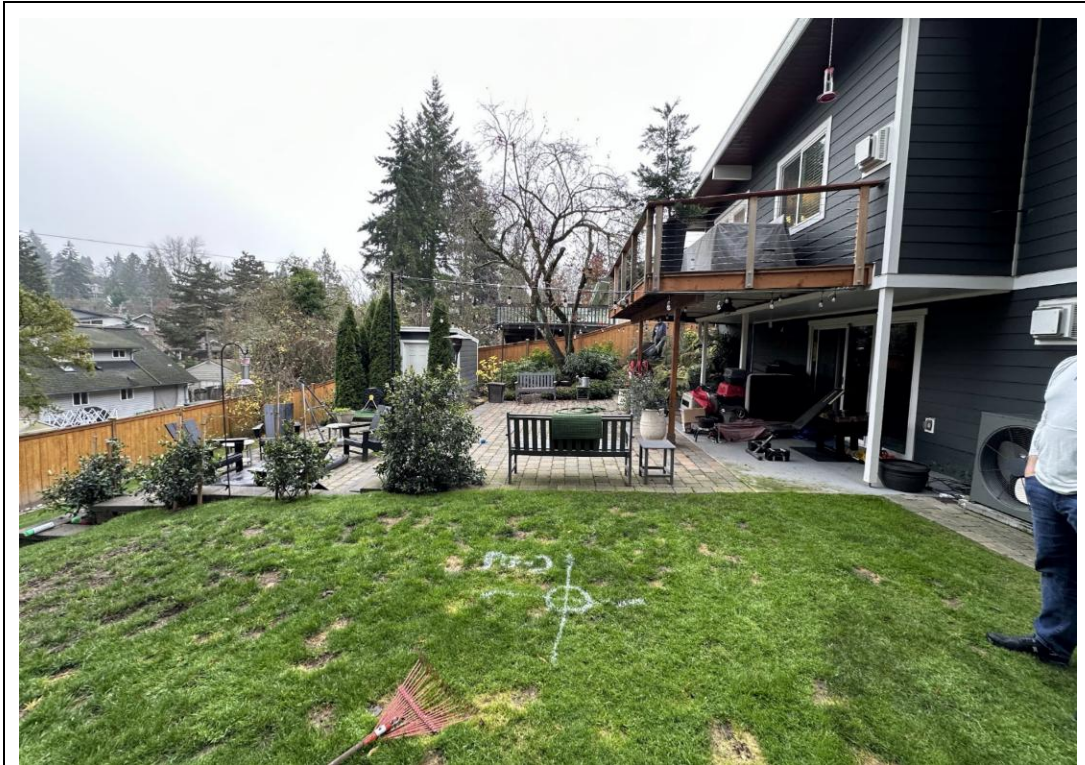
*Plate 2. View of the east side of the house near the proposed basement level additions, looking south.*

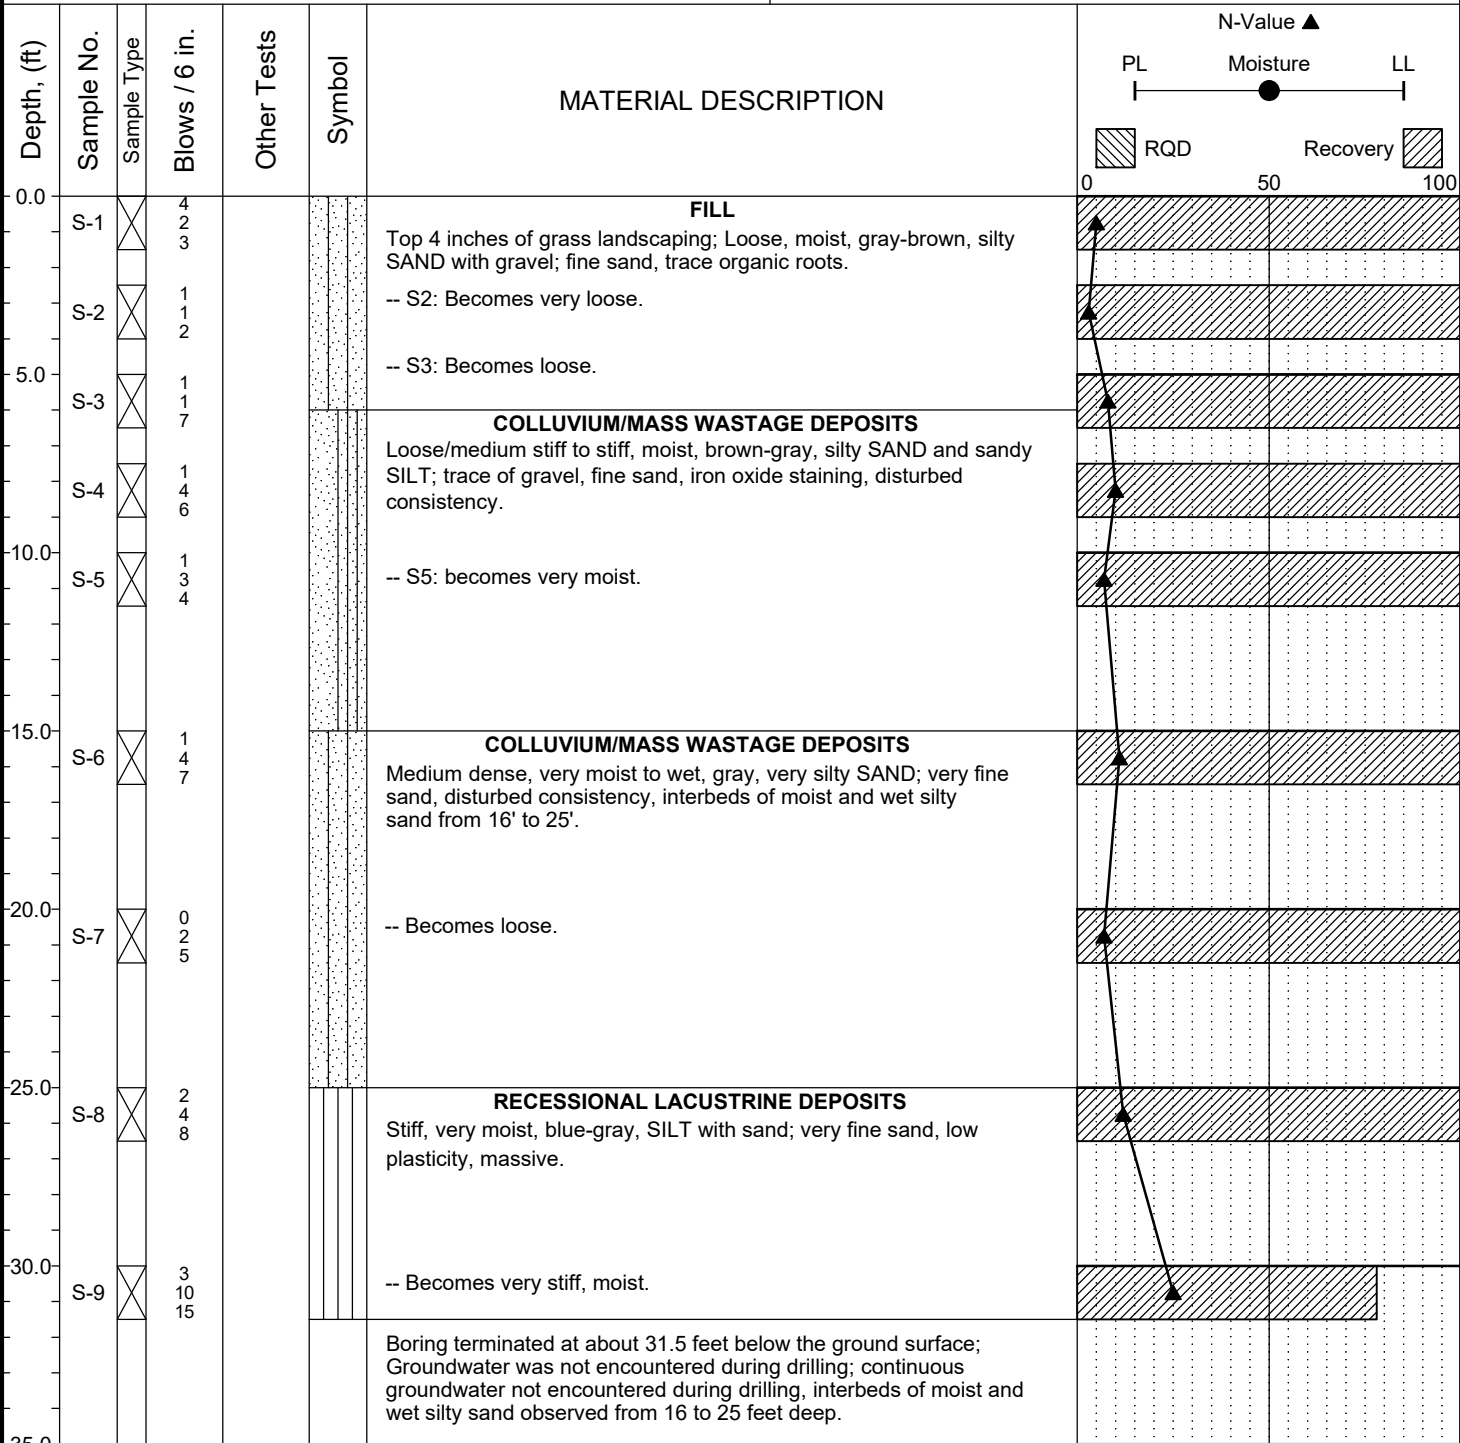
Project:	Proposed Remodel	Surface Elevation:	~116 ft
Job Number:	24-472	Top of Casing Elev.:	N/A
Location:	3424 76th Place Southeast, Mercer Island, Washington	Drilling Method:	Portable Acker, hollow stem auger
Coordinates:	Northing: 47.57921, Easting: -122.2366	Sampling Method:	SPT

Completion Depth:	31.5ft	Remarks: Standard penetration test (SPT) sampler driven with a 140 lb. safety hammer. Hammer operated with a rope and cathead mechanism. Elevation is approximated from the Mercer Island GIS elevation contours. Coordinates are approximated based on their relative location to known site features. This information is provided for relative information only and is not a substitution for field survey. <b>Datum: WGS84/NAVD88.</b>
Date Borehole Started:	12/6/24	
Date Borehole Completed:	12/6/24	
Logged By:	H. Wang	
Drilling Company:	CN Drilling

***Fill:*** In both PG-1 and PG-2, we encountered a surficial soil unit of very loose to loose, silty sand with gravel and organics. We interpret this soil unit as fill, which extended to about 5 to 6 feet deep in both test borings.

***Colluvium/Mass Wastage Deposits:*** Below the fill in both borings, we encountered about 6 to 10 feet of loose/medium stiff to stiff silty sand and sandy silt interbeds, overlying loose to medium dense, very silty sand. We interpret these soil units as colluvium/mass wastage deposits based on the disturbed and nonuniform consistency. The colluvium/mass wastage deposits extended to about 23 and 25 feet deep in borings PG-1 and PG-2, respectively.

Perched groundwater was observed in PG-1 from about 25 to 29 feet deep. A continuous groundwater layer was not encountered in PG-2 but interbeds of moist and wet silty sand were observed from about 16 to 25 feet deep. Groundwater levels will vary depending on
