June 26, 2025
Updated July 21, 2025
ES-10595

**Subject: Infiltration Evaluation
Toda Residence
2262 – 78th Avenue Southeast
Mercer Island, Washington**

Vicinity Map
Toda Residence
Mercer Island, Washington

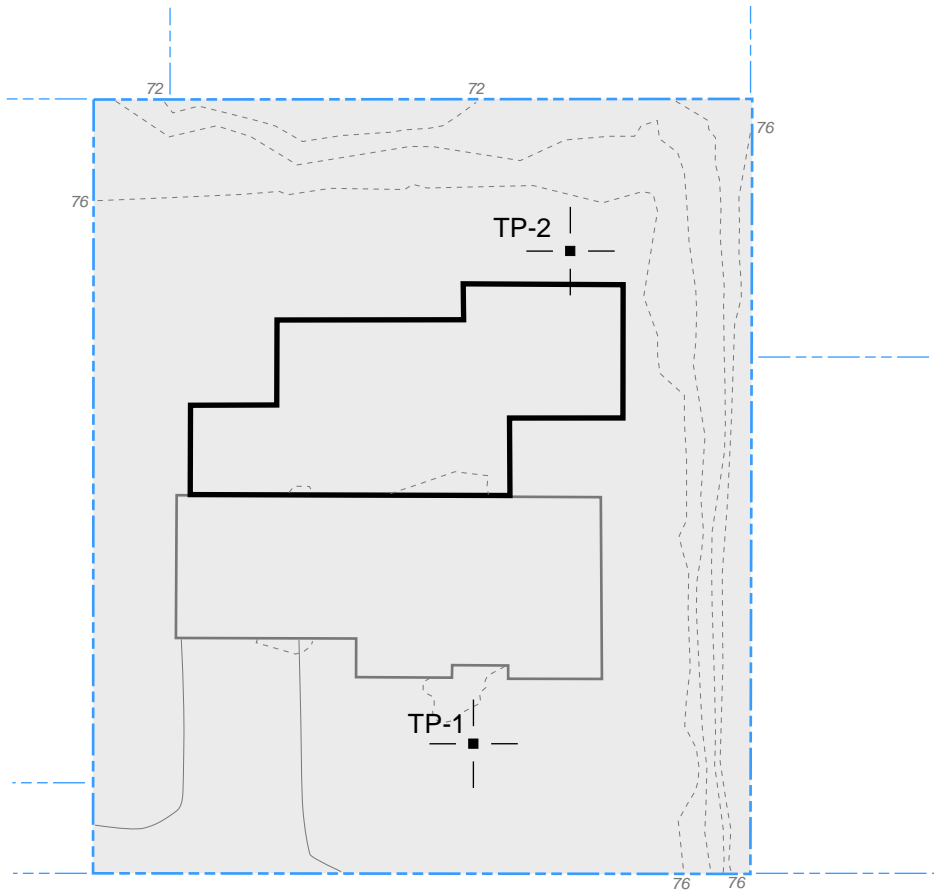
Drawn MRS	Date 06/26/2025	Proj. No. 10595
Checked SSR	Date June 2025	Plate 2

Attachments: Plate 1 – Vicinity Map
Plate 2 – Subsurface Exploration Plan
Subsurface Exploration Logs
Laboratory Test Results
