GEOTECHNICAL ENGINEERING REPORT

Encounter Church – Proposed Addition

PROJECT NO. 25-251

**Subject: Geotechnical Engineering Report
Encounter Church - Proposed Addition
3200 – 78th Avenue SE, Mercer Island, WA**

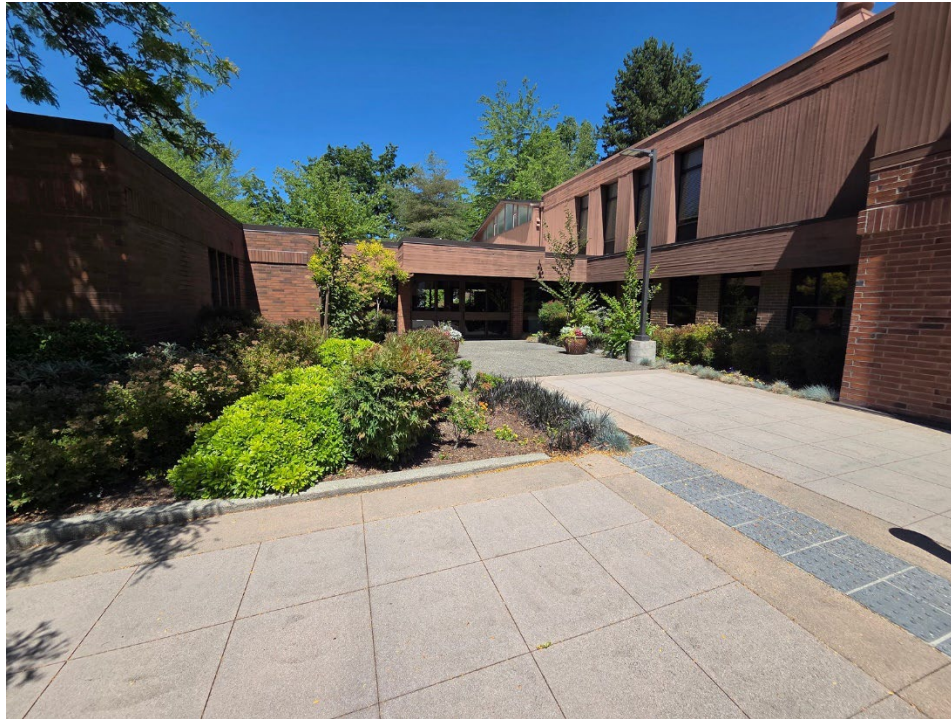
Plate 1. Proposed addition location, looking north (7/8/2025).

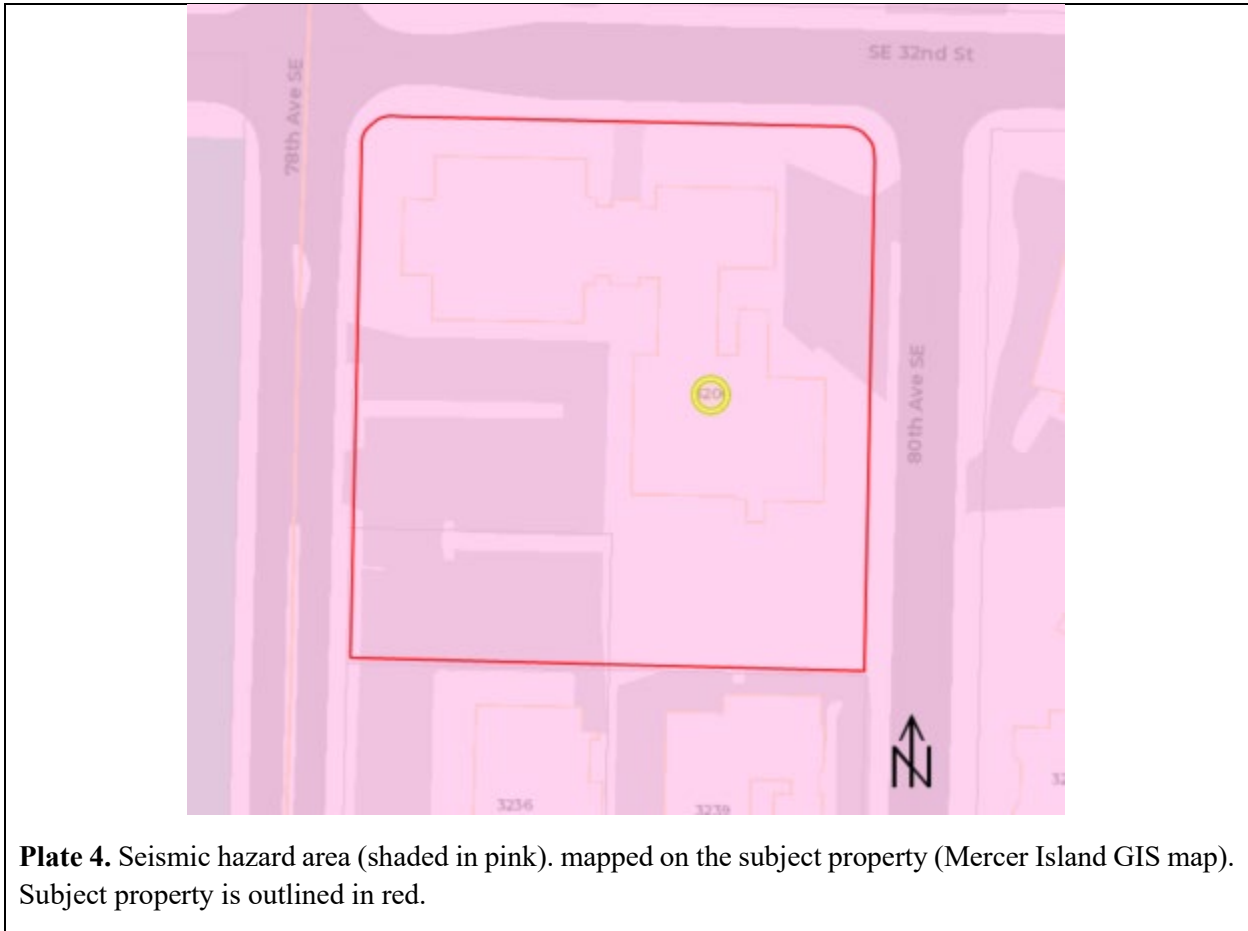
Based on review of the City of Mercer GIS Maps, the entirety of the site is mapped as a seismic/soil liquefaction hazard area (see Plate 4 on the following page).

Based on our subsurface explorations and the soil conditions described in the previous boring advanced at the site, the site is predominately underlain by silt with clay at shallow depths, without a well-defined water table (i.e. only limited perched groundwater). Based on these conditions, in our opinion, the liquefaction potential of the soils underlying the site is low, and design considerations related to soil liquefaction are not necessary for the addition project.

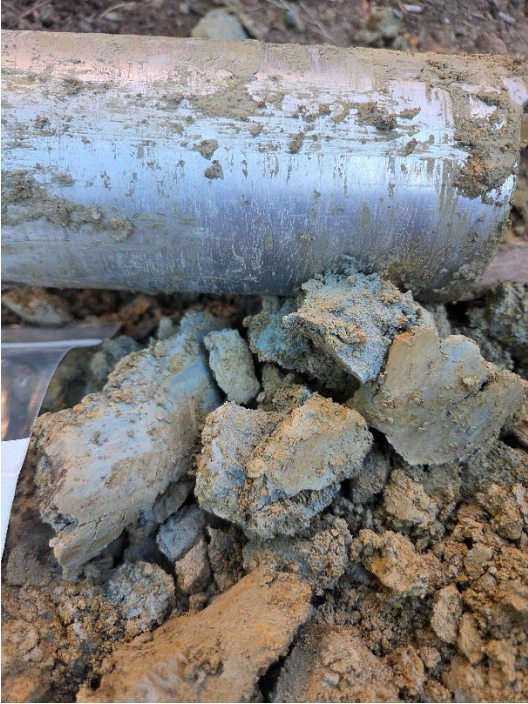
Hand Boring HB-1	
Approximate Location: Northing: 47.58146, Easting: -122.23302	
Approximate ground surface elevation: 90 ft (Vertical Datum: NAVD88)	
<u>Depth (ft)</u>	<u>Material Description</u>
0 – ¼	[Topsoil] Approximately 3 inches of topsoil overlain by landscaping mulch
¼ – 2	[Fill] Loose, brown, silty fine SAND, some fine to coarse subrounded gravel, trace subrounded cobble, trace organics (rootlets), some iron oxide staining; moist; becomes medium dense by about 1½ feet deep
2 – 4½	[Vashon Recessional Lacustrine] Stiff to very stiff, brown to gray, SILT with clay, low to medium plasticity, some iron oxide staining; moist

<p>Image of soils at about 4½ feet below the ground surface. HB-1 was terminated approximately 4½ feet below ground surface. No evidence of significant groundwater were observed at the time of exploration.</p> <p>Logged by: T. Howitz</p>

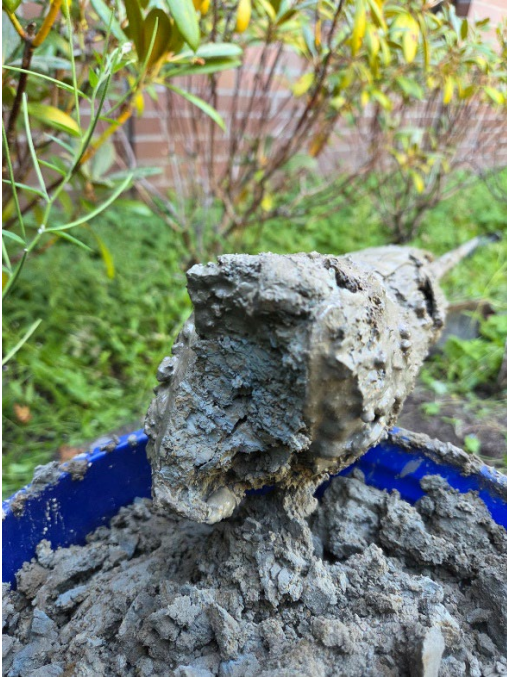
Hand Boring HB-2	
Approximate Location: Northing: 47.58149, Easting: -122.23291	
Approximate ground surface elevation: 90 ft (Vertical Datum: NAVD88)	
<u>Depth (ft)</u>	<u>Material Description</u>
0 – ½	[Topsoil] Approximately 6 inches of topsoil overlain by landscaping mulch
½ – 1½	[Fill] Loose, brown, silty fine SAND, some fine to coarse subrounded gravel, trace subrounded cobble, trace organics (rootlets), some iron oxide staining; moist
1½ – 4	[Vashon Recessional Lacustrine] Stiff to very stiff, brown to gray, SILT with clay, sand seams, low to medium plasticity, some iron oxide staining; moist

Image of soils from about 4 feet below the ground surface. HB-2 was terminated approximately 4 feet below ground surface. Minor perched groundwater was encountered at about 1 foot below the existing ground surface at the time of exploration.	
Logged by: T. Howitz

Minor perched groundwater was encountered at about 1 foot below the ground surface in HB-2 at the time of our field exploration. No obvious signs of groundwater were observed in HB-1. The previous test boring located along the east side of the site encountered groundwater about 5.8 feet below the ground surface, and the previous report suggested that this water was perched on the underlying silt. It should be noted that groundwater elevations and seepage rates are likely to vary depending on the season, local subsurface conditions, and other factors. Groundwater levels and seepage rates are normally highest during the winter and early spring (typically October through May).
