JN 24433

Subject: **Transmittal Letter – Geotechnical Engineering Study**
Proposed Residence Remodel and Additions
Parikh Property
2816 – 68th Avenue Southeast
Mercer Island, Washington

GEOTECHNICAL ENGINEERING STUDY
Proposed Residence Remodel and Additions
Parikh Property
2816 – 68th Avenue Southeast
Mercer Island, Washington

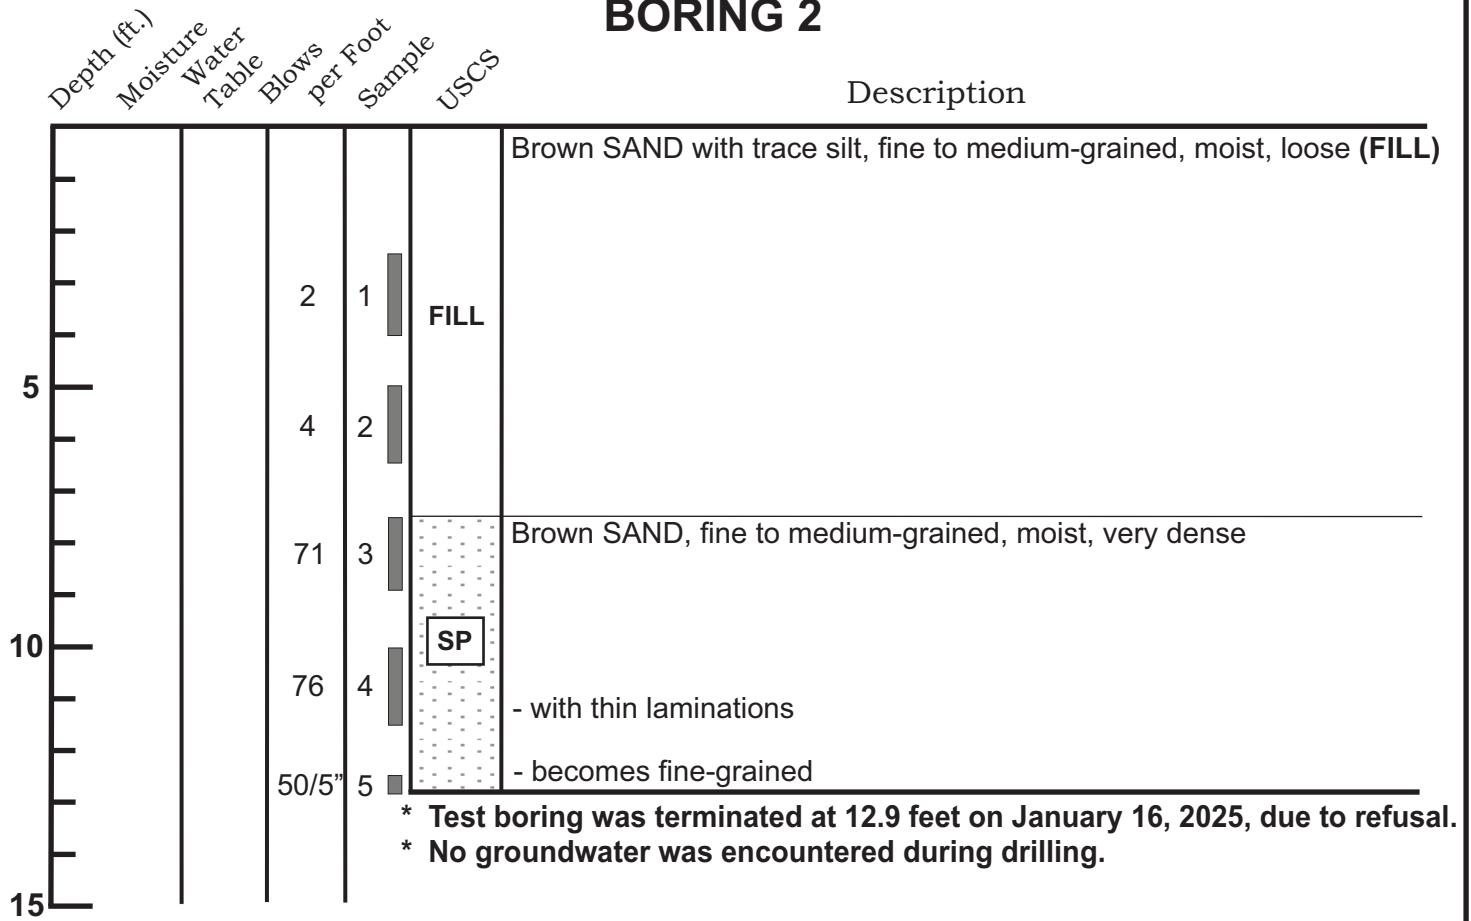
TEST BORING LOG			
2816 - 68th Avenue Southeast Mercer Island, Washington			
Job 24433	Date: Mar. 2025	Logged by: ASM	Plate: 4

BORING 2

The test borings were drilled on January 16, 2025 using both a track-mounted, hollow-stem auger drill and a portable Acker drill. The Acker drill system utilizes a small, gasoline-powered engine to advance a hollow-stem auger to the sampling depth. Samples were taken at approximate 2.5- to 5-foot intervals with a standard penetration sampler. This split-spoon sampler, which has a 2-inch outside diameter, is driven into the soil with a 140-pound hammer falling 30 inches. The number of blows required to advance the sampler a given distance is an indication of the soil density or consistency. A geotechnical engineer from our staff observed the drilling process, logged the test borings, and obtained representative samples of the soil encountered. The Test Boring Logs are attached as Plates 3 through 6.

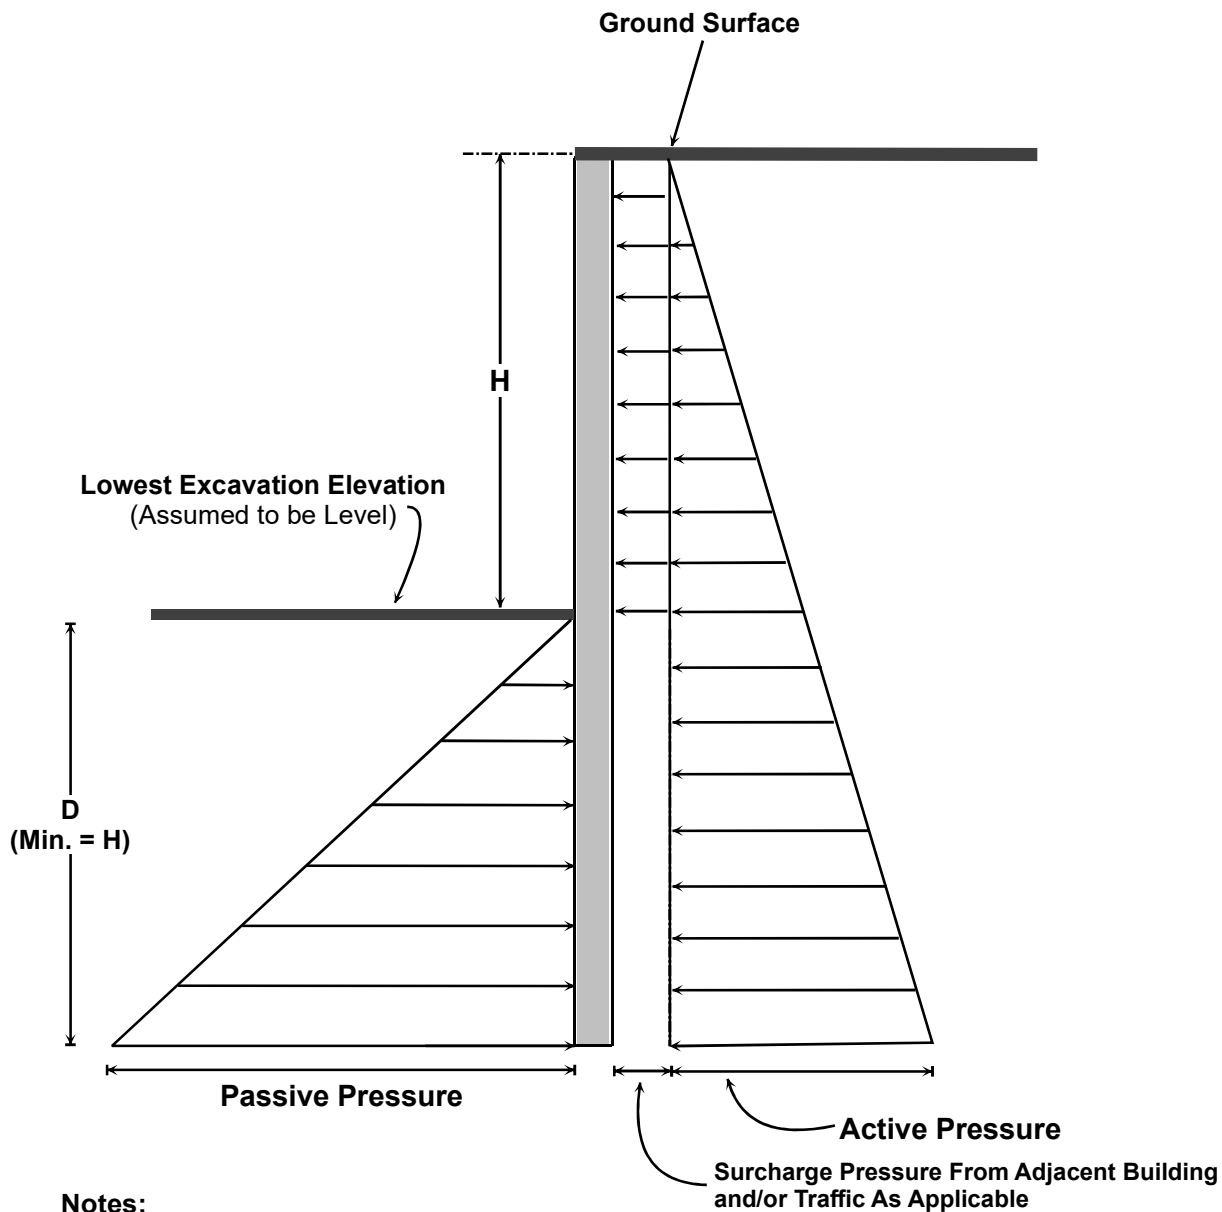
CANTILEVERED SOLDIER PILE RETAINING WALL

- (1) The report should be referenced for specifics regarding design and installation.
- (2) Active pressures act over the pile spacing above the bottom of the excavation, and on the pile diameter below the bottom of excavation.
- (3) Passive pressures act over three times the grouted soldier pile diameter or the pile spacing, whichever is smaller.
- (4) It is assumed that no hydrostatic pressures act on the back of the shoring walls.
- (5) Cut slopes or adjacent structures positioned above or behind shoring will exert additional pressures on the shoring wall.

As excavation proceeds downward, the space between the piles should be lagged with timber, and any voids behind the timbers should be filled with pea gravel, or a slurry comprised of sand and fly ash. Treated lagging is usually required for permanent walls, while untreated lagging can often be utilized for temporary shoring walls. Temporary vertical cuts will be necessary between the soldier piles for the lagging placement. The prompt and careful installation of lagging is important, particularly in loose or caving soil, to maintain the integrity of the excavation and provide safer working conditions. Additionally, care must be taken by the excavator to remove no more soil between the soldier piles than is necessary to install the lagging. Caving or overexcavation during lagging placement could result in loss of ground on neighboring properties. Timber lagging should be designed for an applied lateral pressure of 30 percent of the design wall pressure, if the pile spacing is less than three pile diameters. For larger pile spacings, the lagging should be designed for 50 percent of the design load.

Lateral movement of the soldier piles below the excavation level will be resisted by an ultimate passive soil pressure equal to that pressure exerted by a fluid with a density of 400 pcf. A reduction factor is included in this passive pressure to account for strain compatibility in regards to pile deflection. For permanent walls, we recommend a minimum factor of safety of 1.5 be applied to overturning and sliding calculations when using this ultimate value (temporary installations may use a factor of safety of 1.2). This soil pressure is valid only for a level excavation in front of the soldier pile; due to the glacially consolidated nature of the site soils, this passive pressure can act on three times the grouted pile diameter, or the pile spacing, whichever is smaller. Cut slopes made in front of shoring walls significantly decrease the passive resistance. The minimum pile embedment for cantilever soldier piles should be equal to the height of the "stick-up." A typical Cantilevered Soldier Pile Retaining Wall detail is attached to this report as Plate 7.

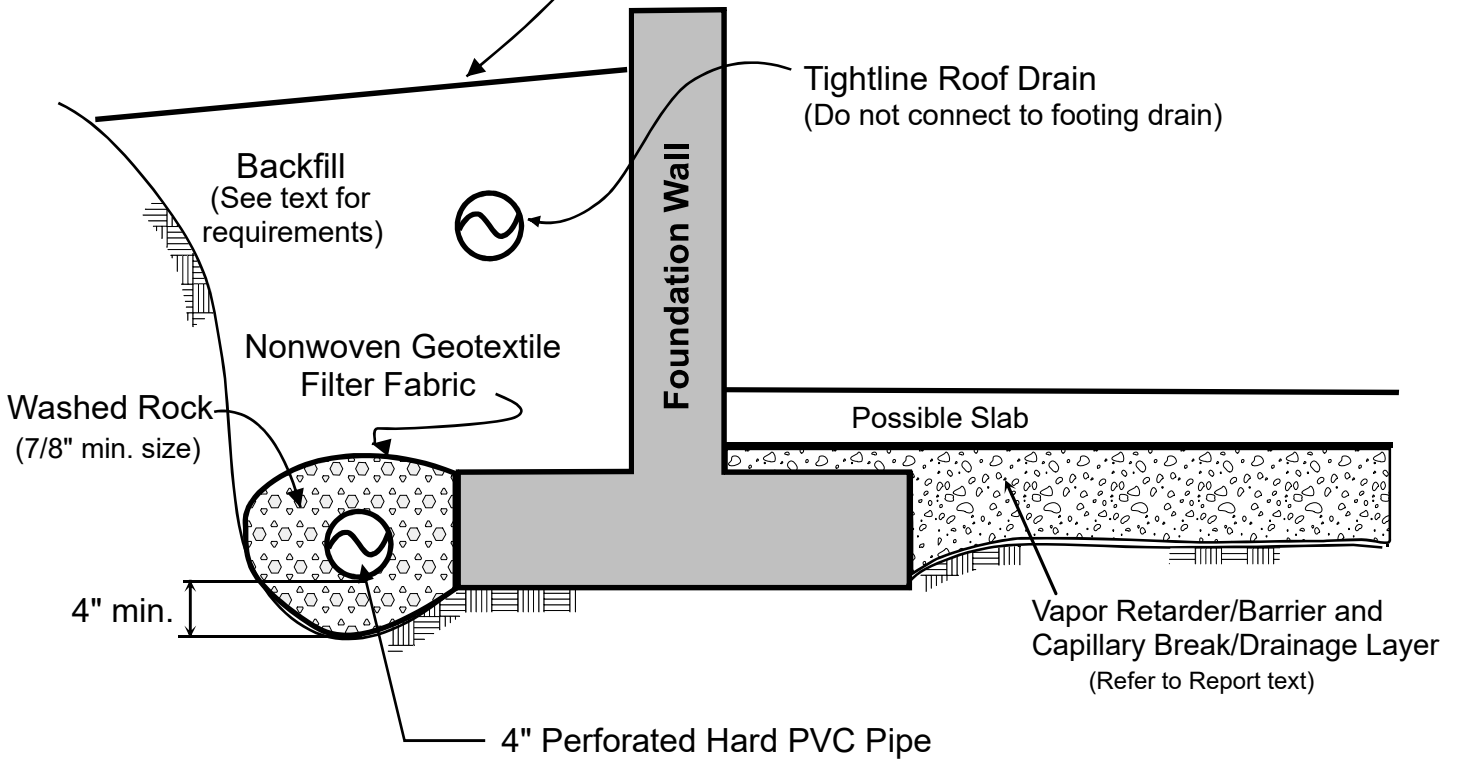
FOOTING DRAIN DETAIL
 2816 - 68th Avenue Southeast
 Mercer Island, Washington

Slope backfill away from foundation. Provide surface drains where necessary.

(Invert at least 6 inches below slab or crawl space. Footing drain pipes can be laid flat with no slope, however, the non-perforated discharge pipes that connect to the footing drains should be sloped for flow to the outlet point. Place holes downward.)

- (1) In crawl spaces, provide an outlet drain to prevent buildup of water that bypasses the perimeter footing drains.
- (2) Refer to report text for additional drainage, waterproofing, and slab considerations.

Footing drains should be used where: (1) crawl spaces or basements will be below a structure; (2) a slab is below the outside grade; or, (3) the outside grade does not slope downward from a building. Drains should also be placed at the base of all earth-retaining walls. These drains should be surrounded by at least 6 inches of 1-inch-minus, washed rock that is encircled with non-woven, geotextile filter fabric (Mirafi 140N, Supac 4NP, or similar material). At its highest point, a perforated pipe invert should be at least 6 inches below the bottom of a slab floor or the level of a crawl space. The discharge pipe for subsurface drains should be sloped for flow to the outlet point. Roof and surface water drains must not discharge into the foundation drain system. A typical footing drain detail is attached to this report as Plate 8. For the best long-term performance, perforated PVC pipe is recommended for all subsurface drains. Clean-outs should be provided for potential future flushing or cleaning of footing drains.
