**GEOTECHNICAL REPORT AND  
GEOLOGIC HAZARD AREAS REVIEW  
Proposed ADU  
4751 Fernridge  
Mercer Island, Washington**

**PROJECT NO. 24-459**  
February 2025

Subject: Geotechnical Report and Geologic Hazard Areas Review  
Proposed ADU  
4751 Fernridge Lane, Mercer Island, WA

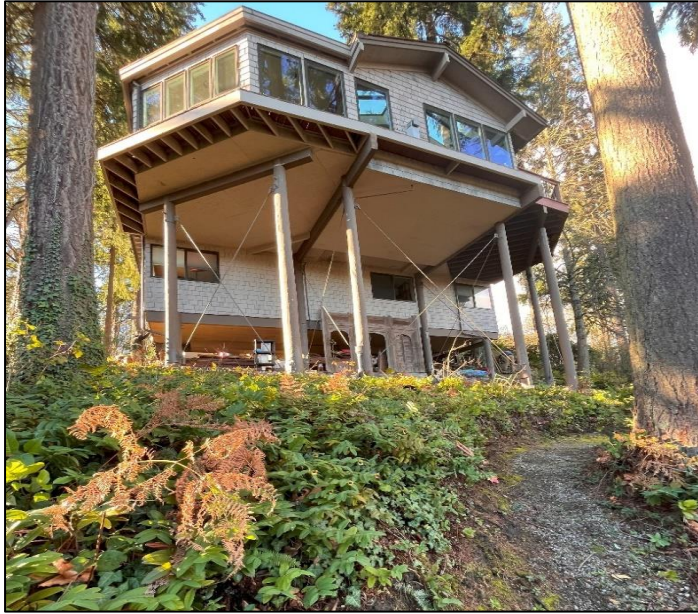
*Plate 1: View of the existing residence. Looking northwest from southeast of the property.*

The general conditions of the site at the time of our field exploration are shown on Plate 1 and 2, following page.

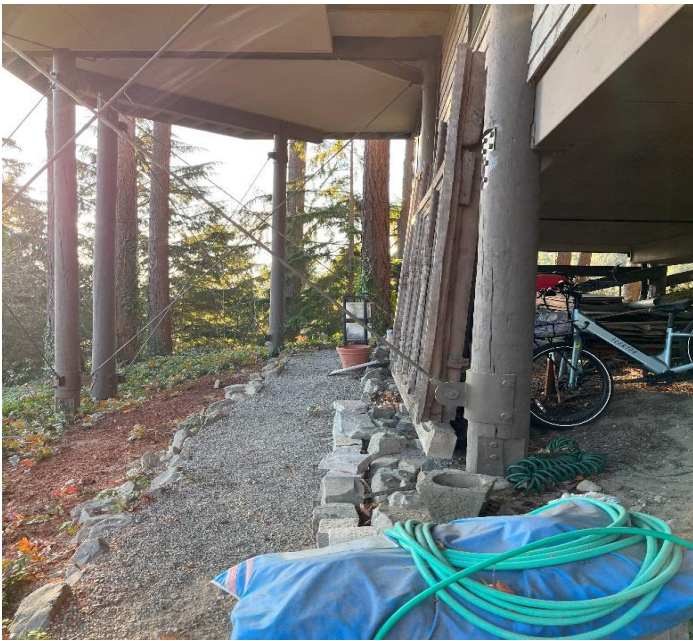
*Plate 2: View of the existing residence underneath the roofline. Looking south from east side of the property.*
