**GEOTECHNICAL REPORT
PROPOSED DECK RECONSTRUCTION
5336 BUTTERWORTH ROAD
MERCER ISLAND, WASHINGTON**

**Project No. 26-005
February 2026**

**Subject: Geotechnical Report
Proposed Deck Reconstruction
5336 Butterworth Road, Mercer Island, WA**

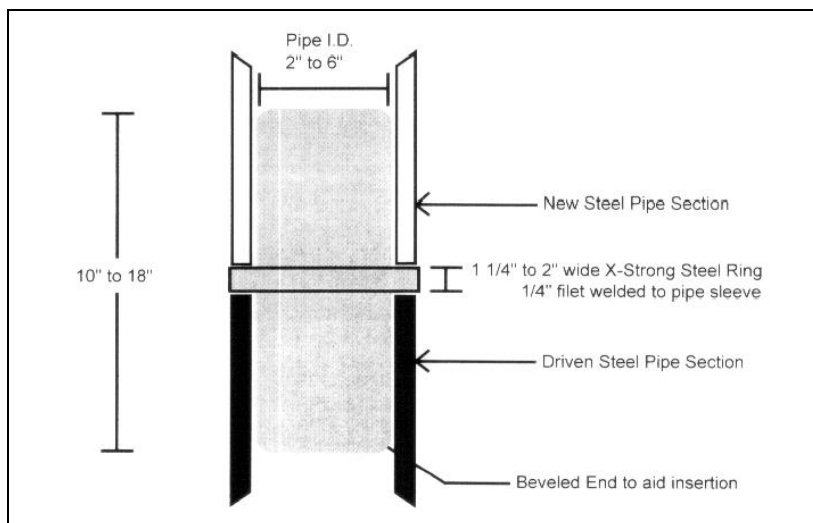
The number of pin piles needed, and pile layout should be determined by the project structural engineer. Piles shall be driven in nominal sections and connected with compression fitted sleeve couplers (see detail below). We discourage welding of pipe joints, particularly when galvanized pipe is used, as we have frequently observed welds broken during driving.
