G-5770-1

Subject: Updated Geotechnical Engineering Report
Proposed Modifications to Driveway and Yard Areas
4624 E. Mercer Way
Mercer Island, Washington 98040

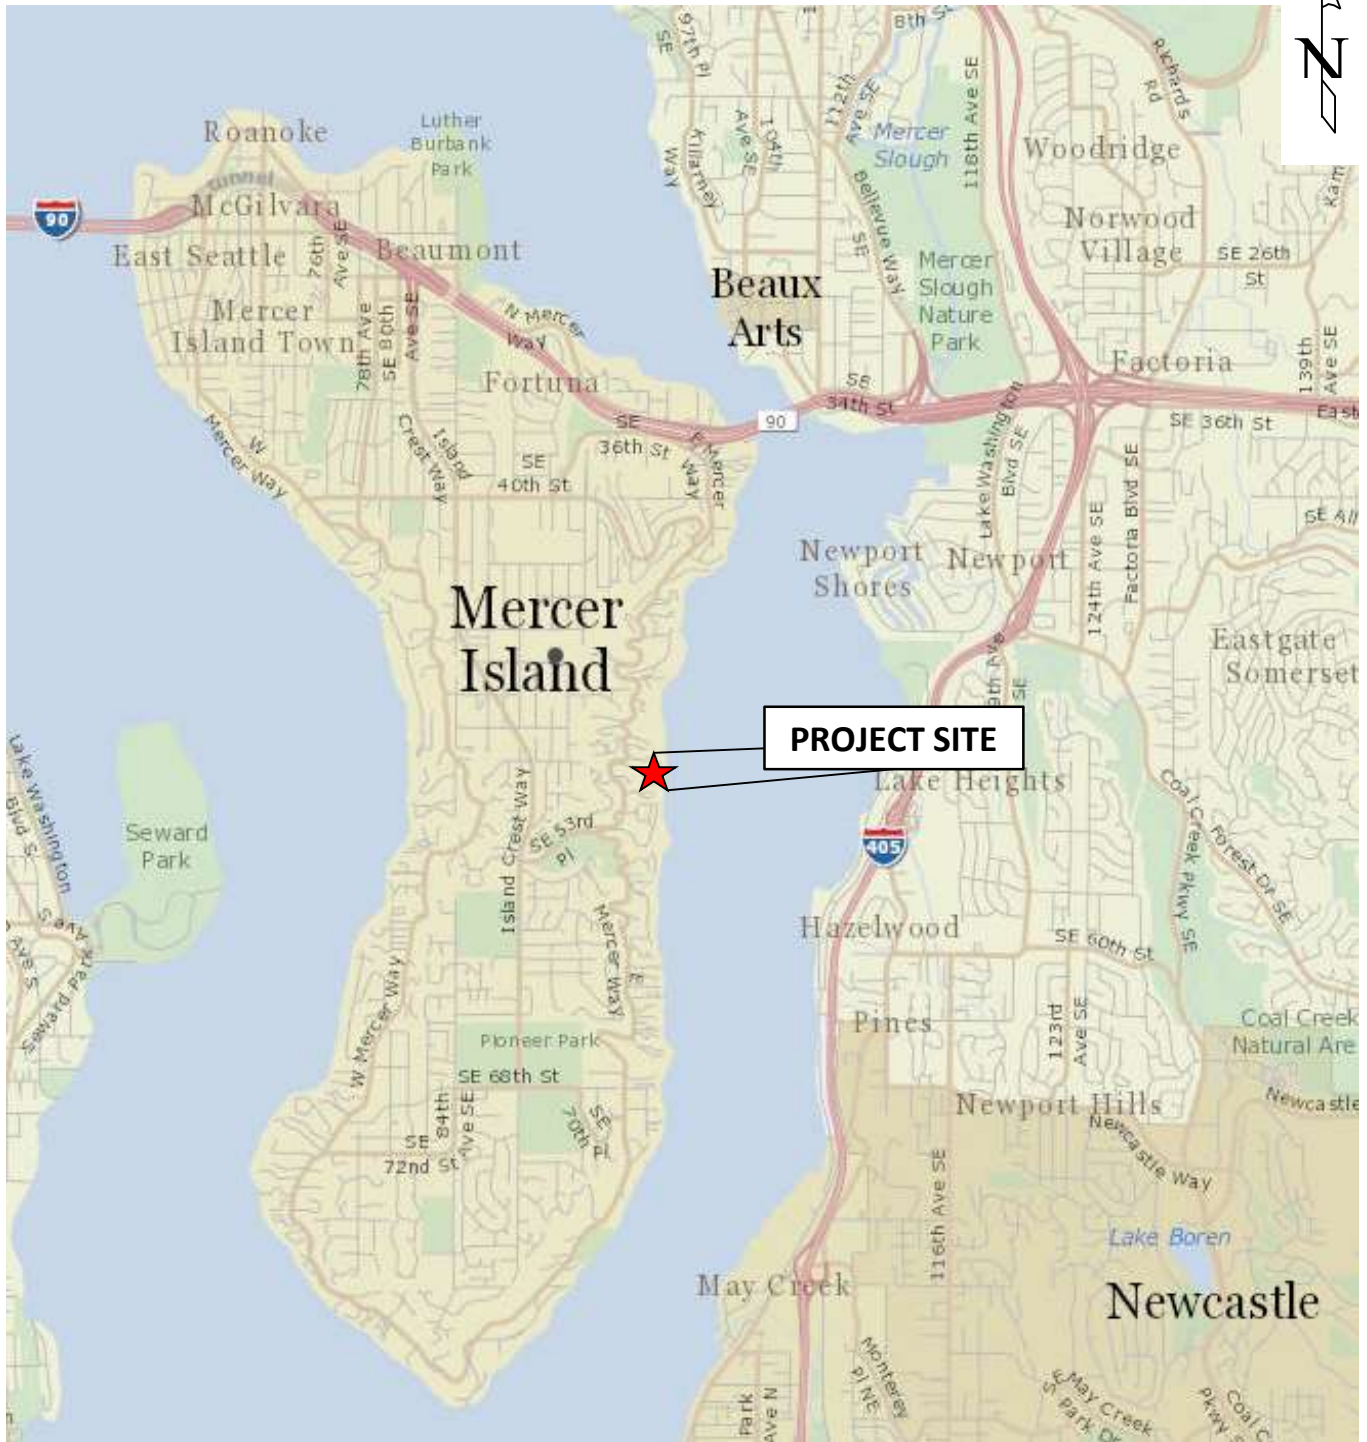
SCALE	NONE	DATE	3/17/2026	MADE	AH/KJ	CHKD	WC	JOB NO.	G-5770-1	PLATE	1
-------	------	------	-----------	------	-------	------	----	---------	----------	-------	---

Source: King County iMap, 2022.

The project site (Parcel No. 755870-0020) has the address 4624 E. Mercer Way and is located on the eastern side of Mercer Island, Washington, as illustrated in Plate 1 – Site Location Map. The site is approximately rectangular-shaped, with the major axis oriented approximately east-west, and is 39,303 square feet (0.90 acres) in size. The site has sloping topography that falls generally eastward toward the Lake Washington shoreline.

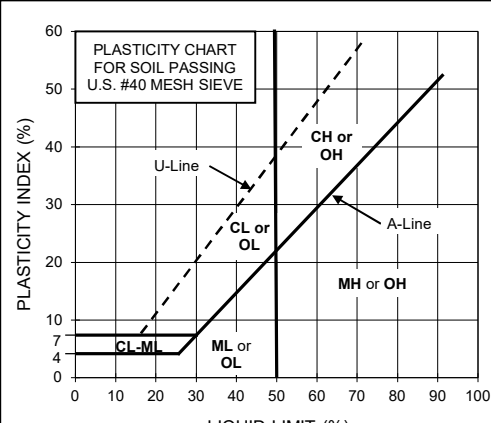
DIRTY SANDS (with some fines)	SM SILTY SANDS, SAND-SILT MIXTURES		ATTERBERG LIMITS BELOW "A" LINE with P.I. LESS THAN 4	
	FINE-GRAINED SOILS Less Than Half by Weight Larger Than No. 200 Sieve	SILTS (Below A-Line on Plasticity Chart, Negligible Organics)	Liquid Limit < 50%	ML INORGANIC SILTS, ROCK FLOUR, SANDY SILTS OF SLIGHT PLASTICITY

Liquid Limit > 50%	MH INORGANIC SILTS, MICACEOUS OR DIATOMACEOUS, FINE SANDY OR SILTY SOIL			
		CLAYS (Above A-Line on Plasticity Chart, Negligible Organics)	Liquid Limit < 50%	CL INORGANIC CLAYS OF LOW PLASTICITY, GRAVELLY, SANDY, OR SILTY CLAYS, LEAN CLAYS			
			Liquid Limit > 50%	CH INORGANIC CLAYS OF HIGH PLASTICITY, FAT CLAYS			
ORGANIC SILTS & CLAYS (Below A-Line on Plasticity Chart)	Liquid Limit < 50%	OL ORGANIC SILTS AND ORGANIC SILTY CLAYS OF LOW PLASTICITY					
	Liquid Limit > 50%	OH ORGANIC CLAYS OF HIGH PLASTICITY					
HIGHLY ORGANIC SOILS			Pt PEAT AND OTHER HIGHLY ORGANIC SOILS
