# **Ecological No Net Loss Assessment Report**

**Thomas Residence  
8149 W Mercer Way  
Mercer Island, WA 98040**

**December 2023**

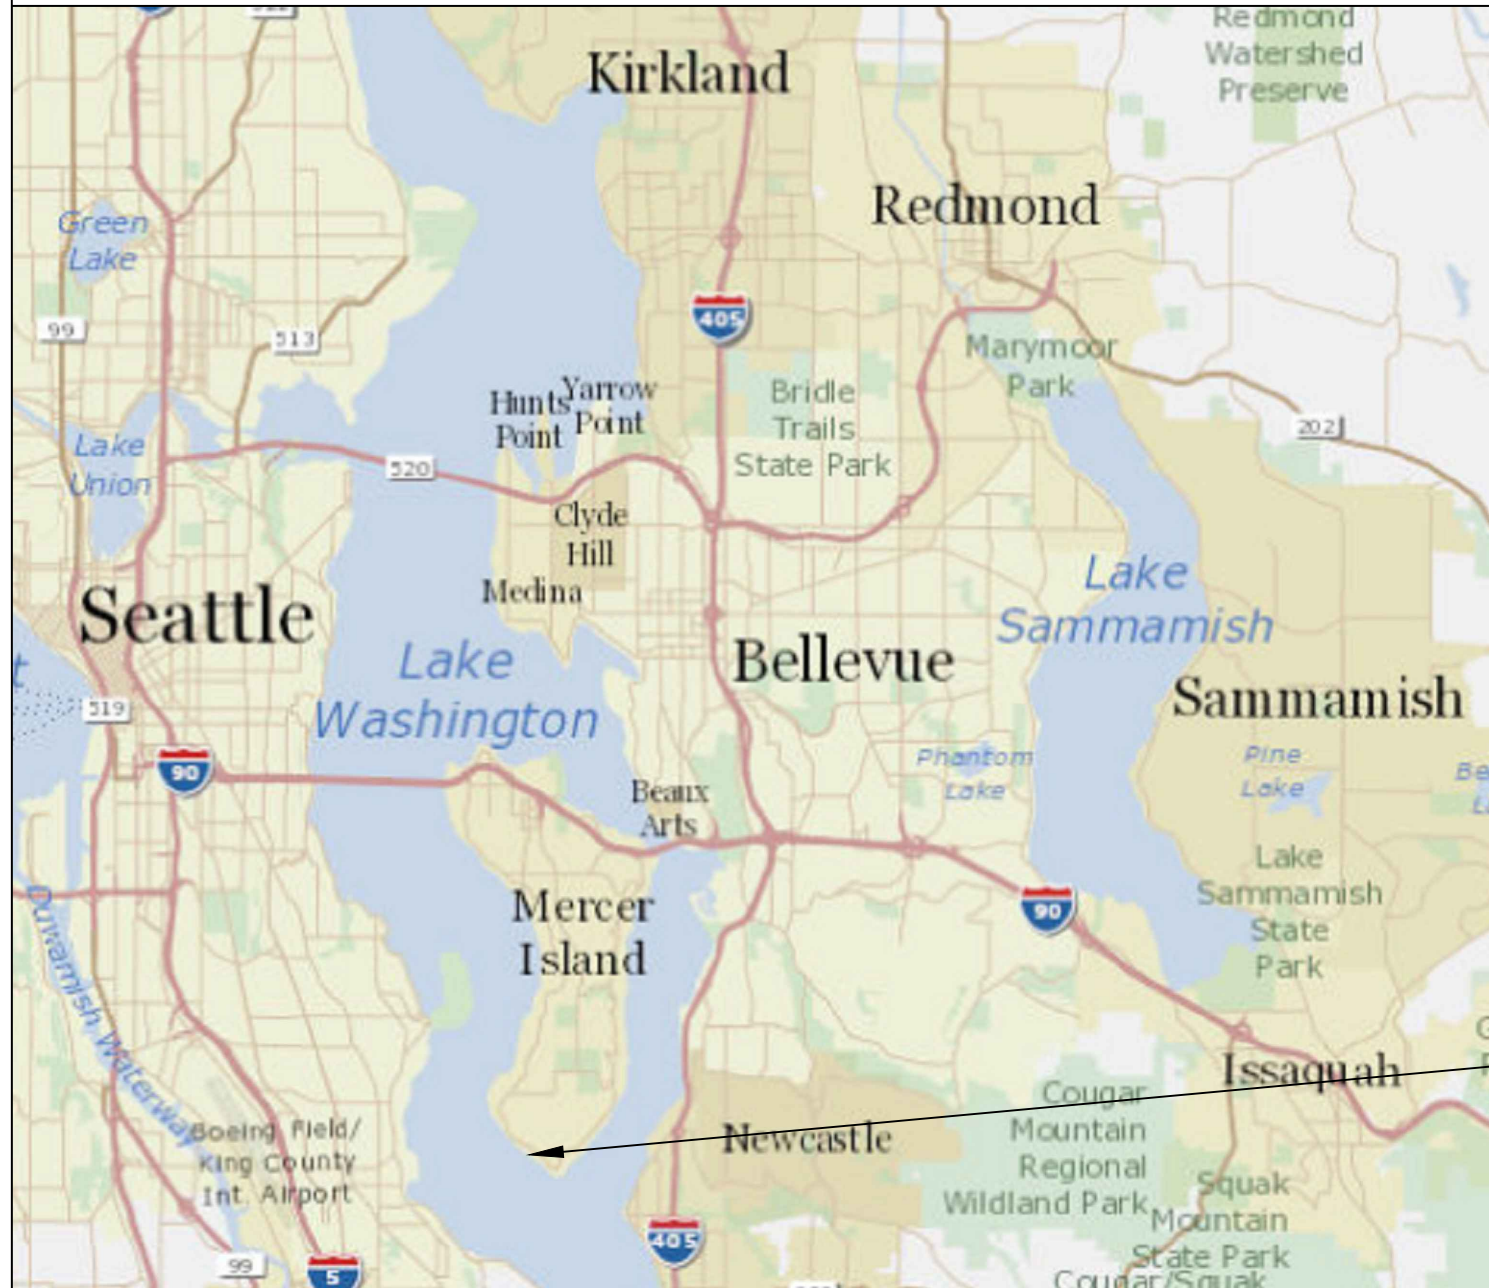
# SITE PLAN

Scope of Work: We propose to repair (14) piles of the east dock, set back 6" and repair 107 lft of existing bulkhead, replace 4 lft of existing rock bulkhead with stairs, raise the existing east dock 1', and repair the existing east dock with (415 sqft) grated decking material.

The subject property is located at 8149 W Mercer Way, Washington (see Appendix A – Sheet A1.0). The parcel is on the waterfront of Lake Washington that contains several endangered fish species listed under the Endangered Species Act and Washington State designated priority fish species.

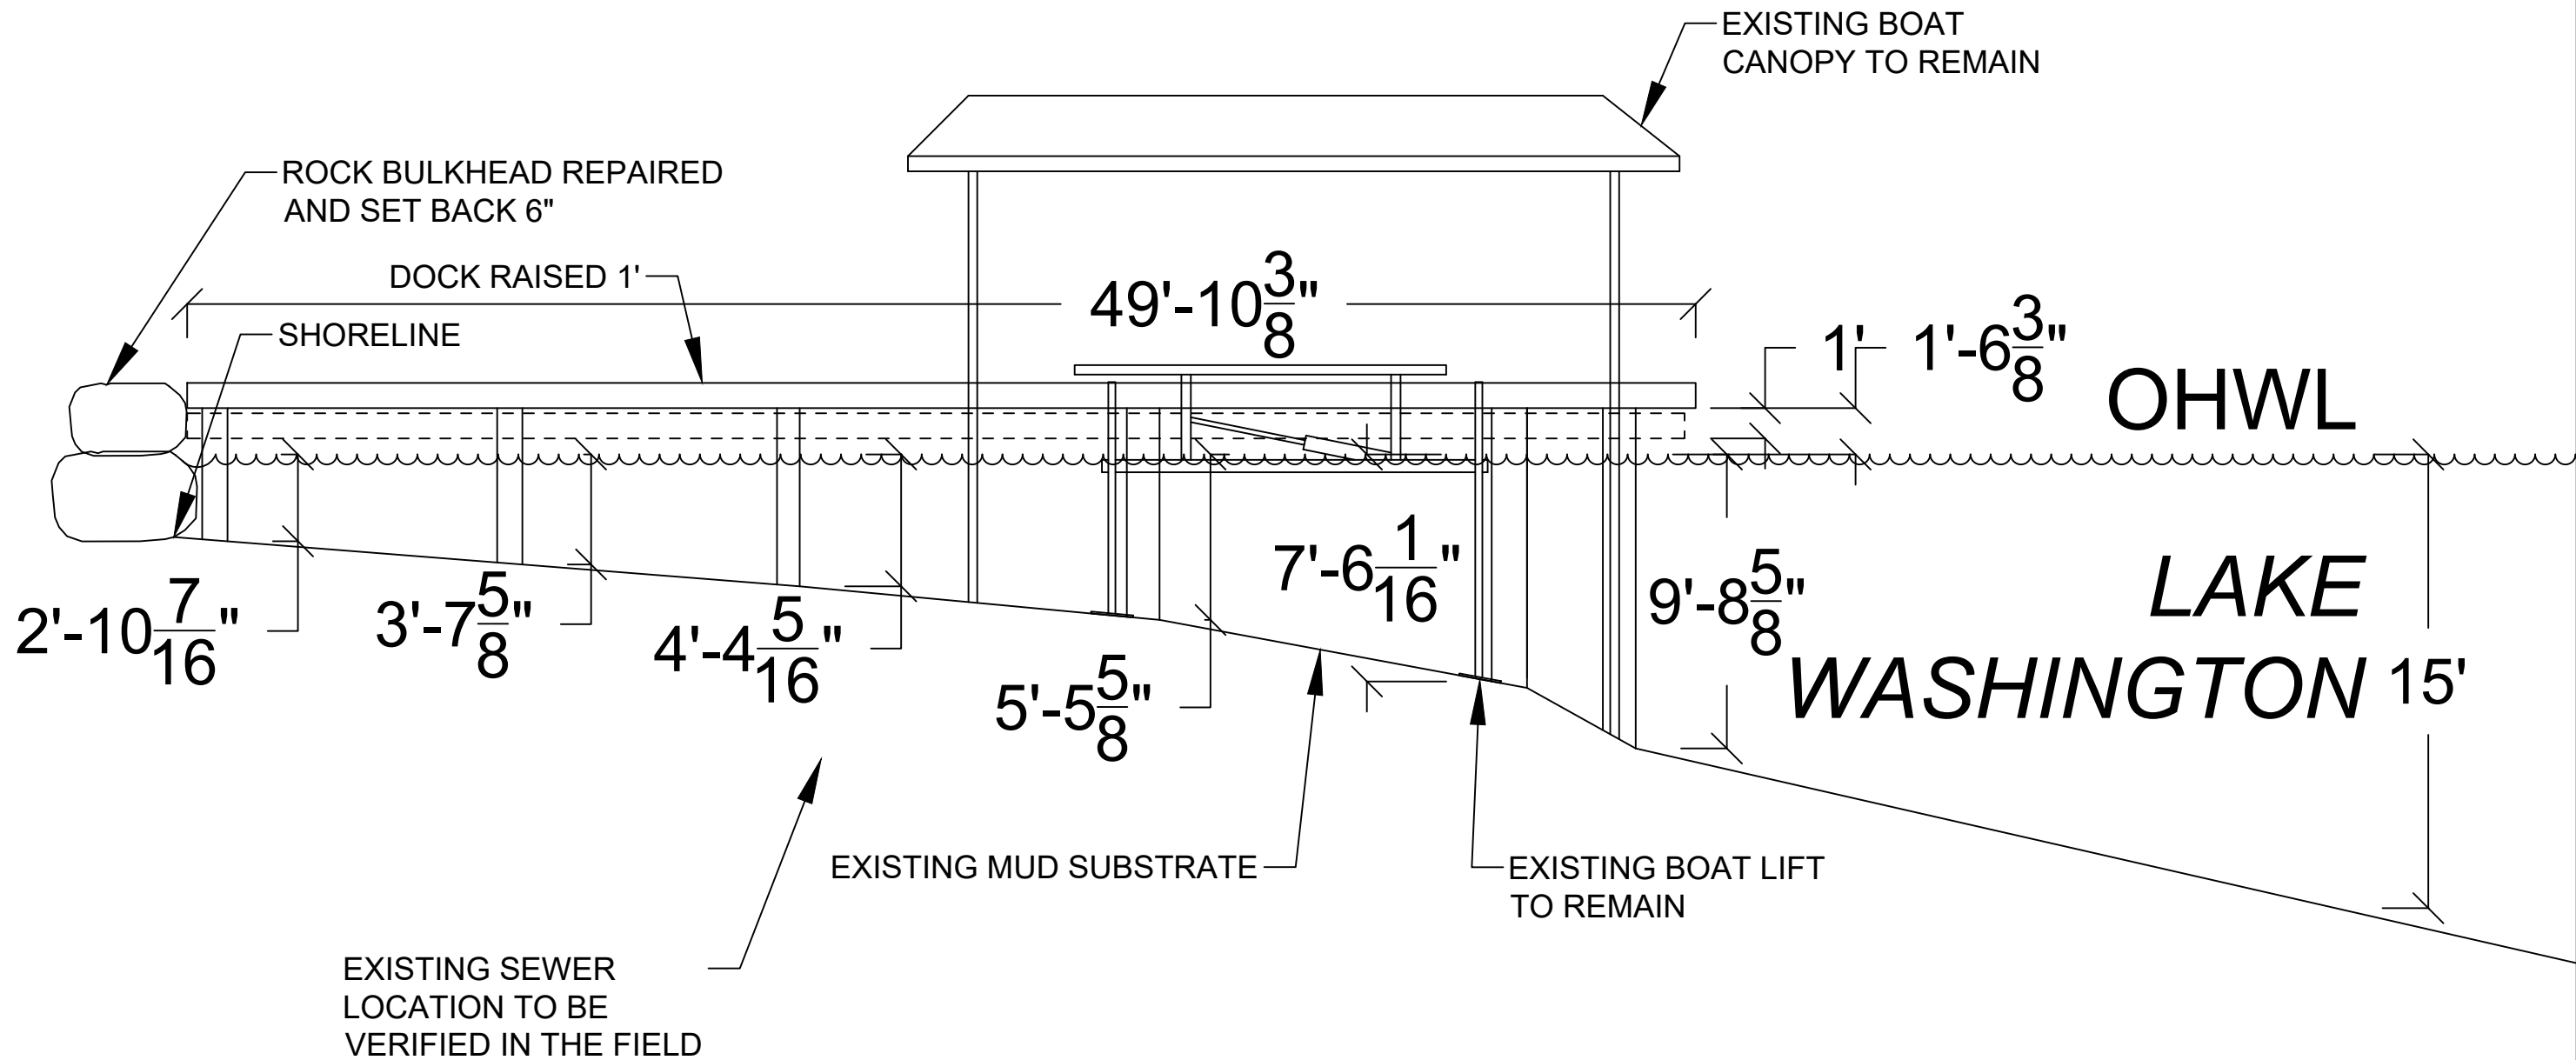
# PIER DETAILS PROPOSED - SECTION VIEW

SECTION VIEW: A'-A'

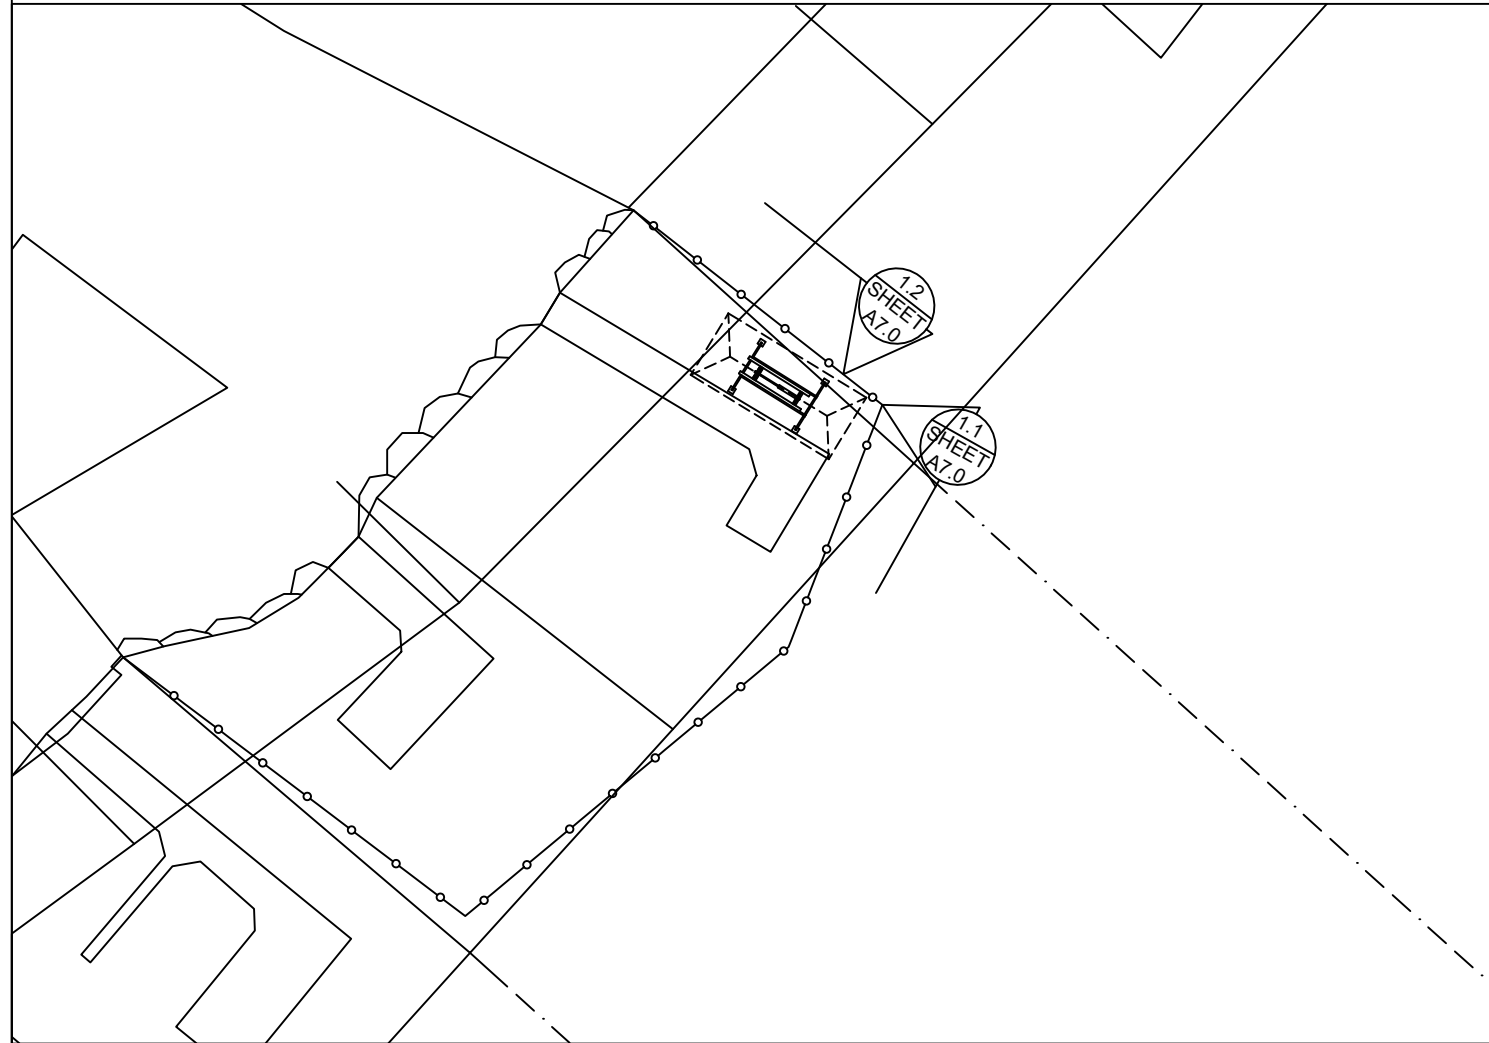
# BMP INFORMATION

- A.** Constant vigilance shall be kept for the presence of protected fish species during all aspects of the proposed action, particularly during in-water activities such as vessel movement, deployment of anchors & spuds, pile driving, dredging, and placement of gravels and other fill.

During construction, a floating boom will surround the work barge and pier. See sheet 7.0.

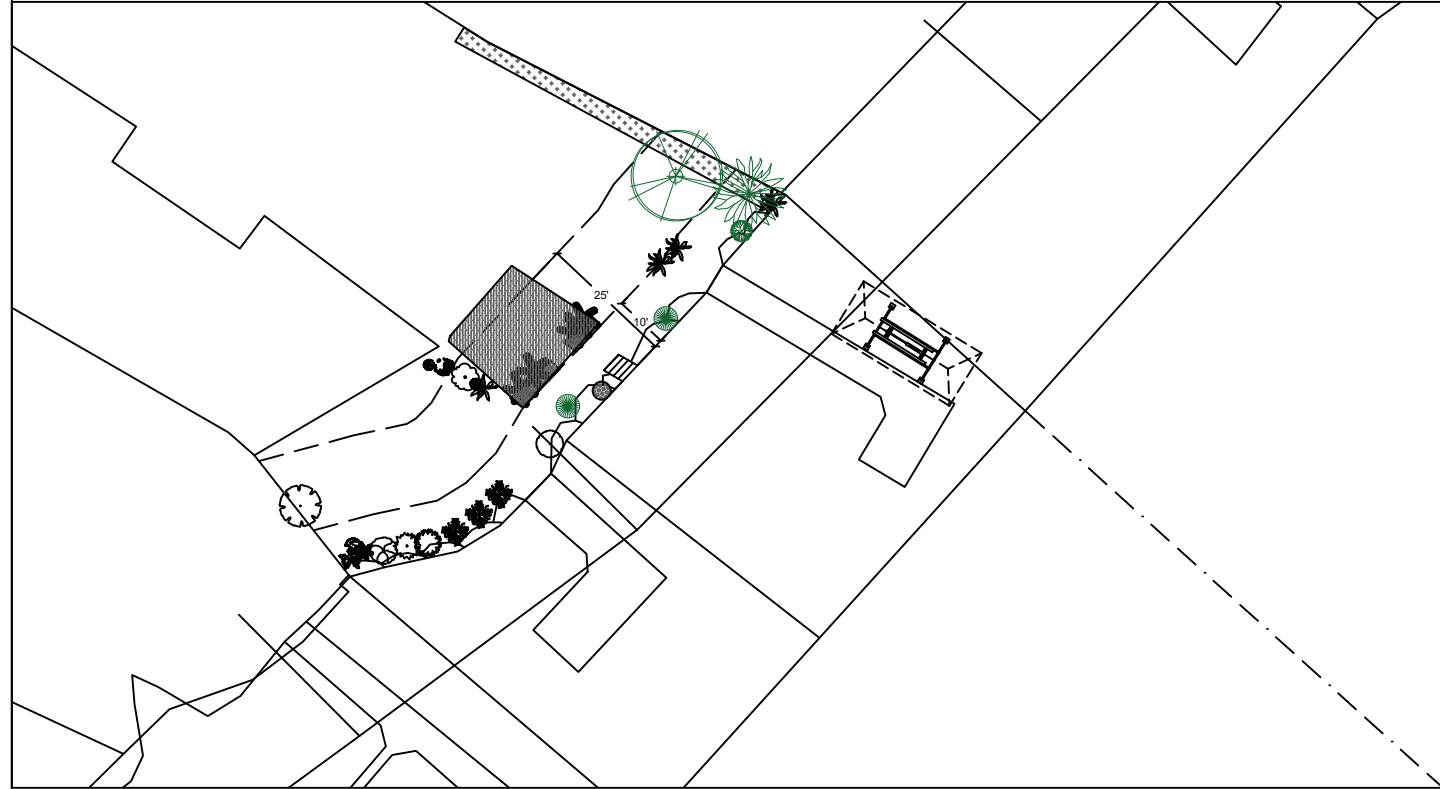
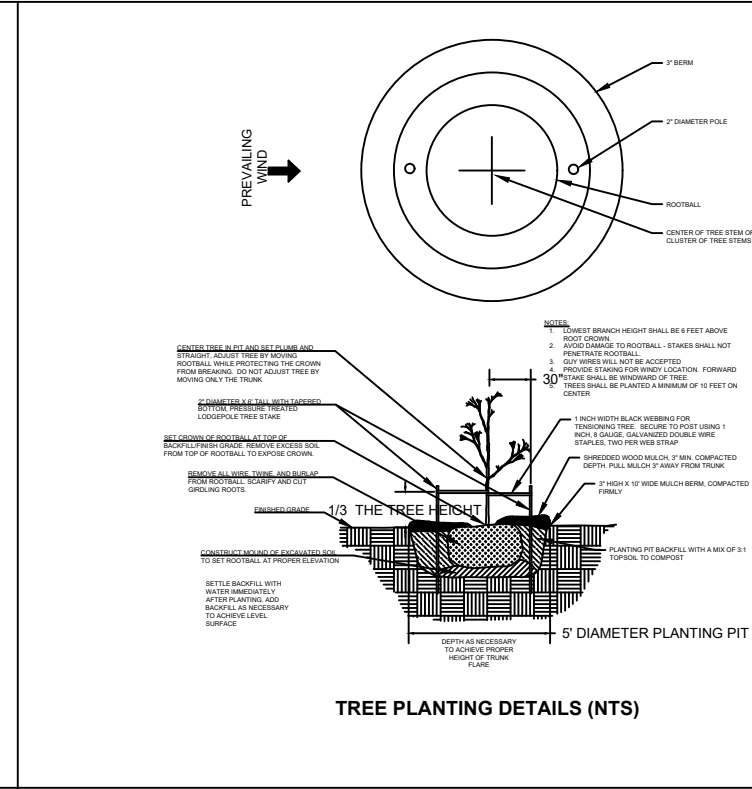
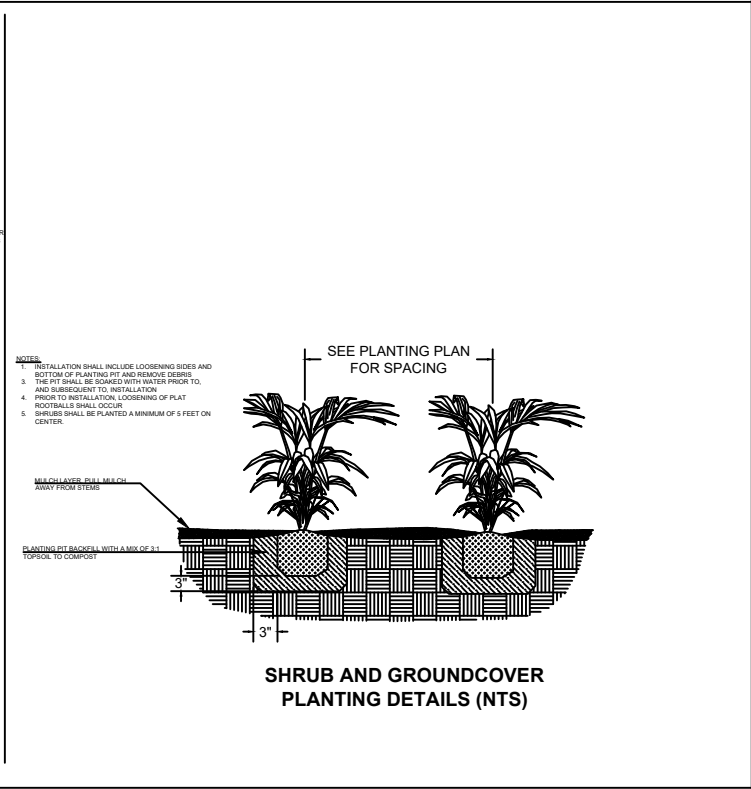
# MITIGATION PLAN

- The property owner shall implement and abide by the shoreline planting plan, including the installation of the identified species, in the identified locations. Shrubs shall be planted at least five feet on center, and trees shall be planted at least ten feet on center.

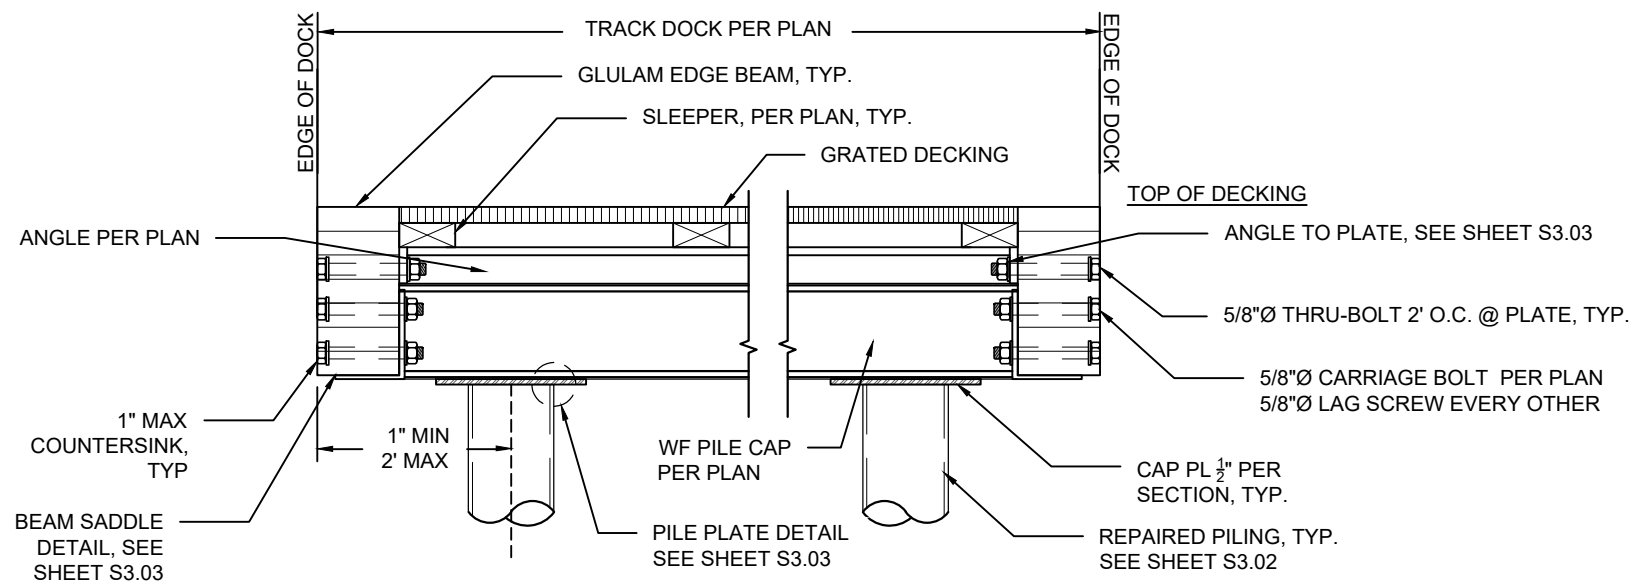
**A**  
S2.01  
**TYPICAL DOCK SECTION**  
SCALE IN FEET

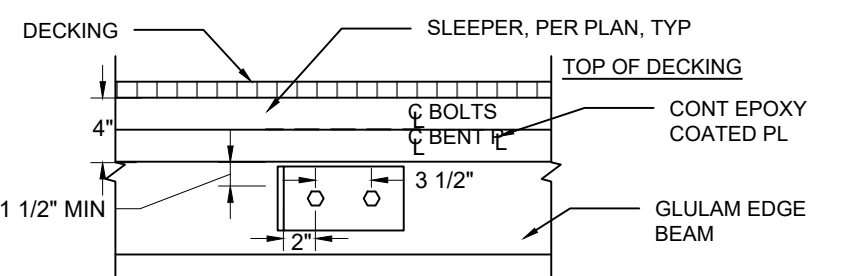
**B**  
S2.01  
**DOCK END SECTION**  
SCALE IN FEET

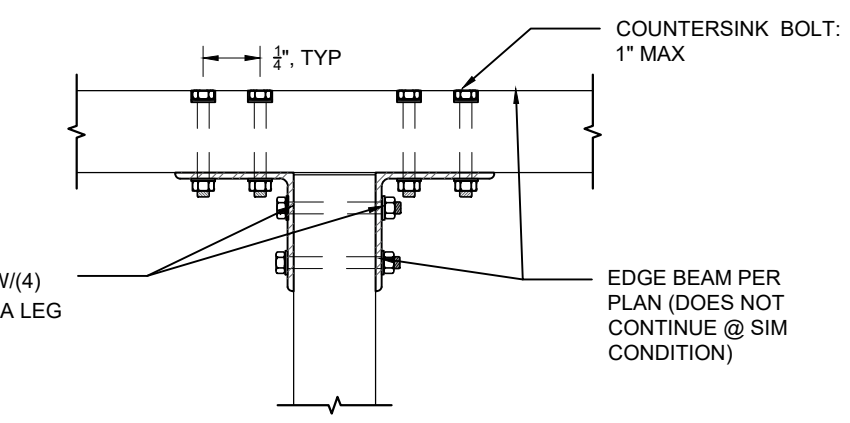
**GLULAM "T" CONNECTION**  
SCALE IN FEET

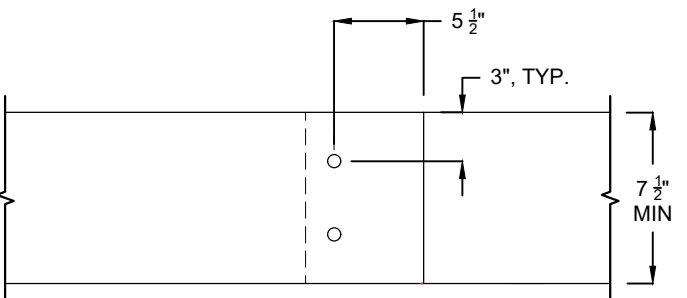
**FILLET CONNECTION**  
SCALE IN FEET

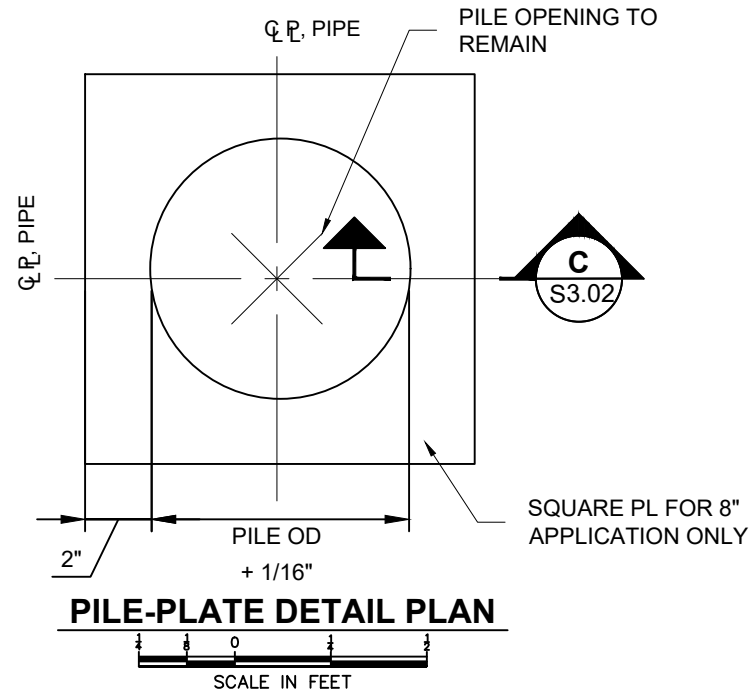
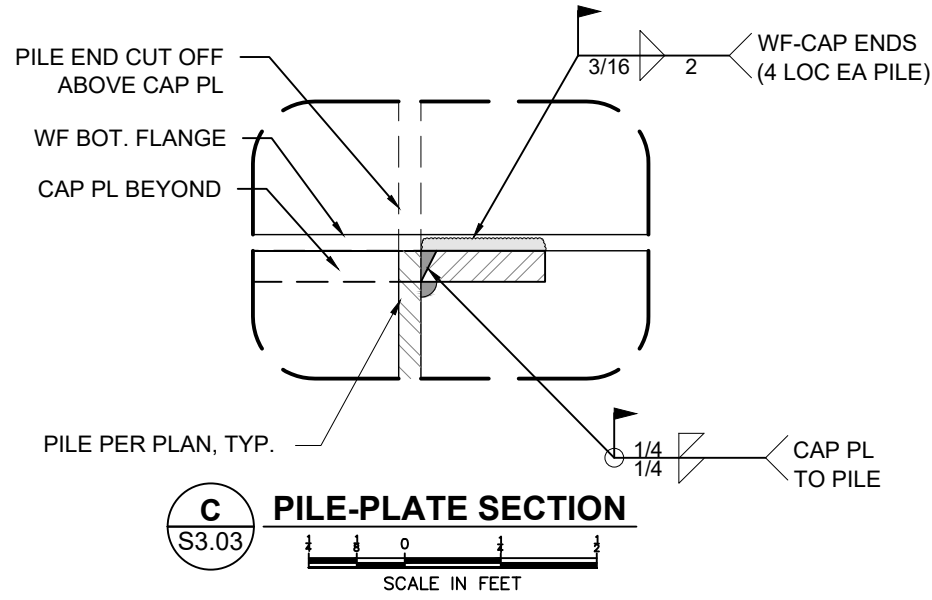
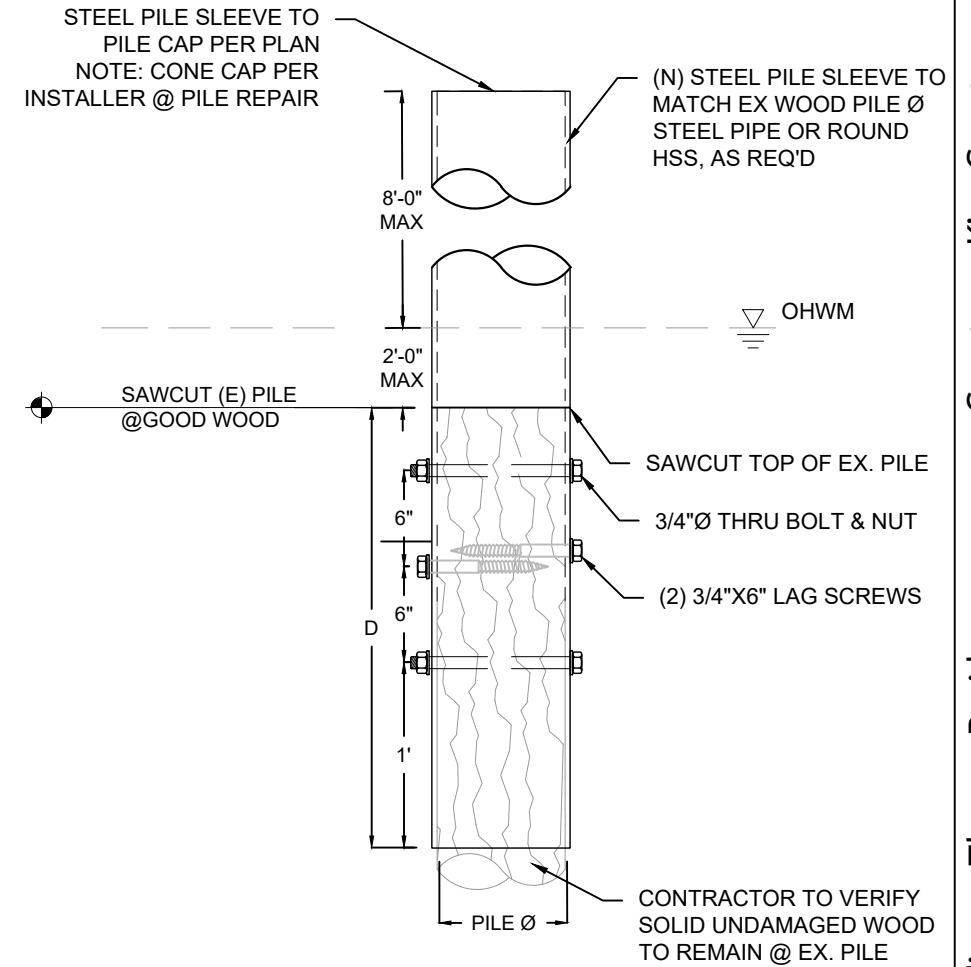
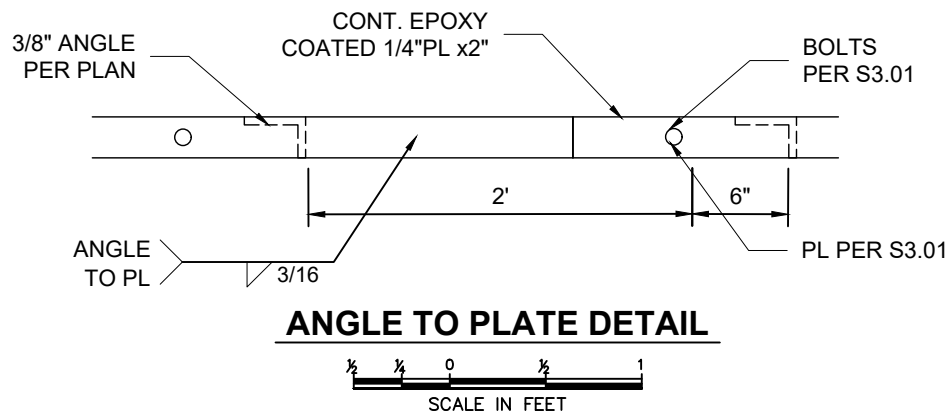
STEEL SLEEVE TABLE	
PILE Ø	MIN D
8"	27"
10"	30"
12"+	36"

CONTRACTOR TO VERIFY THAT THE PILE FITS SNUGLY IN THE SLEEVE SUCH THAT THERE IS UNIFORM BEARING OF THE PILE AGAINST THE SLEEVE

- \* Repair piles are done as a sleeve/strap method

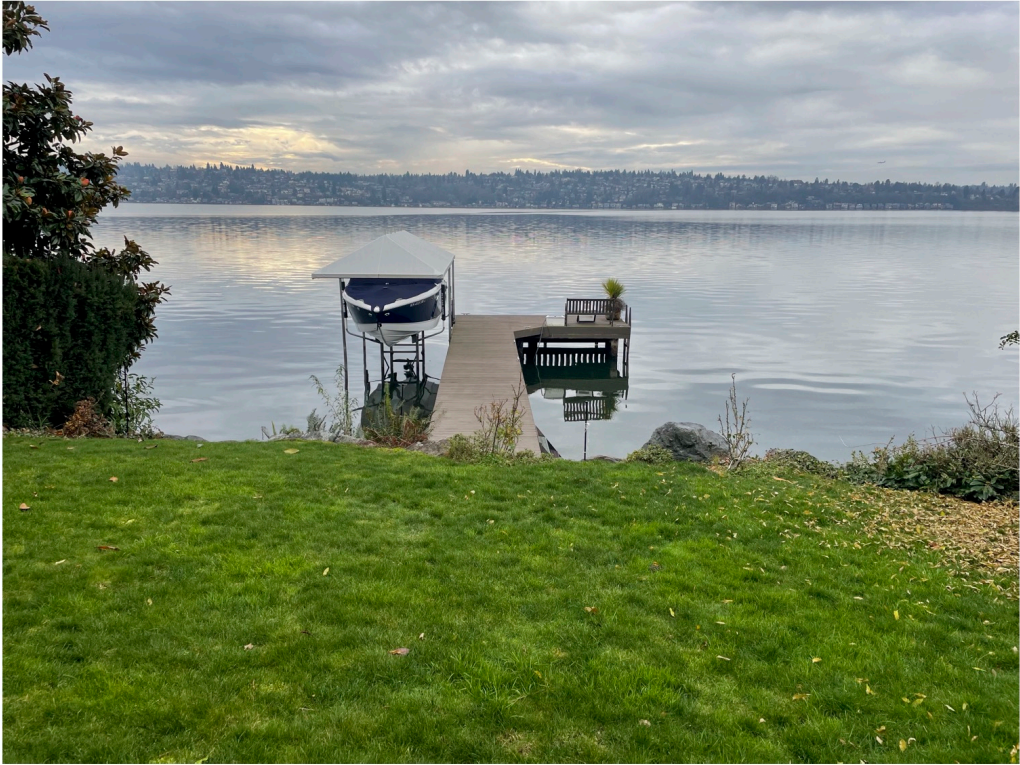
Photo 1 - Existing dock looking waterward.

The only existing structures on the property are the house, the existing dock, and a rock bulkhead. The shoreline a lawn with beds and terraces with a few ornamental beds with a patio. The bulkhead is constructed with granite boulders. Lake substrates are sand and gravel with some cobble. Eurasian milfoil was present in the Lake starting about 20 feet from shore. (Photos 1 through 6).

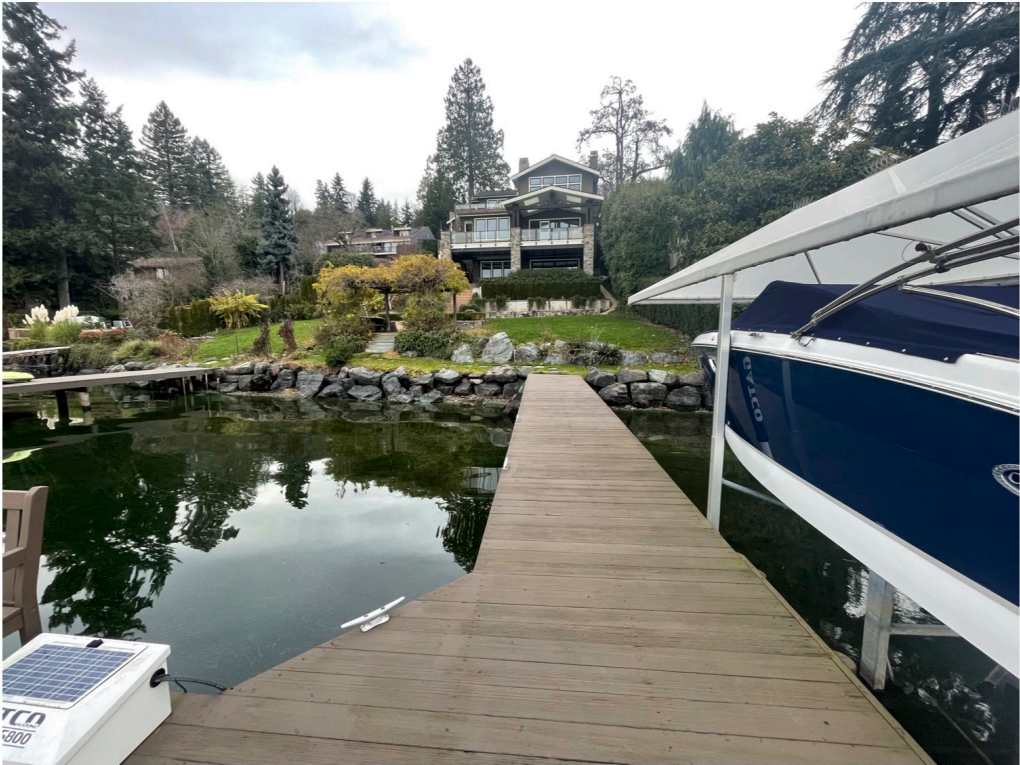
Photo 2 - Existing dock looking landward.

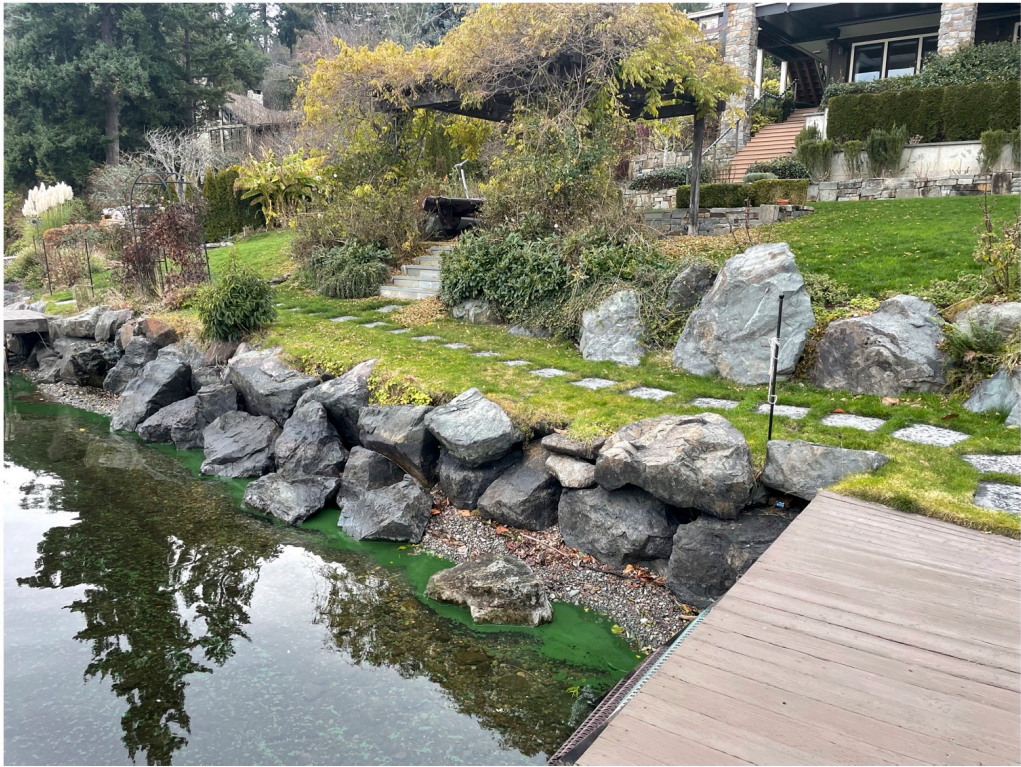
Photo 3 - Existing shoreline looking north.

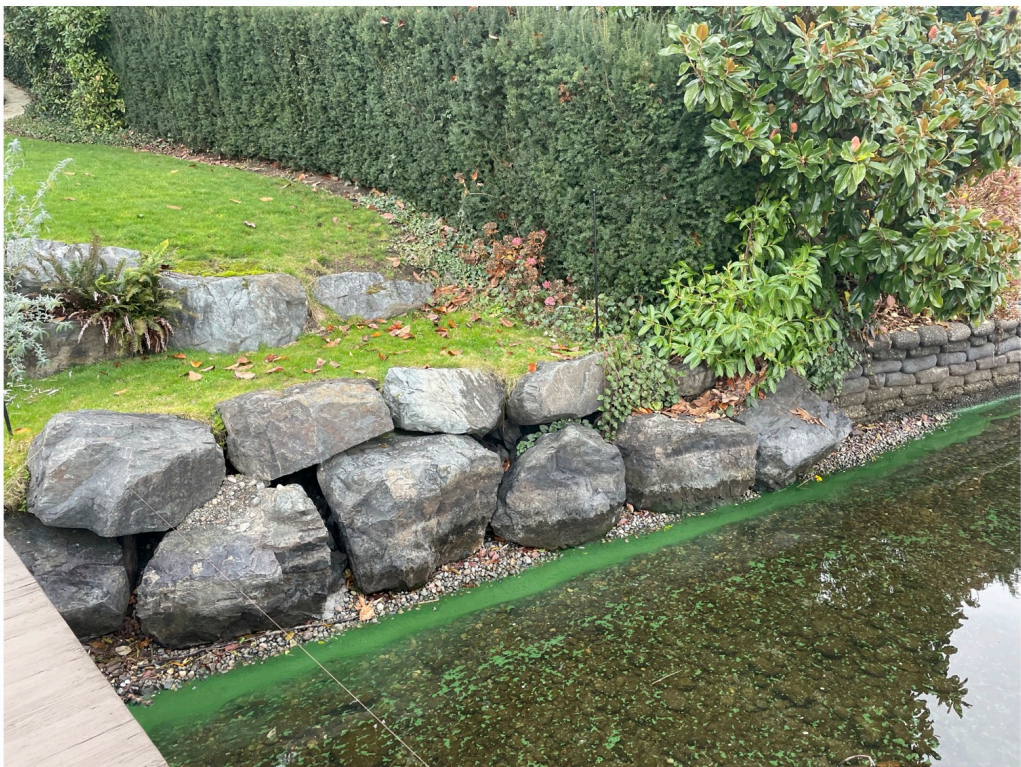
Photo 4 - Existing shoreline looking south.

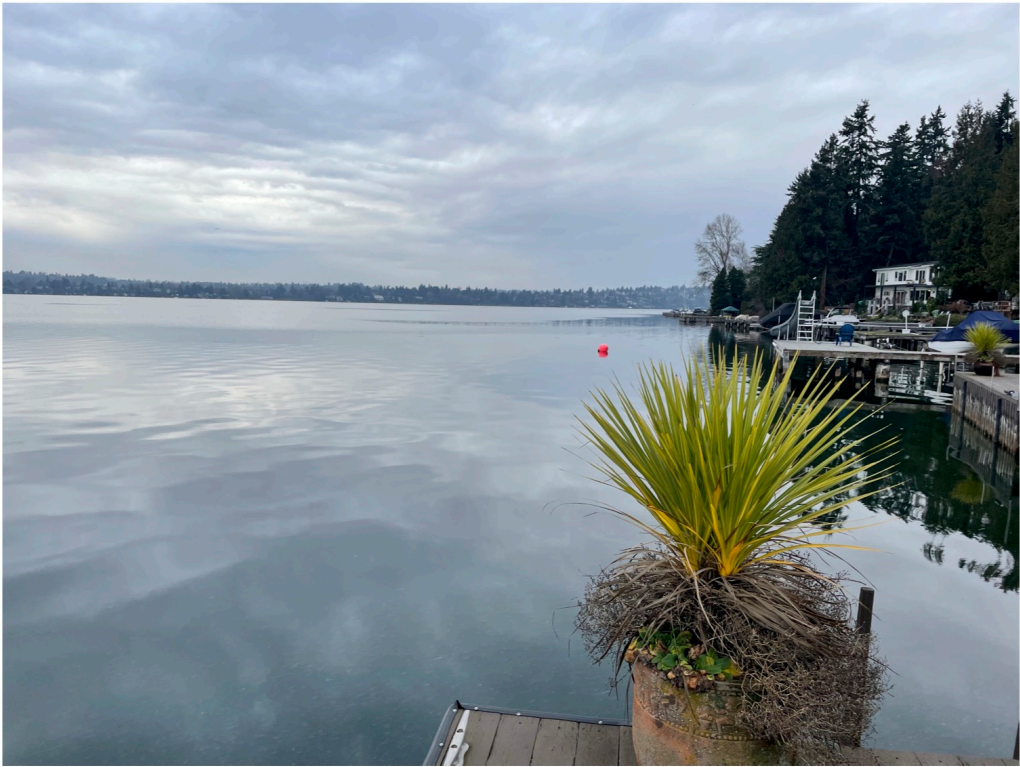
Photo 5 - Existing conditions conditions looking north.

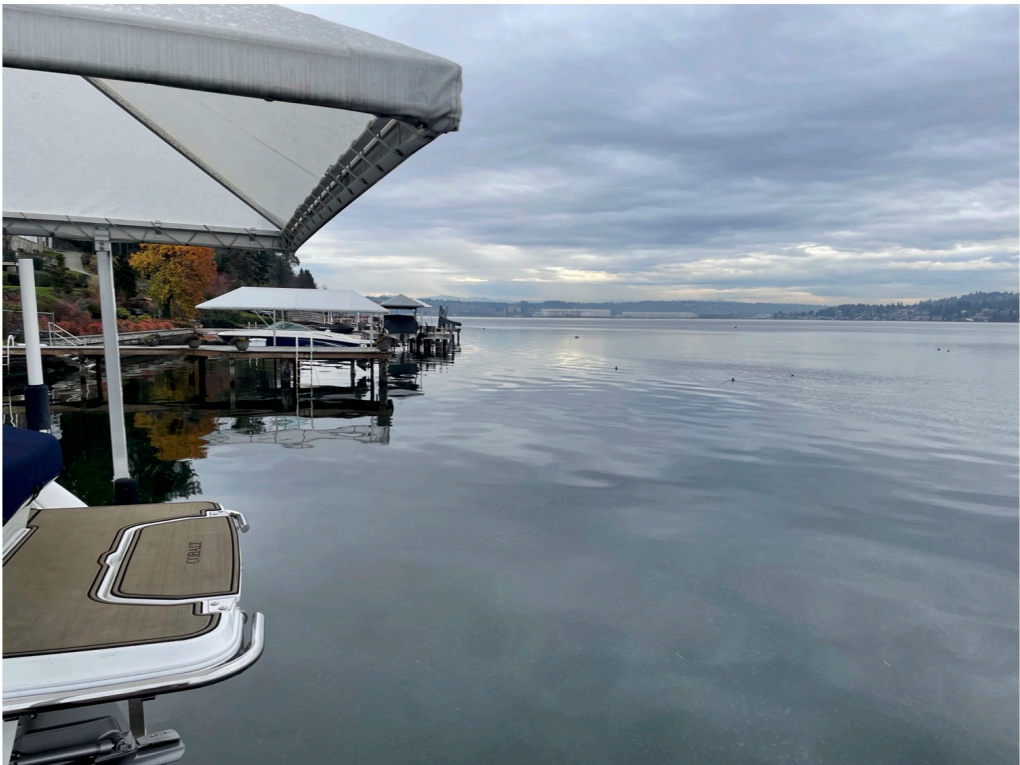
Photo 6 - Existing shoreline conditions looking south.
