# JASON RESIDENCE

4006 East Mercer Way

## Storm Drainage Report

Mercer Island, Washington  
September 11, 2024

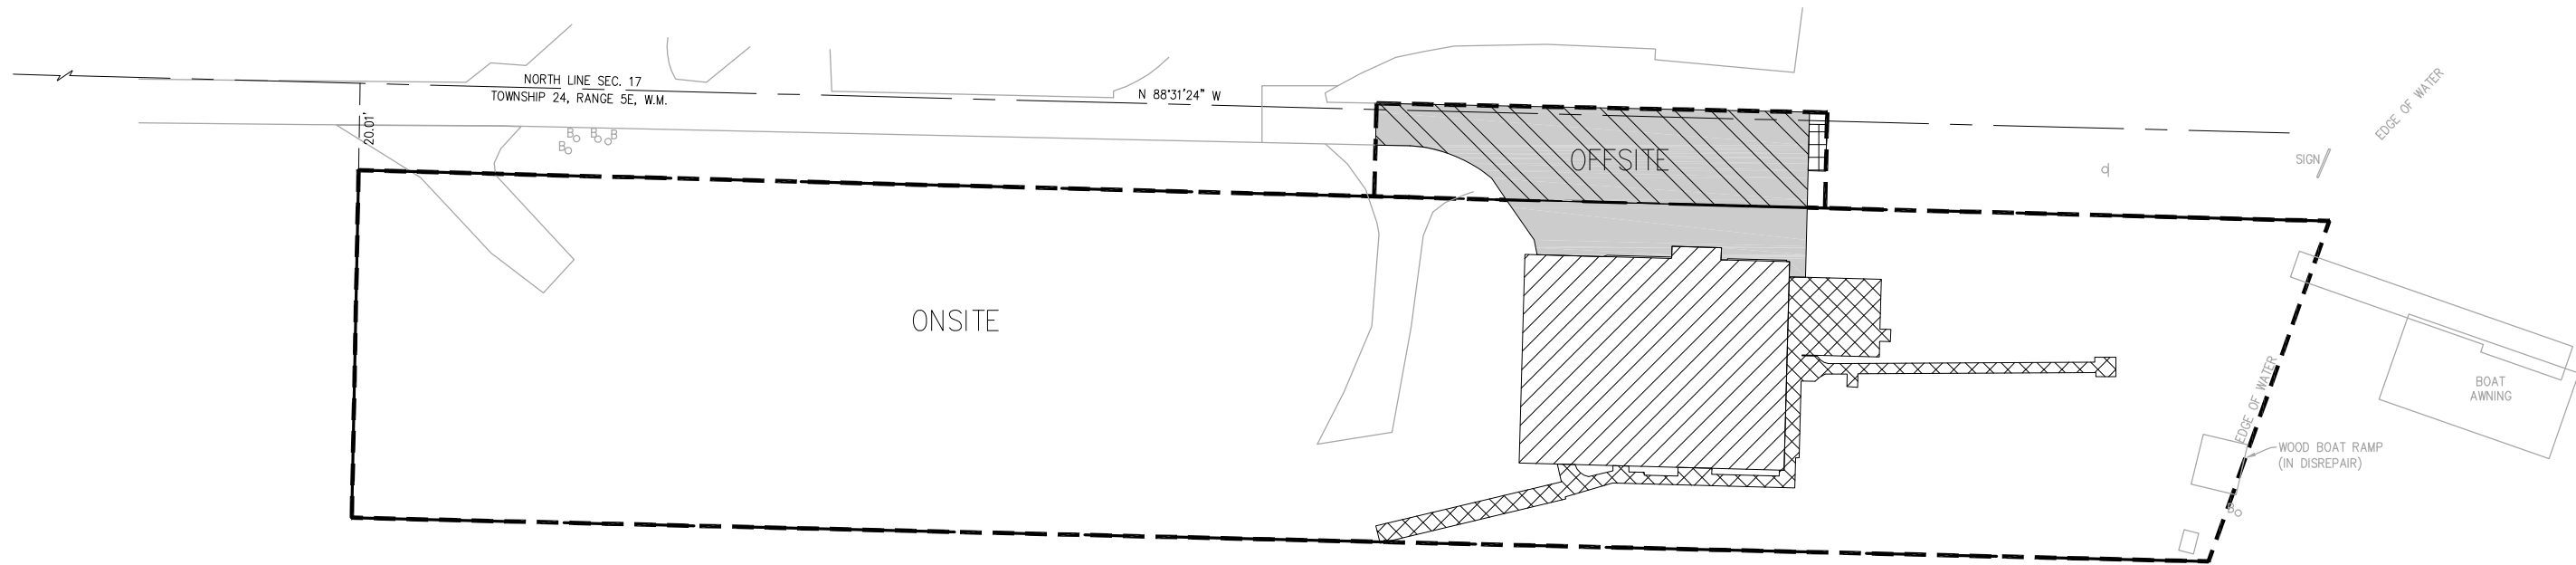
**EXISTING  
IMPERVIOUS AREA**

The existing property is 13 percent impervious. Impervious areas include the building roof, concrete driveway, patios and footpaths. There is also a boat dock with an awning. Existing lawn and landscaping east of the house slopes down to the water's edge. There is no bulkhead. The area west of the house is wooded.

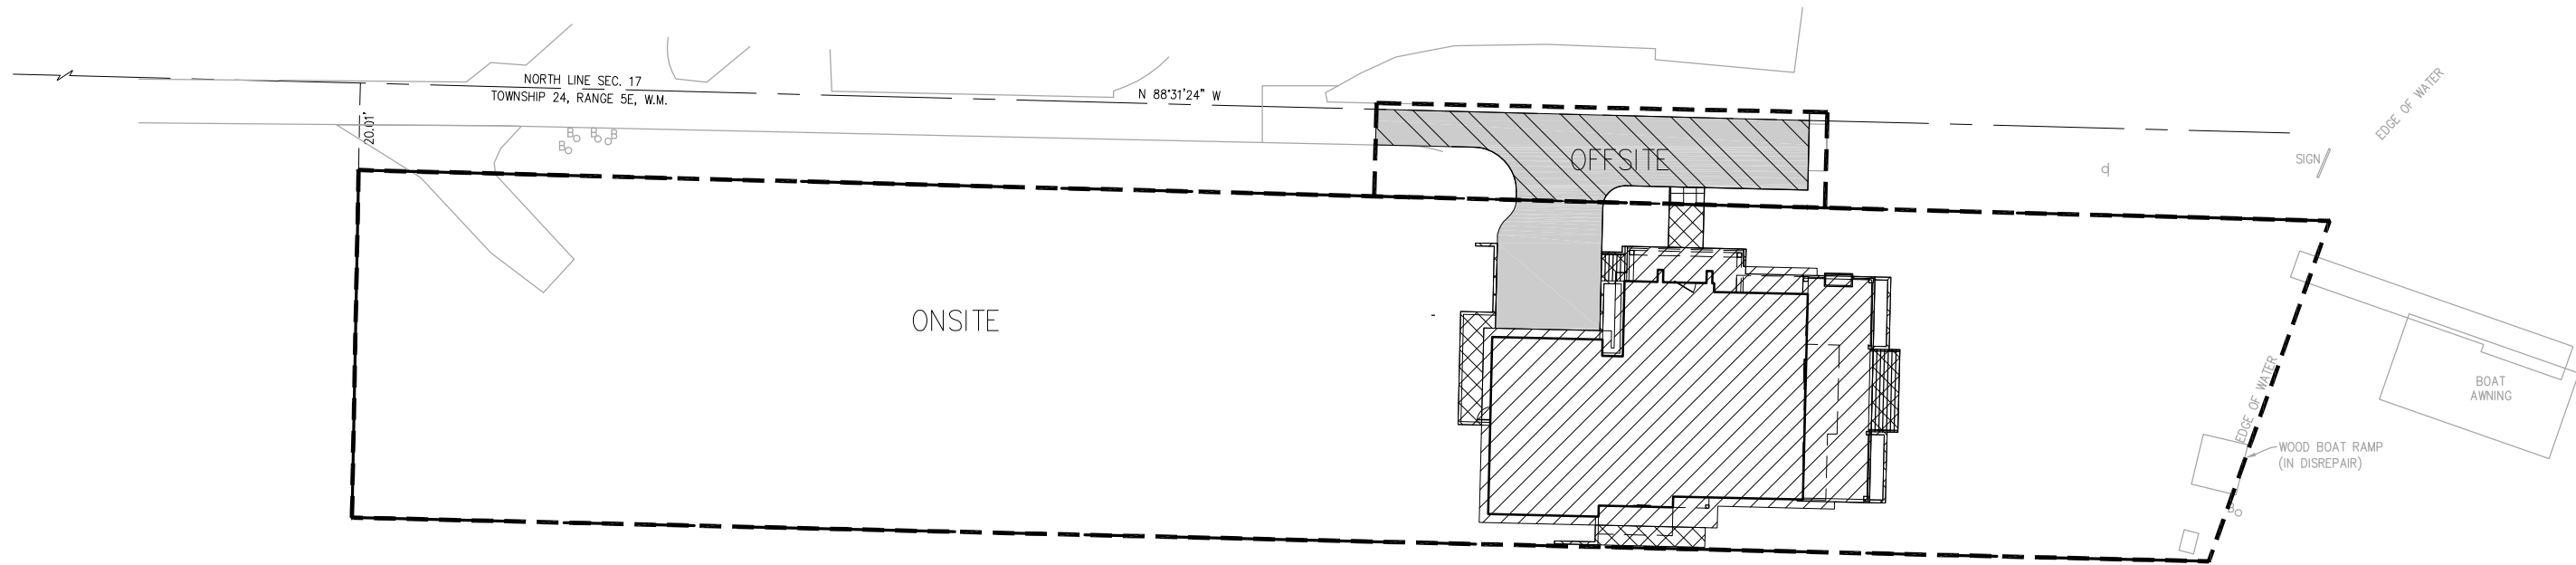
# DEVELOPED IMPERVIOUS AREA

The project is classified as a New Development project (existing impervious area is 17%, inclusive of site and disturbed offsite area) with 907 square feet of new impervious area and 6,709 square feet of replaced impervious area. The quantity of new plus replaced hard surface (7,616 square feet) is more than 5,000 square feet. The project therefore is required to comply with Minimum Requirements #1 through #9 of the 2014 DOE manual.

Project Area:	38,370 sf
Existing Impervious Area:	6,709 sf
Existing Impervious Coverage:	17 %
New Impervious Area:	858 sf
Replaced Impervious Area:	6,709 sf
New plus Replaced Impervious Area	7,567 sf
Existing Impervious Area to Remain	0 sf
Proposed Impervious Area:	7,567 sf
Converted Pervious Area (Native Vegetation converted to landscape):	0 sf
Converted Pervious Area (Native Vegetation converted to pasture):	0 sf
Total Disturbed Area:	38,370 sf

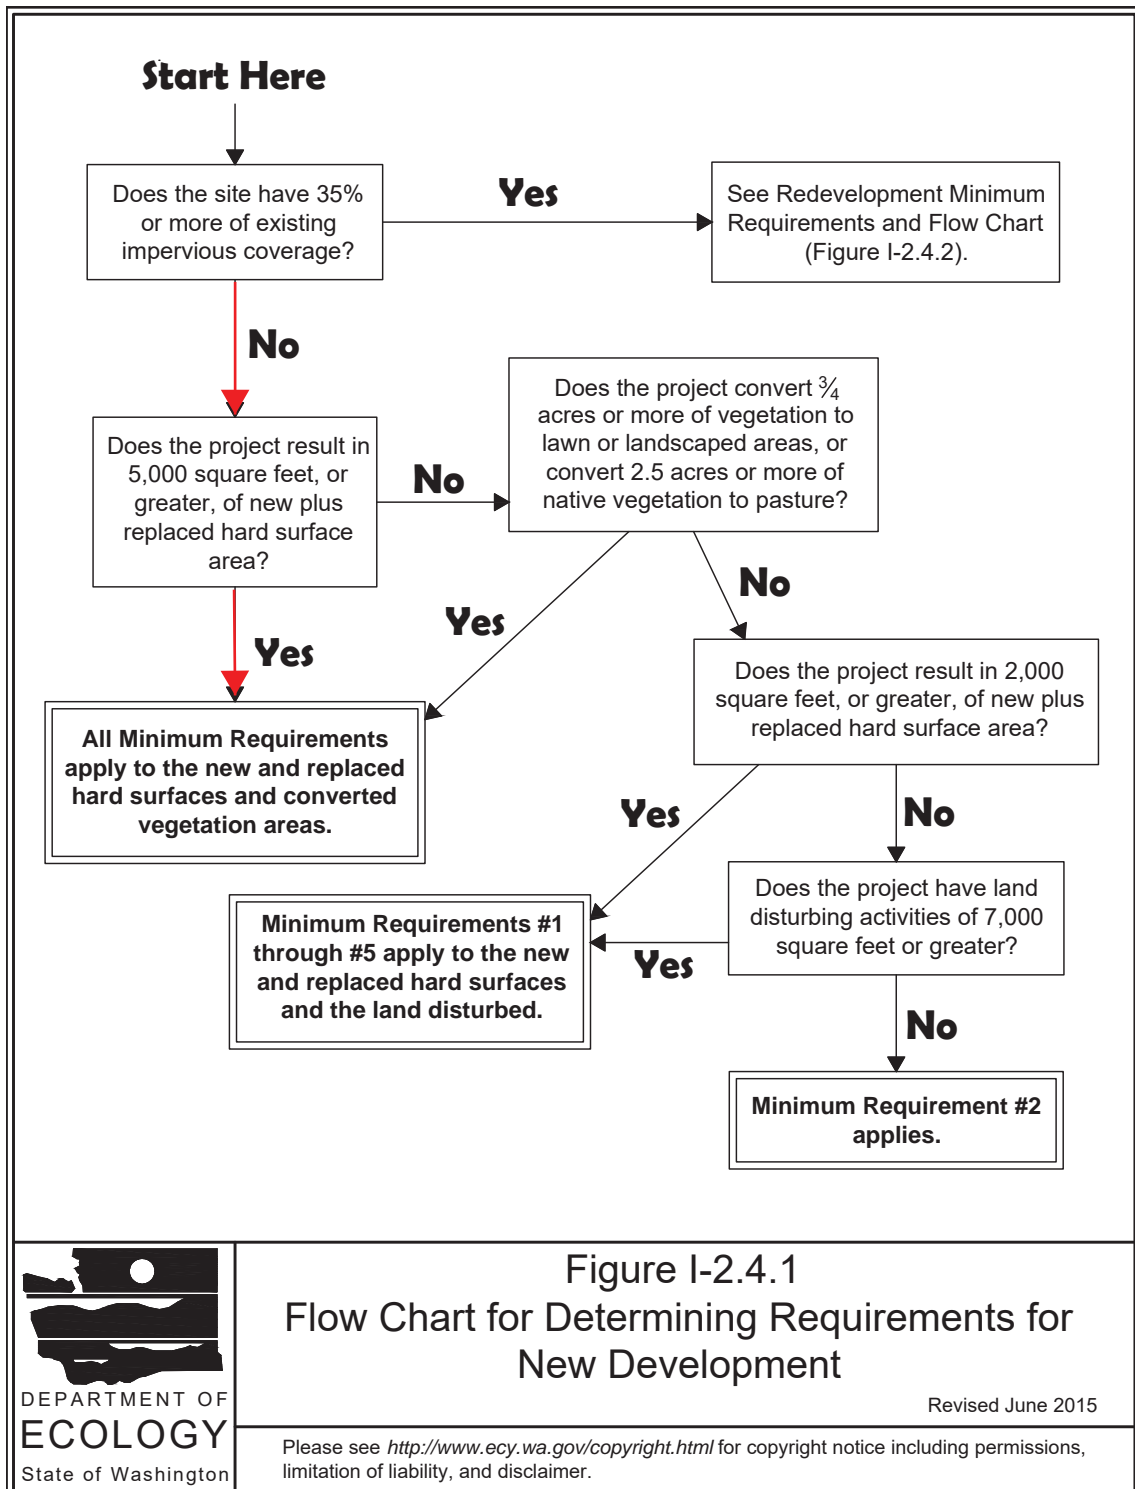
**Figure I-2.4.1 Flow Chart for Determining Requirements for New Development**

Figure I-2.4.1  
Flow Chart for Determining Requirements for  
New Development

Per Figure I-2.4.1 of the 2014 DOE Stormwater Management Manual for Western Washington, the project is required to meet all Minimum Requirements.
