GEOTECHNICAL REPORT PROPOSED SAUNA 5245 FOREST AVENUE SE MERCER ISLAND, WASHINGTON

Project No. 25-130
May 2025

**Subject: Geotechnical Report Addendum #1
2-inch Pin Pile Recommendations
Proposed Sauna
5245 Forest Avenue Southeast, Mercer Island, WA**

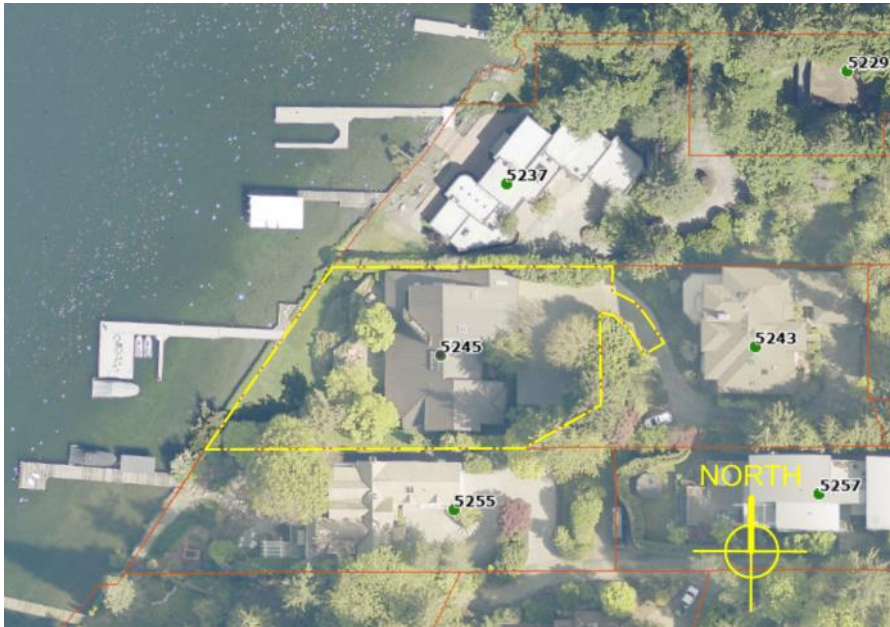
Plate 1: Aerial view of the site.

North is at the top of the image.

The site is outlined in a yellow dashed line.

The project site is an approximately 0.41-acre lot located at 5245 Forest Avenue Southeast in Mercer Island, Washington (See Figure 1 – Vicinity Map). The subject property is approximately trapezoidal shaped, and borders existing single-family residences to the north, east, and south, and Lake Washington to the west (see Figure 2 – Site and Exploration Plan). The site is currently occupied by a 1½-story single-family house with an attached garage. The landscaped areas are vegetated with lawns, landscaping trees, and shrubs. Plate 1 on the following page shows an aerial view of the site. Plate 2 on the following page shows a ground level view of the site conditions at the time of this study.

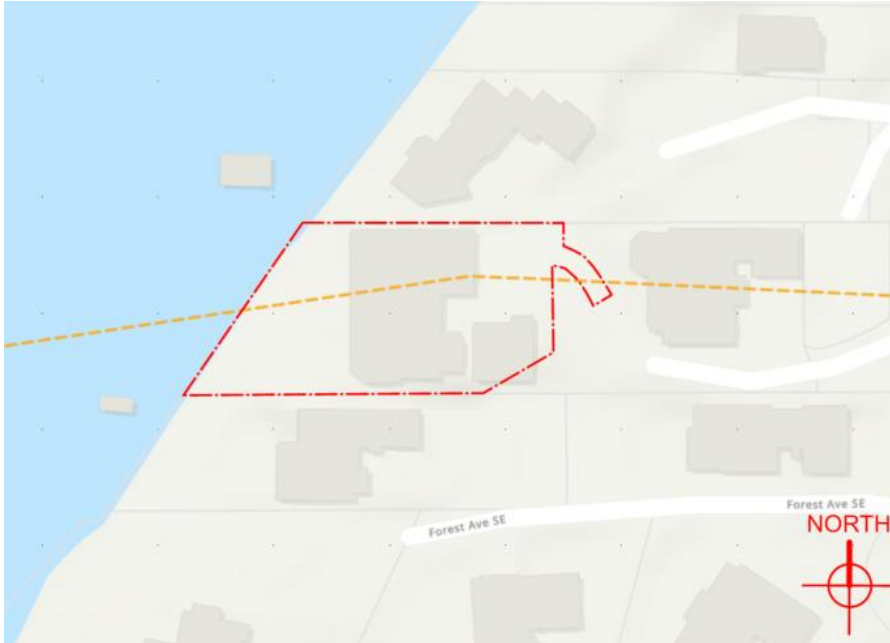
Plate 3: Aerial view of the site with the Seattle fault line shown as an orange dashed line running approximately through the center of the site.

North is at the top of the image.

Where fault lines are present below structures, faulting can potentially displace the structures. Based on our review of the USGS Interactive Fault Map, the closest Class A seismic source to the project is the Seattle fault zone, with one fault line running approximately through the center of the subject site with a reported certainty of “good.” The Seattle fault zone consists of east-west-trending subparallel thrust faults. According to the USGS Quaternary Fault Database (Fault No. 570), this fault has been active within the last approximately 1,100 years (Johnson et al., 2016). Plate 3 on the following page shows the approximate location of the mapped fault line relative to the subject site.
