GEOTECHNICAL REPORT

**Covenant Living at the Shores
9150 Fortuna Drive
Mercer Island, Washington**

Project No. T-8879

Terra Associates, Inc.

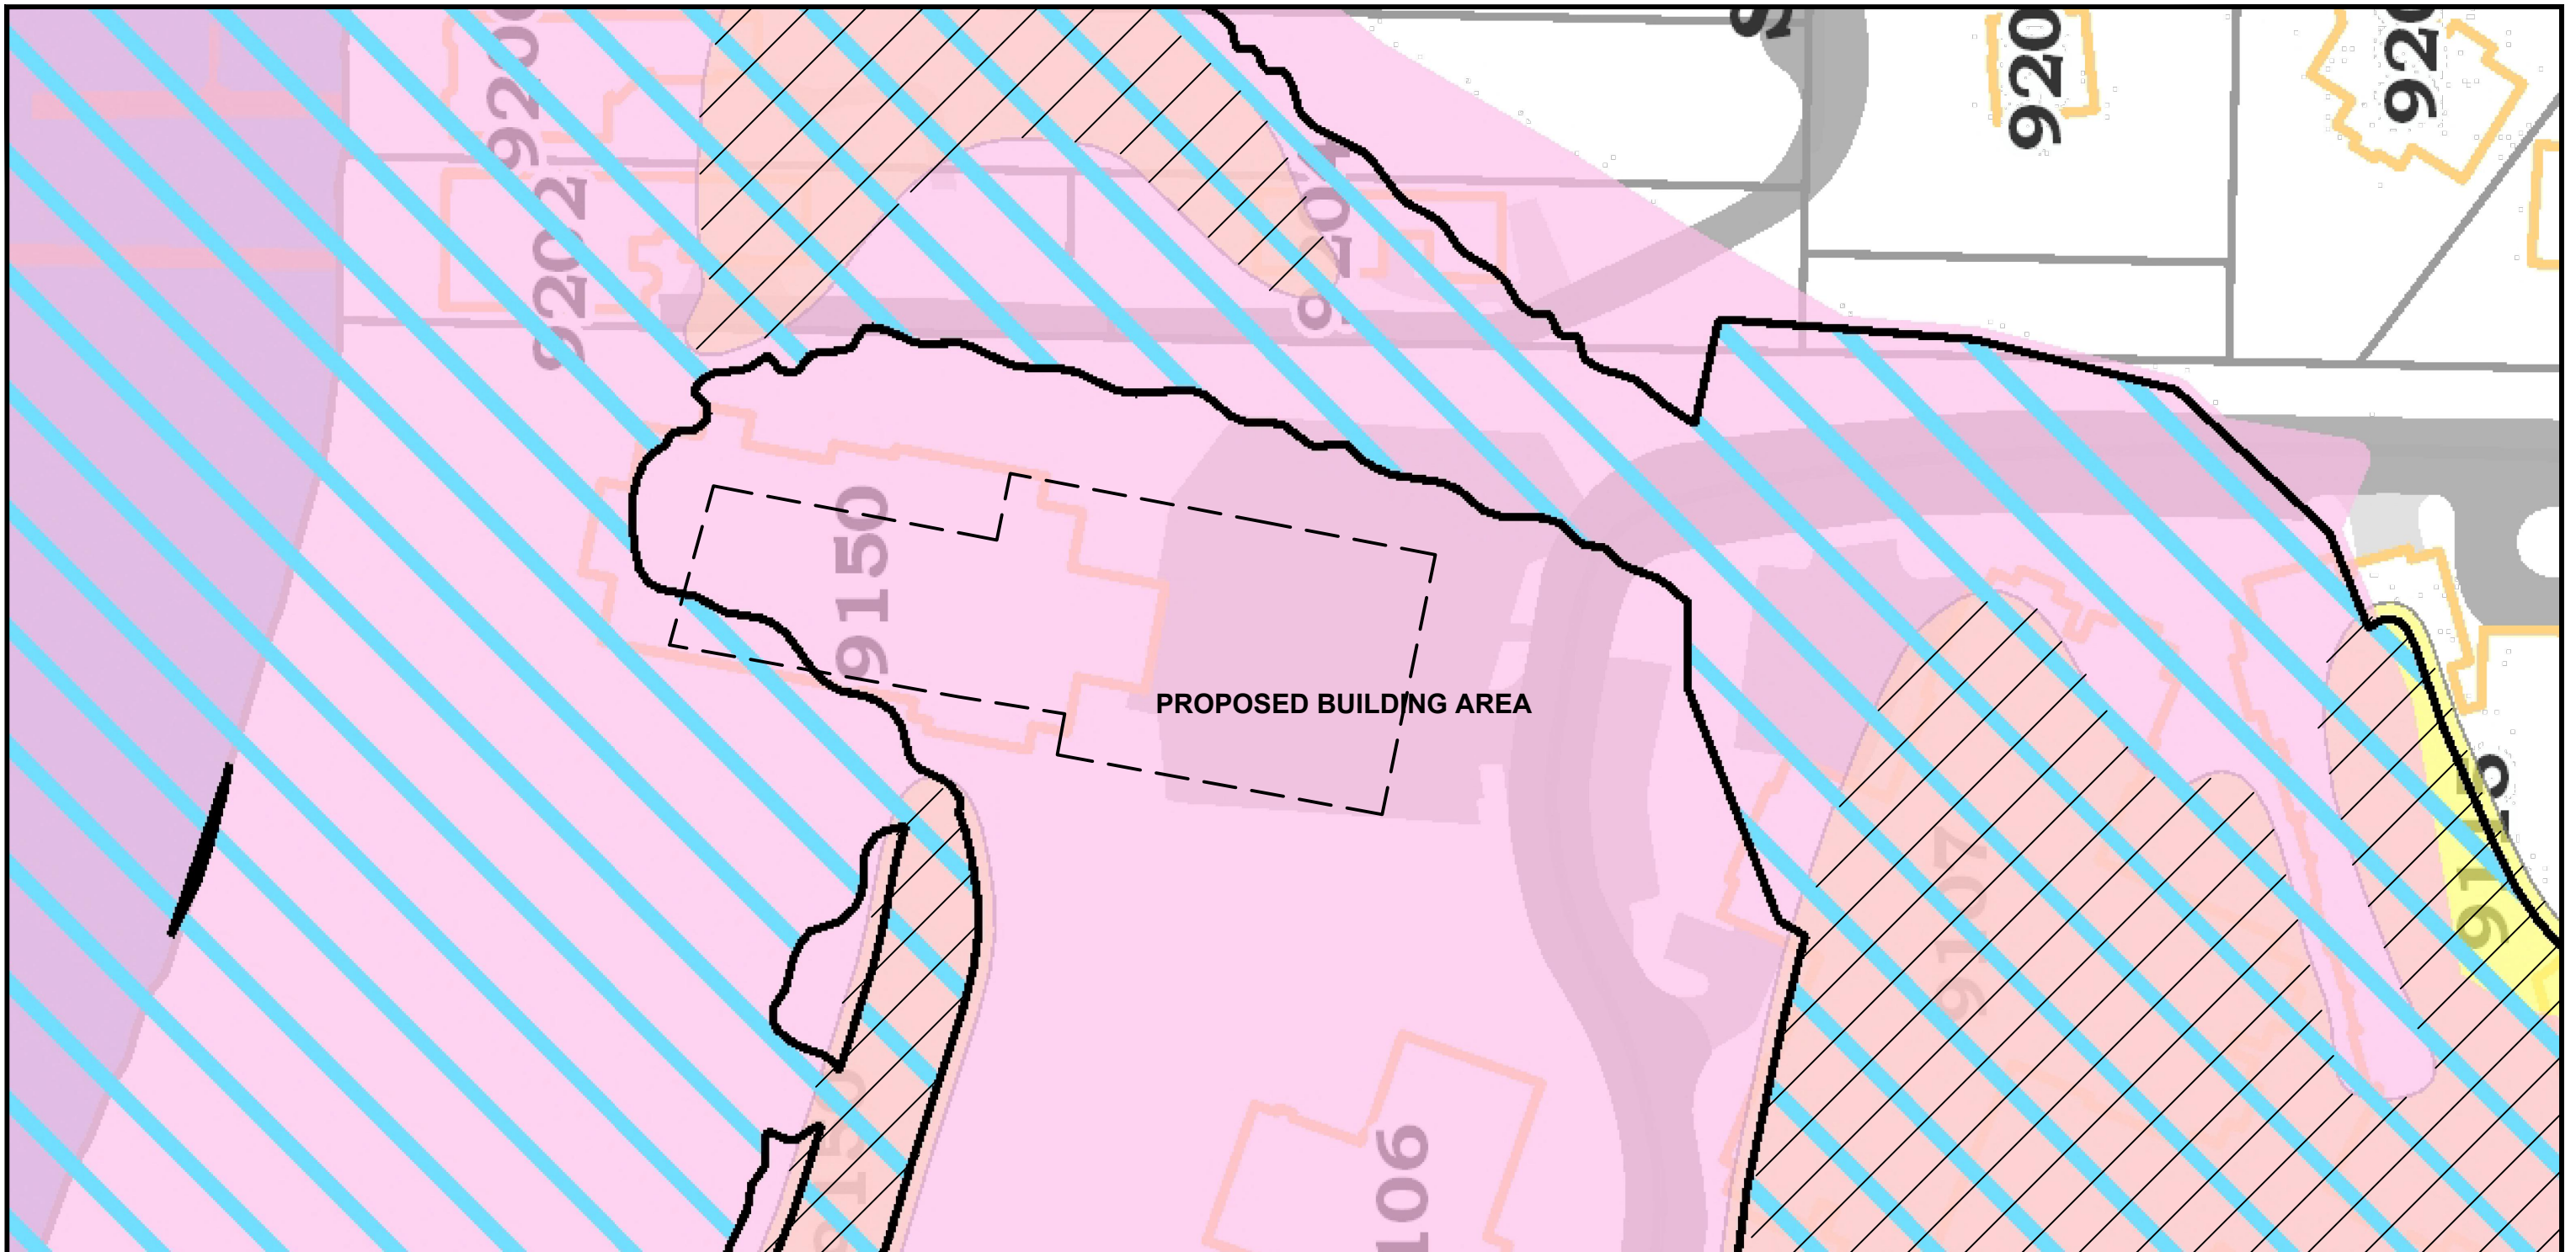
Proj. No.T-8879	Date FEB 2026	Figure 4
-----------------	---------------	----------

SEISMIC HAZARD AREA PER MERCER ISLAND IGS MAPPING

**GEOLOGIC HAZARD AREAS MAP
 COVENANT LIVING AT THE SHORES
 MERCER ISLAND, WASHINGTON**

We evaluated site conditions for the presence of geologic hazards. Mercer Island City Code (MICC) Section 19.07.160.A defines geologically hazardous areas as "...lands that are susceptible to erosion, landslides, seismic events, or other factors as identified by WAC 365-190-120." Geologically hazardous areas shown mapped on or adjacent to the planned development area by the City of Mercer Island Information & Geographic Services (IGS) map portal website include erosion hazard, potential landslide hazard, and seismic hazard areas. The mapped geologically hazardous areas are shown on Figure 4.

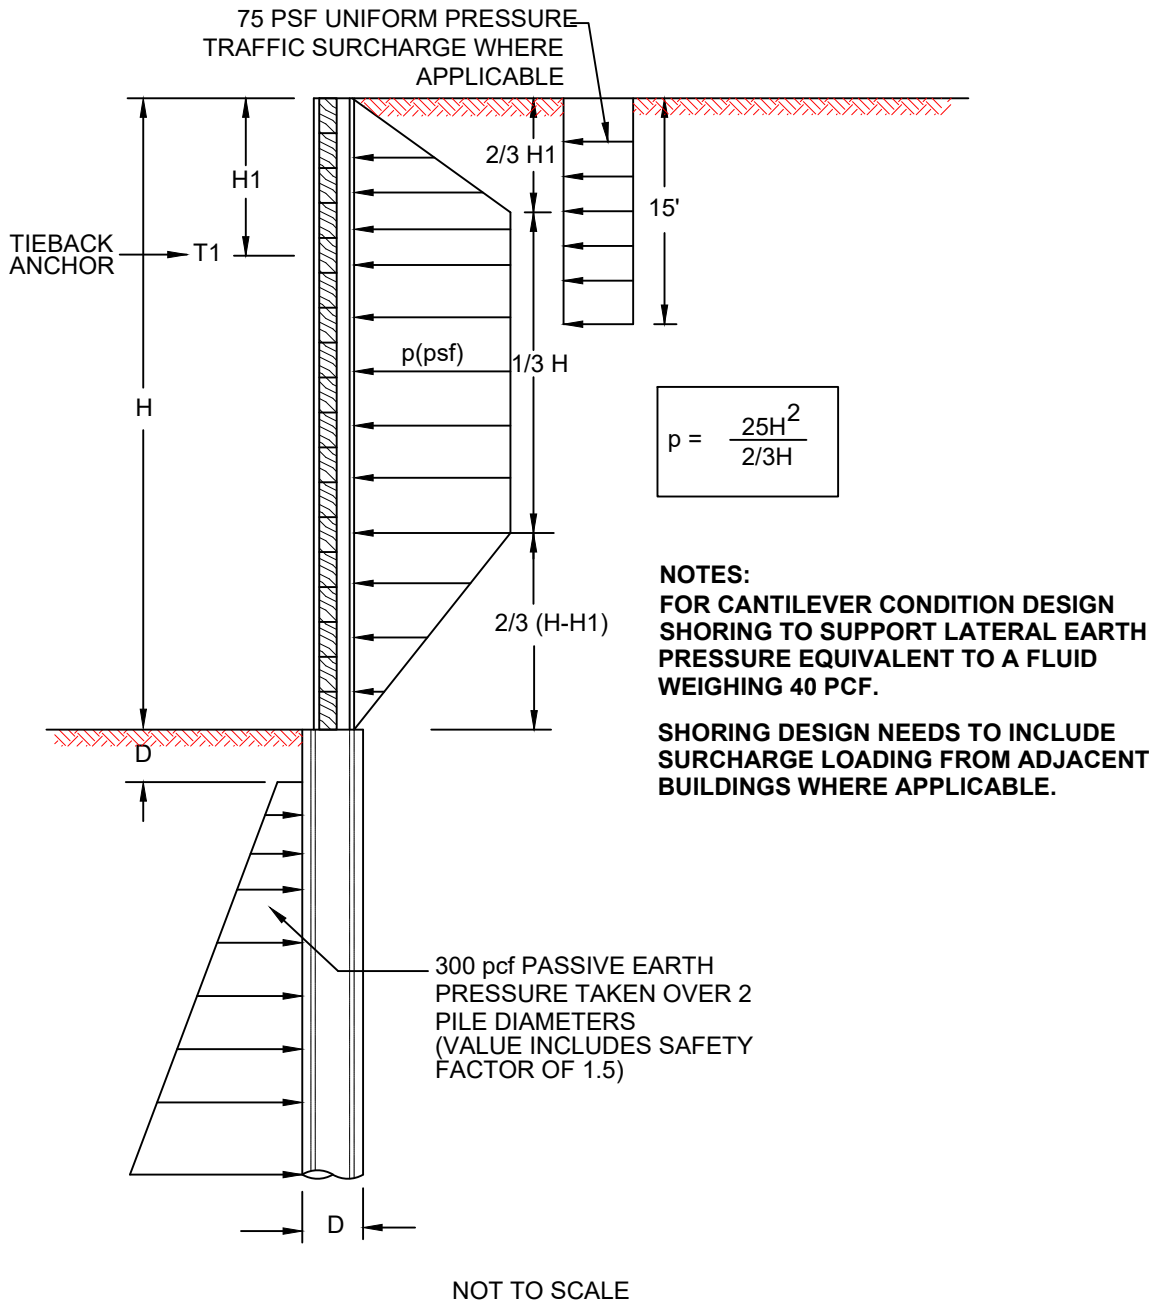
Figure 5

EARTH PRESSURE LOADING DIAGRAM SINGLE TIEBACK

NOTES:
FOR CANTILEVER CONDITION DESIGN
SHORING TO SUPPORT LATERAL EARTH
PRESSURE EQUIVALENT TO A FLUID
WEIGHING 40 PCF.

**SHORING DESIGN NEEDS TO INCLUDE
SURCHARGE LOADING FROM ADJACENT
BUILDINGS WHERE APPLICABLE.**

Temporary shoring will be required where site constraints preclude the use of an open-cut excavation. We recommend shoring the excavations using conventional cantilevered or tieback-anchored soldier piles with timber lagging. The shoring system would then be used as a back-form for construction of the permanent below-grade walls. Soldier pile walls should be designed to resist lateral loads imposed by the adjacent soils and surcharge loadings that will be imposed. Recommended design earth pressure diagrams are presented on Figures 5 and 6.

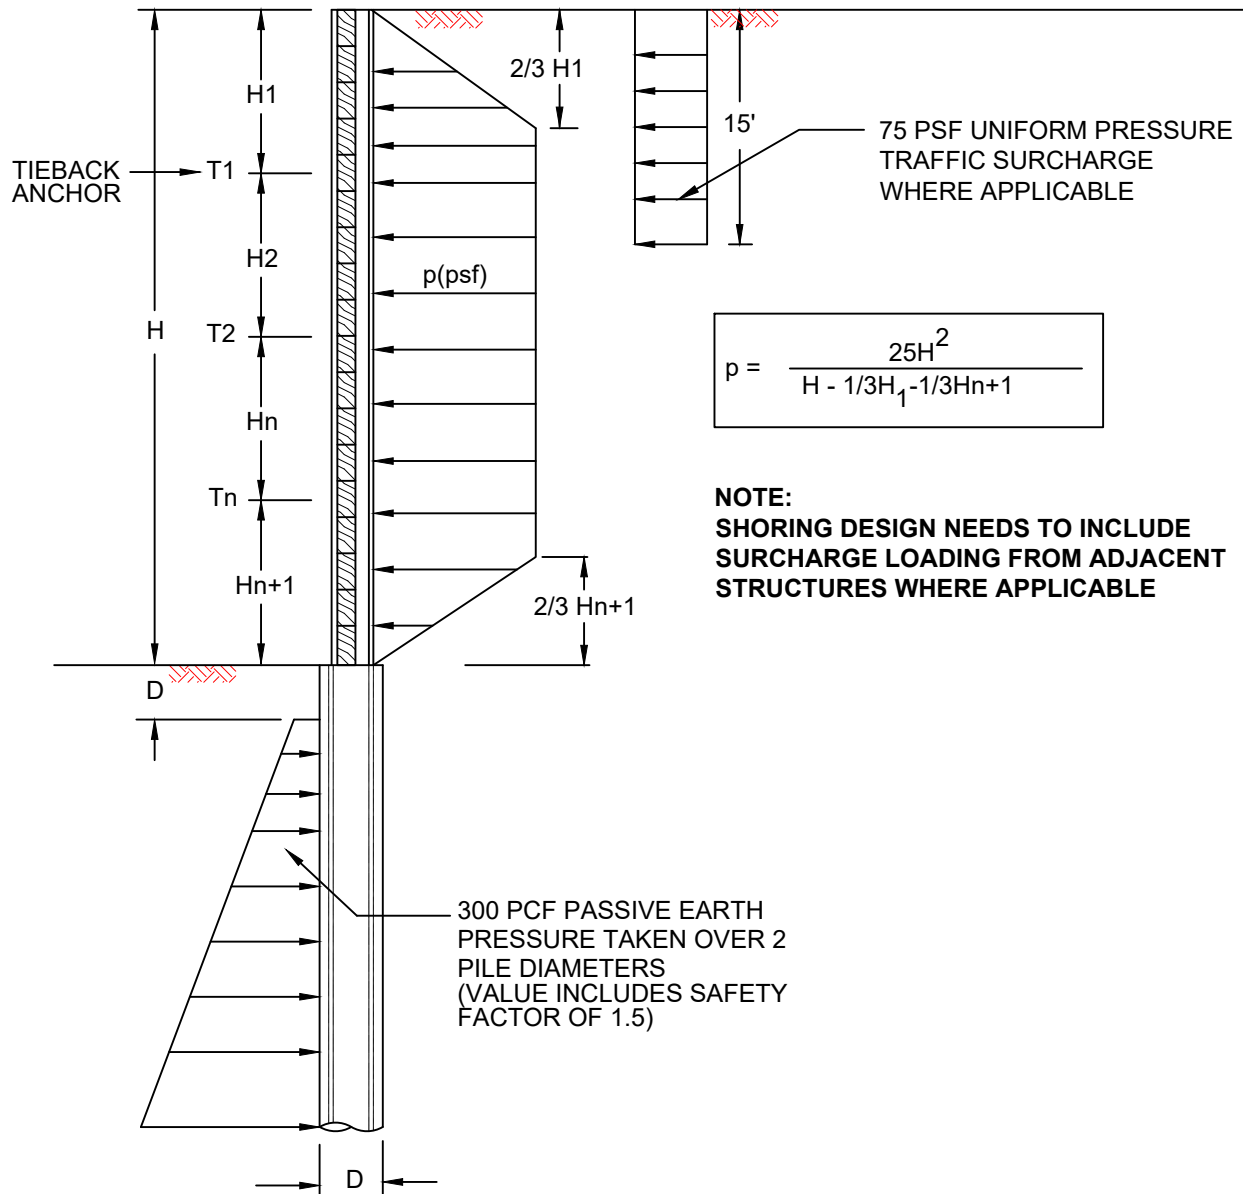
Figure 6

EARTH PRESSURE LOADING DIAGRAM MULTIPLE TIEBACK

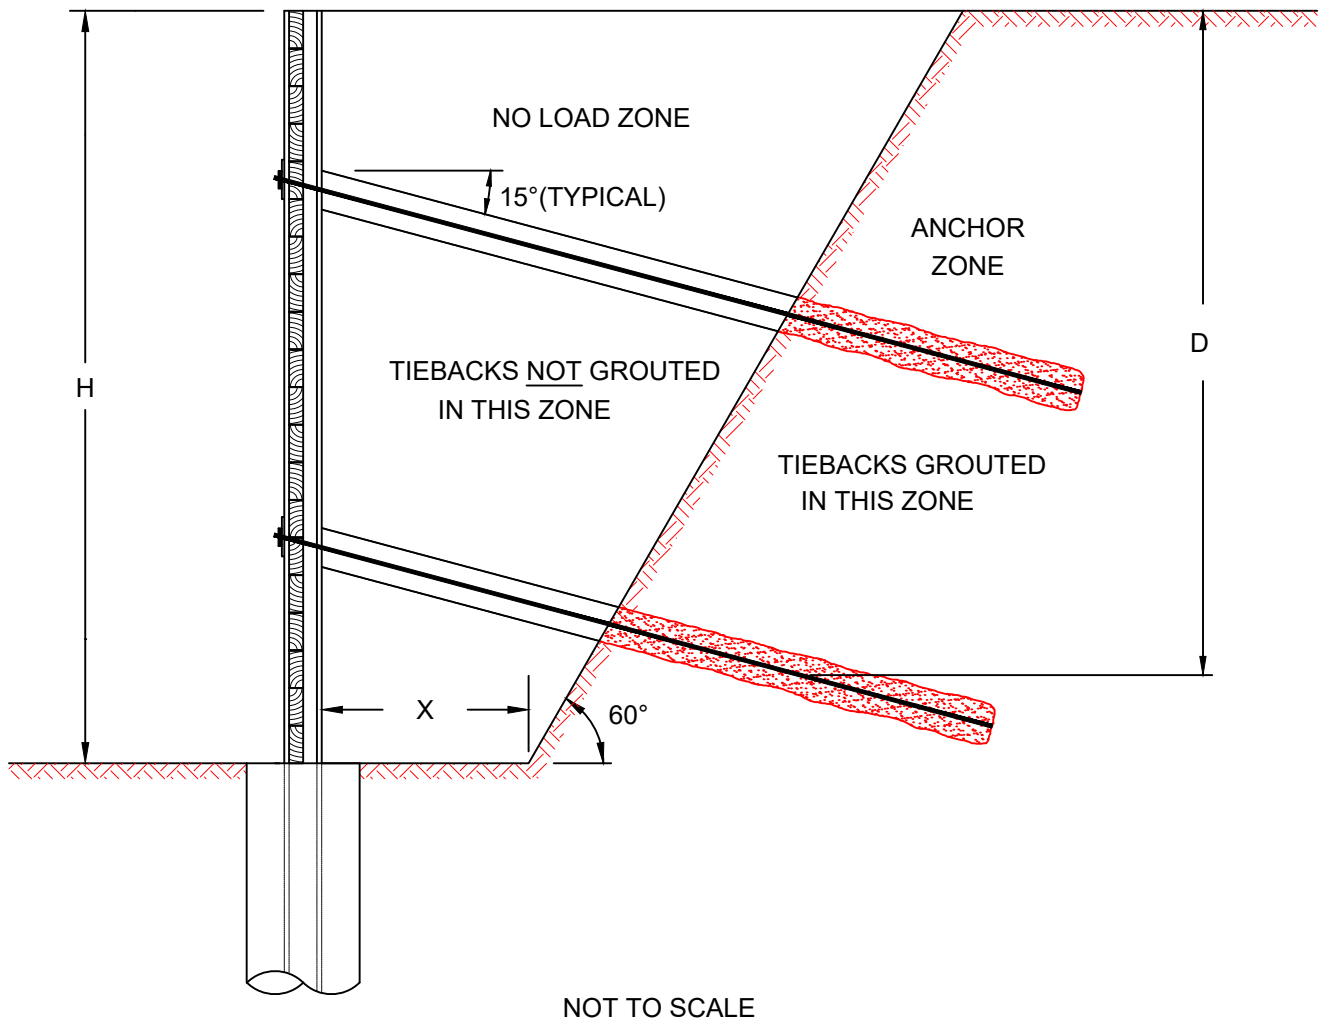
Figure 7

TIEBACK SOLDIER PILE / LAGGING SHORING WALL

1. SEE REPORT NARRATIVE FOR ALLOWABLE TIEBACK ADHESION CAPACITY IN ANCHOR ZONE.
2. $X = 5$ FEET OR $0.2H$, WHICHEVER IS GREATER.

Tieback anchors should be installed in the soil behind the excavation to a sufficient distance to allow the desired lateral load resistance. The recommended configuration of the no load zone is shown on Figure 7. The minimum horizontal spacing between anchors should be four feet to ensure that group effects between adjacent ground anchors are minimized and that anchor intersection is avoided. Group effects will reduce the load-carrying capacity of individual ground anchors.

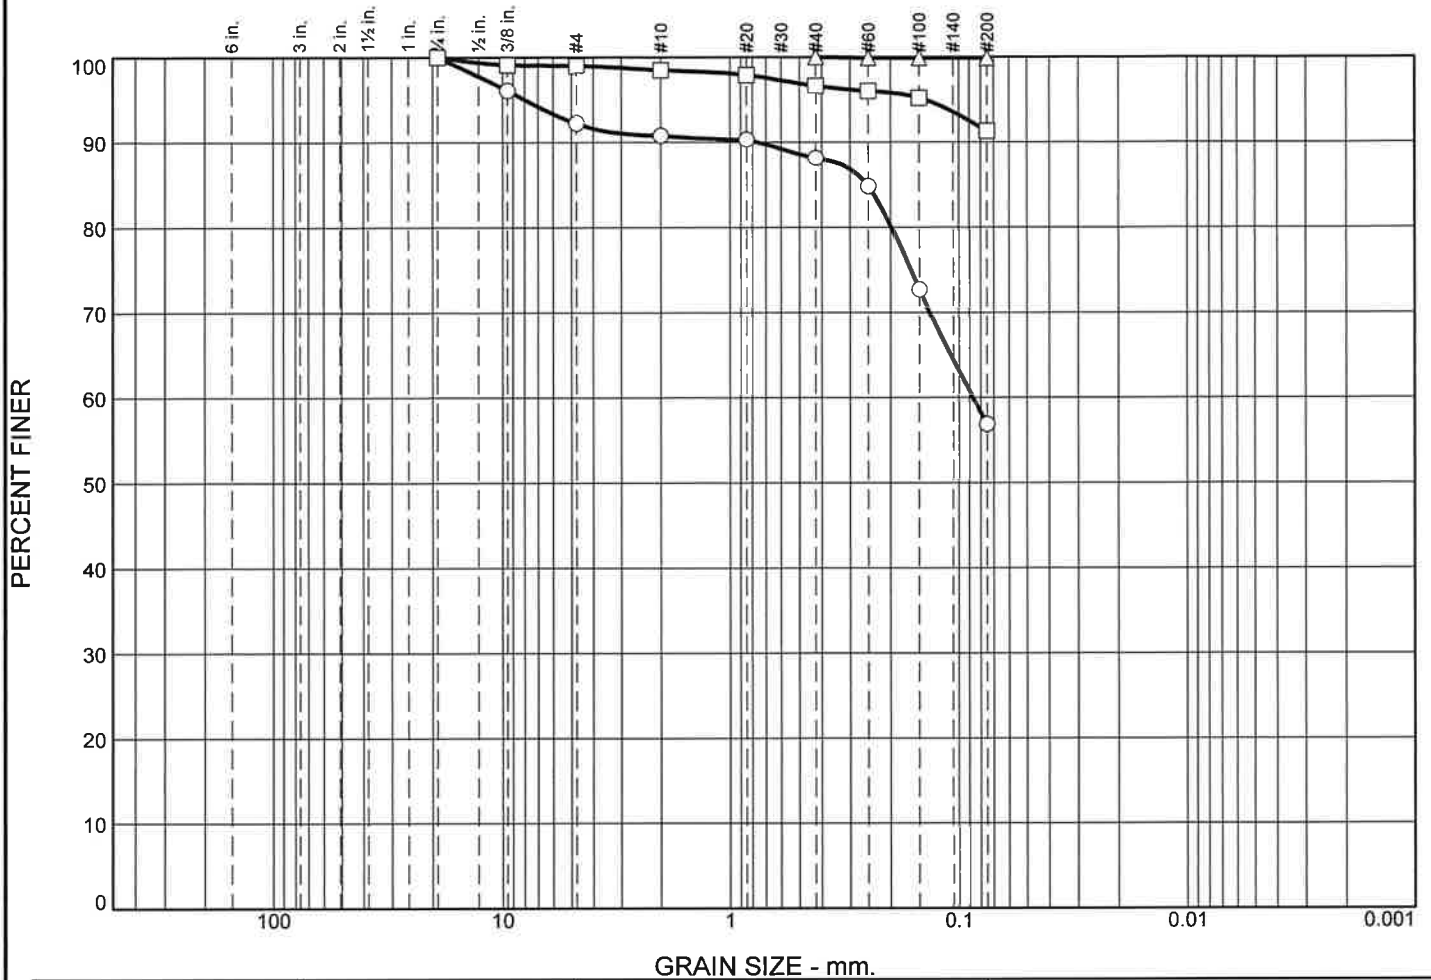
Particle Size Distribution Report

% +3"		% Gravel		% Sand			% Fines		
			Coarse	Fine	Coarse	Medium	Fine	Silt	Clay	
○	0.0		0.0	7.8	1.4	2.7	31.2	56.9		
□	0.0		0.0	1.0	0.5	1.9	5.3	91.3		
△	0.0		0.0	0.0	0.0	0.0	0.1	99.9		
⊗	LL	PL	D ₈₅	D ₆₀	D ₅₀	D ₃₀	D ₁₅	D ₁₀	C _c	C _u
○			0.2533	0.0869						
□										
△

Material Description							USCS	AASHTO
○	sandy SILT						ML	
□	SILT						ML	
△	SILT						ML

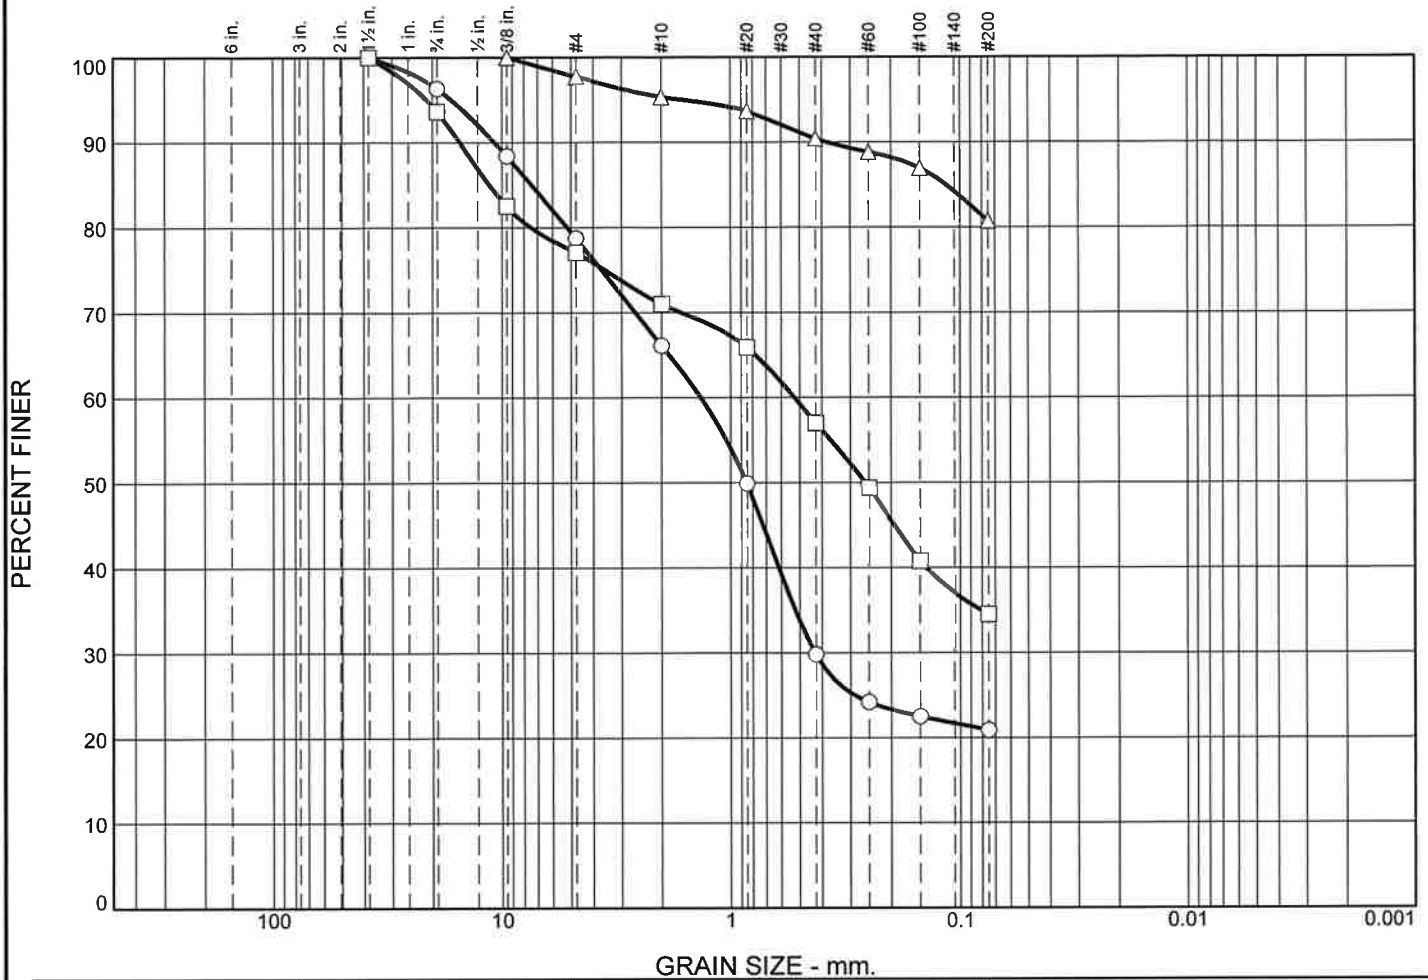
Particle Size Distribution Report

% +3"		% Gravel		% Sand			% Fines		
				Coarse	Fine	Coarse	Medium	Fine	Silt	Clay	
○		0.0		3.7	17.6	12.6	36.3	8.9	20.9		
□		0.0		6.4	16.6	6.0	14.0	22.5	34.5		
△		0.0		0.0	2.3	2.4	4.9	9.7	80.7		
⊗		LL	PL	D85	D60	D50	D30	D15	D10	Cc	Cu
○				7.4175	1.3479	0.8531	0.4291				
□				11.3050	0.5266	0.2595					
△				0.1161

Material Description	USCS	AASHTO
○ silty SAND with gravel	SM	
□ silty SAND with gravel	SM	
△ SILT with sand	ML

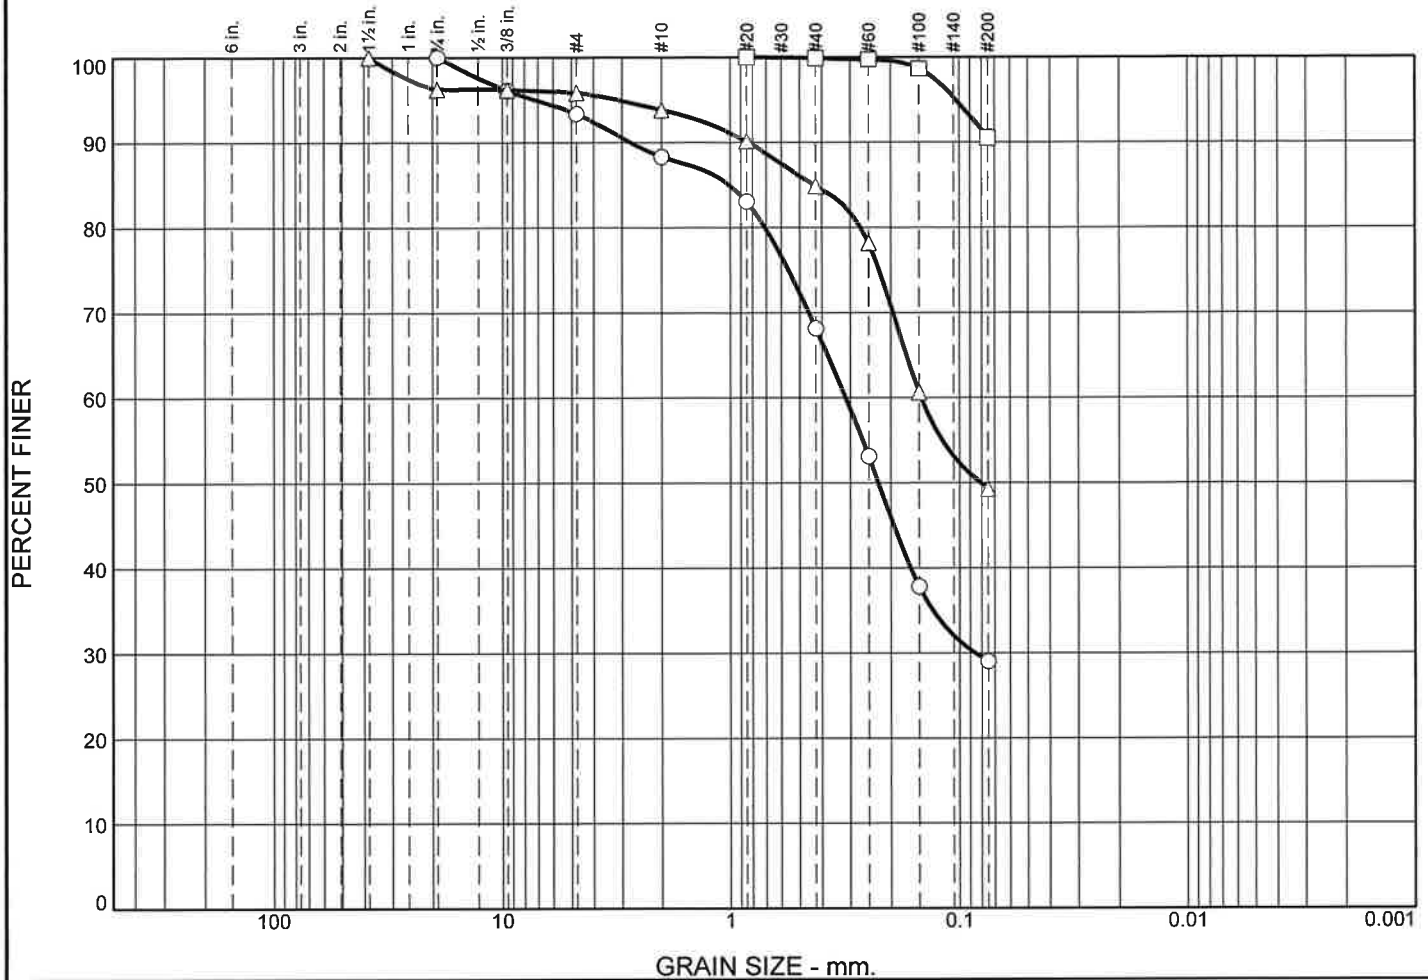
Particle Size Distribution Report

% +3"		% Gravel		% Sand			% Fines		
			Coarse	Fine	Coarse	Medium	Fine	Silt	Clay	
○	0.0		0.0	6.7	5.0	20.2	39.1	29.0		
□	0.0		0.0	0.0	0.0	0.1	9.4	90.5		
△	0.0		3.8	0.4	2.0	9.0	35.5	49.3		
⊗	LL	PL	D85	D60	D50	D30	D15	D10	Cc	Cu
○			1.0147	0.3152	0.2268	0.0856				
□										
△			0.4373	0.1470	0.0809

Material Description							USCS	AASHTO
○	silty SAND						SM	
□	SILT						ML	
△	silty SAND						SM

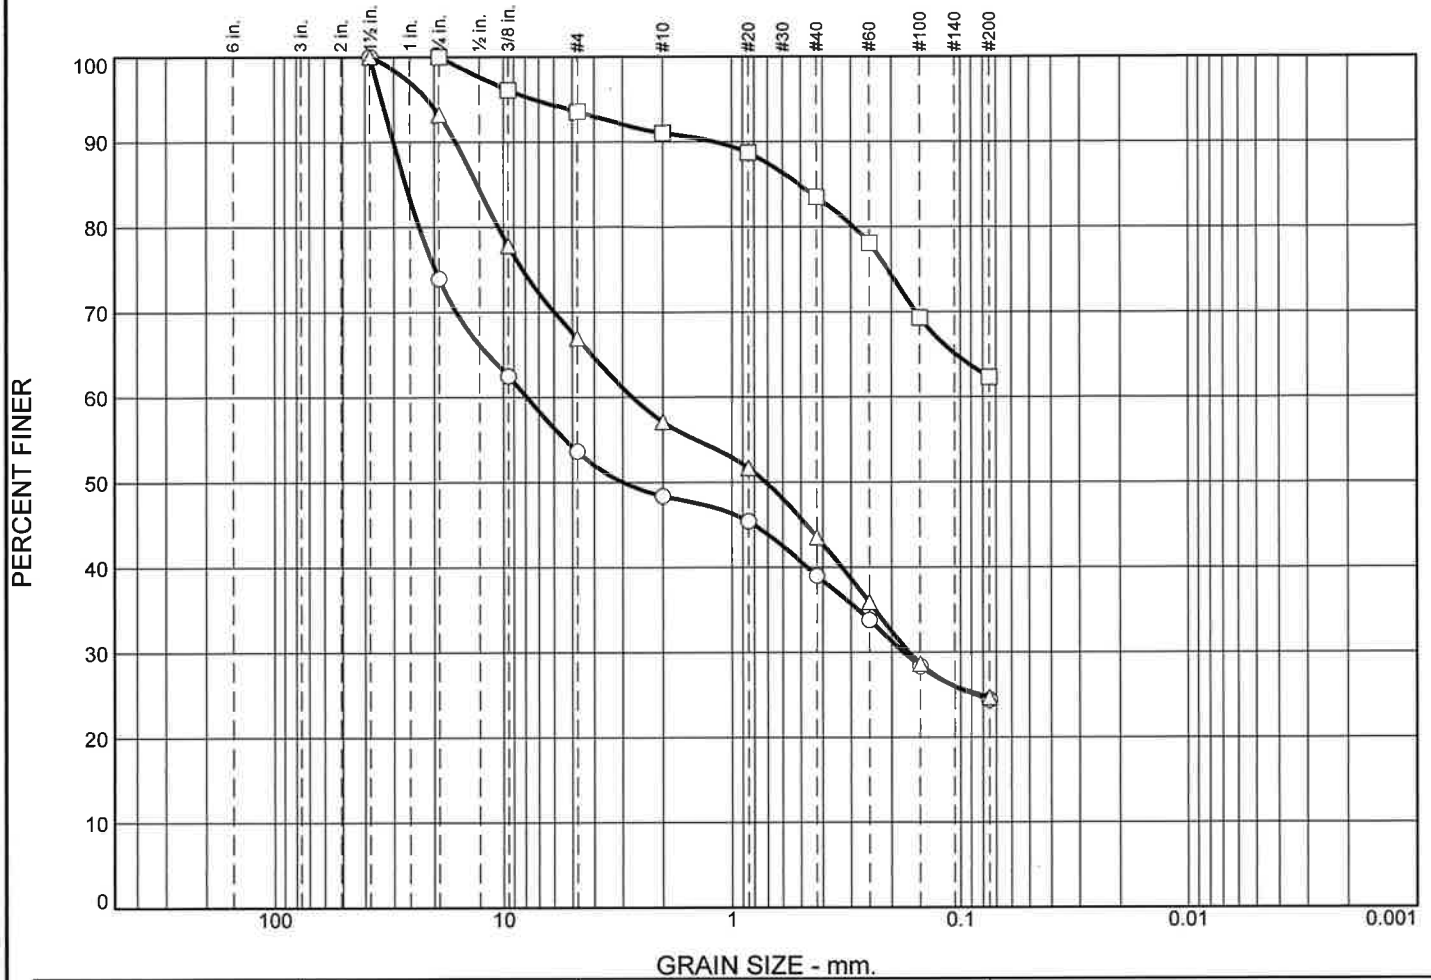
Particle Size Distribution Report

% +3"		% Gravel		% Sand			% Fines		
			Coarse	Fine	Coarse	Medium	Fine	Silt	Clay	
○	0.0		26.1	20.3	5.2	9.4	14.6	24.4		
□	0.0		0.0	6.5	2.5	7.6	21.1	62.3		
△	0.0		6.8	26.3	9.8	13.6	18.8	24.7		
⊗	LL	PL	D85	D60	D50	D30	D15	D10	Cc	Cu
○			26.5853	7.8774	2.9891	0.1779				
□			0.5135							
△			13.0234	2.7172	0.7125	0.1685

Material Description	USCS	AASHTO
○ silty GRAVEL with sand	GM	
□ sandy SILT	ML	
△ silty SAND with gravel	SM

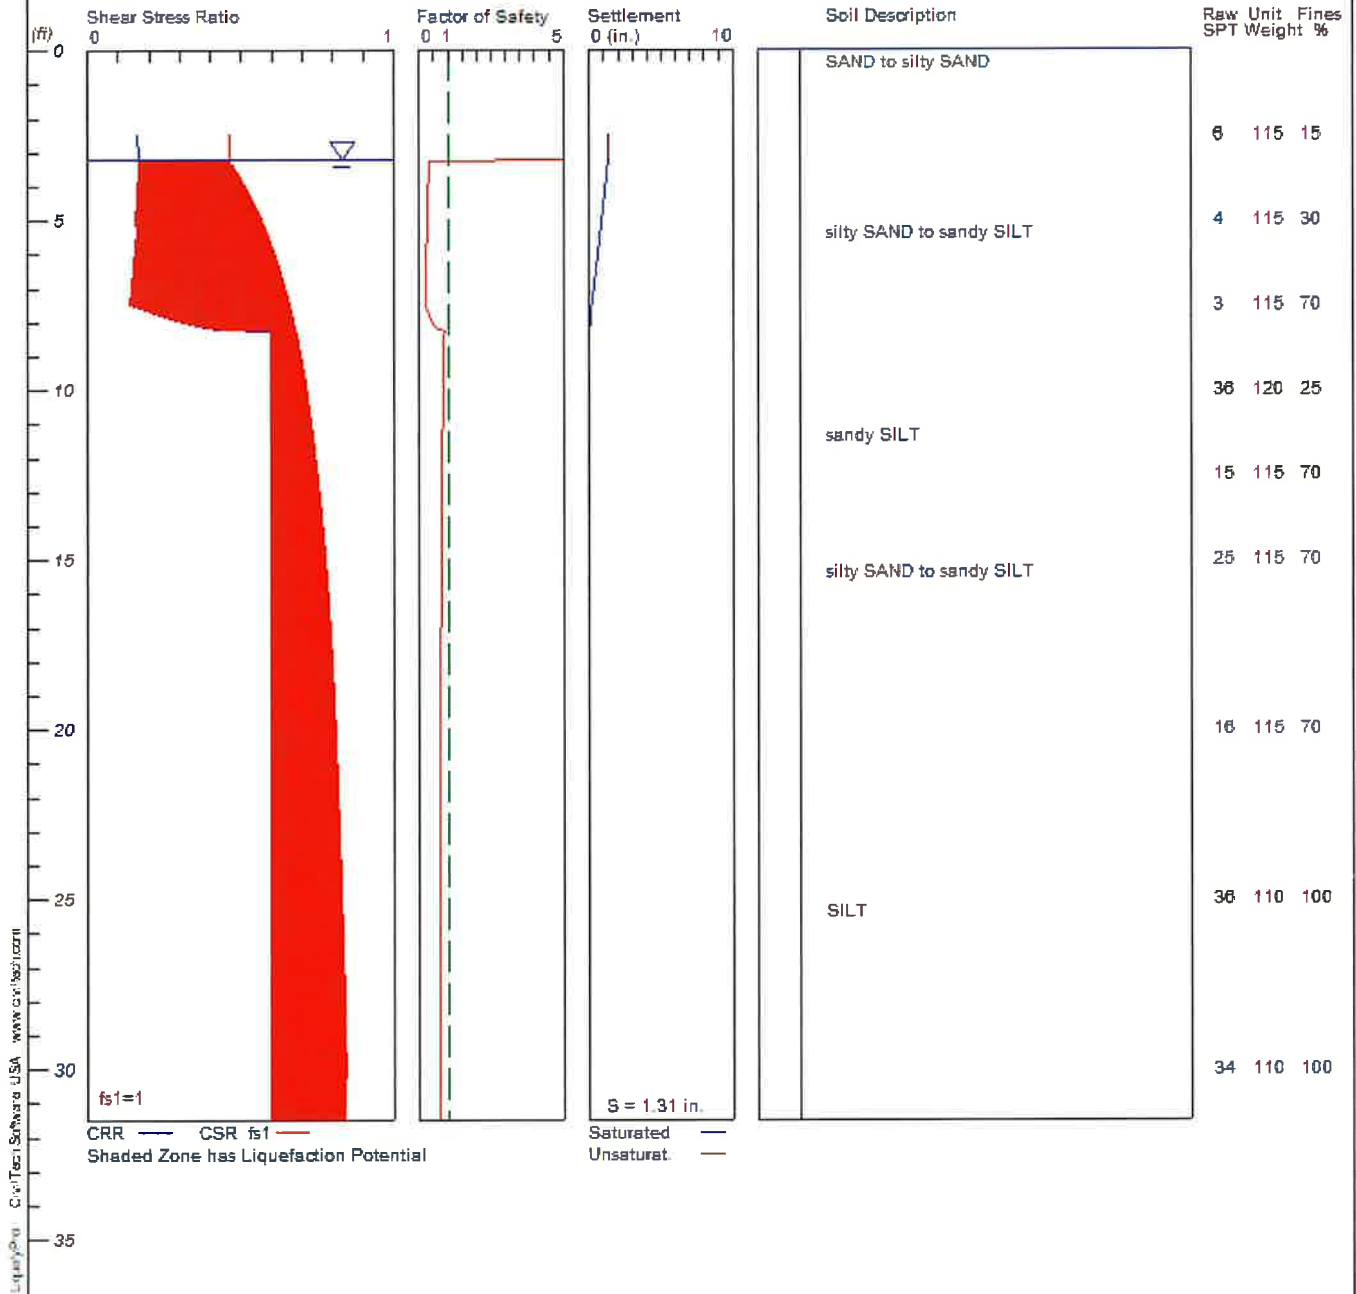
Hole No.=B-5 Water Depth=3.2 ft Surface Elev.=30

Magnitude=7
Acceleration=0.715g

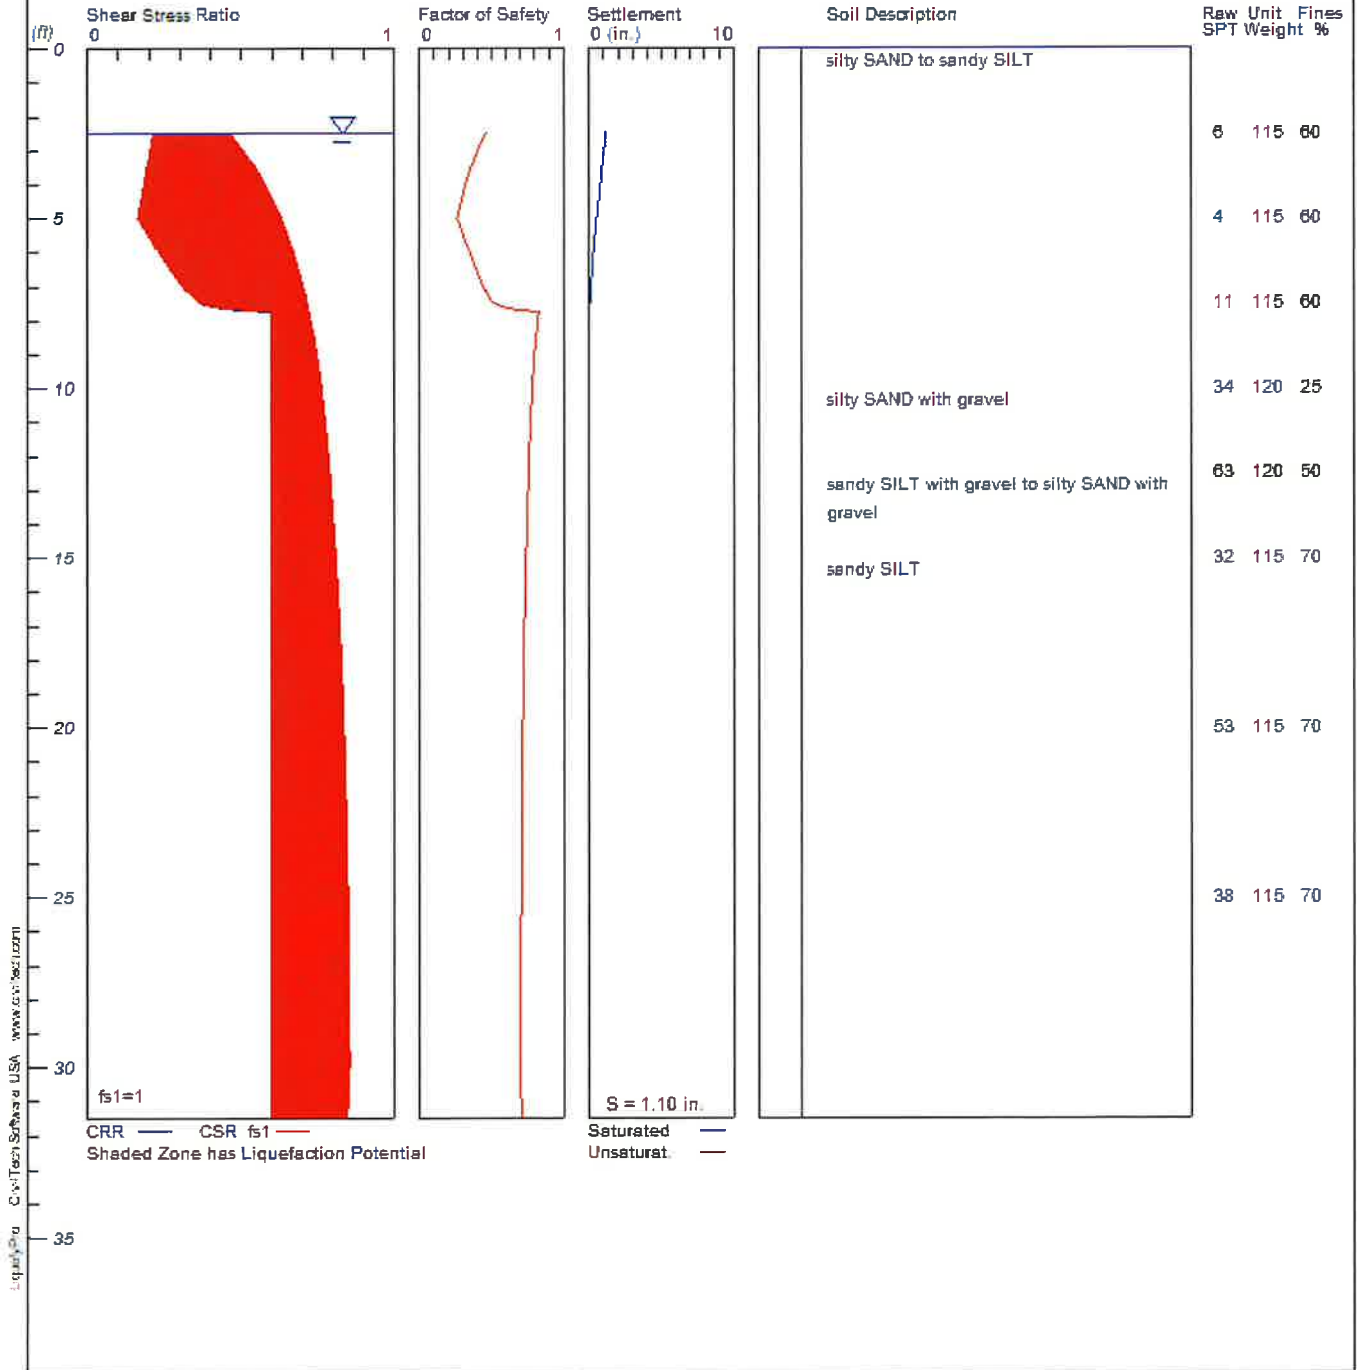
LIQUEFACTION ANALYSIS

Hole No.=B-6 Water Depth=2.5 ft Surface Elev.=30

Magnitude=7
Acceleration=0.715g
