**PRELIMINARY SHORT PLAT  
STAFF REPORT AND DECISION**

<b>Project Number:</b>	SUB16-011
<b>Description:</b>	The application proposes to subdivide the subject site into two lots and one access and utility tract.
<b>Applicant:</b>	Mark Pendergraft (Mead Gilman and Associates)
<b>Owner:</b>	David Yeh (7239 LLC)
<b>Site Address:</b>	7239 SE 27 <sup>th</sup> St, Mercer Island WA 98040
<b>Parcel No.:</b>	531510-0695
<b>Zoning:</b>	R-9.6
<b>Exhibits:</b>	<ol style="list-style-type: none"><li>1. Development Application signed August 31, 2016</li><li>2. Determination of Completeness, dated October 10, 2016</li><li>3. Notice of Application, dated October 24, 2016</li><li>4. Geotechnical Report prepared by The Riley Group, dated April 6, 2016</li><li>5. Geotechnical Report Addendum, prepared by The Riley Group, dated October 24, 2016</li><li>6. Preliminary short plat prepared by Mead Gilman, dated January 3, 2022</li><li>7. Civil plan prepared by Core Design, dated January 3, 2022</li><li>8. Wetland/Stream Reconnaissance Memorandum, prepared by C. Gary Schutz, dated May 17, 2017</li><li>9. Arborist Report Summary Memo prepared by Tree Solutions, dated September 3, 2021</li><li>10. Public com

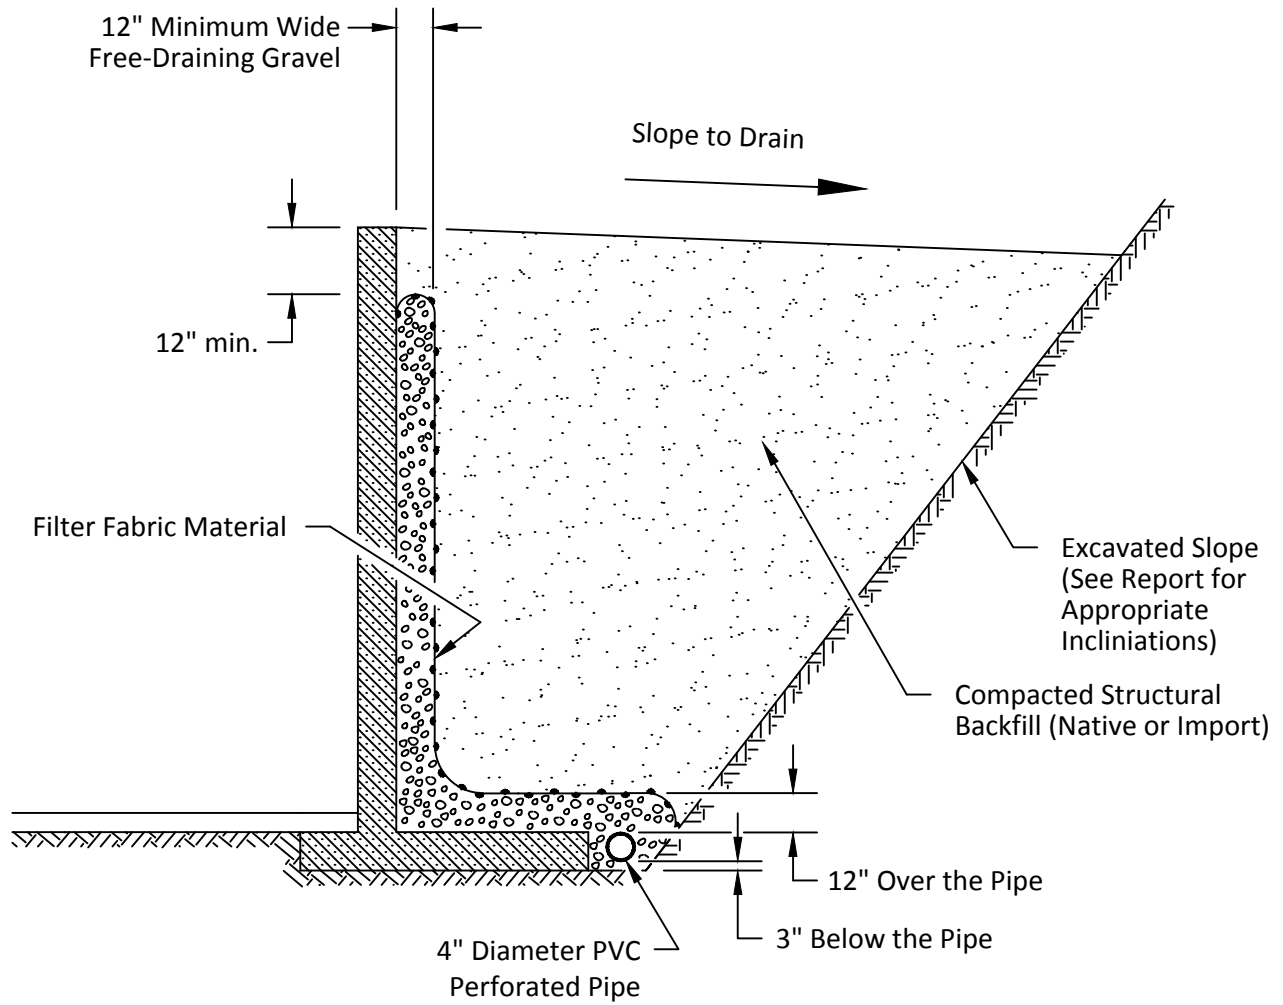
<p>Corporate Office 17522 Bothell Way Northeast Bothell, Washington 98011 Phone: 425.415.0551 Fax: 425.415.0311</p>	27th Street Short Plat		Figure 3
	RGI Project Number 2016-120	Retaining Wall Drainage Detail	Date Drawn: 08/2016
	Address: 7239 Southeast 27th Street, Mercer Island, Washington 98040

If retaining walls are needed for the basements or the detention structure, RGI recommends cast-in-place concrete walls be used. The magnitude of earth pressure development on retaining walls will partly depend on the quality of the wall backfill. RGI recommends placing and compacting wall backfill as structural fill. Wall drainage will be needed behind the wall face. A typical retaining wall drainage detail is shown on Figure 3.

RGI recommends installing perimeter foundation or retaining wall drains, details shown on Figures 3 and 4. The foundation or retaining wall drains and roof downspouts should be tightlined separately to an approved discharge facility. Subsurface drains must be laid with a gradient sufficient to promote positive flow to a controlled point of approved discharge.

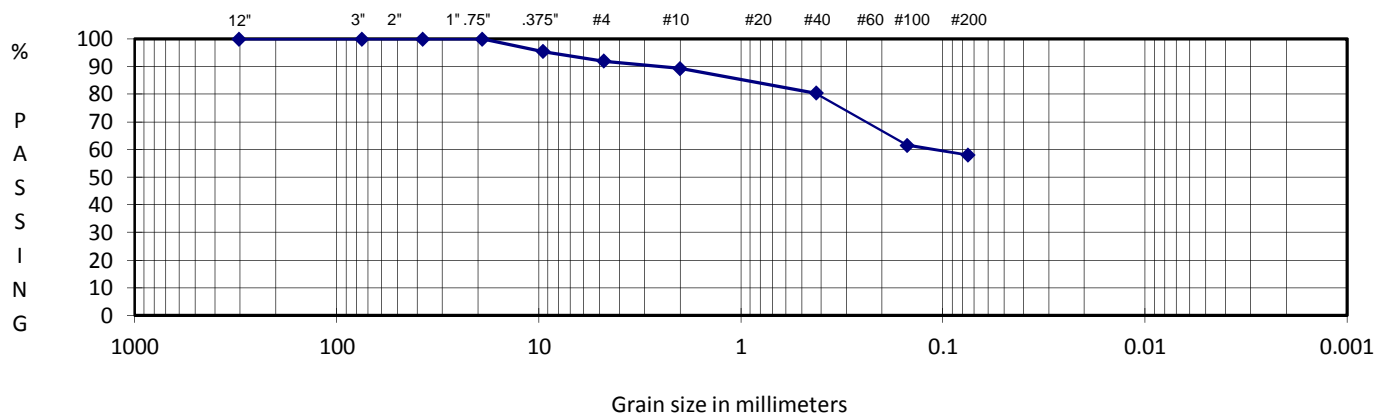
DESCRIPTION: Sandy SILT with trace gravel  
 USCS: ML

More detailed descriptions of the subsurface conditions encountered are presented in the borings are included in Appendix A. Sieve analysis was performed on four selected soil samples. The grain-size distribution curves are included in Appendix A.

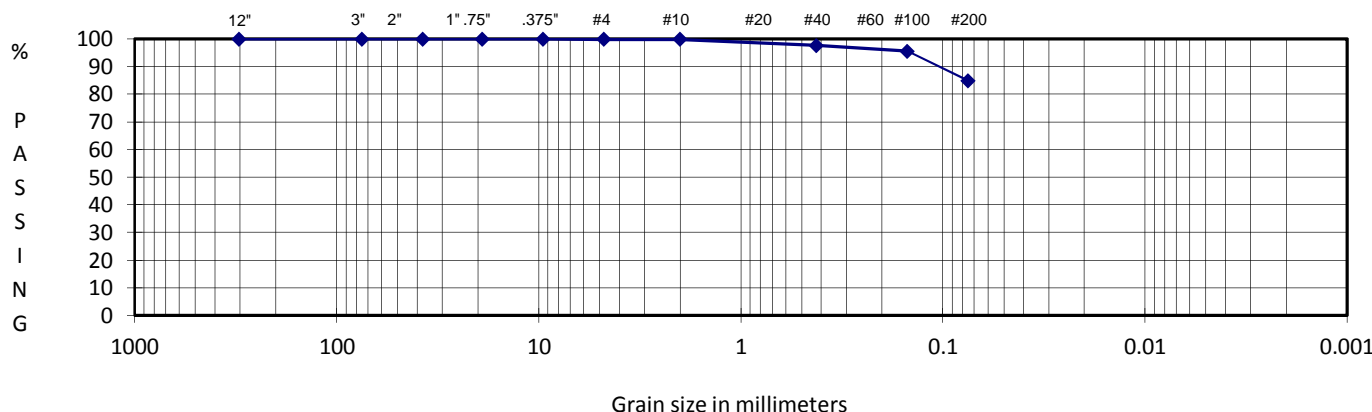
DESCRIPTION: SILT with trace sand  
 USCS: ML

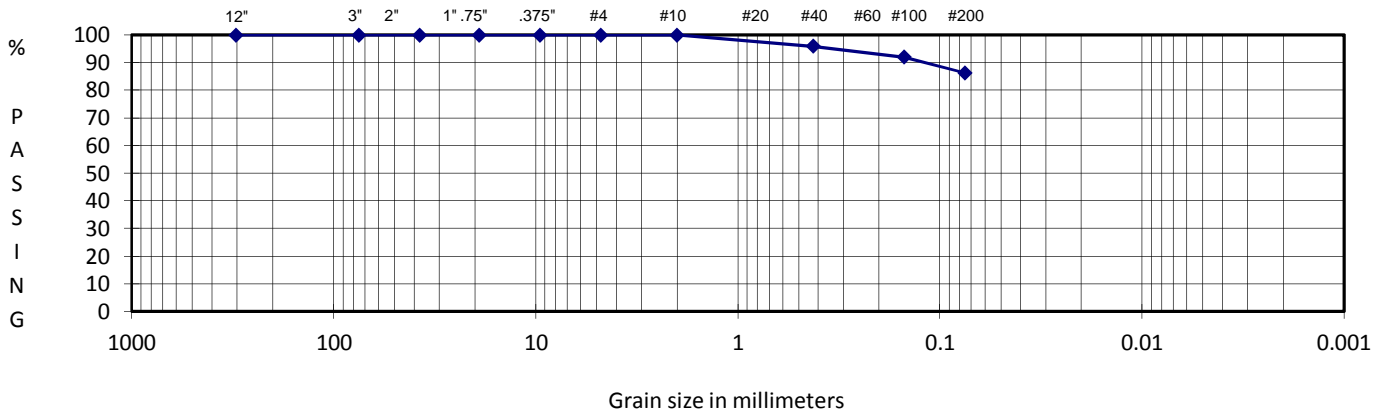
DESCRIPTION: SILT with trace sand  
 USCS: ML

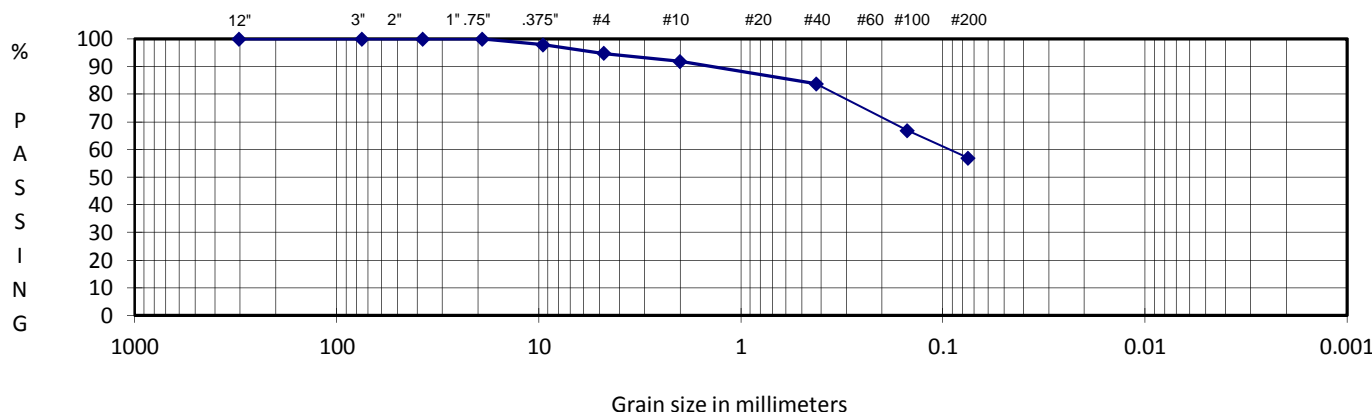
DESCRIPTION: Sandy SILT with trace gravel  
 USCS: ML

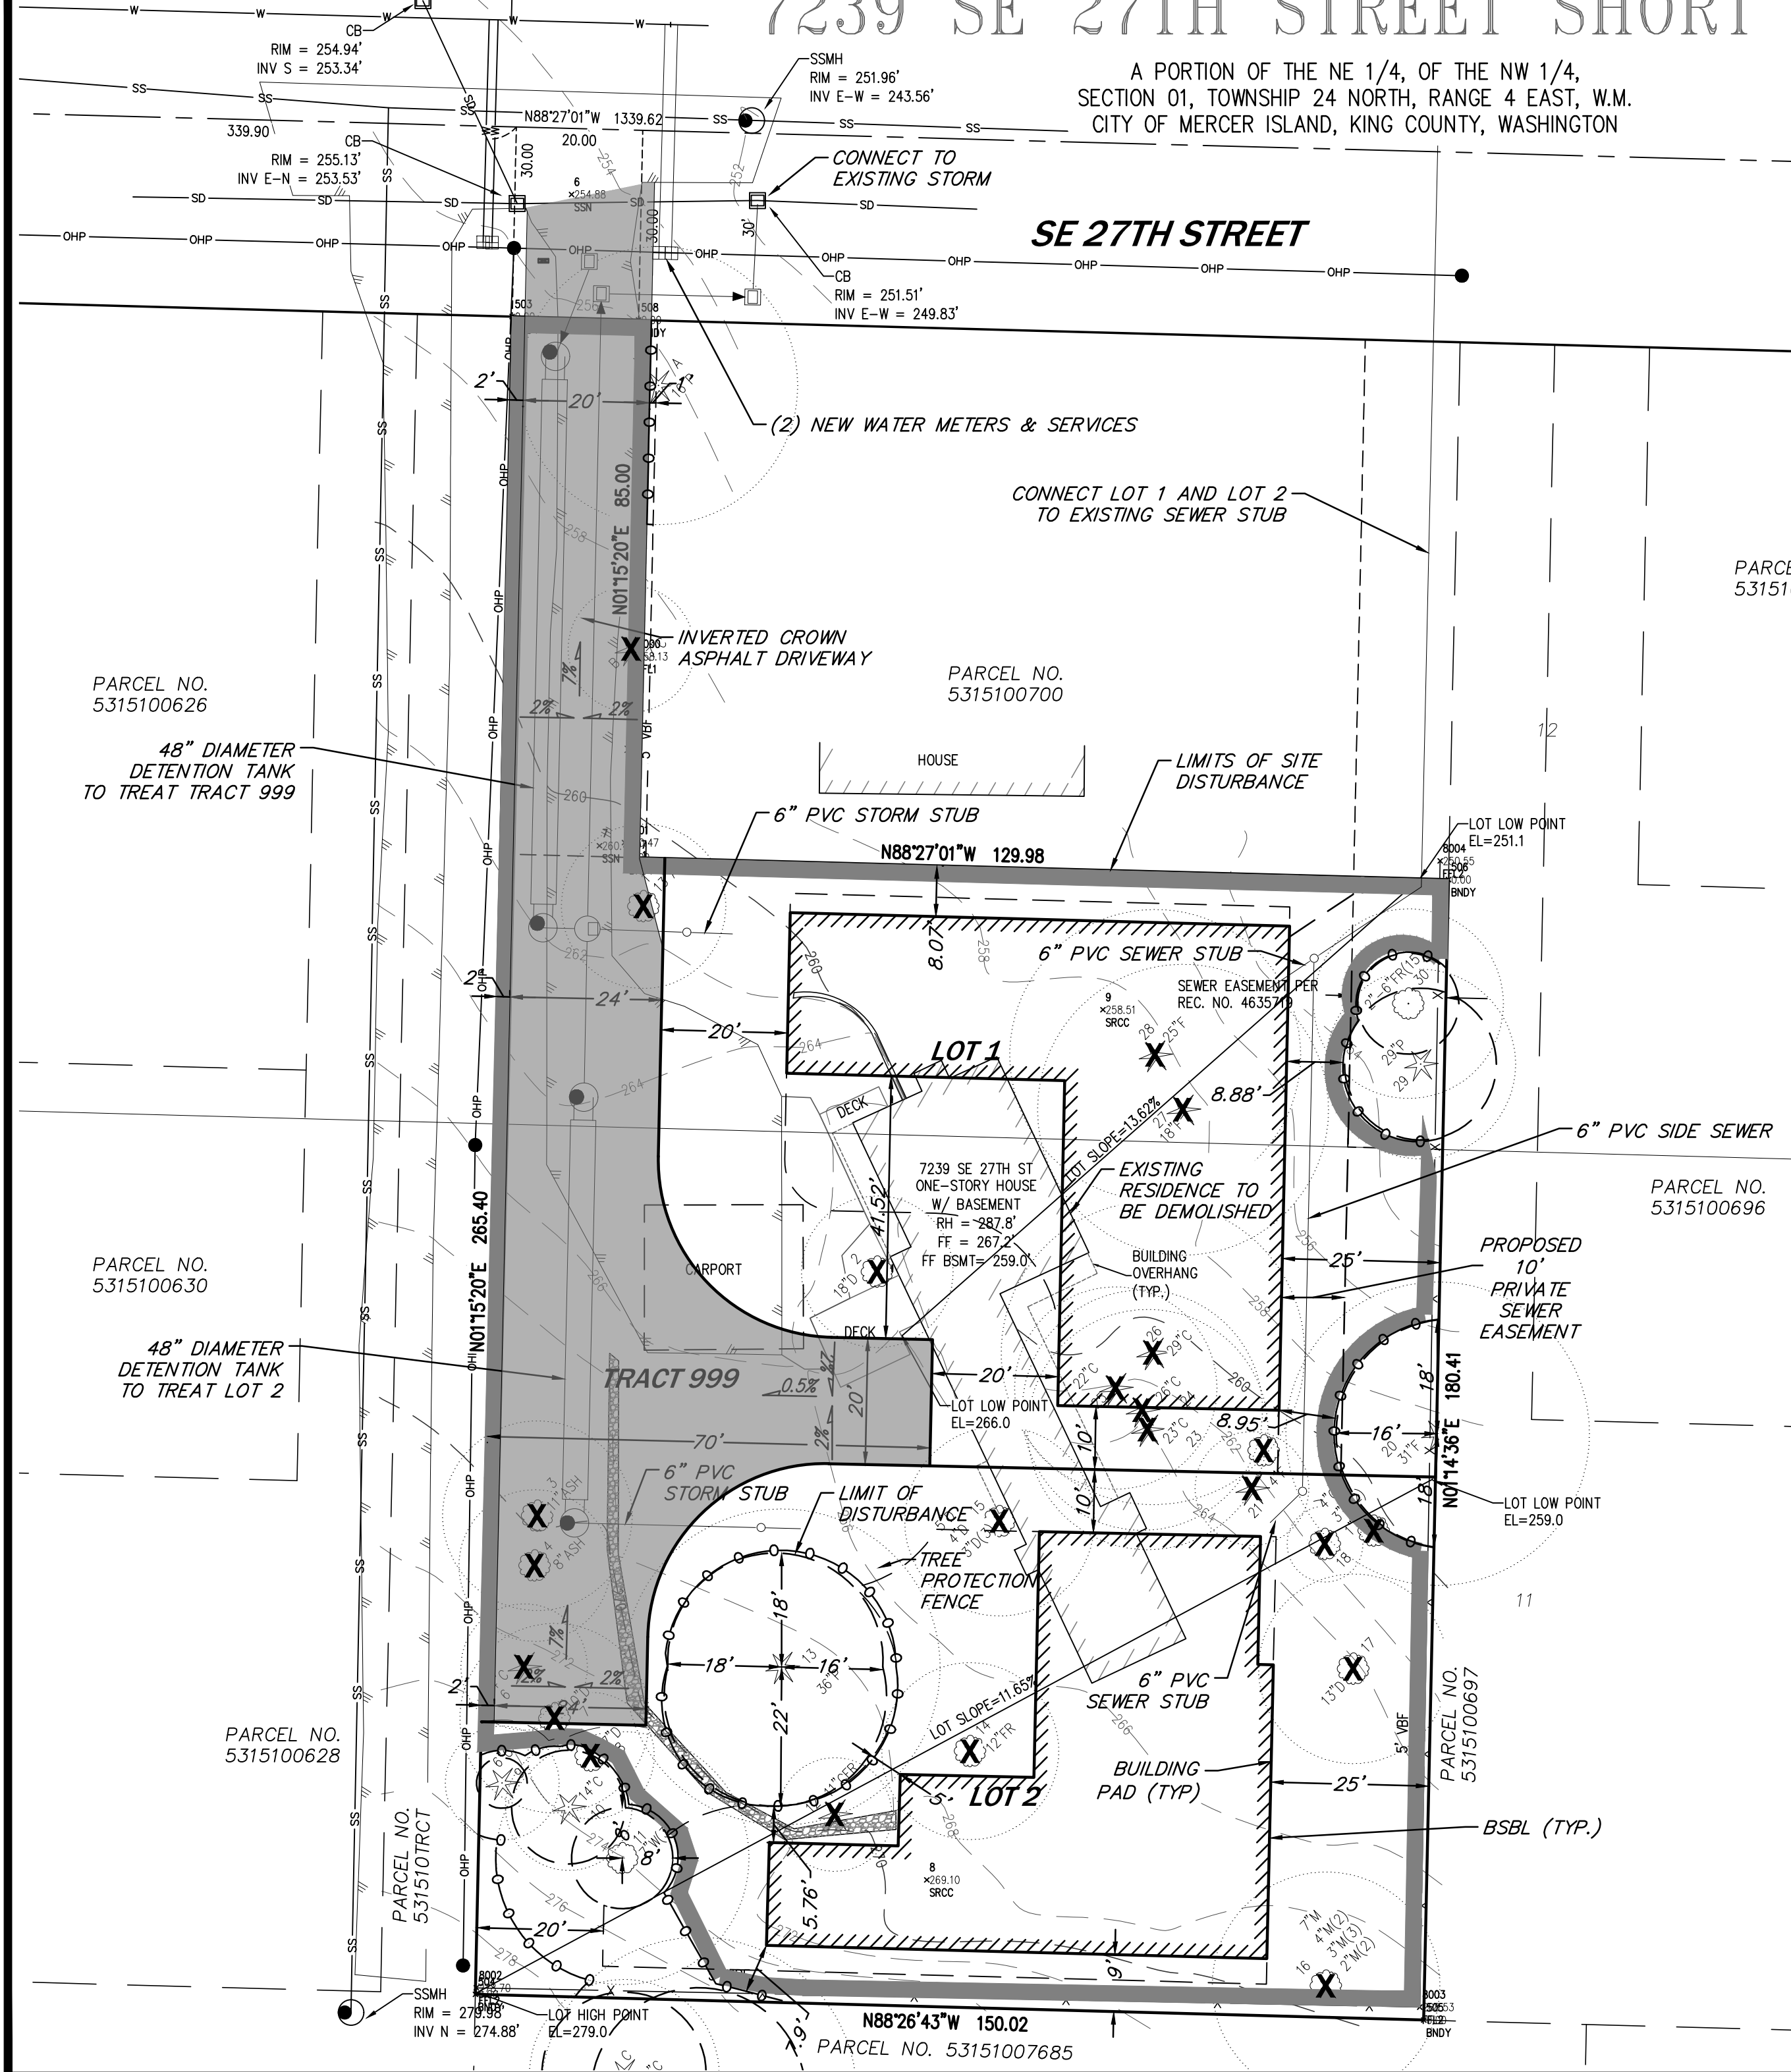
# 7239 SE 27TH STREET SHORT PLAT

3. PROPERTY AREA = 28,759± SQUARE FEET (0.6602± ACRES).
4. ALL DISTANCES ARE IN FEET.
5. THIS IS A FIELD TRAVERSE SURVEY. A SOKKIA FIVE SECOND COMBINED ELECTRONIC TOTAL STATION WAS USED TO MEASURE THE ANGULAR AND DISTANCE RELATIONSHIPS BETWEEN THE CONTROLLING MONUMENTATION AS SHOWN. CLOSURE RATIOS OF THE TRAVERSE MET OR EXCEEDED THOSE SPECIFIED IN WAC 332-130-090. ALL MEASURING INSTRUMENTS AND EQUIPMENT ARE MAINTAINED IN ADJUSTMENT ACCORDING TO MANUFACTURER'S SPECIFICATIONS.

6. TOPOGRAPHIC INFORMATION SHOWN HEREON WAS PROVIDED BY SITE SURVEYING, INCORPORATED. CORE DESIGN DOES NOT WARRANT THE ACCURACY OR COMPLETENESS OF SAID INFORMATION.

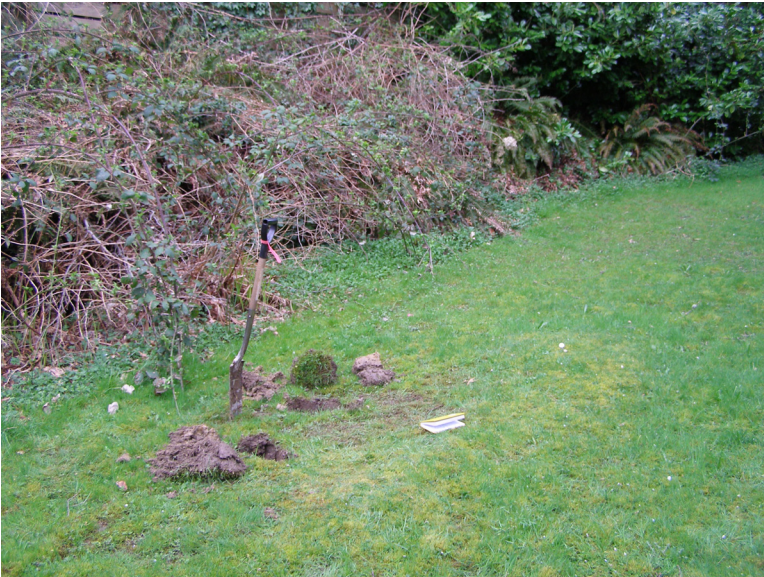
View: South central portion of Lot.  
Wetland Data Plot 1 is near the toe of an old rockery.

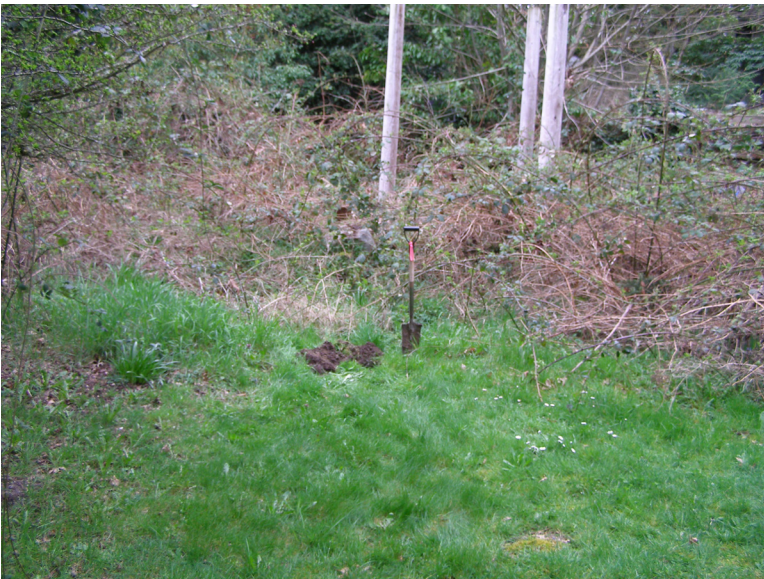
View: Southeast corner of Lot.  
Wetland Data Plot 2 is also in a lawn area near the old rockery.

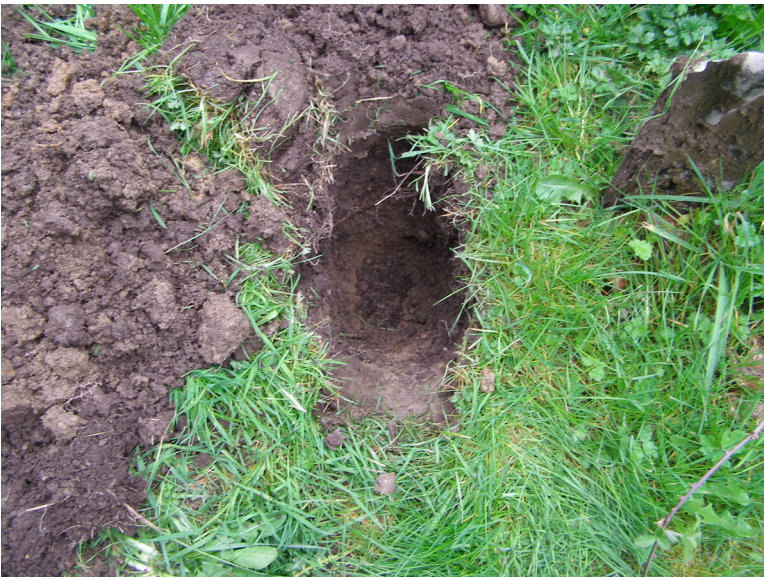
View: Wetland Data Plot 2 soil pit. The soil pit was dry - non-hydric soil and no wetland hydrology.

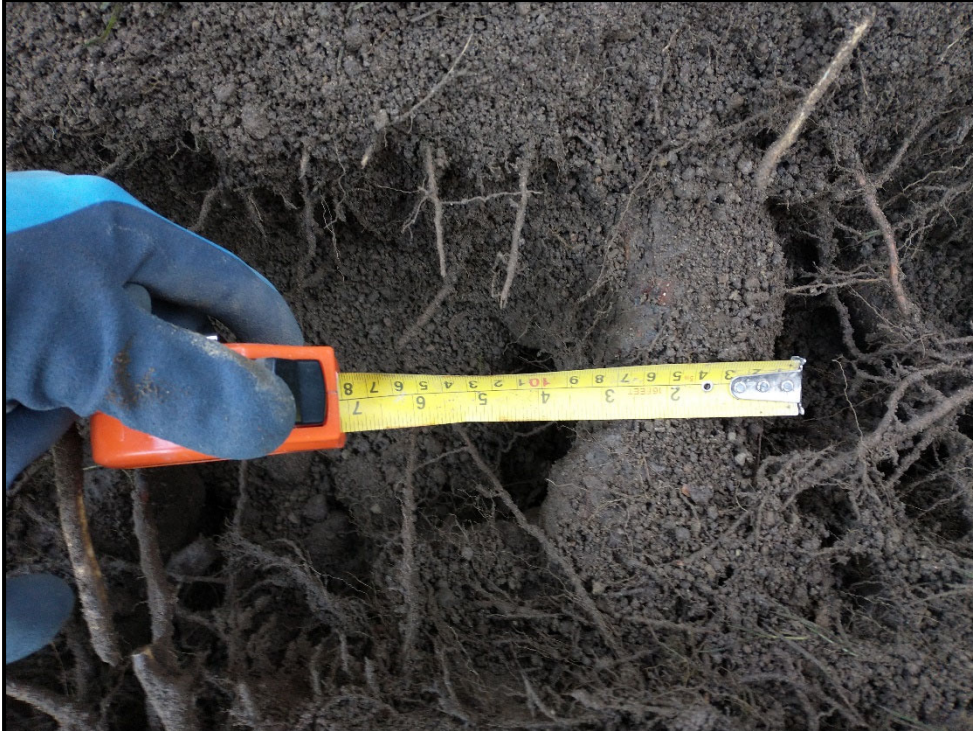
**Photograph 3.** Tree 13: Largest root exposed was 2.5 inch diameter, approximately 18 feet away from trunk on north side of tree.

The three structural roots exposed on the north trench measured three inches in diameter or less (see Photo 2); the largest of which can be seen in Photo 3. In my opinion, the LOD can be modified and set along this trench line (see red lines shown in Appendix A). I believe cutting roots along this line, and not allowing disturbance (including landscape work) within the area closer to the tree, will allow the tree to be viable long-term, and there will be minimal impact on the tree's structural integrity.

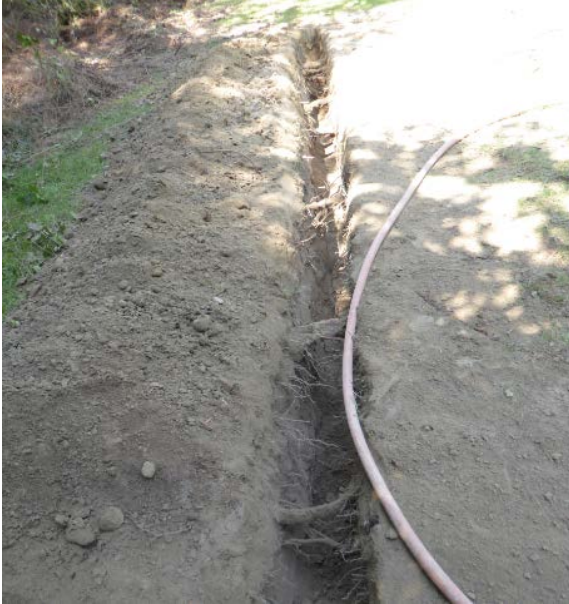
Photo 2. View looking to the north along the east trench. This view shows the low density of structural roots encountered.

I observed the air excavation of a trench 22 feet south and 16 feet east of tree 13 at the above site address (see Photos 1a and 1b). Excavation exposed a low density of roots. Five structural roots were exposed east of the tree measuring less than three inches in diameter (see Photo 2). The largest root can be seen in photo 3.

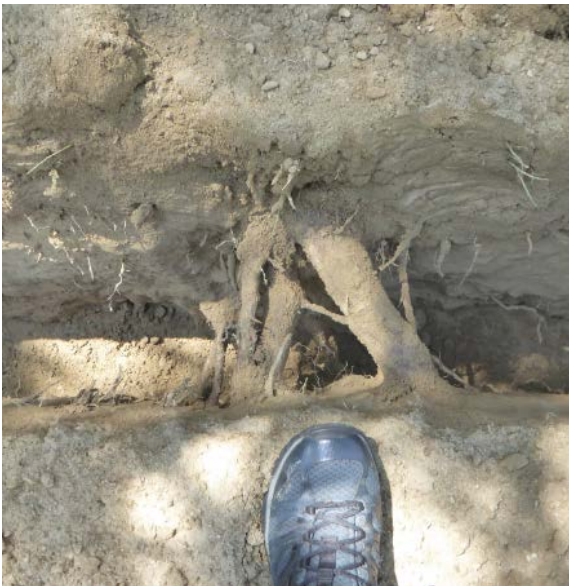
Photo 3. View of largest root exposed approximately 16 feet away from the tree.
