# PRELIMINARY DRAINAGE REPORT

**2436 74<sup>th</sup> Ave SHORT PLAT**  
2436 74<sup>TH</sup> AVE SE Mercer Island, WA

**DRS Project No. 23001**  
**Mercer Island Permit No. SUB26-XXXX**

D. R. STRONG Consulting Engineers, Inc.  
620 7<sup>th</sup> Ave.  
Kirkland WA 98033  
(425) 827-3063

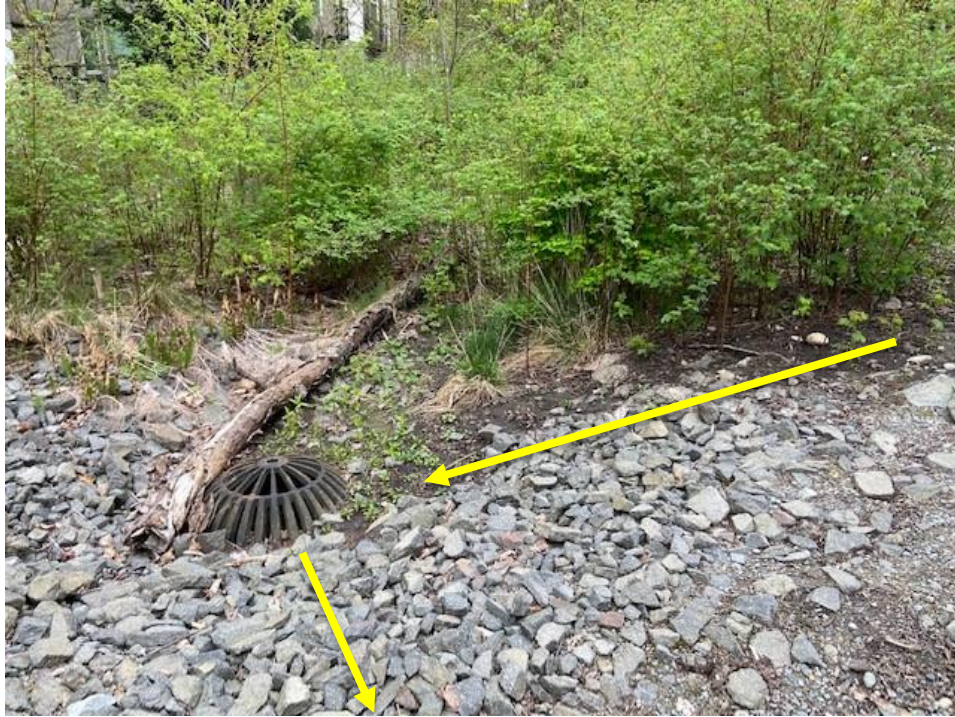
Runoff sheet flows east toward the adjacent Aegis Living property and is collected by an interceptor trench along the property line. This system connects to the community flow through system, within the Aegis Living property.

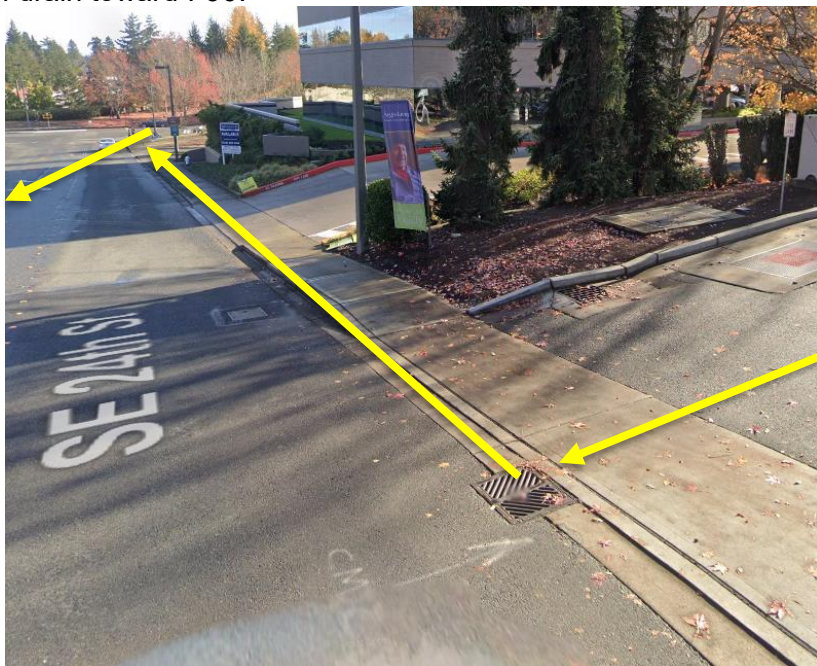
Runoff leaves the Aegis Living property to the north entering the existing SE 24<sup>th</sup> St conveyance system. Within SE 24<sup>th</sup> St it is conveyed east through a series of catch basins as the storm line increases to 24" diameter. Once the system reaches 76<sup>th</sup> Ave SE, runoff turns north in a 24" storm drain toward I-90.

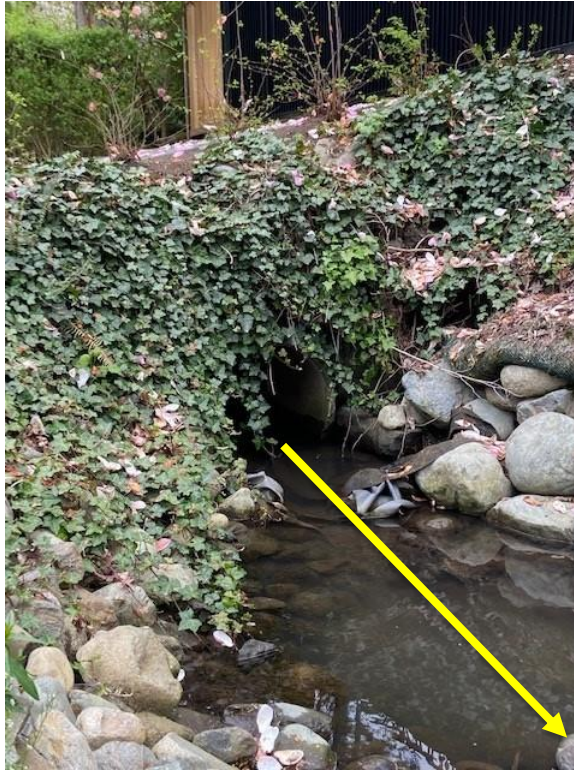
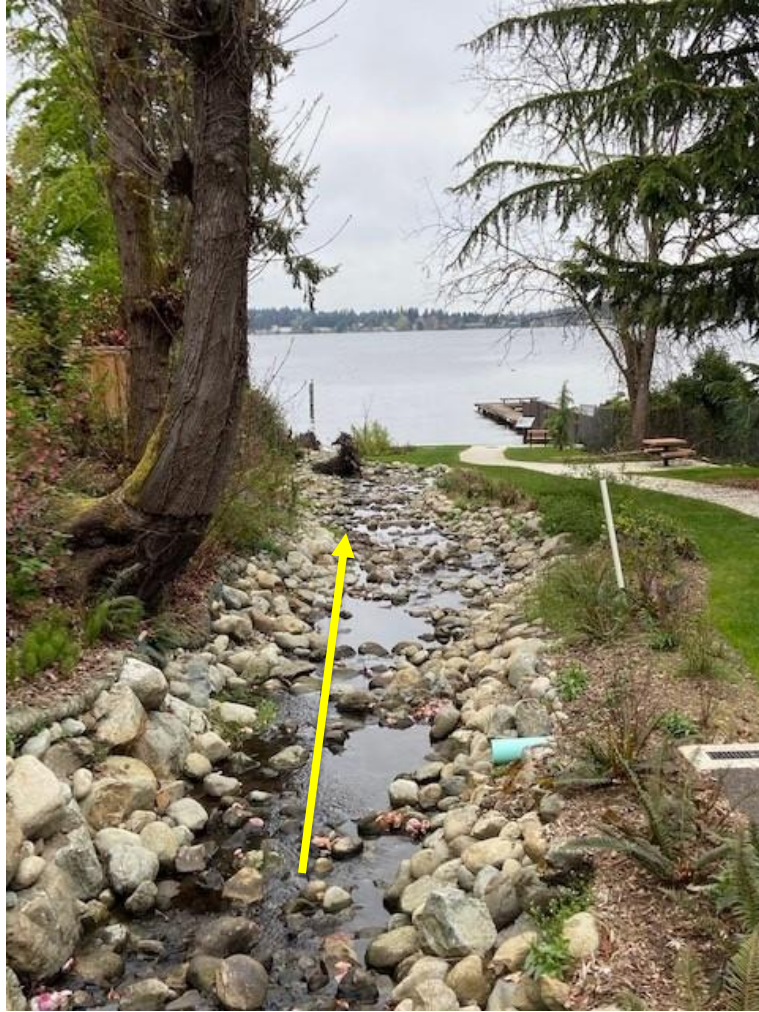
Runoff continues north along 76<sup>th</sup> Ave SE through a 24" and 36" culvert.

The open channel continues north through Lincoln Landing and outfalls to Lake Washington Approximately 2,400 ft from the site.
