Re: Chen Residence Soils Report for Design Infiltration Rates
Site Address: 5024 West Mercer Way, Mercer Island, WA
Tax Parcel No.: 1924059317

*Subsurface Exploration, Geologic Hazard,
and Geotechnical Engineering Report*

CHEN RESIDENCE

Subject: Subsurface Exploration, Geologic Hazard,
and Geotechnical Engineering Report
Chen Residence
5024 West Mercer Way
Mercer Island, Washington

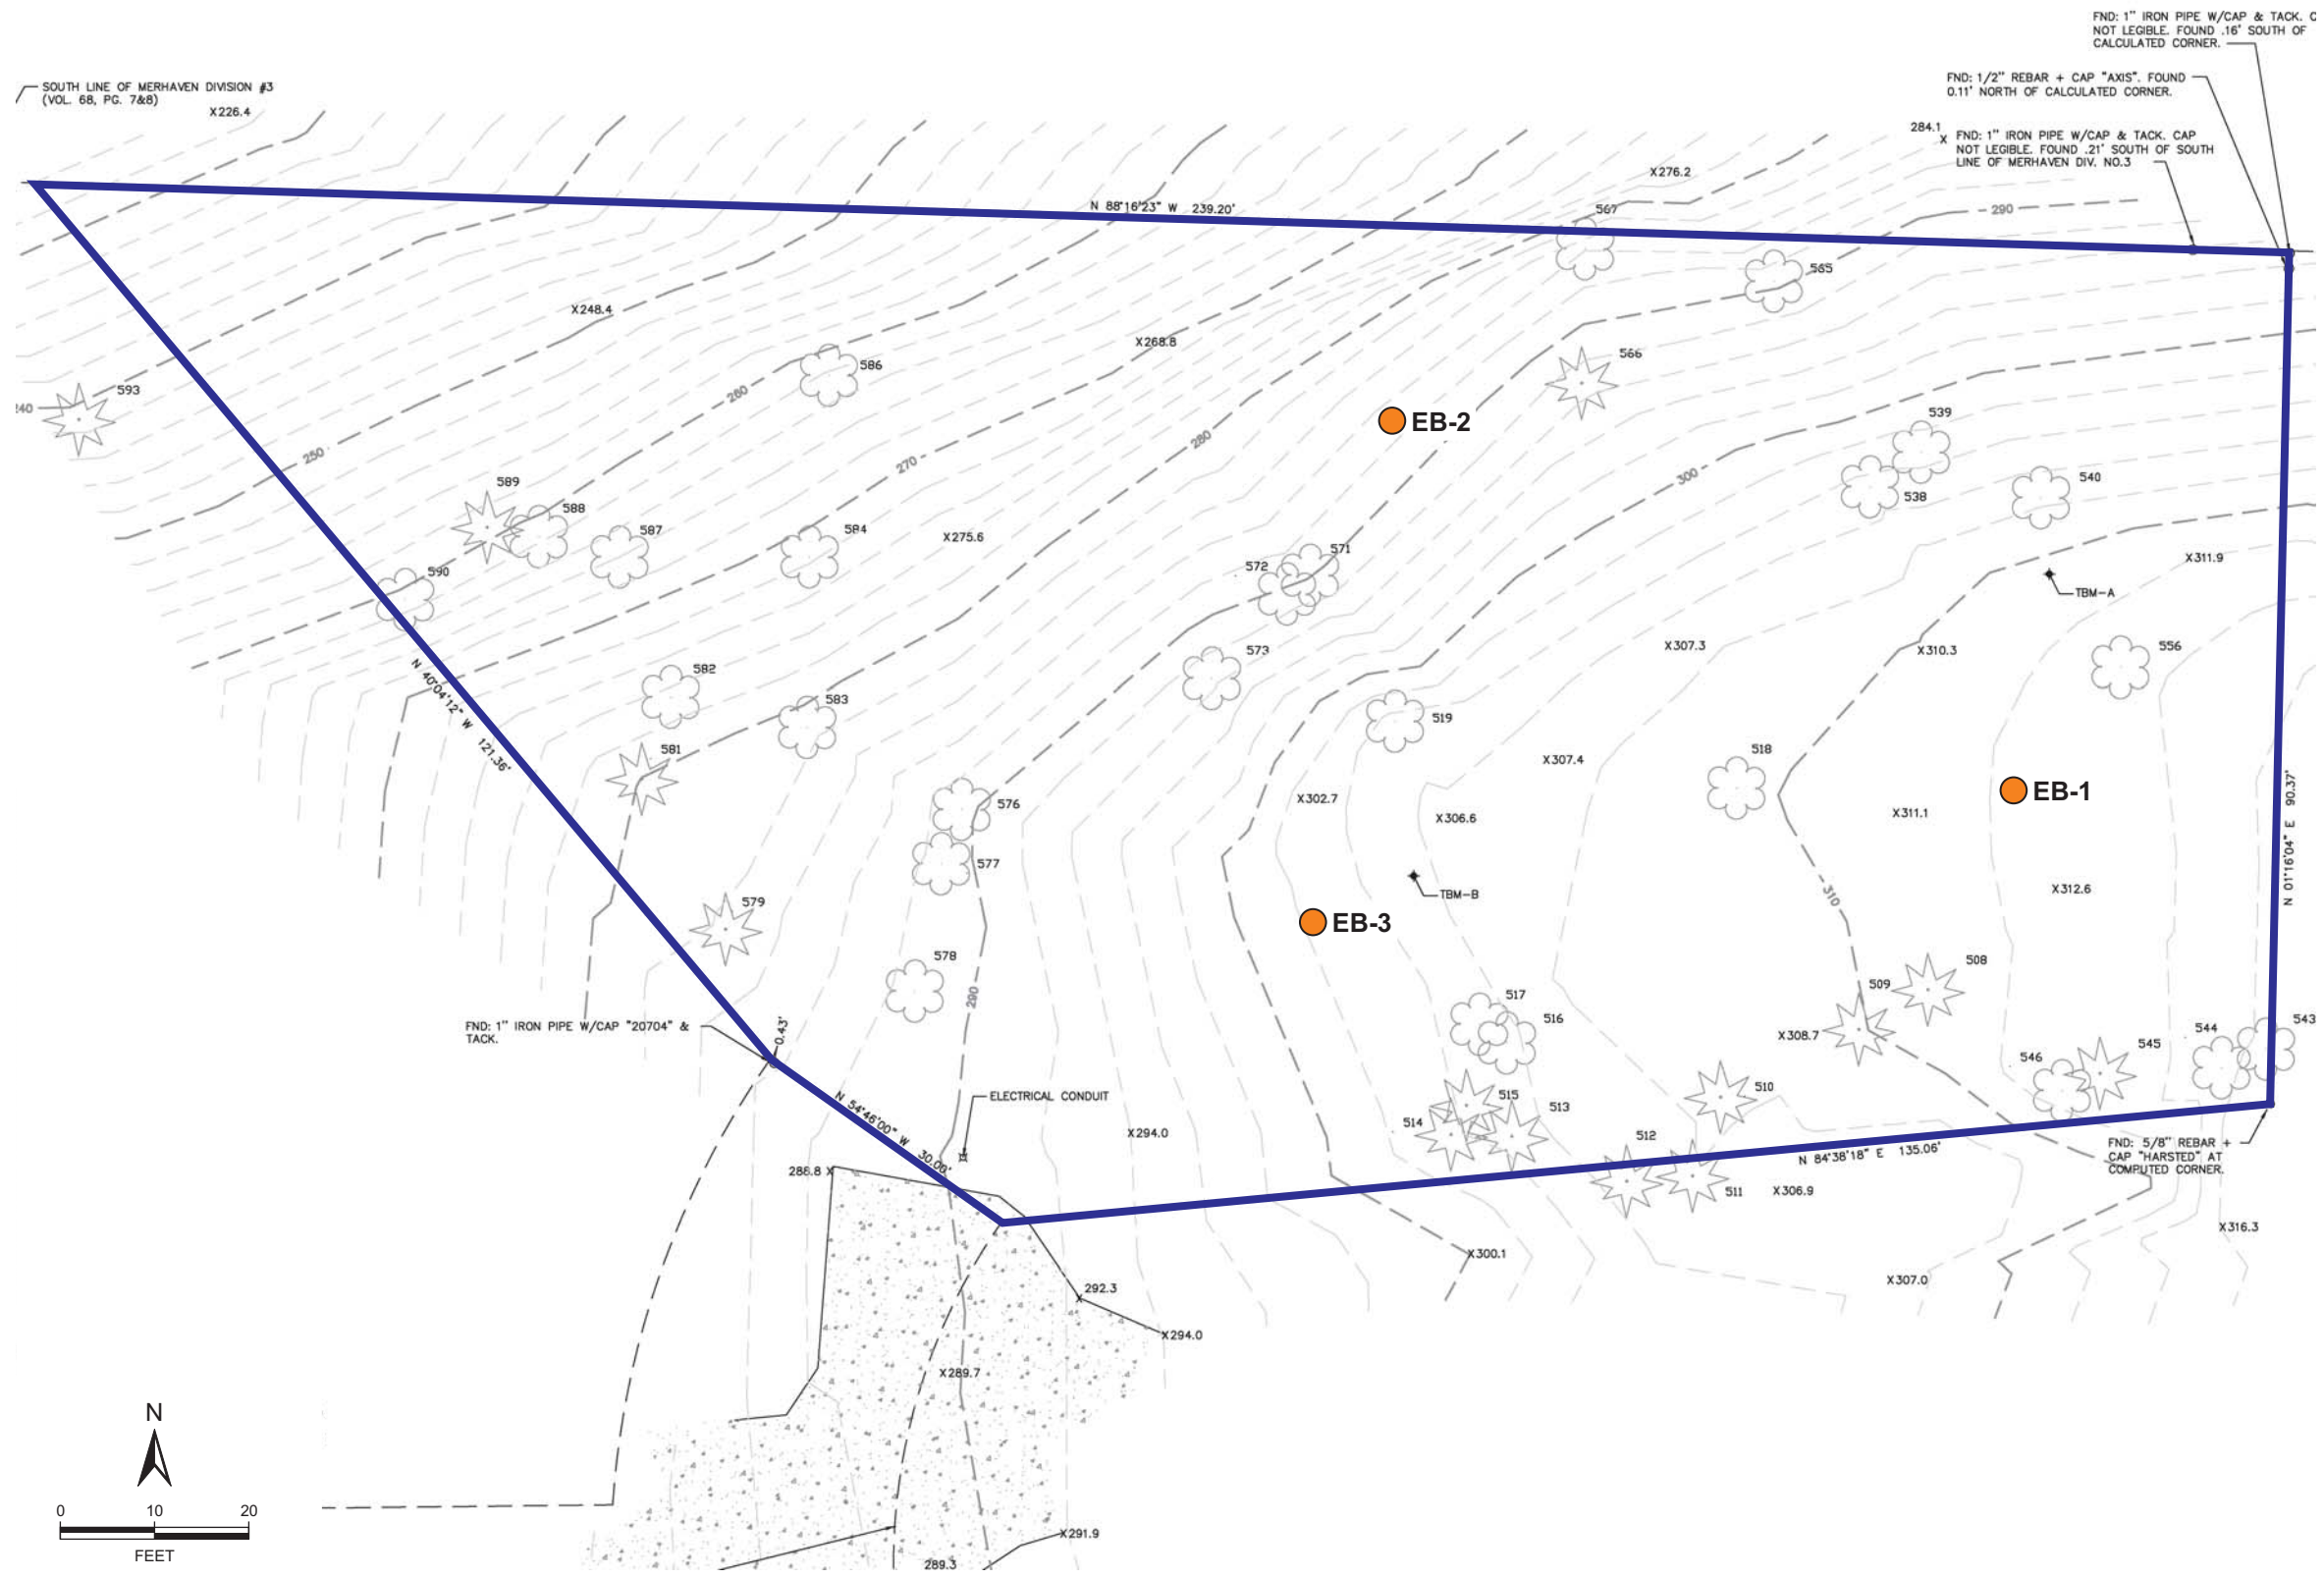
180261 Chen \ 180261E001 F2 S-E Plan.cdr

LEGEND:
 ● EB EXPLORATION BORING
 — SITE BOUNDARY

CONTOUR INTERVAL = 2'

Our field study included drilling three exploration borings on August 28, 2018. The various types of sediments, as well as the depths where the characteristics of the sediments changed, are indicated on the exploration logs presented in the Appendix. The depths indicated on the logs where conditions changed may represent gradational variations between sediment types. If changes occurred between sample intervals in our exploration borings, they were interpreted. Our explorations were approximately located in the field by measuring from known site features and the above-referenced site plan. The site and the approximate locations of the subsurface explorations referenced in this study are presented on the "Site and Exploration Plan" (Figure 2).
