# **TECHNICAL INFORMATION REPORT**

### **Ramaiyah and Subramarian Residence**

**7466 East Mercer Way**

**Eastside Consultants, Inc. File No. 24014**

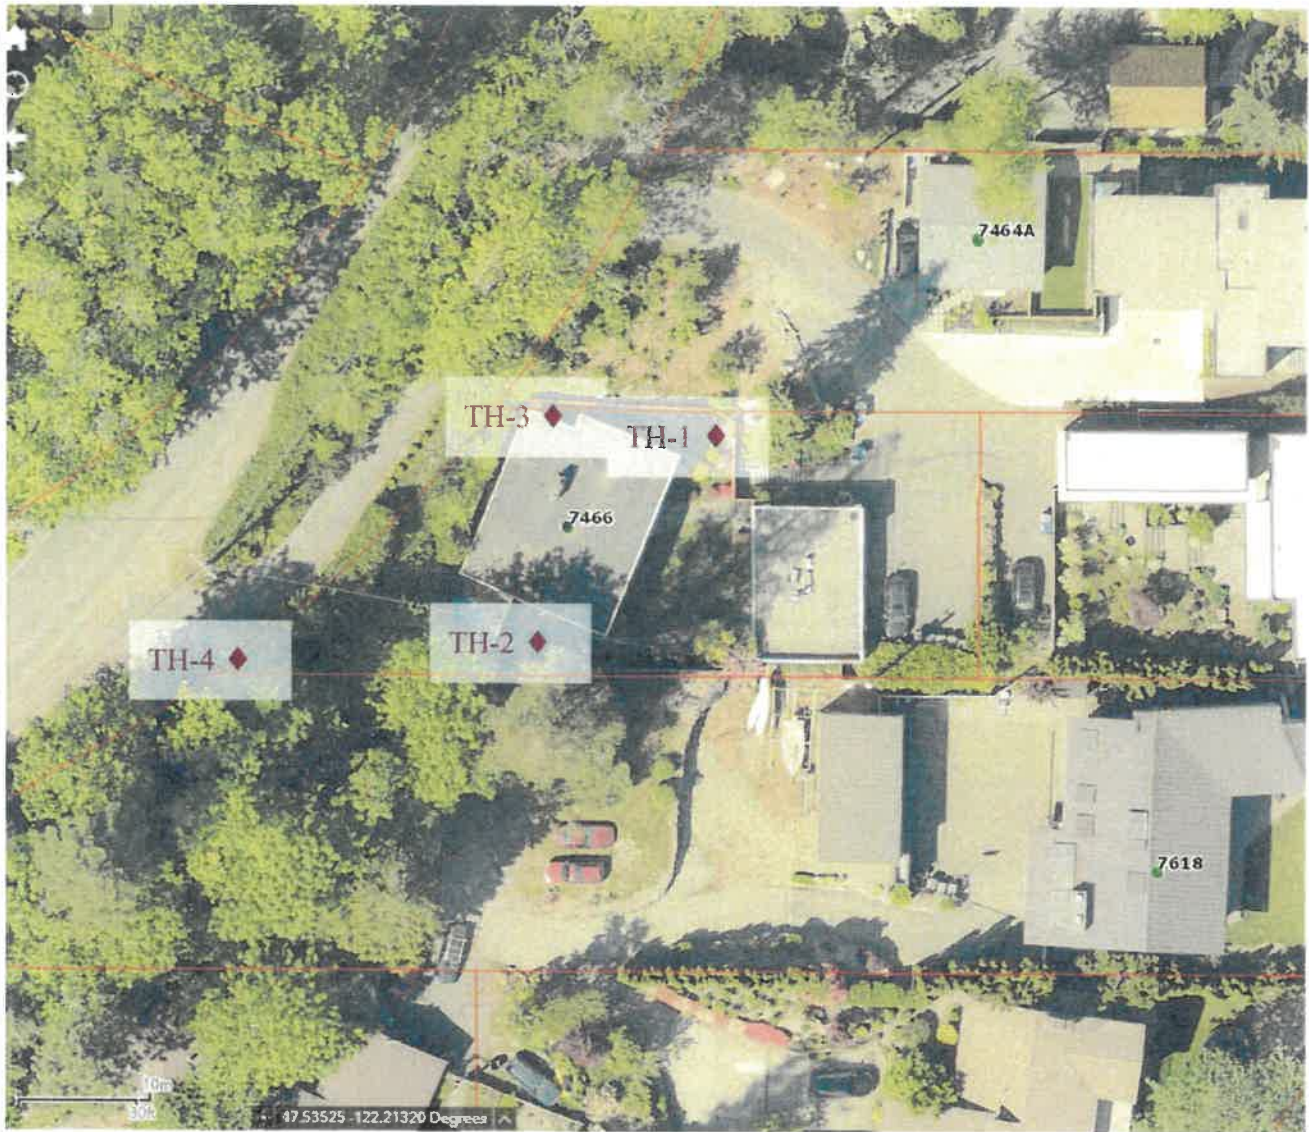
Figure 2

**KEY:**  
 APPROXIMATE LOCATION OF TEST HOLE      TH-1 ◆

Figures A-1 through A-3 present more detailed descriptions of the subsurface conditions encountered in the test holes. The approximate test hole locations are shown on the Exploration Location Plan provided in Figure 2.

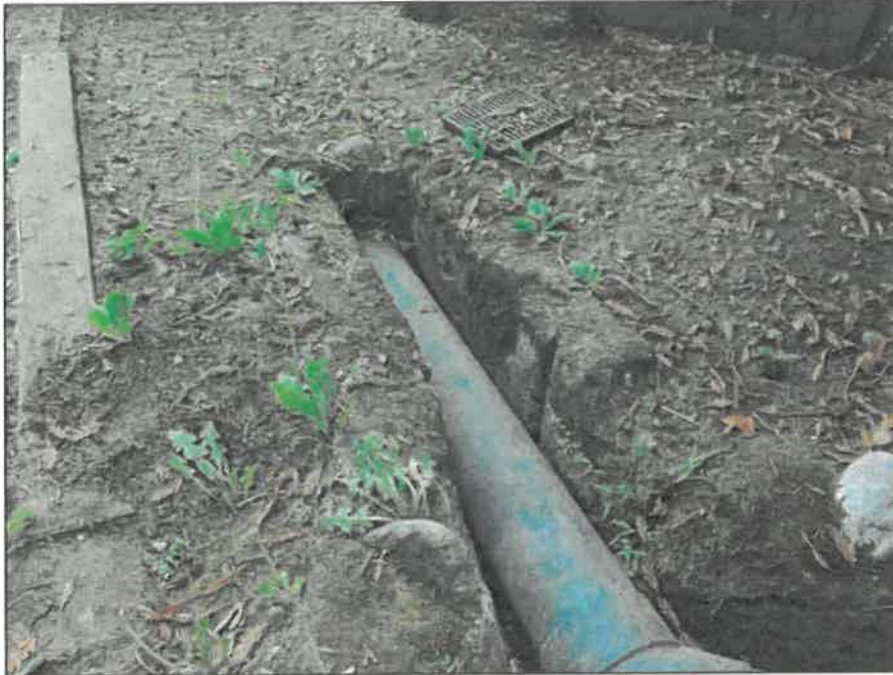
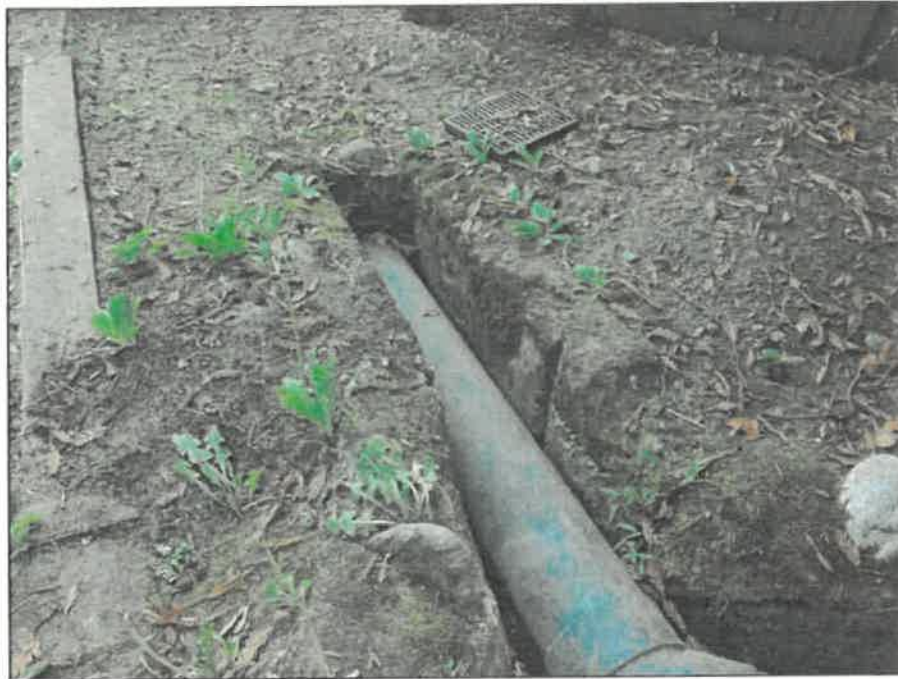
**Figure 2. Watercourse A on the subject property, facing southeast (9/11/20)**

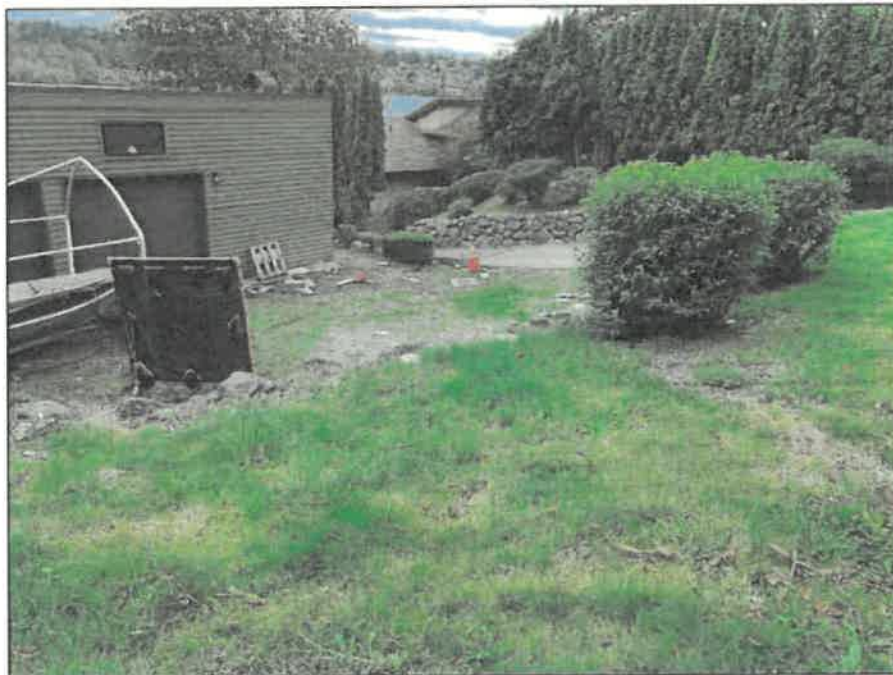
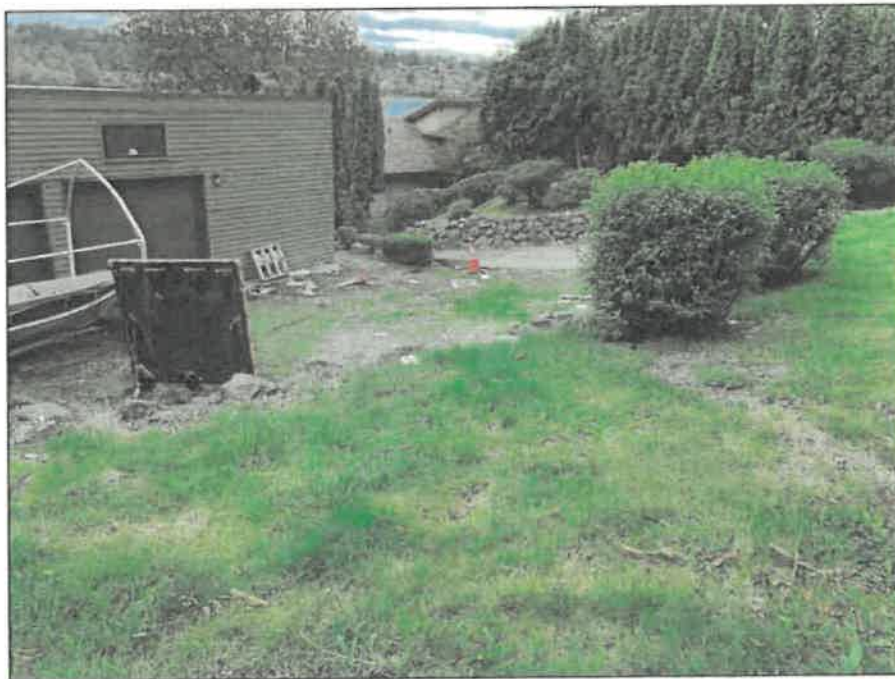
**Figure 3. Location where open channel segment of Watercourse A is mapped south of subject property, facing southeast (10/16/20).**

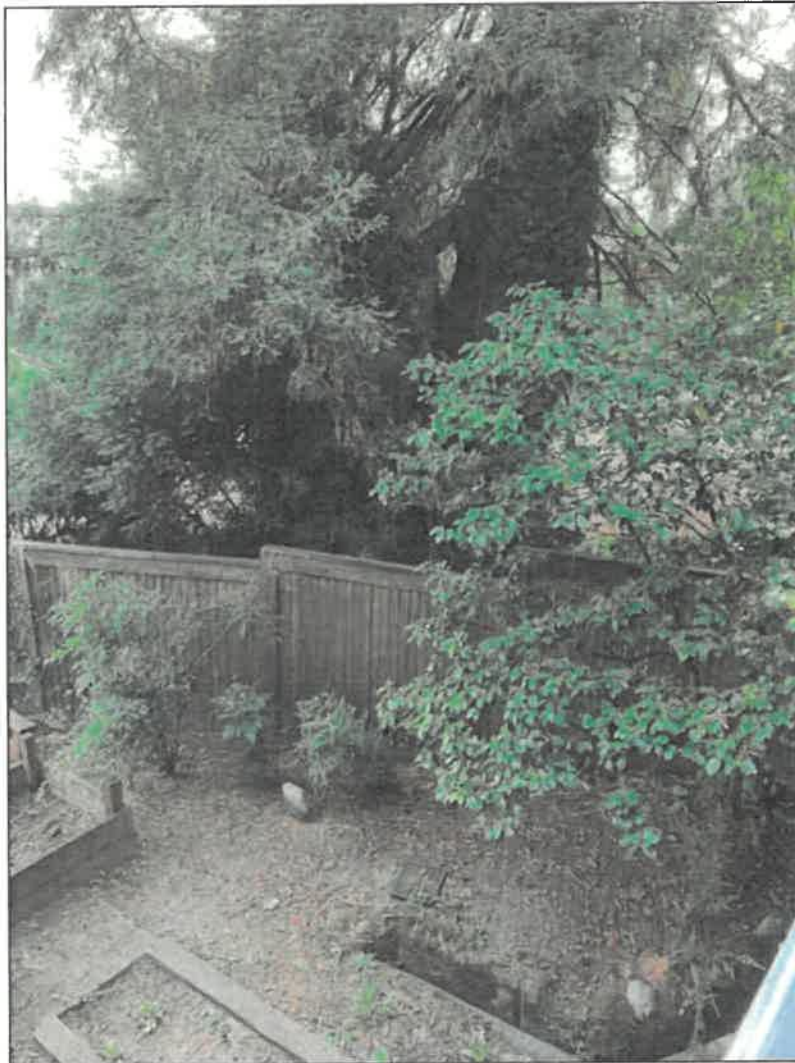
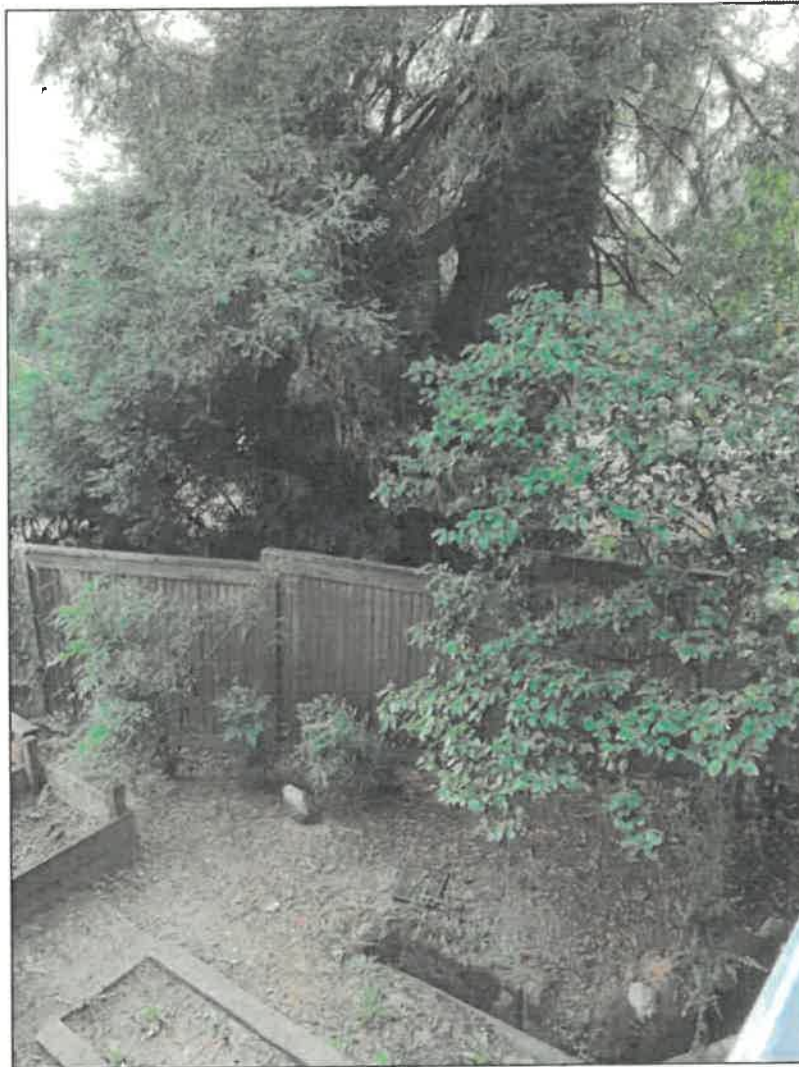
The piped segment of Watercourse A is located beneath the canopy of and within the critical root zone of an old-growth California redwood tree (*Sequoia sempervirens*) on the adjacent property to the south (Parcel #3024059114) (Figure 6). Based on visual estimates from the subject property, the redwood tree has a diameter at breast height of greater than 60 inches. Daylighting Watercourse A would necessitate the removal of this tree. The City prioritizes the retention of exceptional trees, and a redwood tree of this size and age is generally irreplaceable. The removal of the tree would represent an unnecessary risk of environmental damage due to the irreplaceable loss of habitat, soil stability, and evapotranspiration functions provided by this rare, old-growth tree, which conflicts with the requirements of MICC 19.07.180.C.6.d.ii. The environmental benefit of daylighting this short watercourse segment would not compensate for the loss of this tree, and it is not possible to completely mitigate the loss of this tree. Additionally, the redwood tree is not located on the subject property, meaning its removal would cause an additional impact on a neighboring property, which is in conflict with the requirements of MICC 19.07.180.C.6.c.ii. Daylighting Watercourse A would also create a watercourse buffer on the adjacent property where none currently exists, which conflicts with the same provision.

**Figure 6. Watercourse A with old-growth redwood tree in background, facing southeast (9/11/20)**

The portion of Watercourse A located immediately adjacent and upslope of the existing residence is at the base of a steep slope and retaining wall. It seems likely that creating an open channel in this location could risk slope stability and structural stability of the residence. The Watershed Company does not provide geotechnical analysis, but it is our understanding that a geotechnical engineer will assess the associated risk of this potential action.
