GEOTECHNICAL ENGINEERING REPORT

RGI PROJECT No. 2024-240-1

**ISLAND CREST WAY RESIDENCE ADDITION
3633 ISLAND CREST WAY
MERCER ISLAND, WASHINGTON**

AUGUST 30, 2024

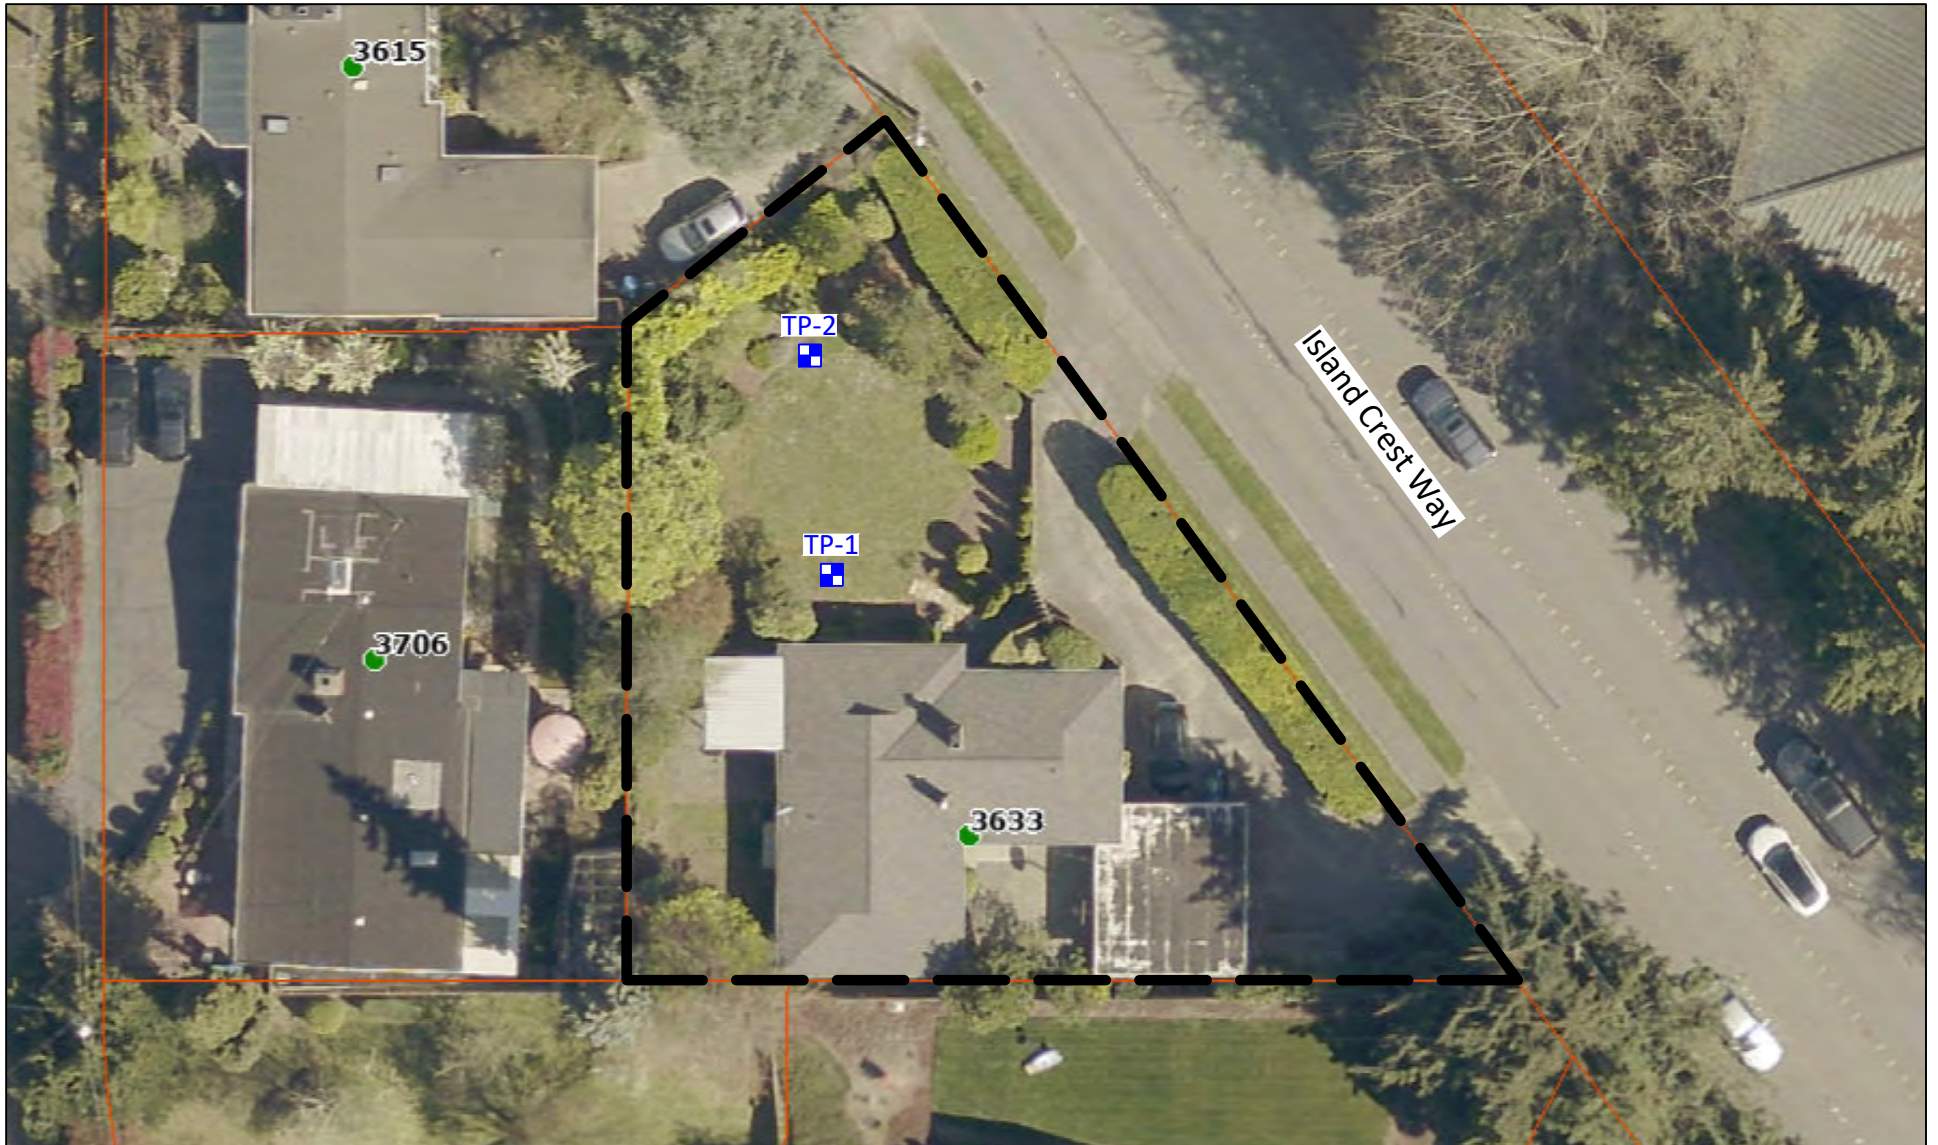
Island Crest Way Residence		Figure 2
RGI Project Number: 2024-240-1	Geotechnical Exploration Plan	Date Drawn: 08/2024
Address: 3633 Island Crest Way, Mercer Island, Washington 98040

On August 15, 2024, RGI observed the excavation of 2 test pits. The approximate exploration locations are shown on Figure 2.

= Test pit locations by RGI, 08/15/2024

On August 15, 2024, RGI performed field explorations using a rubber tracked excavator. We explored subsurface soil conditions at the site by observing the excavation of two test pits to a maximum depth of 7.5 feet below existing grade. The test pit locations are shown on Figure 2. The exploration locations were approximately determined by measurements from existing property lines and paved roads.

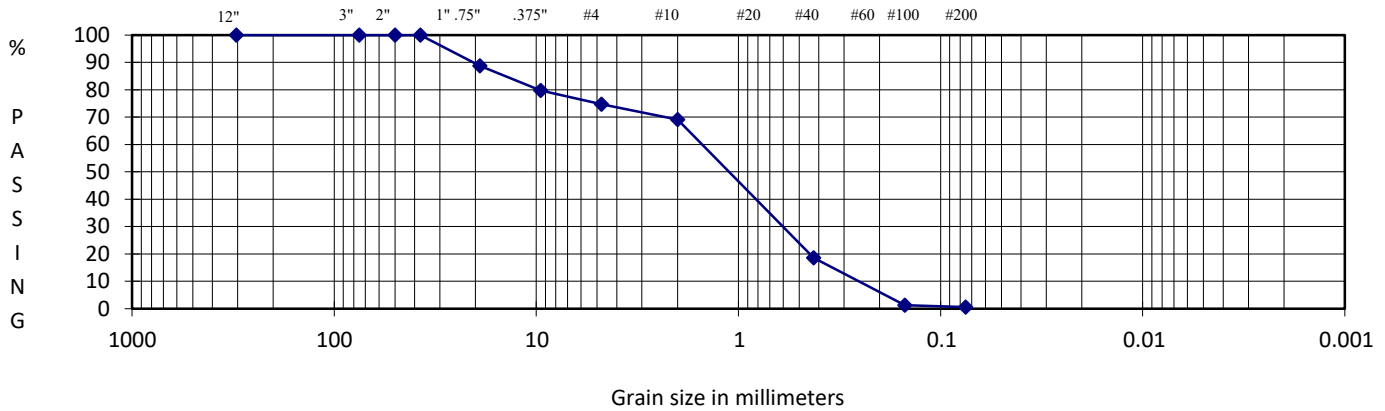
PROJECT TITLE	Island Crest Way Residence Addition	SAMPLE ID/TYPE	TP-2
PROJECT NO.	2024-240-1	SAMPLE DEPTH	6.5 Feet
TECH/TEST DATE	CM/LW 8/23/2024	DATE RECEIVED	8/15/2024

SIEVE ANALYSIS					
		Wt Ret	(Wt-Tare)	Cumulative	% PASS		
		+Tare		{(wt ret/w6)*100}	(100-%ret)		
% COBBLES	0.0	12.0"	212.3	0.00	0.00	100.00	cobbles
% C GRAVEL	11.2	3.0"	212.3	0.00	0.00	100.00	coarse gravel
% F GRAVEL	14.0	2.5"					coarse gravel
% C SAND	5.7	2.0"	212.3	0.00	0.00	100.00	coarse gravel
% M SAND	50.4	1.5"	212.3	0.00	0.00	100.00	coarse gravel
% F SAND	18.0	1.0"					coarse gravel
% FINES	0.6	0.75"	308.3	96.00	11.20	88.80	fine gravel
% TOTAL	100.0	0.50"					fine gravel
D10 (mm)	0.23	0.375"	386.2	173.90	20.28	79.72	fine gravel
D30 (mm)	0.59	#4	428.6	216.30	25.22	74.78	coarse sand
D60 (mm)	1.4	#10	477.5	265.20	30.93	69.07	medium sand
Cu	6.1	#20					medium sand
Cc	1.1	#40	910.1	697.80	81.38	18.62	fine sand
		#60					fine sand
		#100	1059.0	846.70	98.74	1.26	fine sand
		#200	1064.4	852.10	99.37	0.63	finer
		PAN	1069.8	857.50	100.00	0.00	silt/clay

DESCRIPTION Poorly graded SAND with some gravel and trace silt

USCS SW

More detailed descriptions of the subsurface conditions encountered are presented in the test pits included in Appendix A. Sieve analysis was performed on selected soil samples. Grain size distribution curves are included in Appendix A.
