# Drainage Report

**ADDRESS:** 6427 E Mercer Way Mercer Island, WA 98040

**DATE:** May 2025

**FOR SUBMITTAL TO:  
CITY OF MERCER ISLAND**

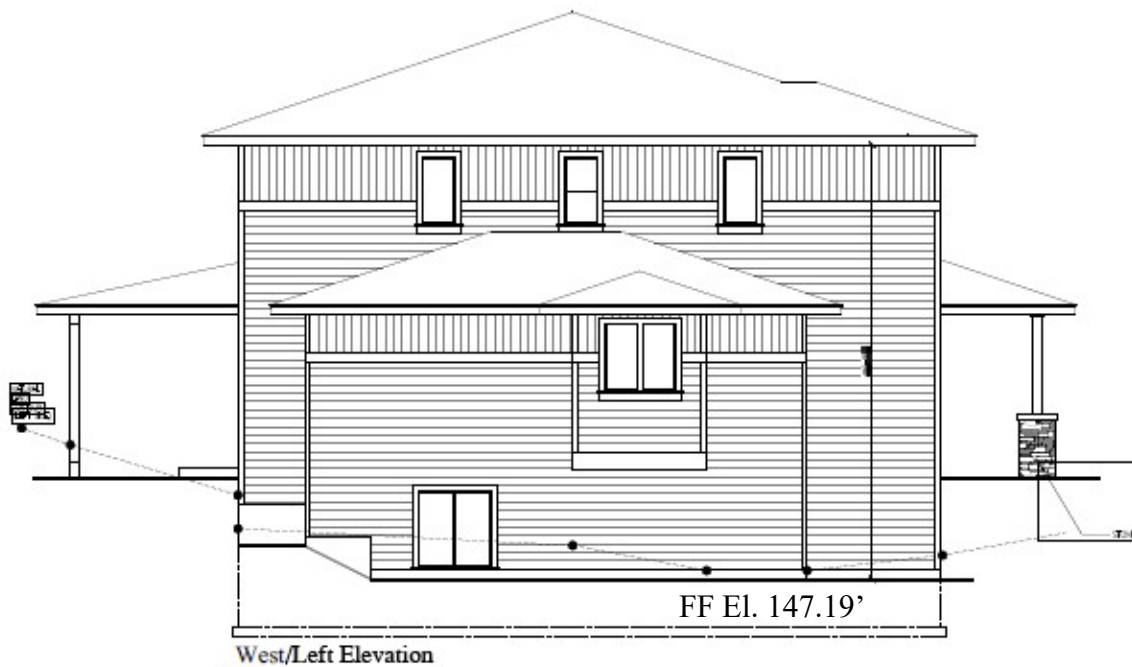
*Plate 2 –Schematic West Elevation, dated 9/15/20, by Mcleod Home Designs.*

house will consist of a daylight basement open to the northeast. We anticipate excavations for the house foundation will be on the order of 8 feet, or less.

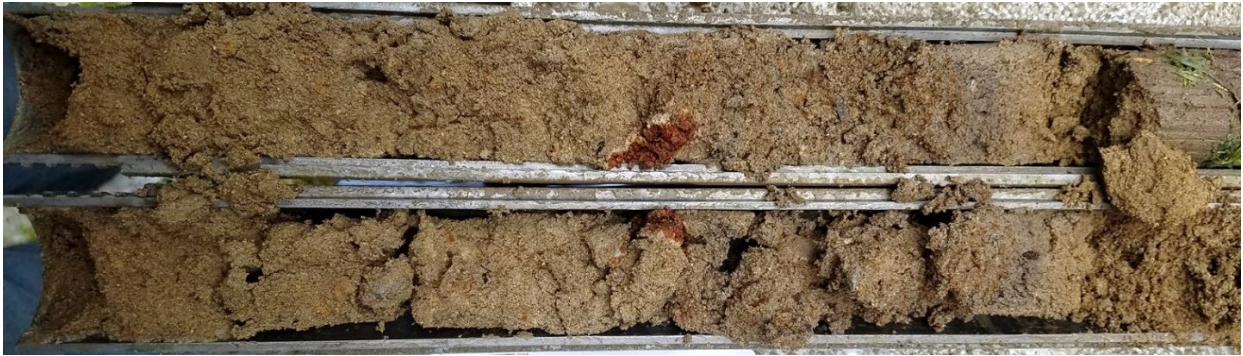
*Plate 3 –Hf | Loose, silty sand | PG-2, S-1 @ 2½ – 4 feet.*

**Selected Sample Photos:** *Plates 3 through 5* below depict select soil samples obtained from our recent test borings. For reference purposes, the split-soon samplers pictured below have an outside diameter of 2 inches.

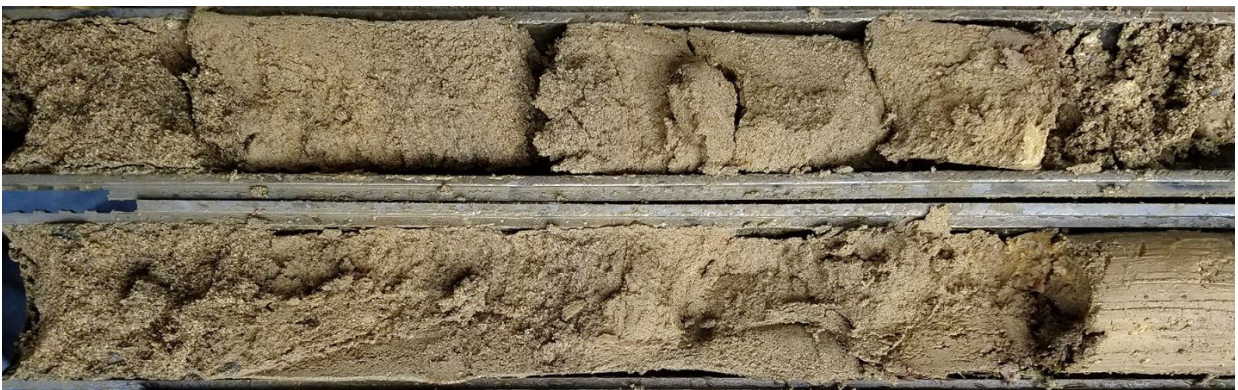
*Plate 4 –Qvlc | Medium dense SILT | PG-3, S-1 @ 5-6½ feet.*

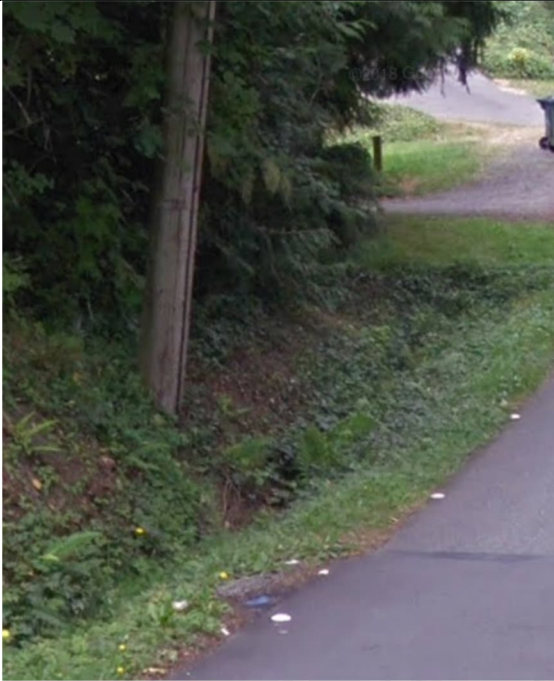
| <p>Photo 1 (looking north): culvert flowing north into type 1 catch basin. 8" corrugated polyethylene pipe flowing north.</p> | <p>Photo 2 (looking west): type 1 catch basin. 12" concrete pipe flowing north.</p> |

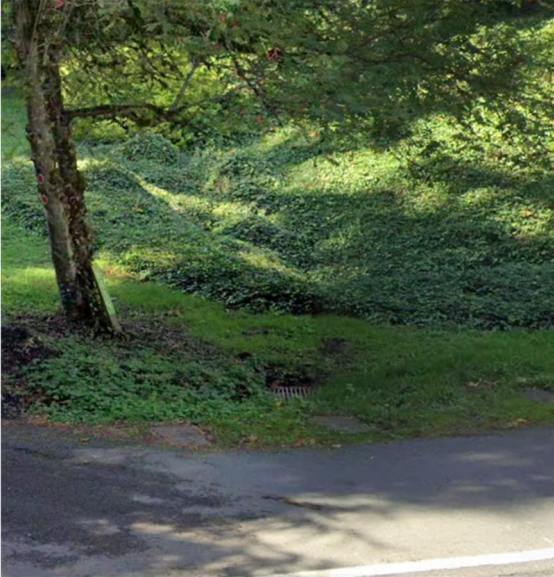
| <p>Photo 3 (looking northwest): type 2 catch basin. 12" concrete pipe flowing east.</p> | |
