GEOTECHNICAL REPORT

**78th Avenue Short Plat
7414 – 78th Avenue Southeast
Mercer Island, Washington**

Project No. T-8832

Terra Associates, Inc.

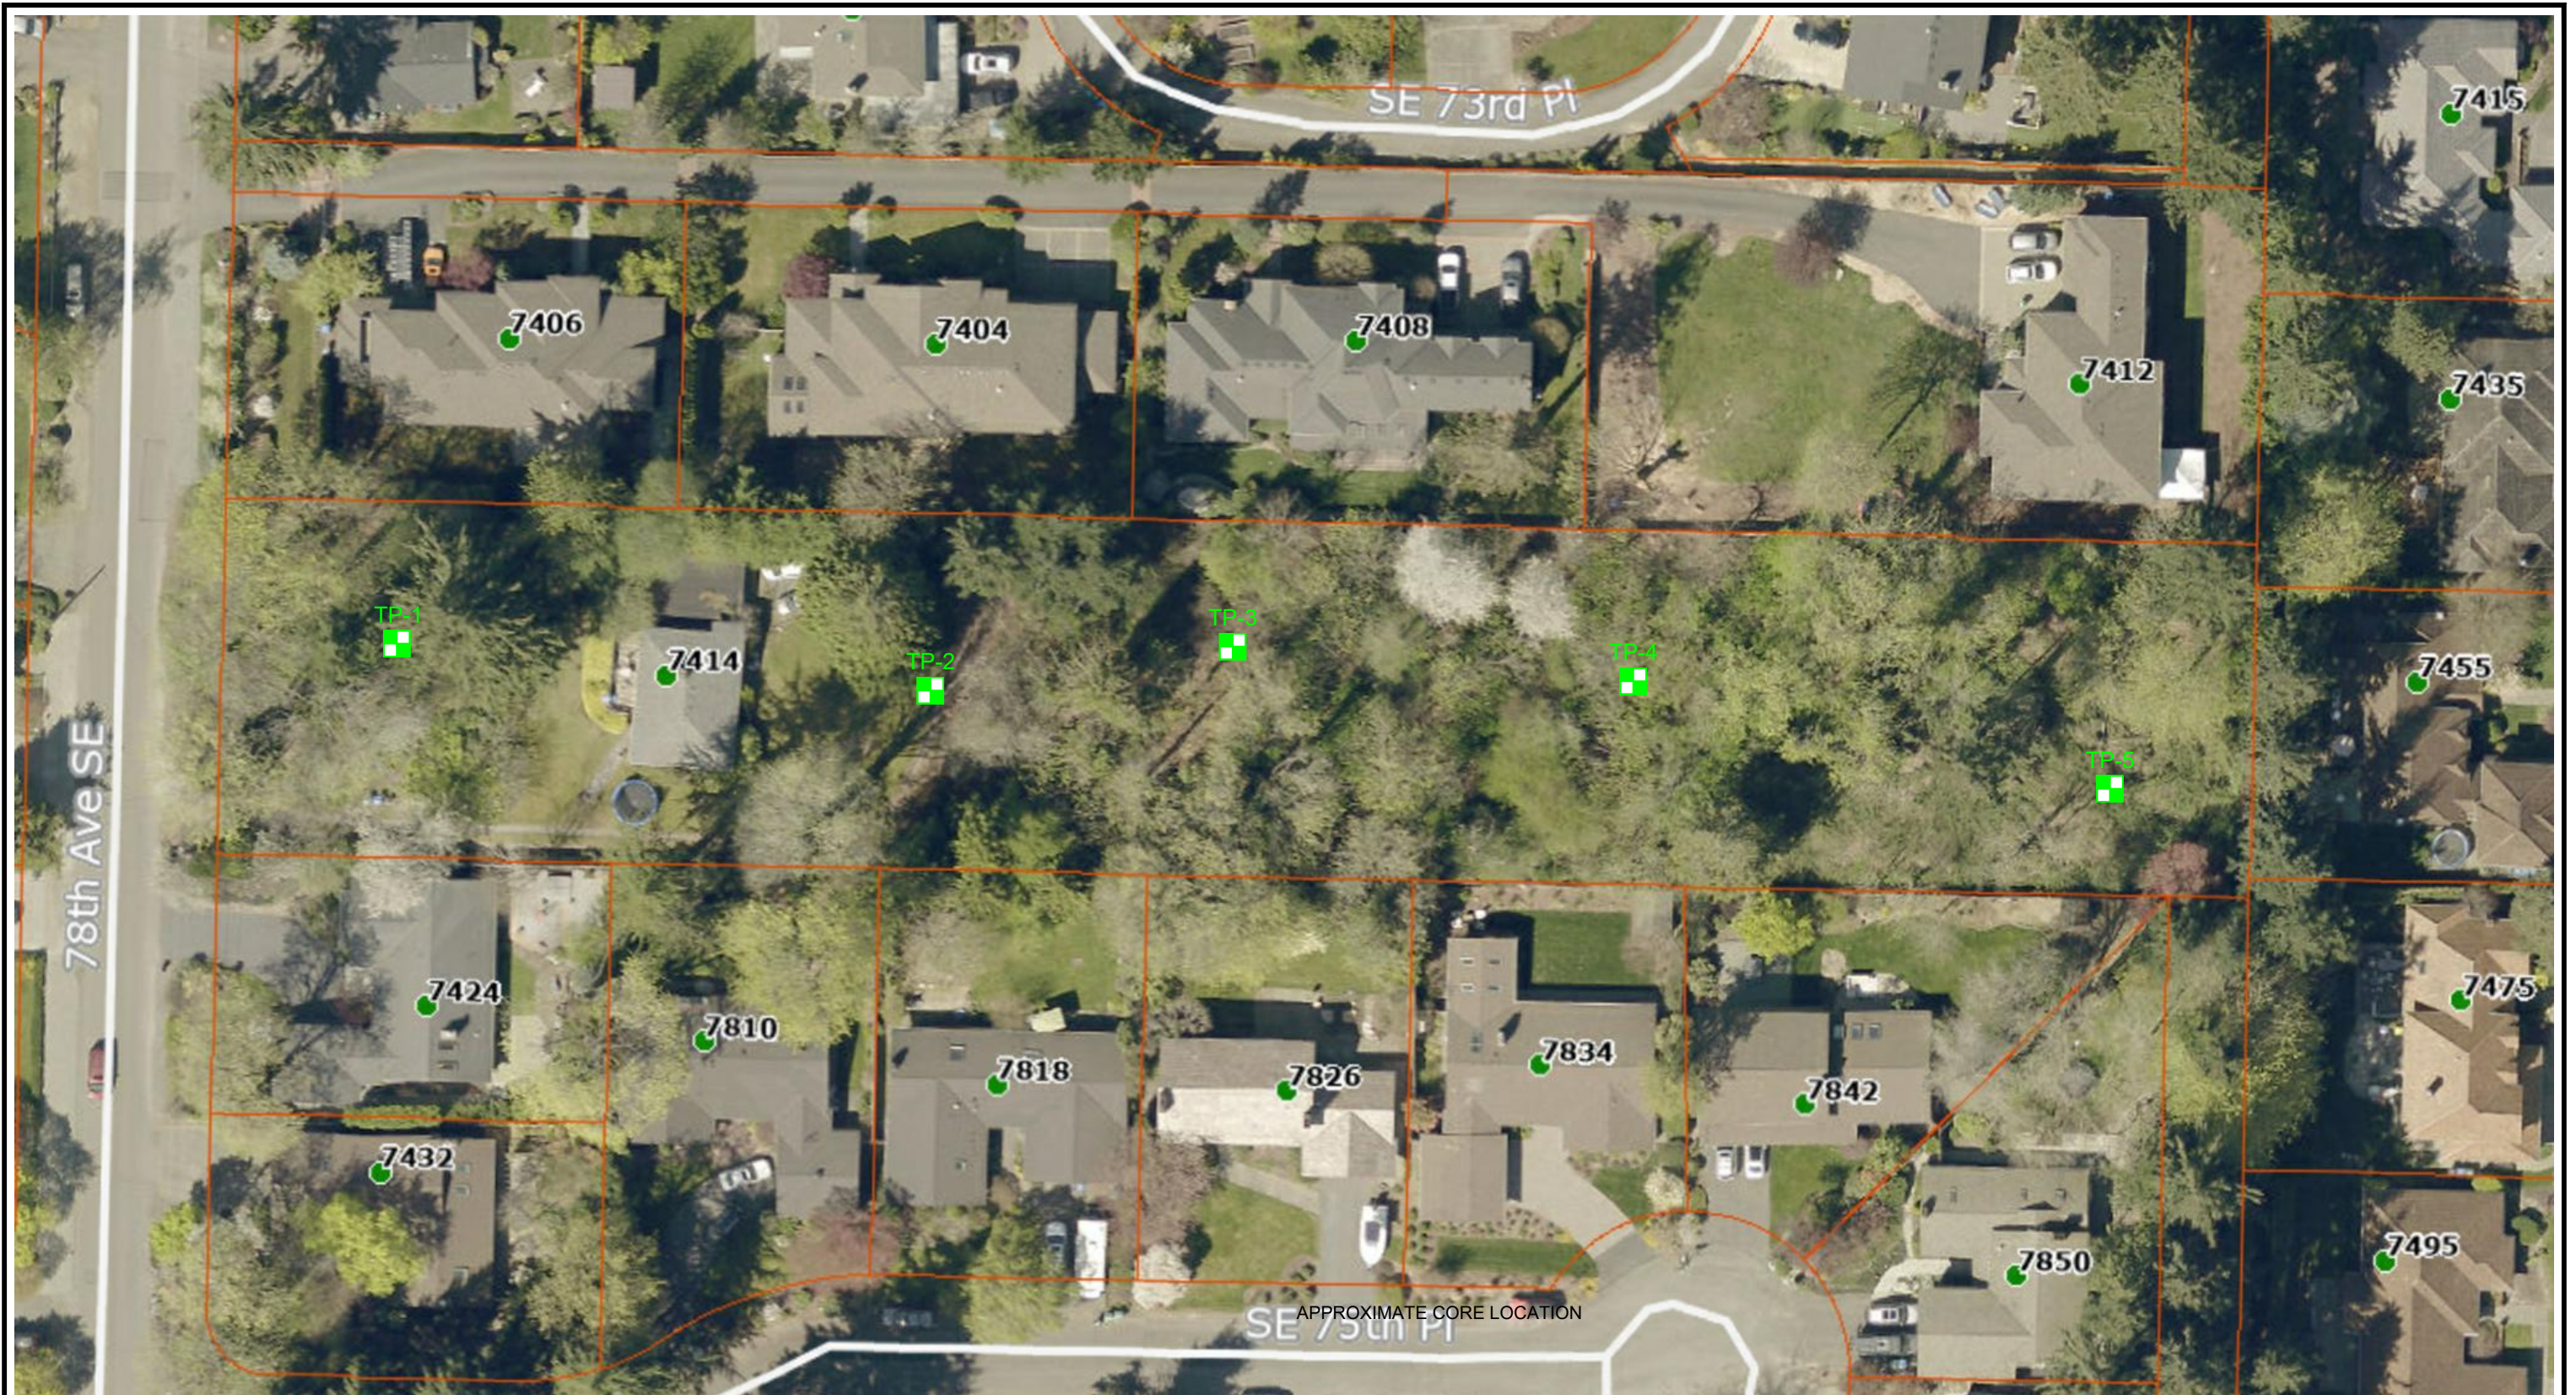
Figure 2

The preceding discussion is intended to be a general review of the soil conditions encountered. For more detailed descriptions, please refer to the Test Pit Logs in Appendix A. The approximate location of the test pits are shown on Figure 2, the Exploration Location Plan.

On November 21, 2022, we completed our site exploration by observing soil conditions at five test pits. The test pits were excavated using a track-mounted excavator to a maximum depth of approximately 14 feet below existing site grades. Test pit locations were approximately determined in the field using GPS tracking and by pacing and sighting from existing site features. The approximate location of the test pits is shown on the attached Exploration Location Plan, Figure 2. Test Pit Logs are presented on Figures A-2 through A-6.
