November 13, 2023  
Updated February 16, 2024

**RE: Geotechnical Evaluation**  
Proposed Residence  
9619 SE 34<sup>th</sup> Street  
Mercer Island, Washington

### **Site and Project Description**

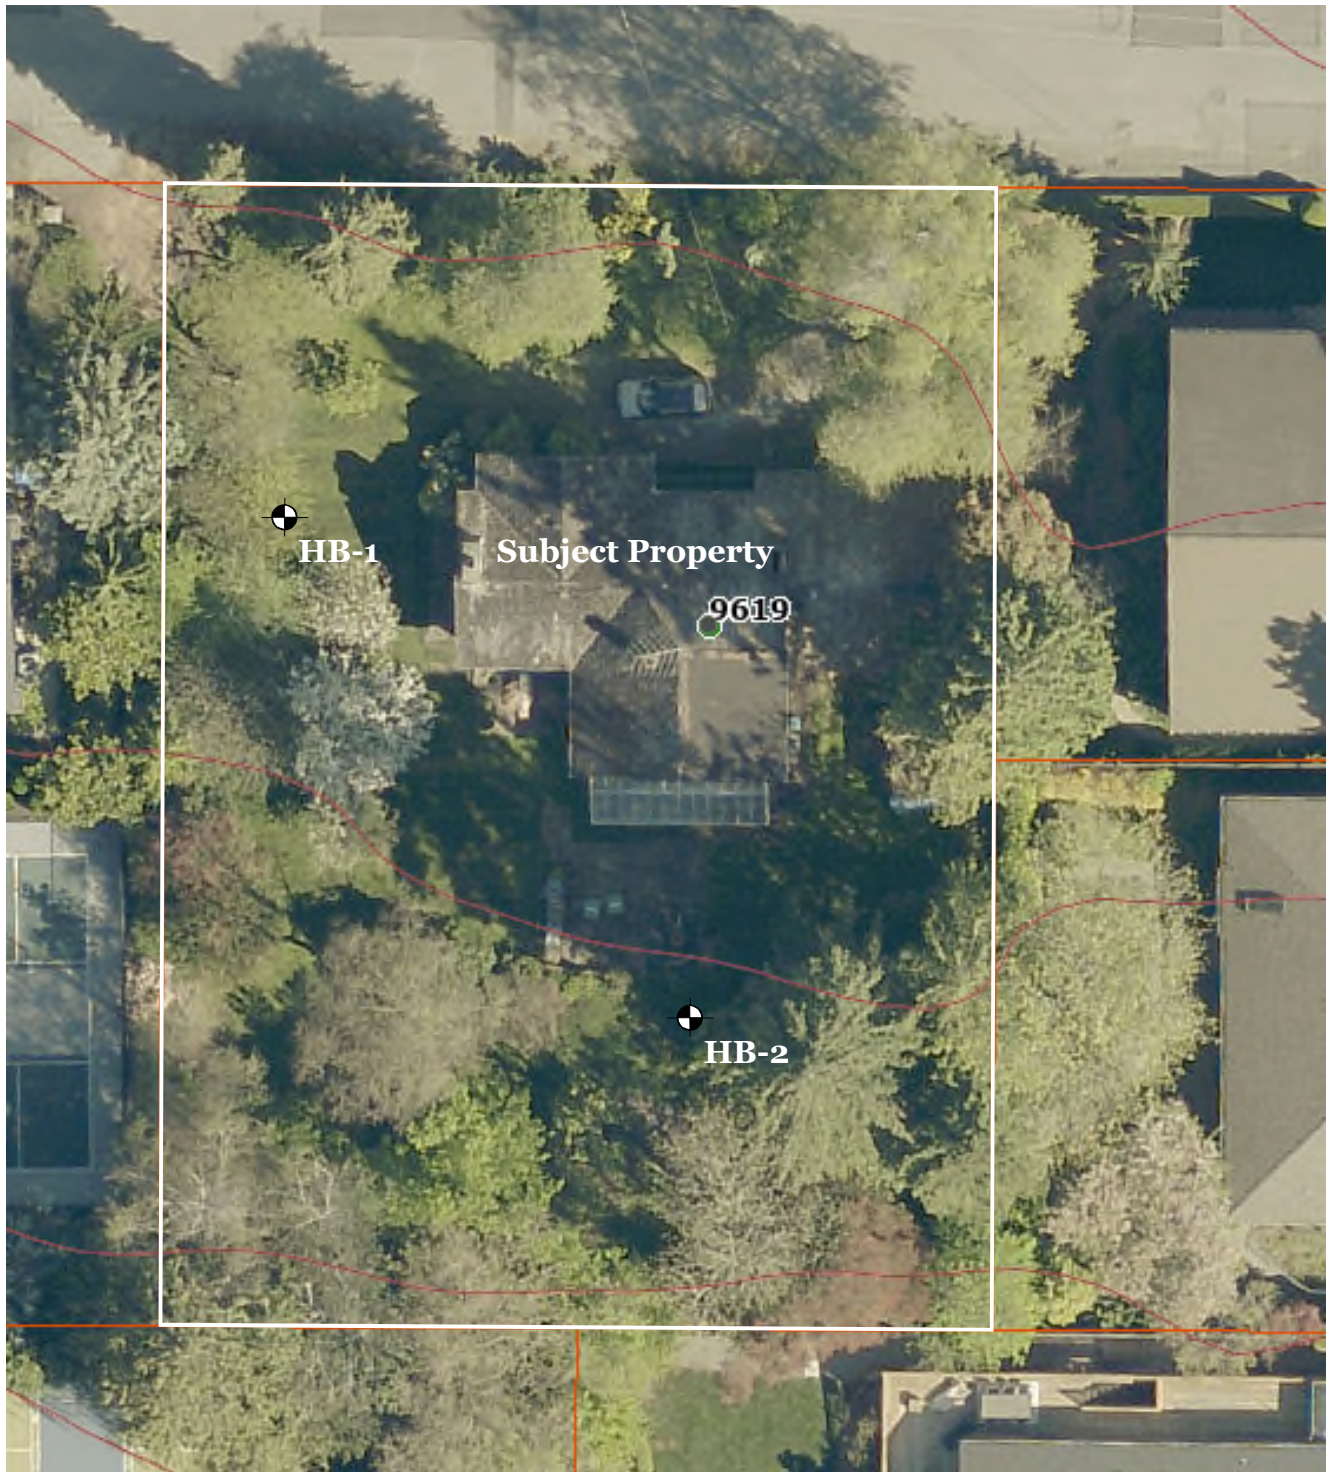
### Figure 2

**Approximate Hand Boring Location**  
**HB-1**

We have provided a site plan with topographic information in Figure 2.

We have provided a site plan in Figure 2.

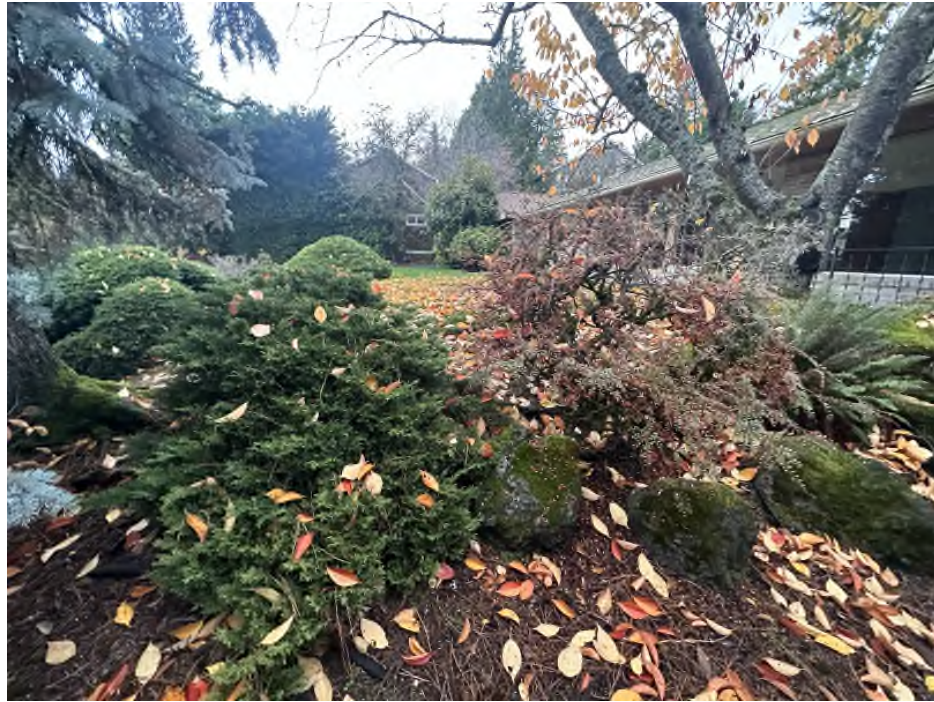
Looking across the property. No steep slopes noted.

It is our opinion that the seismic hazard risks are low due to the very fine-grained nature of the near surface soils. Mitigation for these hazards is not warranted. The risk of landslide activity is also very low at this time due to a lack of steeper topography and the current conditions (well developed area with streets and residences). There are no steep slope areas within at least 100 feet of the site.

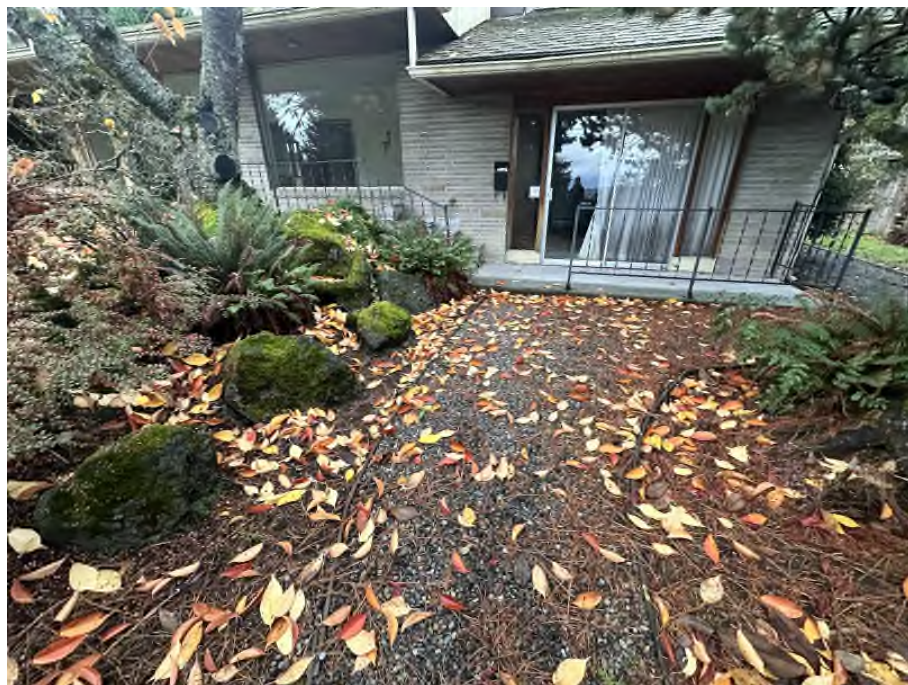
Looking at existing structure and vegetation.

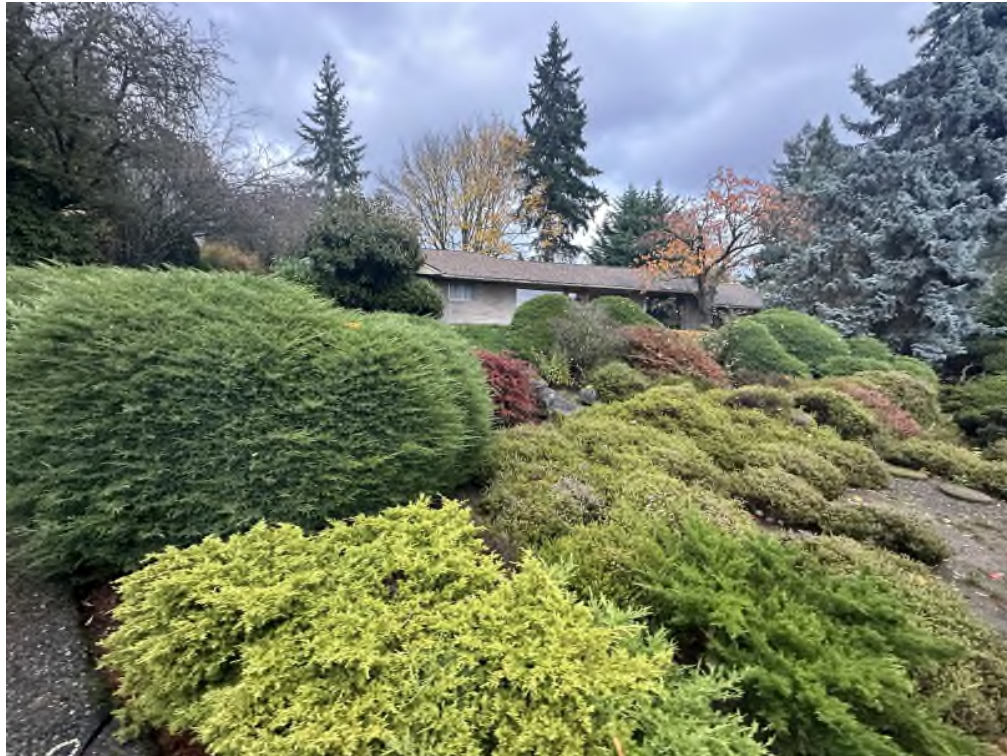
Looking into the property and residence. No steep slopes noted.

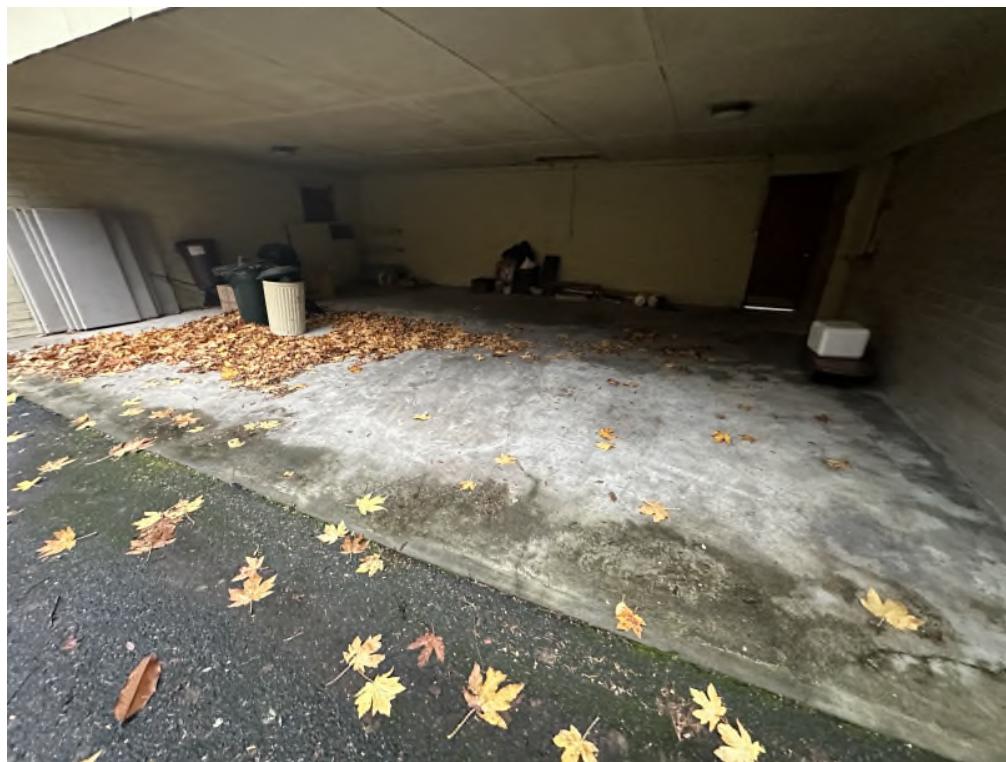
Looking into carport of structure.
