Cobalt Geosciences, LLC
P.O. Box 1792
North Bend, WA 98045

March 26, 2024
Updated July 23, 2024

RE: Geotechnical/Geologic Evaluation
Proposed Addition
3777 79th Ave SE
Mercer Island, Washington

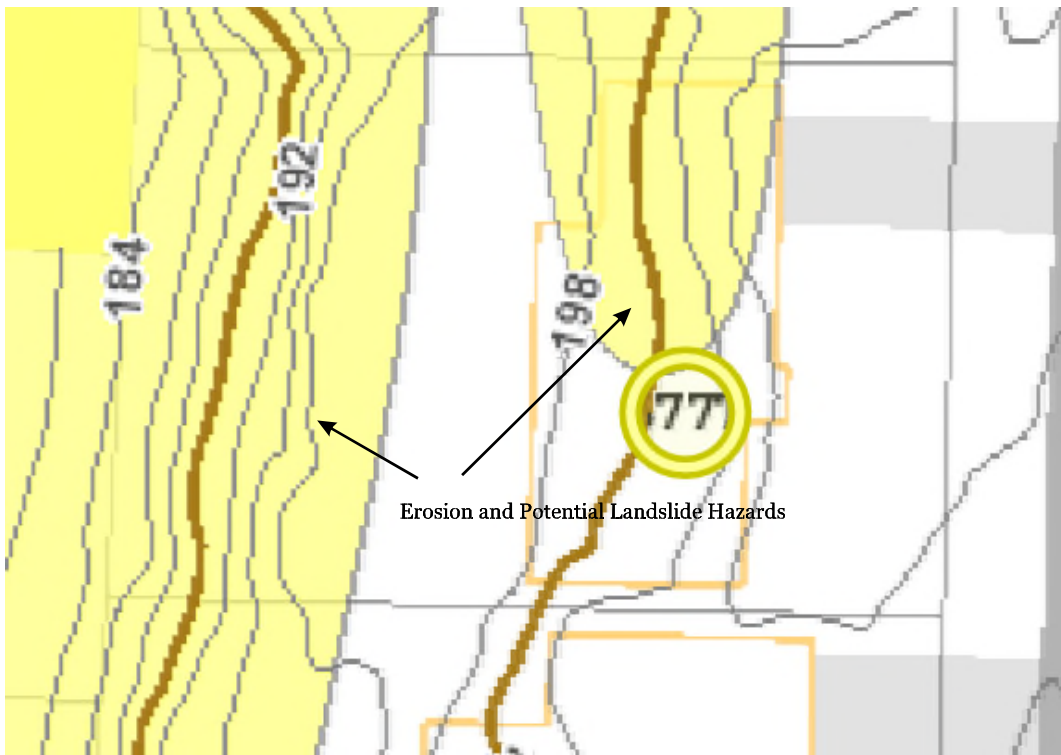
The City of Mercer Island GIS maps indicate that the site contains localized erosion and potential landslide hazard areas.

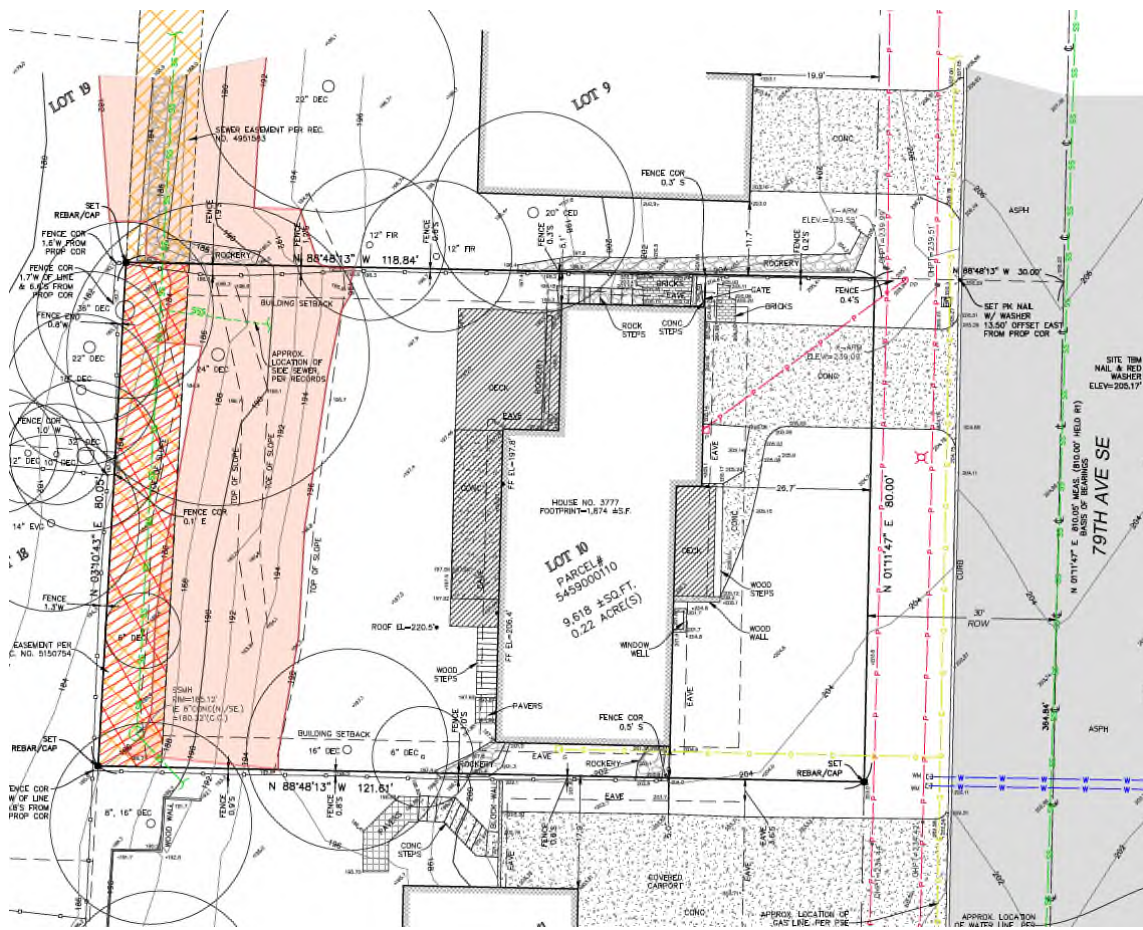
topographic map

We have provided the topographic survey information in Figure 2. A site plan excerpt is included in this figure.

We have provided a scaled topographic survey in Figure 2.

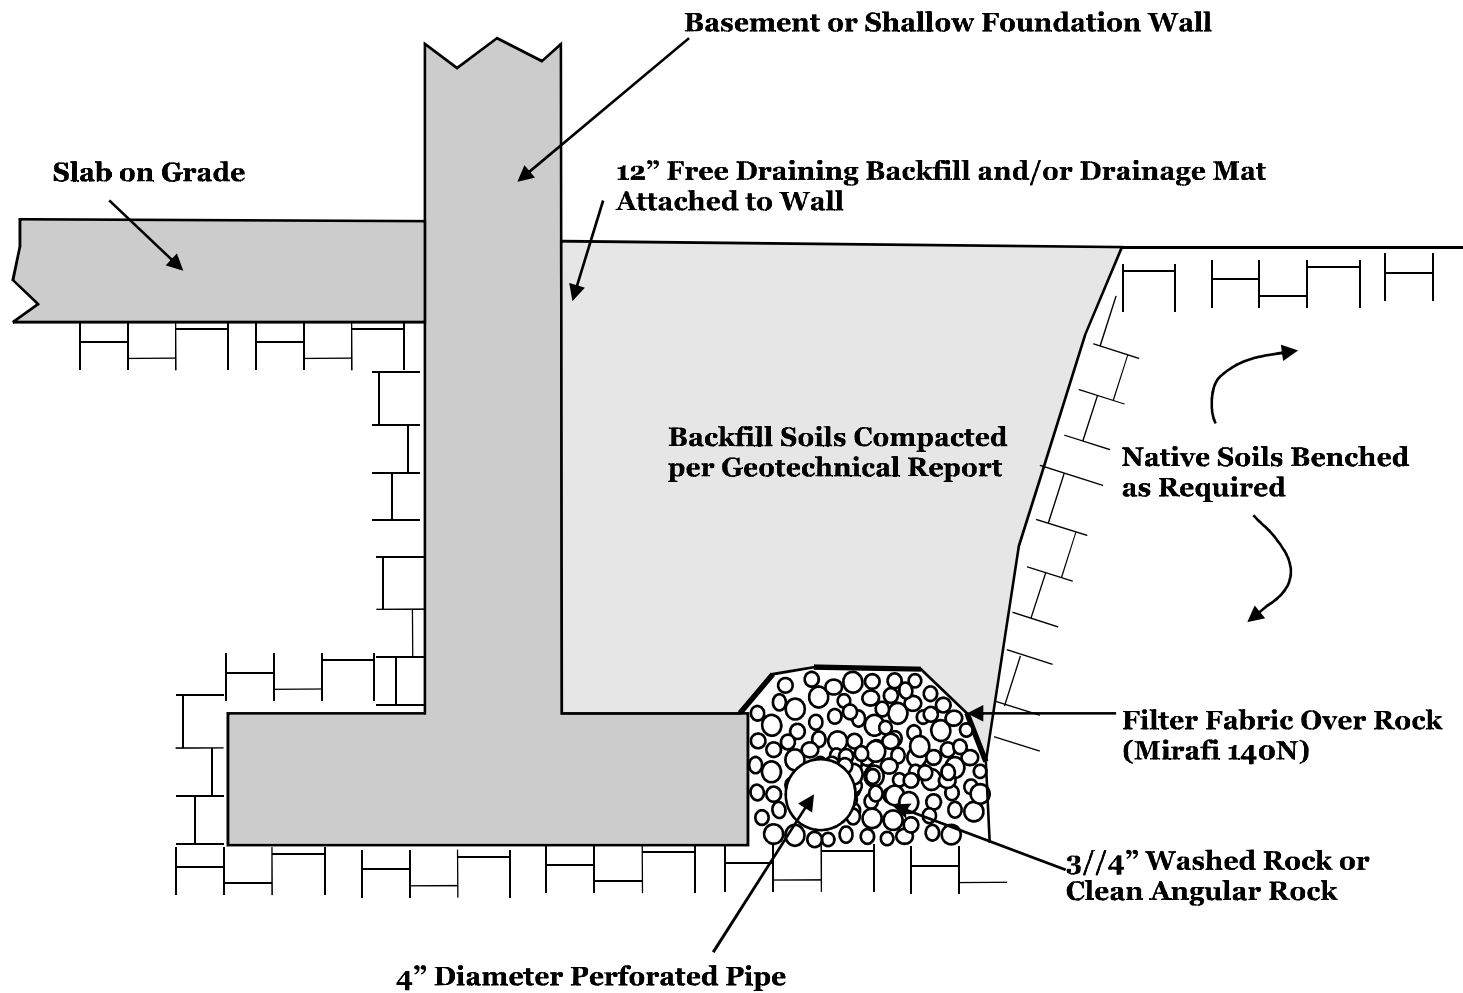
Typical Foundation Drain Detail

A perimeter drainage system is recommended unless interior slab areas are elevated a minimum of 12 inches above adjacent exterior grades. If installed, a perimeter drainage system should consist of a 4-inch diameter perforated drain pipe surrounded by a minimum 6 inches of drain rock wrapped in a non-woven geosynthetic filter fabric to reduce migration of soil particles into the drainage system. The perimeter drainage system should discharge by gravity flow to a suitable stormwater system.
