Subject: **Addendum to Geotechnical Report/Critical Area Study –  
Critical Area Mitigation Sequencing**  
Proposed Landscape Improvements  
8636 North Mercer Way  
Mercer Island, Washington

**SUBJECT: SUPPLEMENTAL RECOMMENDATIONS AND  
GEOTECHNICAL REVIEW**

Proposed Residence Replacement  
8636 North Mercer Way  
Mercer Island, Washington  
Project No. 10-117-01

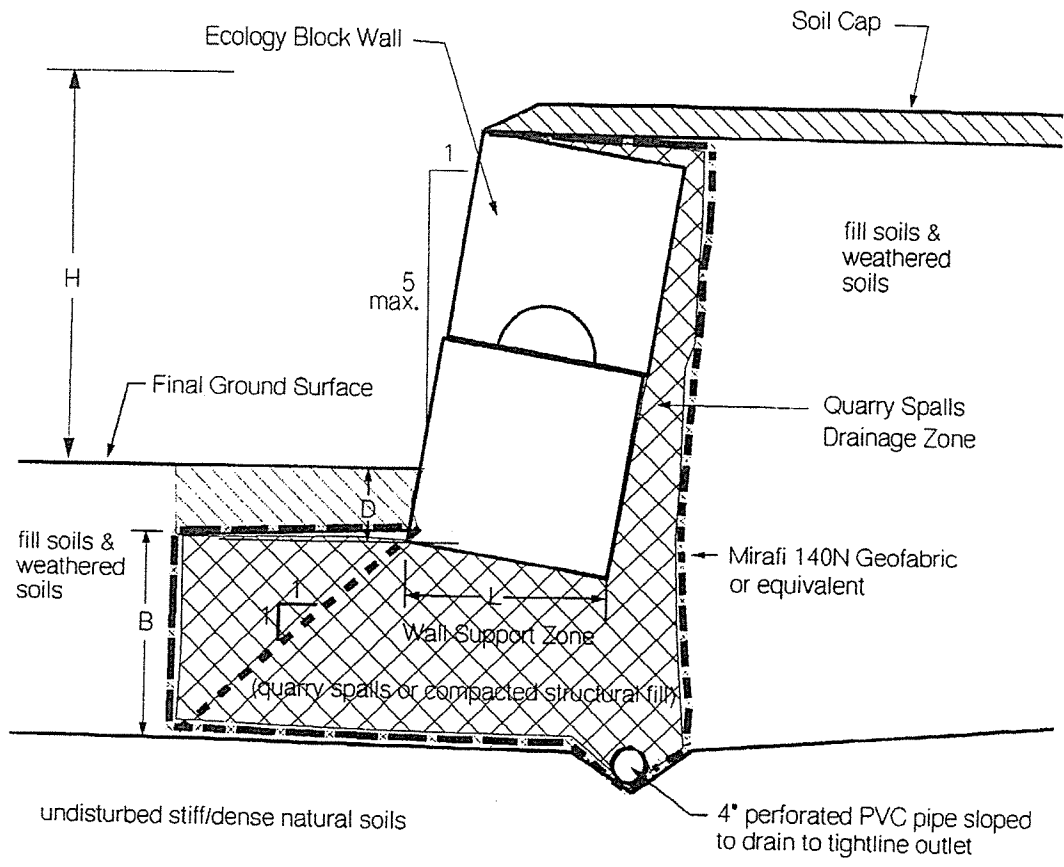
Quarry Spalls material, 4" to 6" maximum particle size with less than 5 percent fines (passing #200 sieve) and free of organics.
-

Soil cap, 6 inch minimum thickness, consisting of silty soil or topsoil of low permeability. Slope to drain away from the wall.
-

Perforated or slotted drain pipe, 4 inches minimum diameter with positive gradient to a tightline outlet pipe. The outlet pipe should have a non-erosive discharge into the storm drain system.
-

Mirafi 140 N geofabric or equivalent.
- H Wall height, measured from final ground surface. Maximum of 4 feet.
- D Soil embedment, minimum of 6 inches.
- L Wall width dimension, minimum of 2 feet.
- B Support zone thickness. Maximum thickness equal to 1/2 H, or depth to stiff/dense natural soils whichever is less.

**ECOLOGY BLOCK WALL DETAIL**

Ecology Wall Detail: We understand that ecology block walls are proposed to support landscape area grade changes up to 4 feet in height along the lower side of the proposed detached garage. Based on our previous site explorations and construction observations we expect the areas where ecology block walls are proposed may have fill and/or weathered soils exposed at the ground surface. We recommend that where fill and/or weathered soils are exposed at the proposed ecology block wall location, the existing soils should be excavated and replaced with a zone of structural fill or quarry spalls for support of the ecology block. The detail of Figure 7 attached, presents our recommendations for support and construction of the proposed ecology block walls.

Based on our review we find the rockery and ecology block wall facing details on the referenced C3.1 sheet to be in conformance with our supplemental recommendations for rockeries and ecology block walls as presented in this letter and the attached Figures 6 and 7.
