**PRELIMINARY CRITICAL AREAS STUDY  
FOR 5236 WEST MERCER WAY**

**Site Address / Tax Parcel Number:**  
5236 West Mercer Way, Mercer Island, WA 98040  
192405-9324

**Study Dated:**  
February 18, 2024

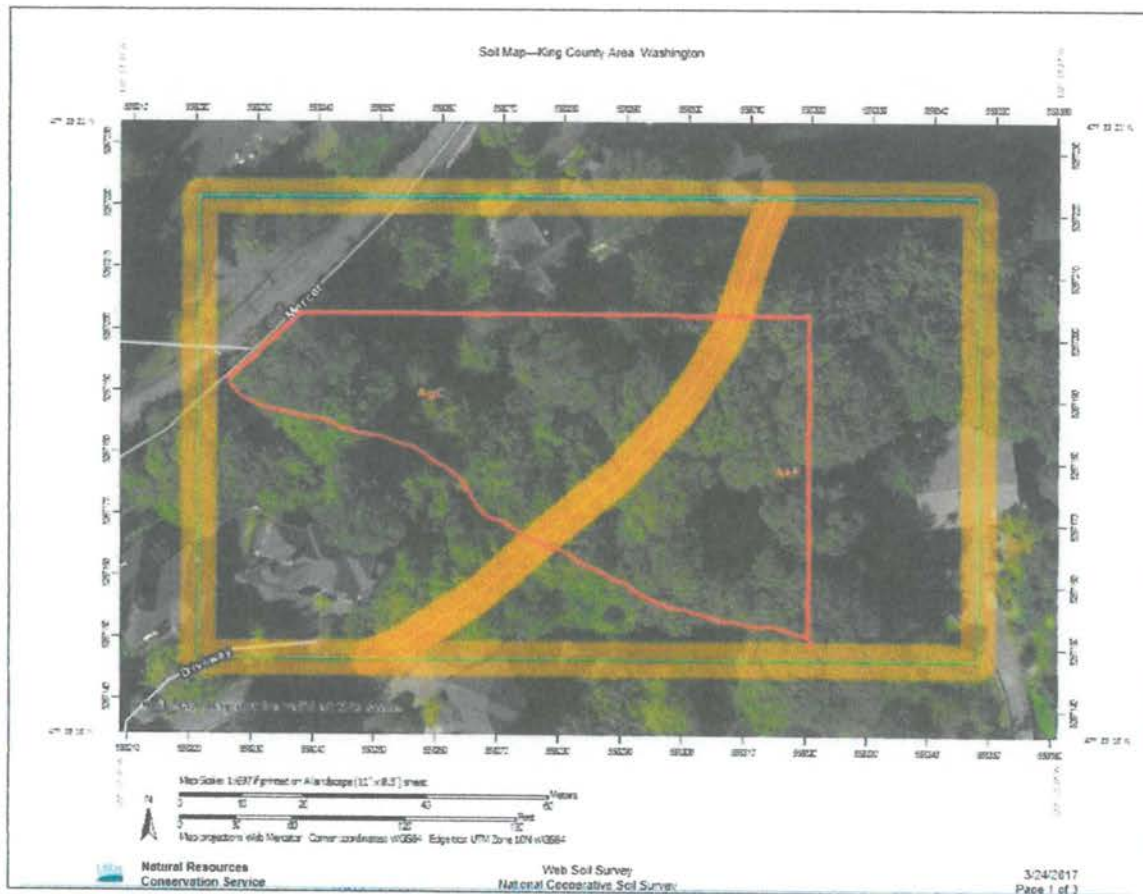
Figure 1 NRCS Soil Type Map

Per the NRCS online Web Soil Survey (NRCS, 2016), two soil types cover the site. *Alderwood gravelly sandy loam 8-15% slopes* (AcG) covers the west half. This soil type developed from glacial outwash. The site's east portion is covered in *Alderwood and Kitsap soils, very steep* (AkF). This soil type developed on glacial moraines and till plains. Both soil types are moderately well drained and feature water tables that are generally 18 to 37 inches below the surface. Neither of these soil types is hydric but field investigations are required to determine if hydric soils occupy small areas.

| King County Area, Washington (WA633) | | | |
|---|---|---|---|
| AgC | Alderswood gravelly sandy loam, 8 to 15 percent slopes | 1.3 | 55.3% |
| AkF | Alderswood and Kilsap soils, very steep | 1.0 | 44.7% |

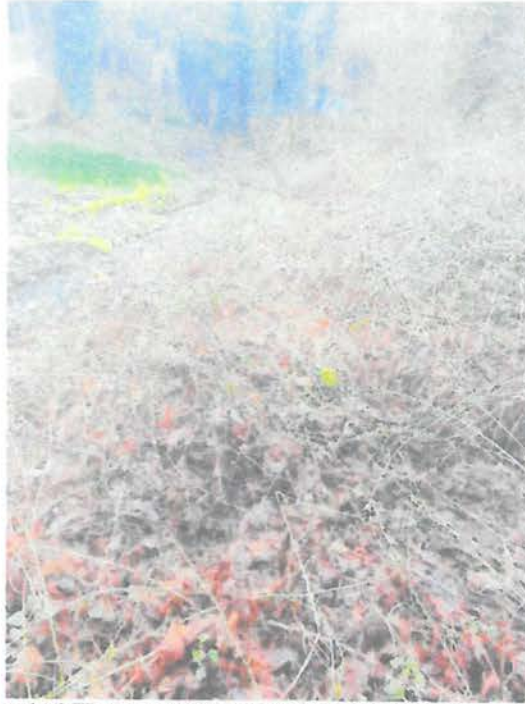
Picture 1: View of the western end of *Wetland W*. The onsite stream is in the upper left and the lawn is part of the property directly south of the site.

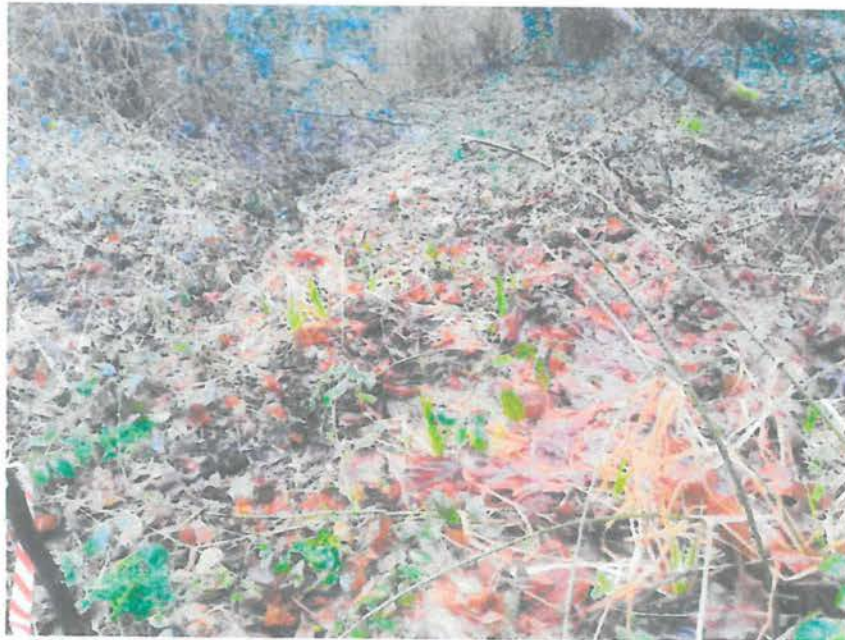
Picture 2: View of Sample Point 1, located within the east end of *Wetland W*. The photo was taken in mid-March and various emergent plants were sprouting including sawbeak sedge and giant horsetail.

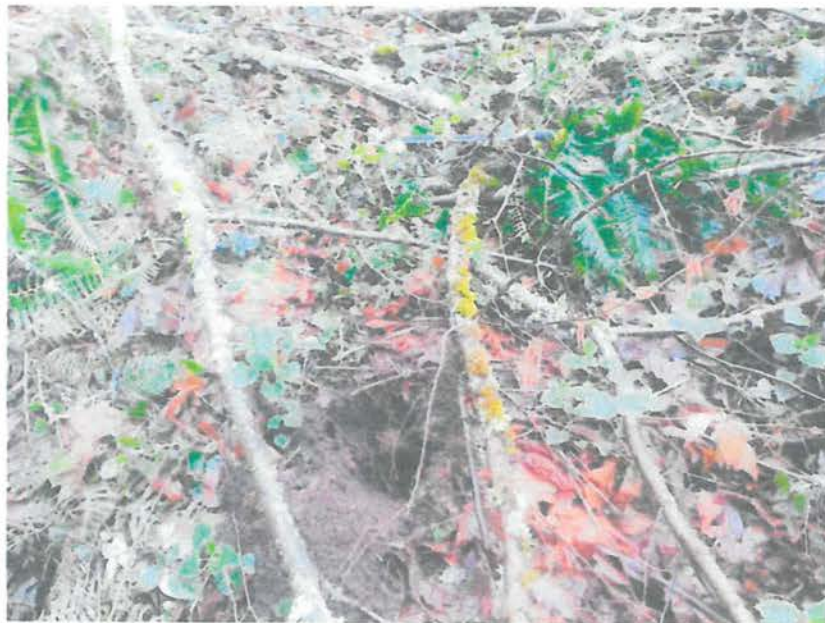
Picture 3: View of Sample Point 2, located just outside of *Wetland W*. This area had some hydrophytic plants such as stinging nettle but the plant community was not hydrophytic. Additionally, the soils had chroma 2 colors without redoximorphic features and were therefore not hydric and wetland hydrology was not present.

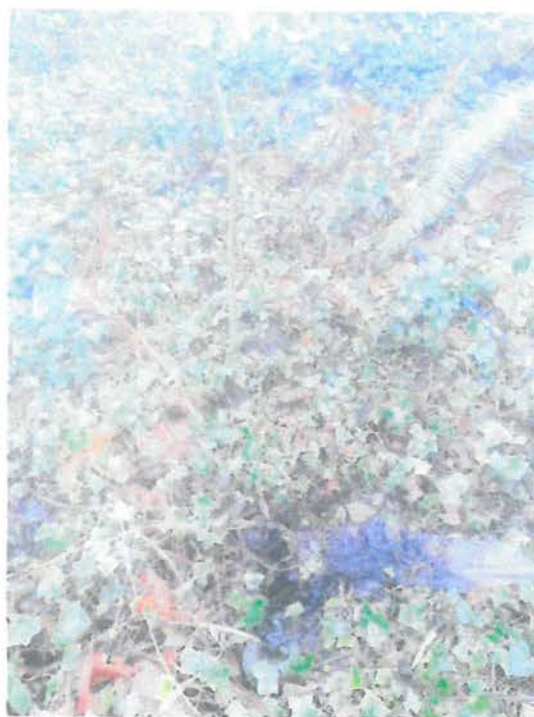
Picture 4: View of Sample Point 3, located on the central part of the site and within *Wetland W*. This area featured a hydrophytic plant community (lady fern had been dead and had not emerged at the time of the photo and red alder is not visible in this picture). The area also featured soils with chroma 1 colors that were saturated to the surface.
