# GEOTECHNICAL ENGINEERING REPORT

**Proposed Remodel  
3424 76<sup>th</sup> Place Southeast  
Mercer Island, WA 98040**

**Project No. 24-472  
Rev. July, 2025**

**Subject: Geotechnical Engineering Report – Revision 1  
Proposed Remodel  
3424 76<sup>th</sup> Place Southeast, Mercer Island, WA 98040**

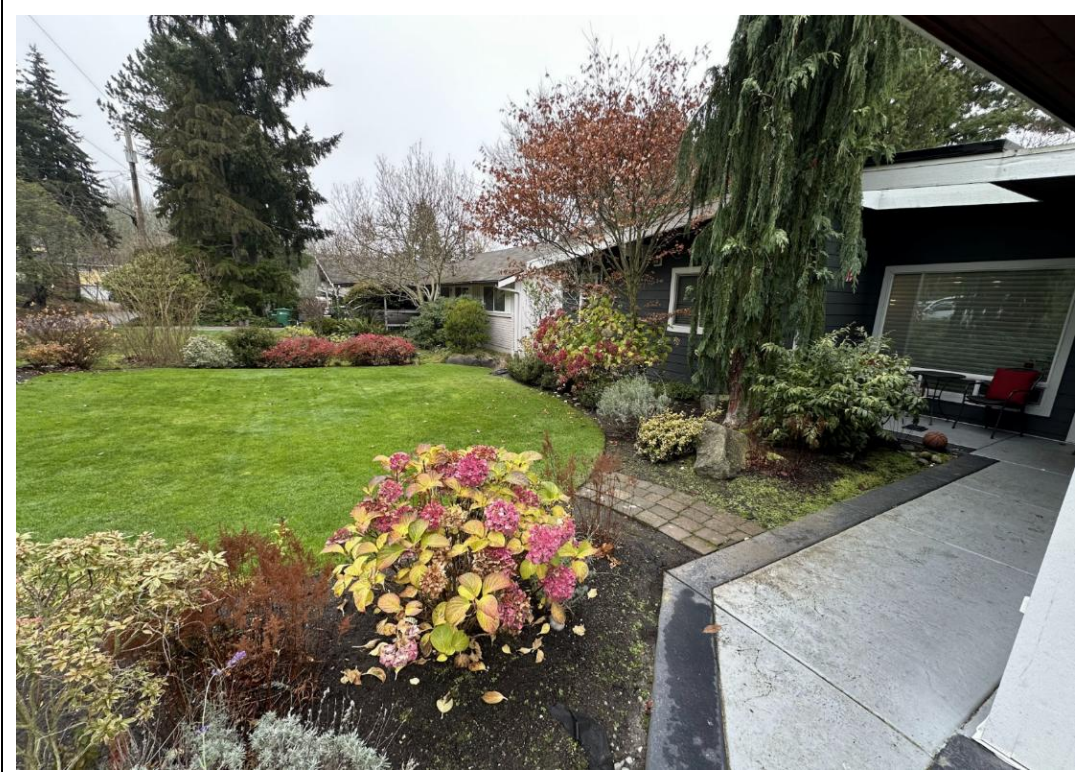
***Plate 1.*** View of the front yard of subject property near the proposed new entryway, looking northeast from the driveway.

(descending from first floor to daylit basement level) and on the east side of the backyard. Site conditions at the time of our site visits are shown on Plates 1 and 2 below.

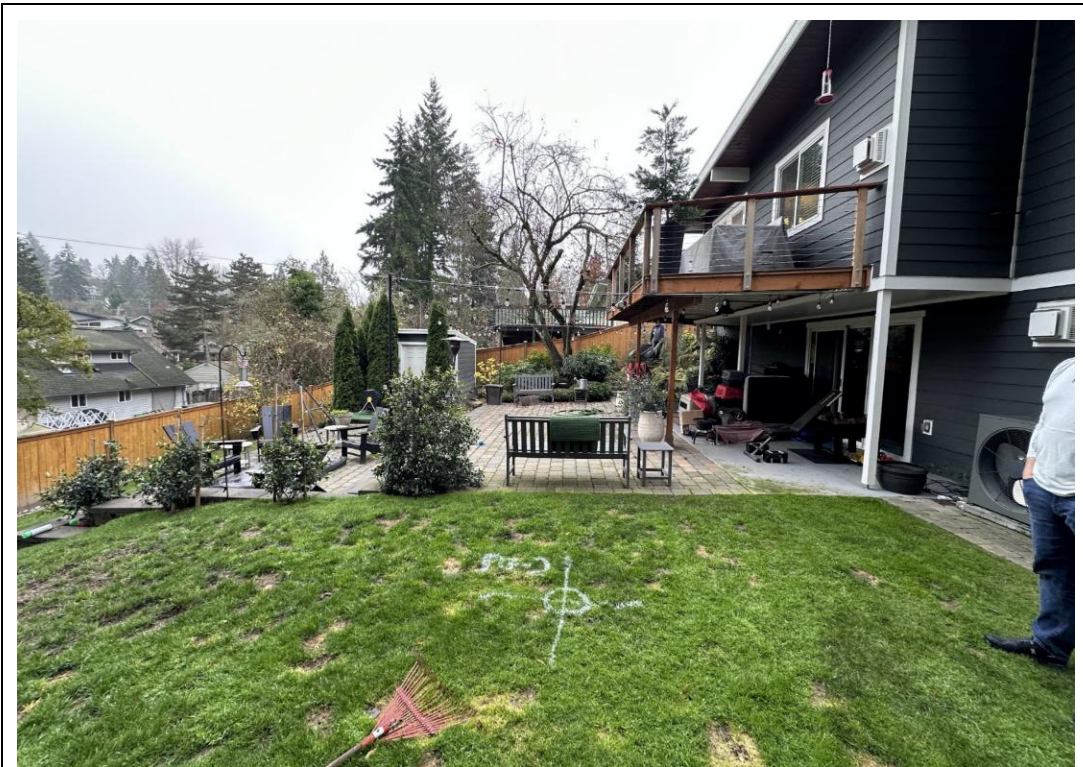
**Plate 2.** *View of the east side of the house near the proposed basement level additions, looking south.*

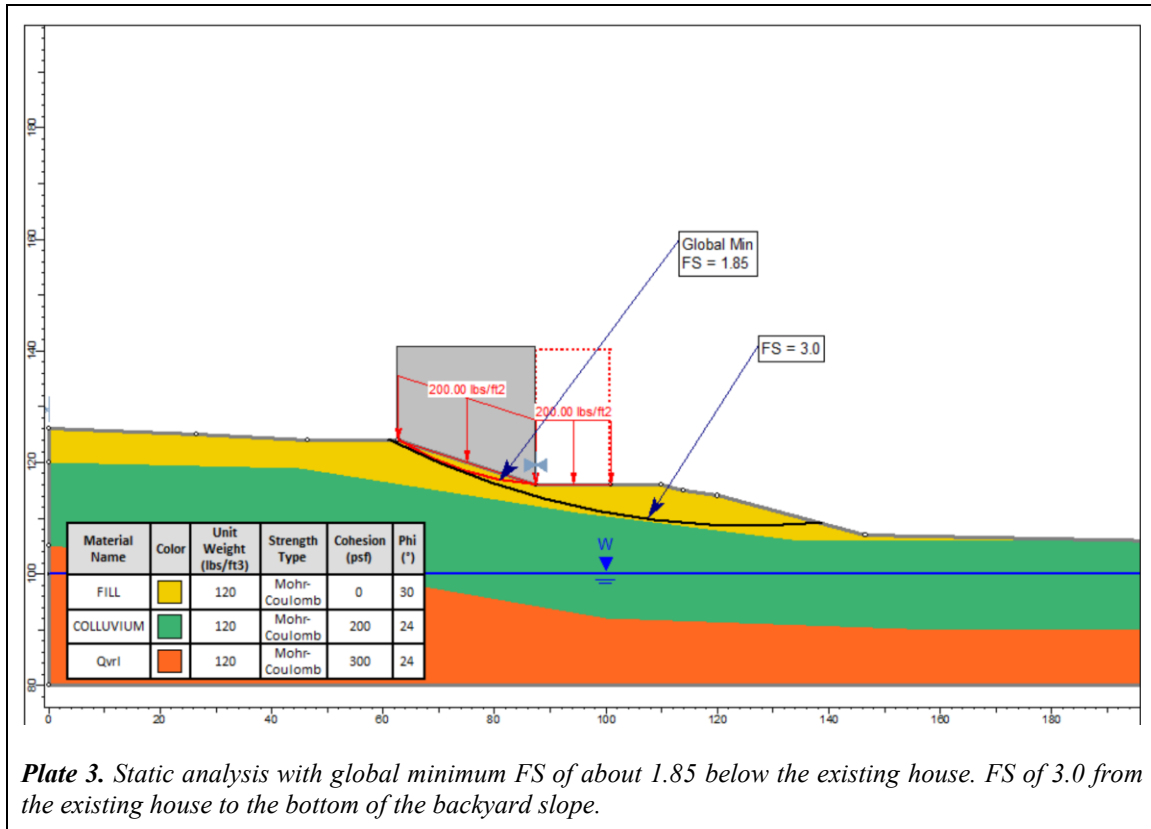
Based on the results from our analysis, we calculated minimum factors of safety for the existing site condition of 1.85 for the static case (see Plate 3 on the following page) and 1.17 for the seismic case (see Plate 4 on the following page). Additionally, for the post-liquefaction condition (i.e. immediately after earthquake while soil is liquefied), we calculated a minimum factor of safety of 1.38 (see Plate 5).

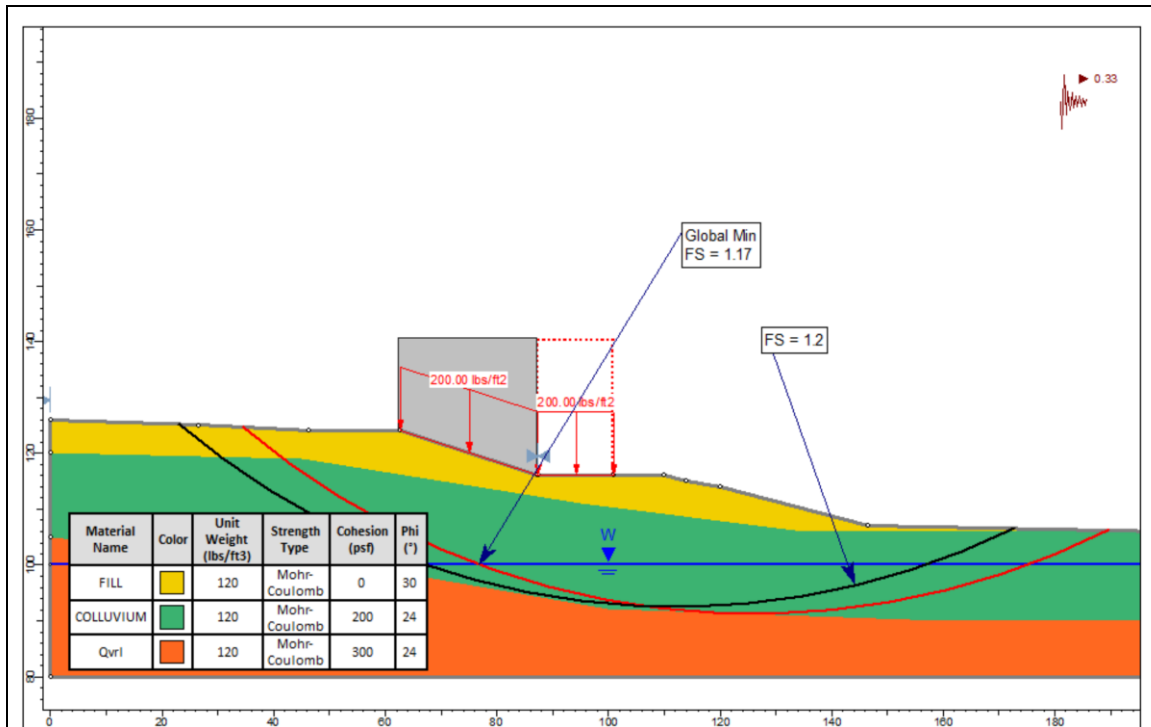
**Plate 4.** Seismic analysis with global minimum FS of about 1.17 along slope.

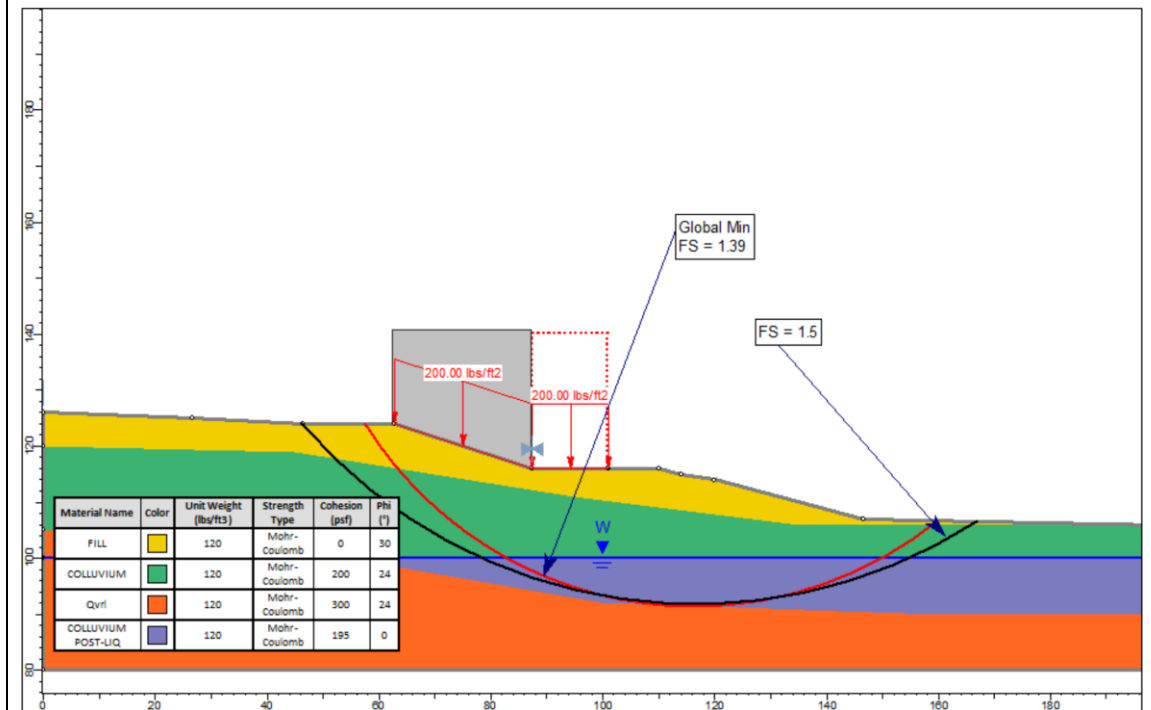
**Plate 5.** Post-liquefaction analysis with global minimum FS of about 1.39 along slope.

As summarized in [Section 5.1](#) above, we performed a slope stability analysis to assess the risk for lateral spreading due to liquefaction. We calculated a global minimum factor of safety of 1.39 for the post-liquefaction condition, indicating a relatively stable slope condition in the event of liquefaction. As such, it is our opinion that the risk for lateral spreading is low for the site and that additional mitigation measures to address lateral spreading are not needed for this site.

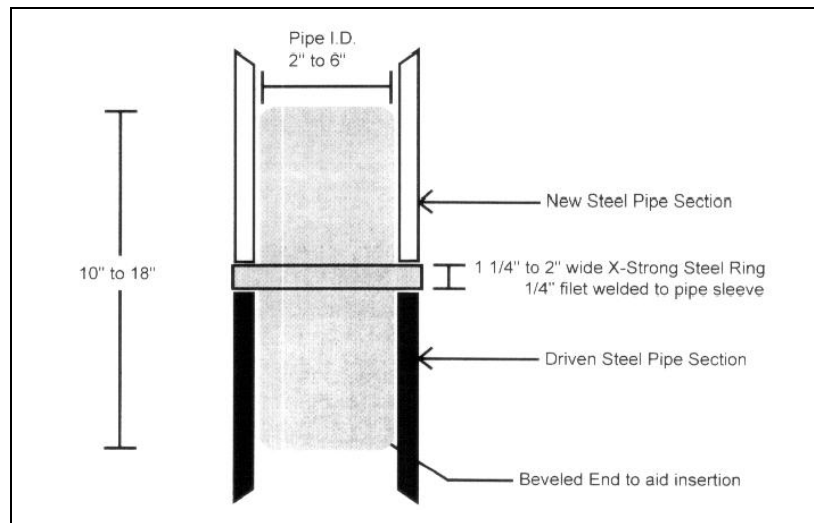
6. Piles shall be driven in nominal sections and connected with compression fitted sleeve couplers (see detail below – Courtesy of McDowell Pile King, Kent, WA). We discourage welding of pipe joints, particularly when galvanized pipe is used, as we have frequently observed welds broken during driving.

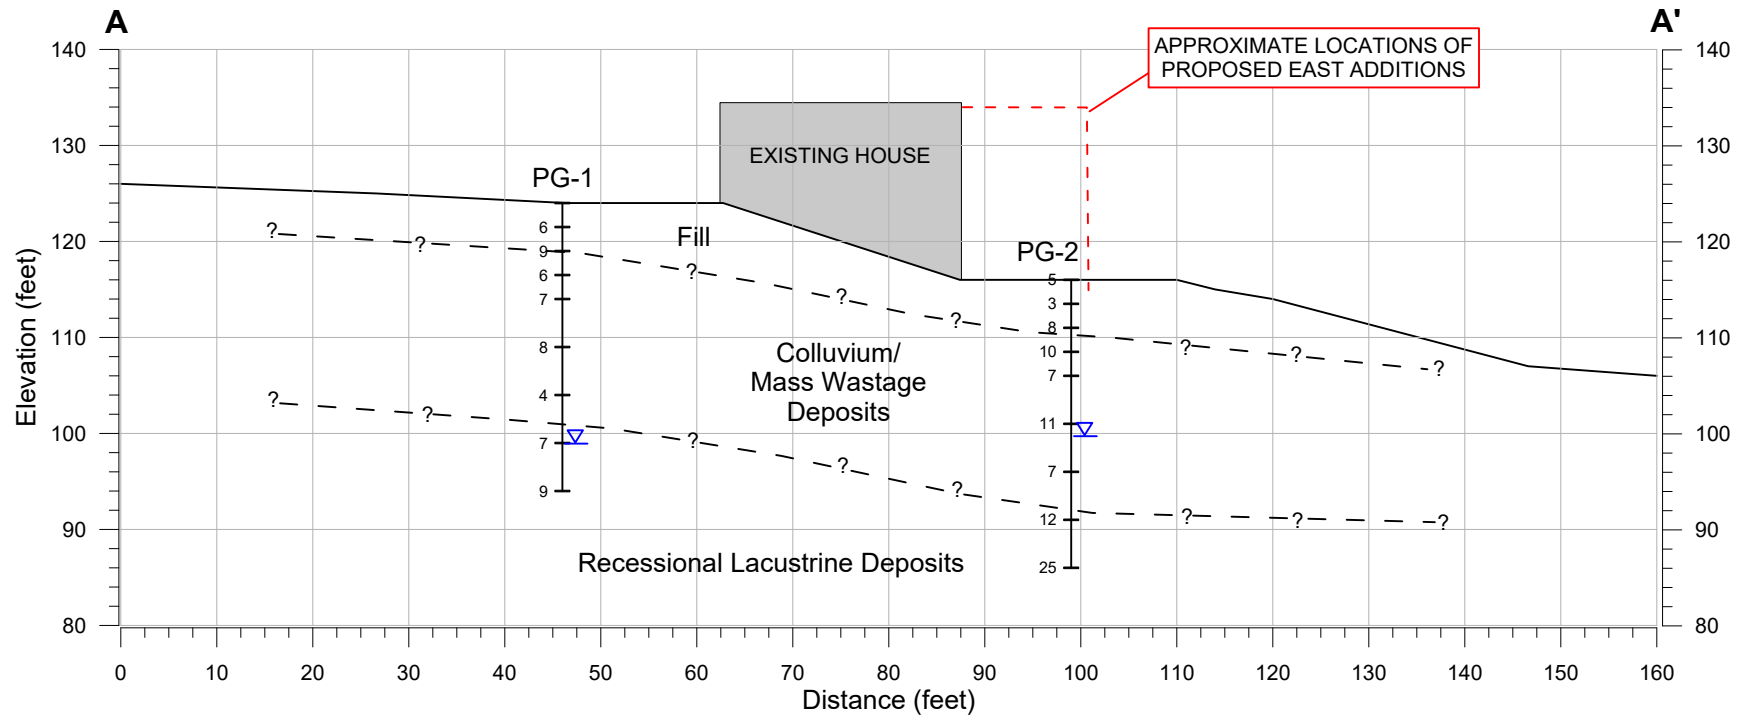
1. Ground surface elevations approximated from elevation contours shown on project topographic survey (see Figure 2).
2. Transitions between soil units and in between borings are best estimates and may vary from the actual soil conditions.
3. See Figure 2 for Site Plan view of the site with approximate profile location.

The analysis was based on the soil profile shown on Figure 3. The soil profile was oriented to be generally perpendicular to the slope and most critical to the slope stability. Our analysis was performed for the post-construction condition for both the static and seismic cases.

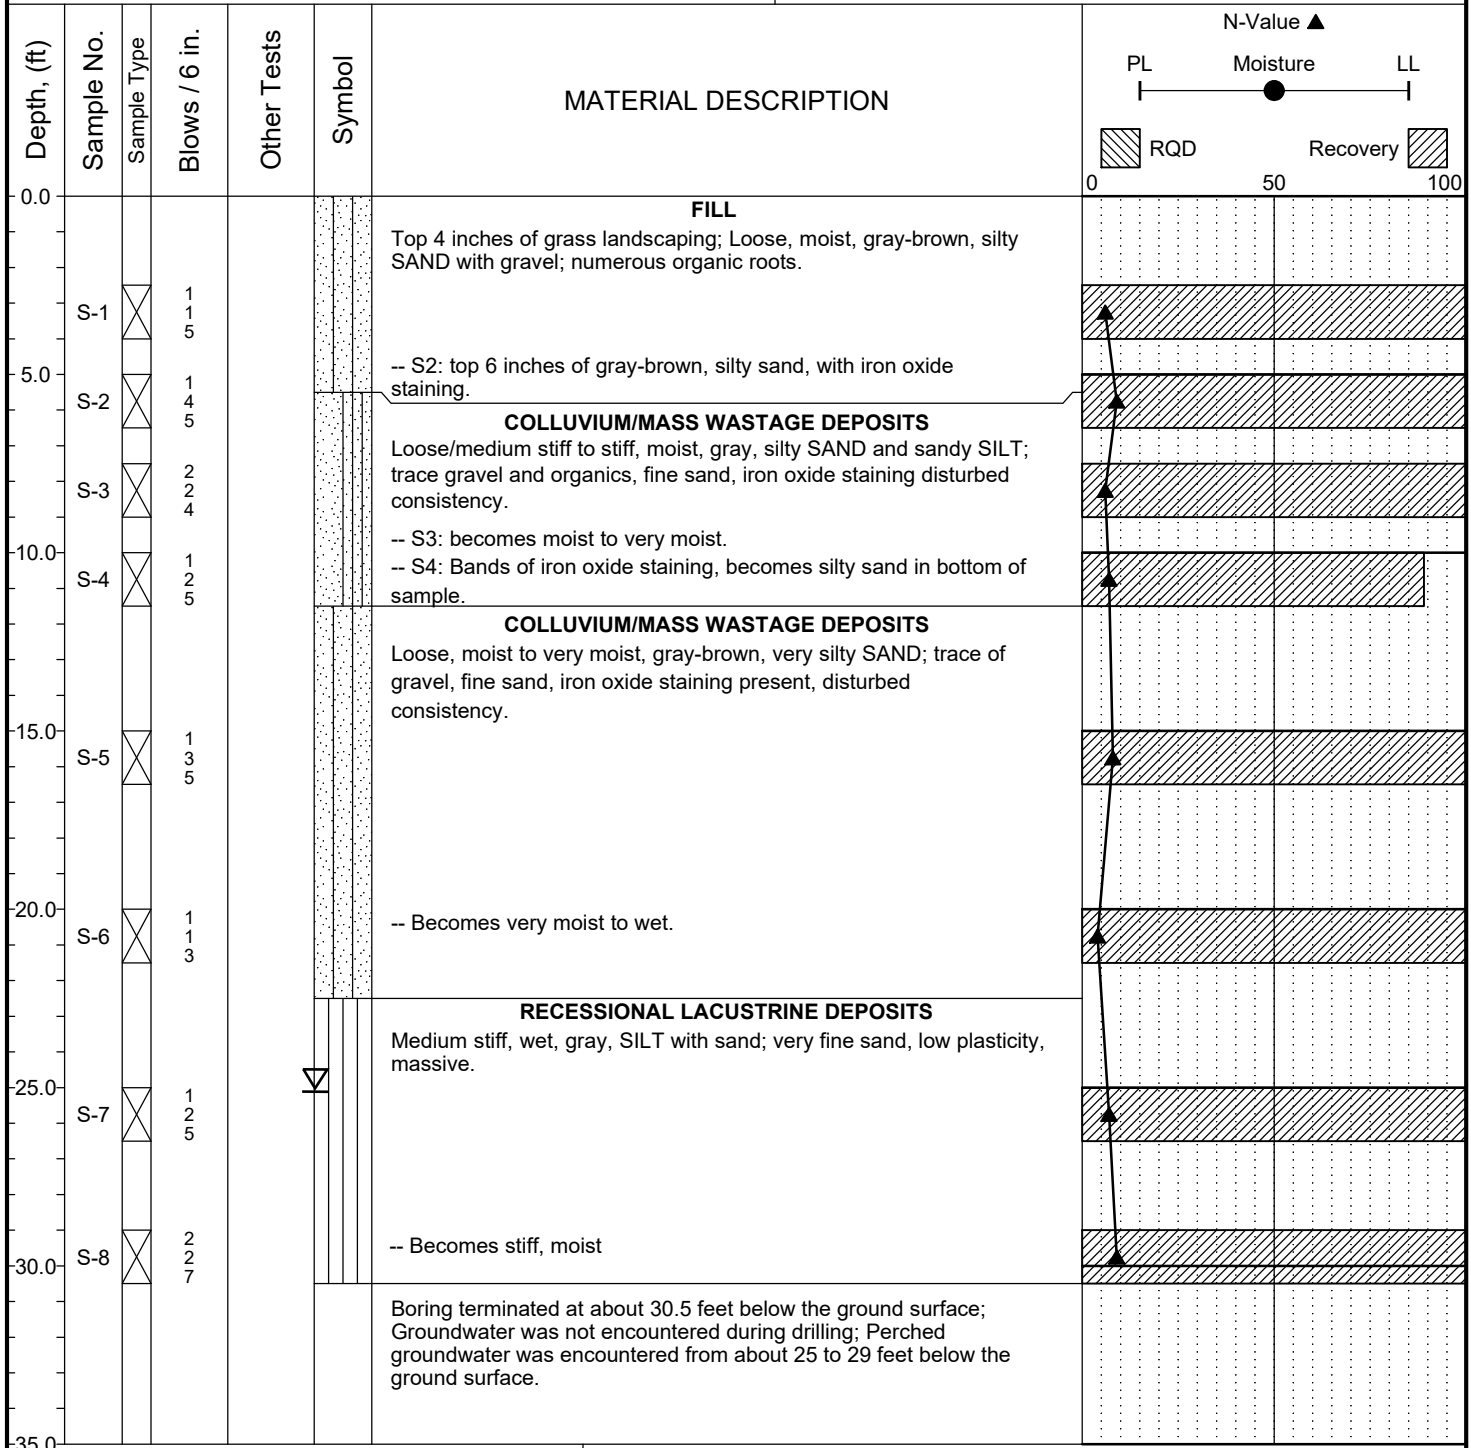
Completion Depth: 30.5ft  
 Date Borehole Started: 12/6/24  
 Date Borehole Completed: 12/6/24  
 Logged By: H. Wang  
 Drilling Company: CN Drilling

Remarks: Standard penetration test (SPT) sampler driven with a 140 lb. safety hammer. Hammer operated with a rope and cathead mechanism. Elevation is approximated from the Mercer Island GIS elevation contours. Coordinates are approximated based on their relative location to known site features. This information is provided for relative information only and is not a substitution for field survey. **Datum: WGS84/NAVD88.**

***Fill:*** In both PG-1 and PG-2, we encountered a surficial soil unit of very loose to loose, silty sand with gravel and organics. We interpret this soil unit as fill, which extended to about 5 to 6 feet deep in both test borings.

***Colluvium/Mass Wastage Deposits:*** Below the fill in both borings, we encountered about 6 to 10 feet of loose/medium stiff to stiff silty sand and sandy silt interbeds, overlying loose to medium dense, very silty sand. We interpret these soil units as colluvium/mass wastage deposits based on the disturbed and nonuniform consistency. The colluvium/mass wastage deposits extended to about 23 and 25 feet deep in borings PG-1 and PG-2, respectively.

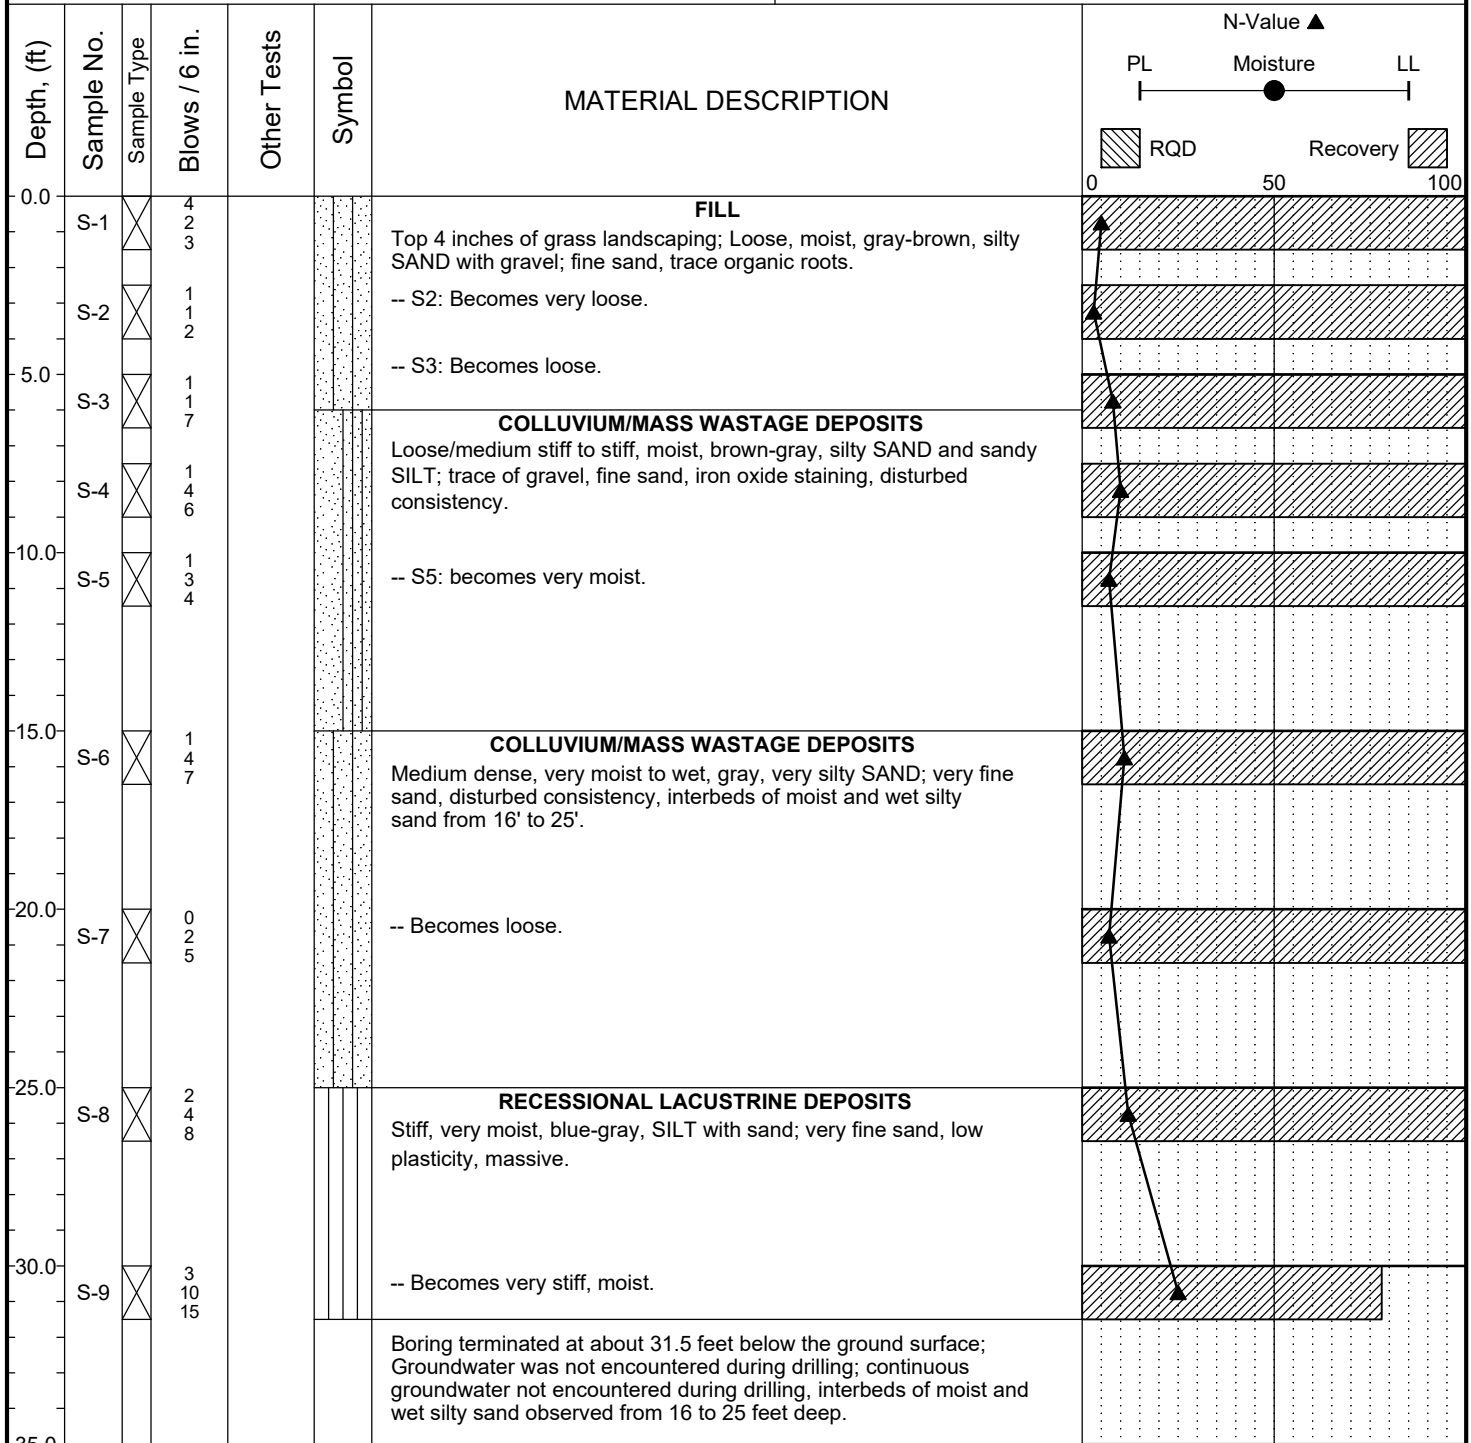
Completion Depth: 31.5ft  
 Date Borehole Started: 12/6/24  
 Date Borehole Completed: 12/6/24  
 Logged By: H. Wang  
 Drilling Company: CN Drilling

Remarks: Standard penetration test (SPT) sampler driven with a 140 lb. safety hammer. Hammer operated with a rope and cathead mechanism. Elevation is approximated from the Mercer Island GIS elevation contours. Coordinates are approximated based on their relative location to known site features. This information is provided for relative information only and is not a substitution for field survey. **Datum: WGS84/NAVD88.**
