# Altmann Oliver Associates, LLC

**SUBJECT: Critical Areas Report and Shoreline Enhancement for  
5320 & 5330 Butterworth Road, Parcels 866140-0040 and -0045  
Mercer Island, WA (Revised)**

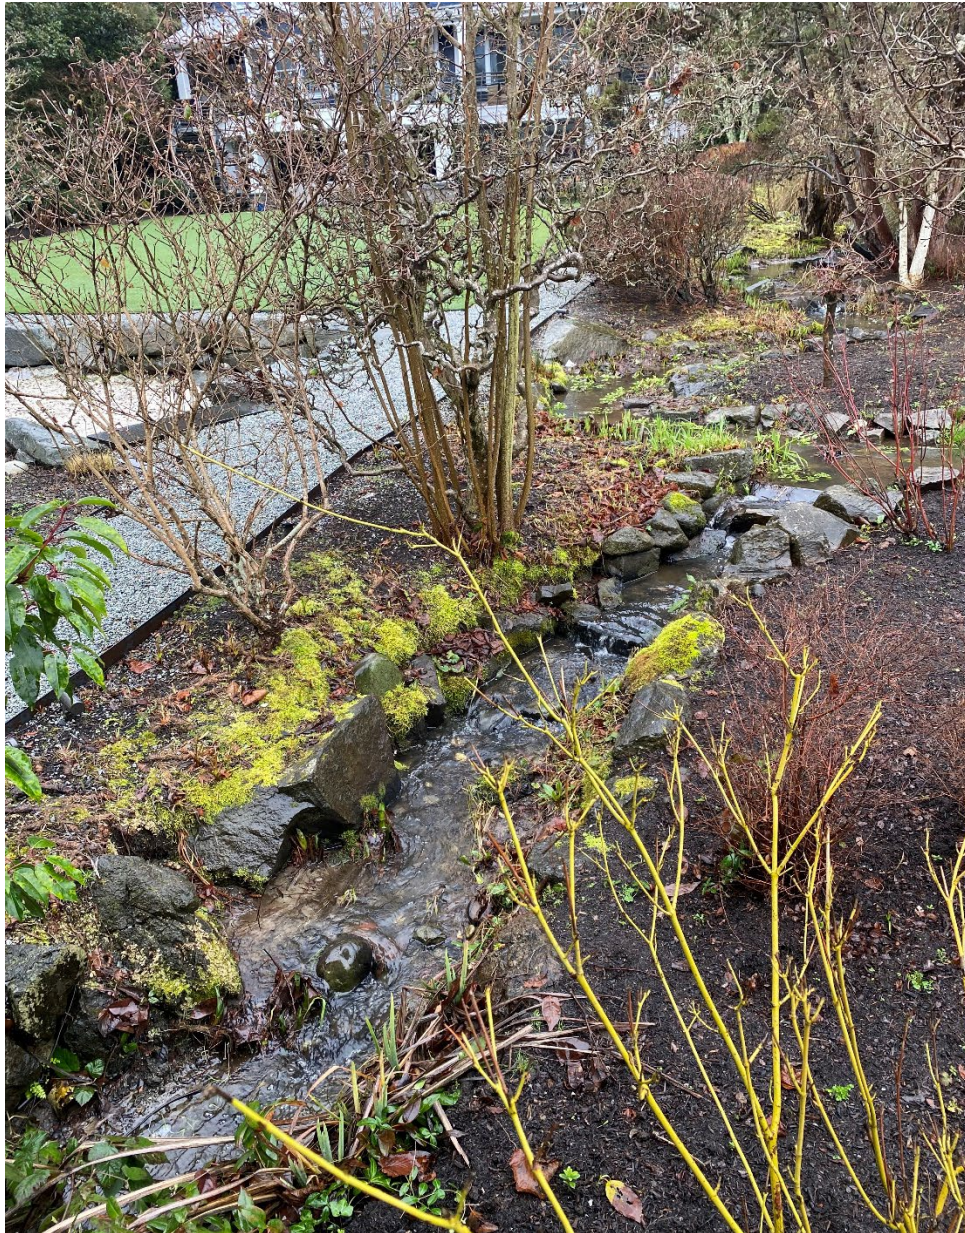
Stream 1 is entirely rock-lined and includes a small created pond (see survey). Vegetation within the corridor of the stream consists primarily of plantings associated with the landscaped areas.

Typical view of rocked stream channel with plantings.

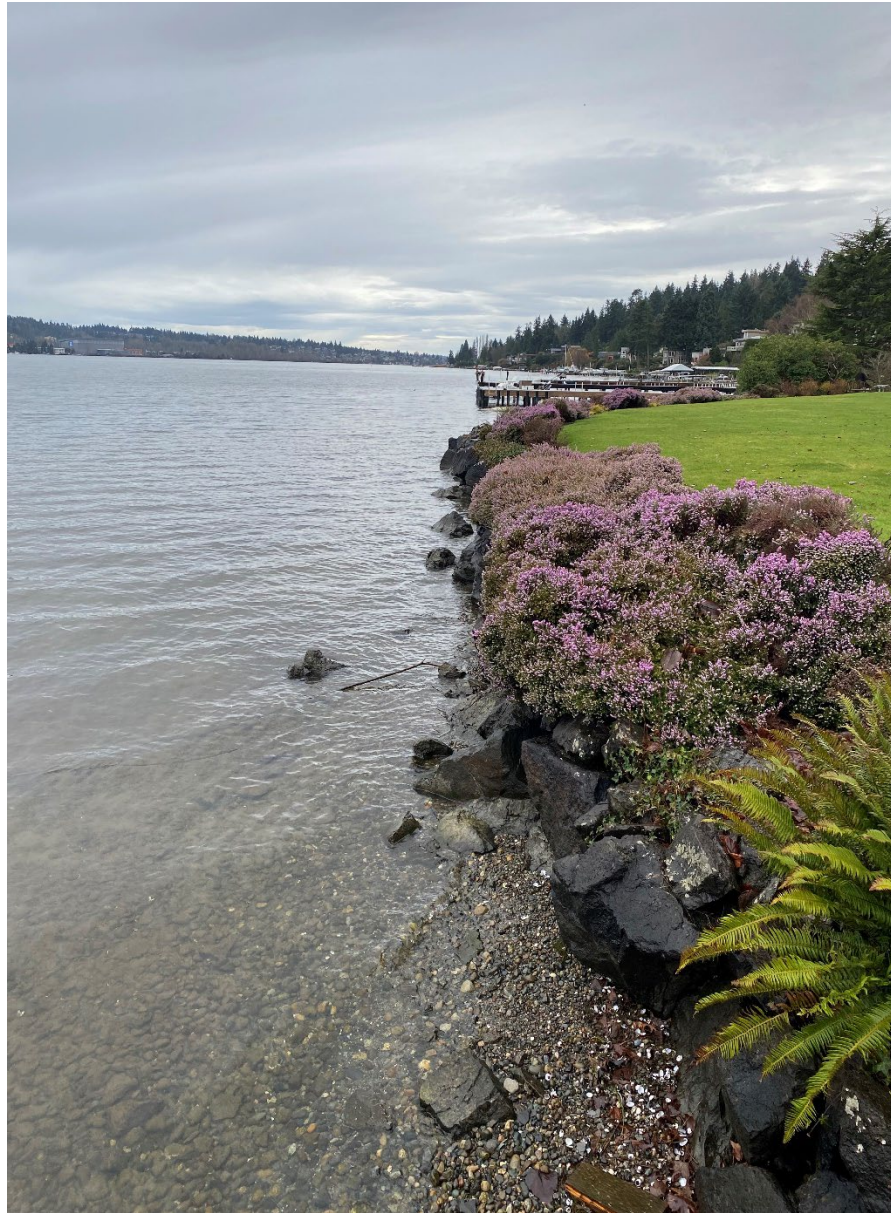
The site is currently entirely developed with a single-family residence, sport court, and associated maintained yard. No intact native or definitive hydrophytic plant communities were observed on the property and a mowed lawn and ornamental groundcover extends to the edge of a rocked bulkhead along the shoreline.

View of lawn and ornamental groundcover extending to edge of shoreline.

Based on the site plan you have provided; we have prepared a planting plan (**Figures 1 through 6**) that maximizes native plantings along the shoreline. The proposed plantings have been designed to increase the plant species and structural diversity along the shoreline and to provide physical and visual screening to the shoreline from the residence. Increasing the plant species and structural diversity within the shoreline would also increase the wildlife habitat of the area over current conditions.
