**FACET**

# Drainage Report – Rev 1

**ADDRESS:** 6427 E Mercer Way Mercer Island, WA 98040

**FOR SUBMITTAL TO:  
CITY OF MERCER ISLAND**

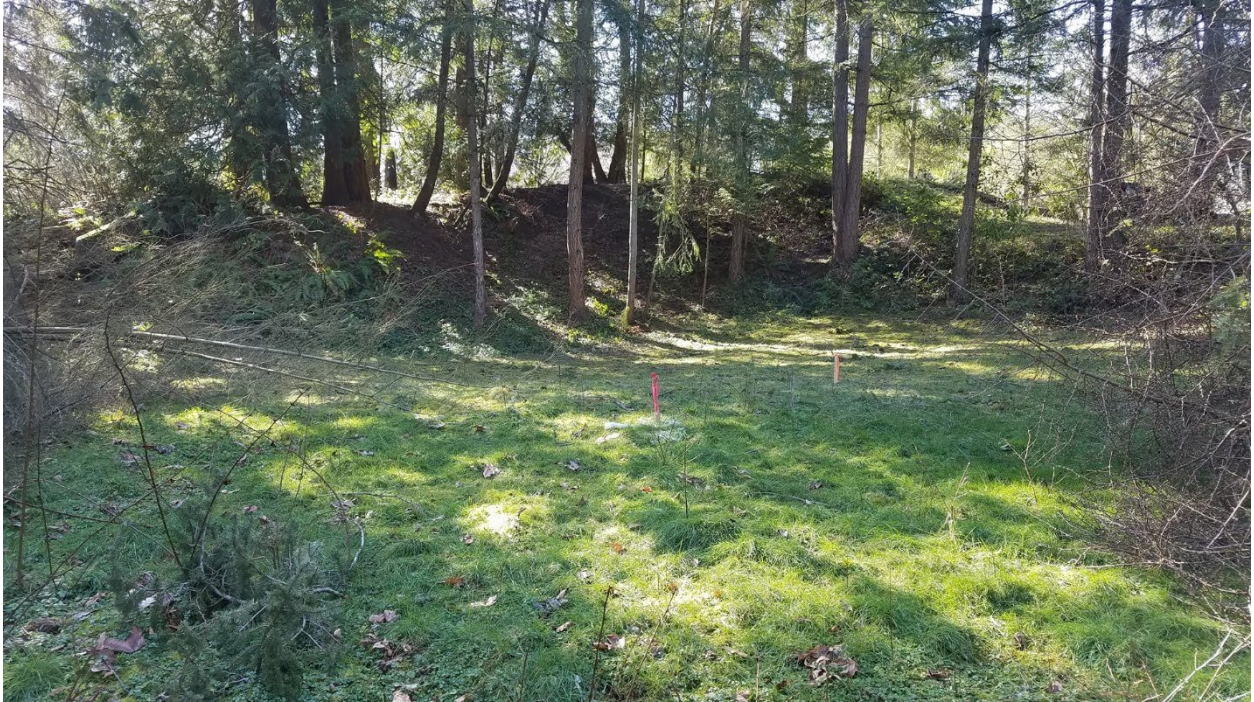
*Plate 1 – General conditions of the East Lot bowl area, looking south. (3/1/2019)*

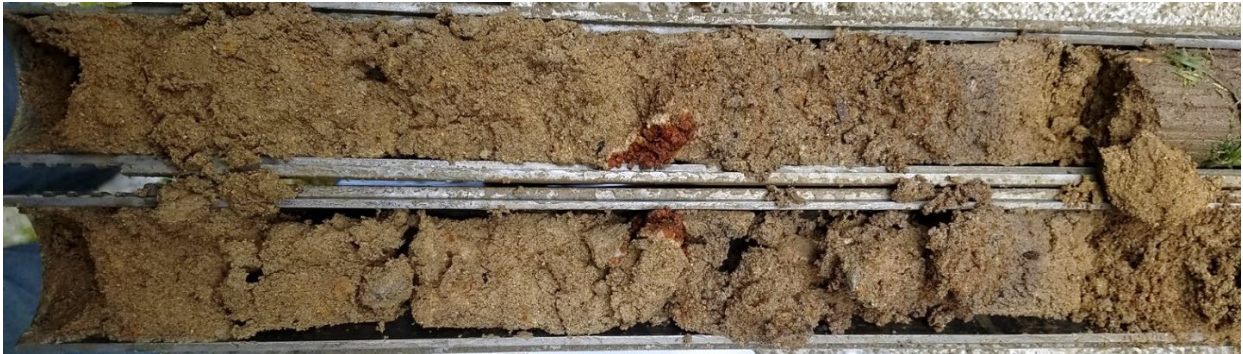
*Plate 3 –Hf | Loose, silty sand | PG-2, S-1 @ 2½ – 4 feet.*

Selected Sample Photos: *Plates 3 through 5* below depict select soil samples obtained from our recent test borings. For reference purposes, the split-soon samplers pictured below have an outside diameter of 2 inches.

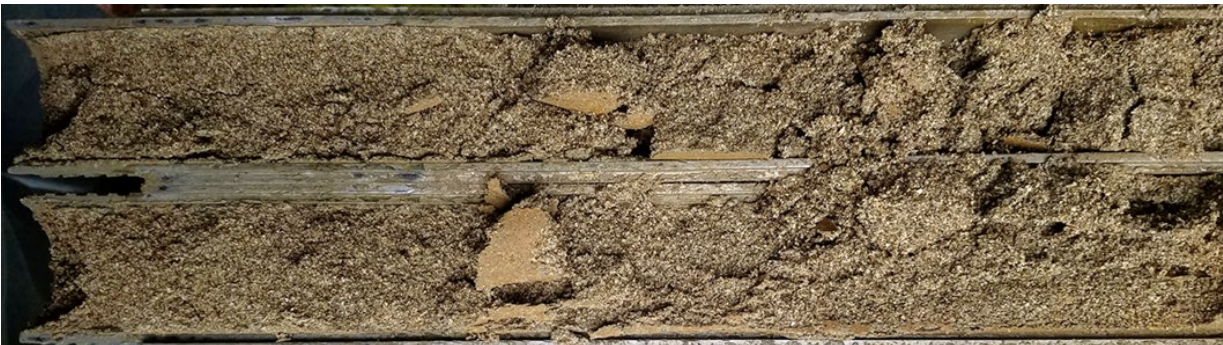
*Plate 5 – Nonglacial Deposits Qpon | Medium Dense to Very dense, SAND, trace silt | PG-1, S-2 @ 5 – 6½ feet.*

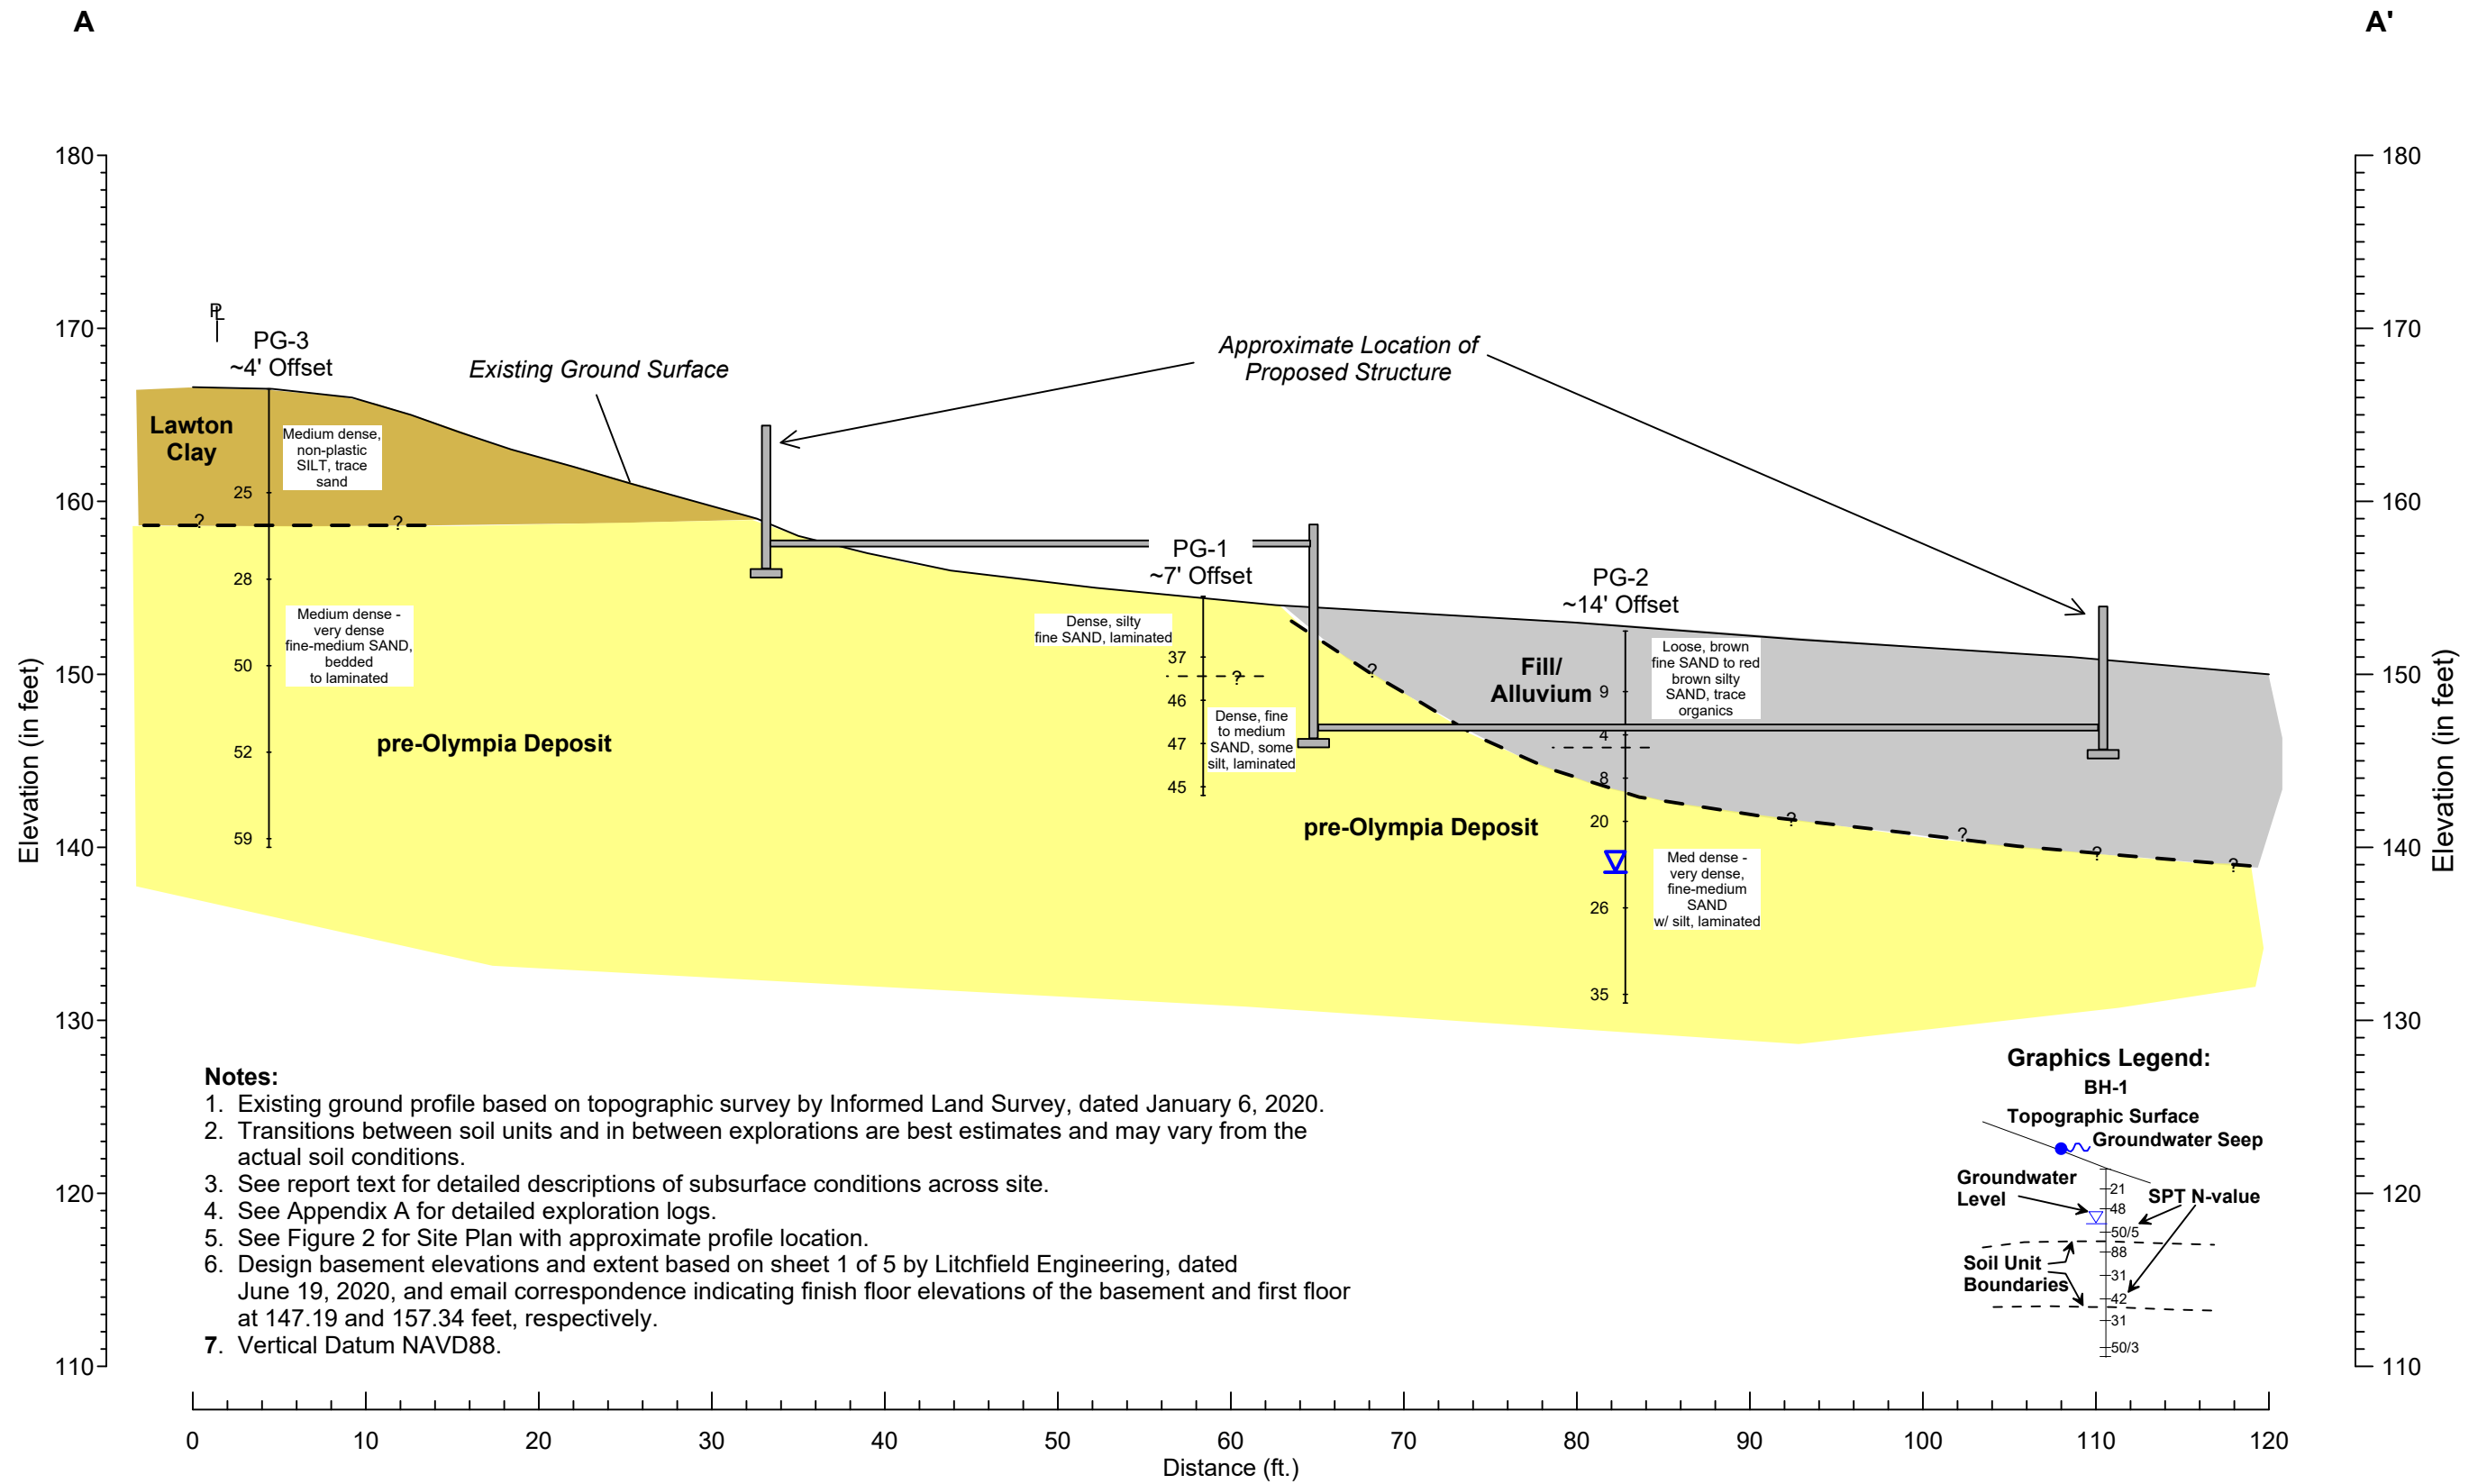
<b>Proposed Single Family Residence</b> 6427 East Mercer Way Mercer Island, Washington	<b>GENERALIZED SUBSURFACE PROFILE SECTION A-A'</b>	
		Project No. 25-036.100	Figure No. 3

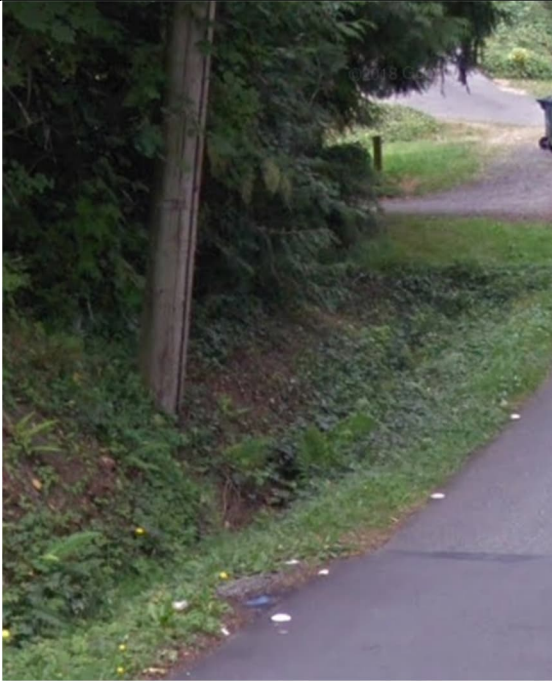
Photo 1 (looking north): culvert flowing north into type 1 catch basin. 8" corrugated polyethylene pipe flowing north.

There was no visual indication of conveyance system capacity problems, localized flooding, erosion impacts, or violations of surface water quality standards. Additionally, there was no evidence of any damage to the drainage system. See Appendix E of this report for the Downstream Drainage Exhibit and Downstream Analysis Photos.

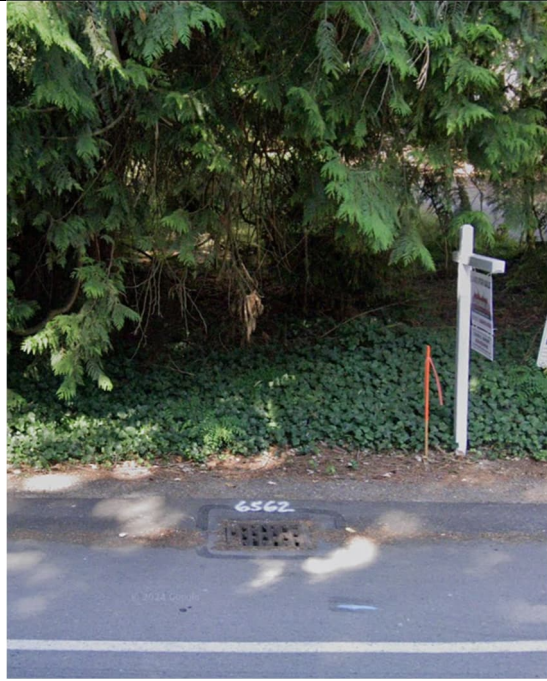
Photo 2 (looking west): type 1 catch basin. 12" concrete pipe flowing north.
