April 24, 2025  
Updated October 3, 2025

**RE: Geotechnical Evaluation**  
Proposed Additions  
9640 SE 61st Place  
Mercer Island, Washington

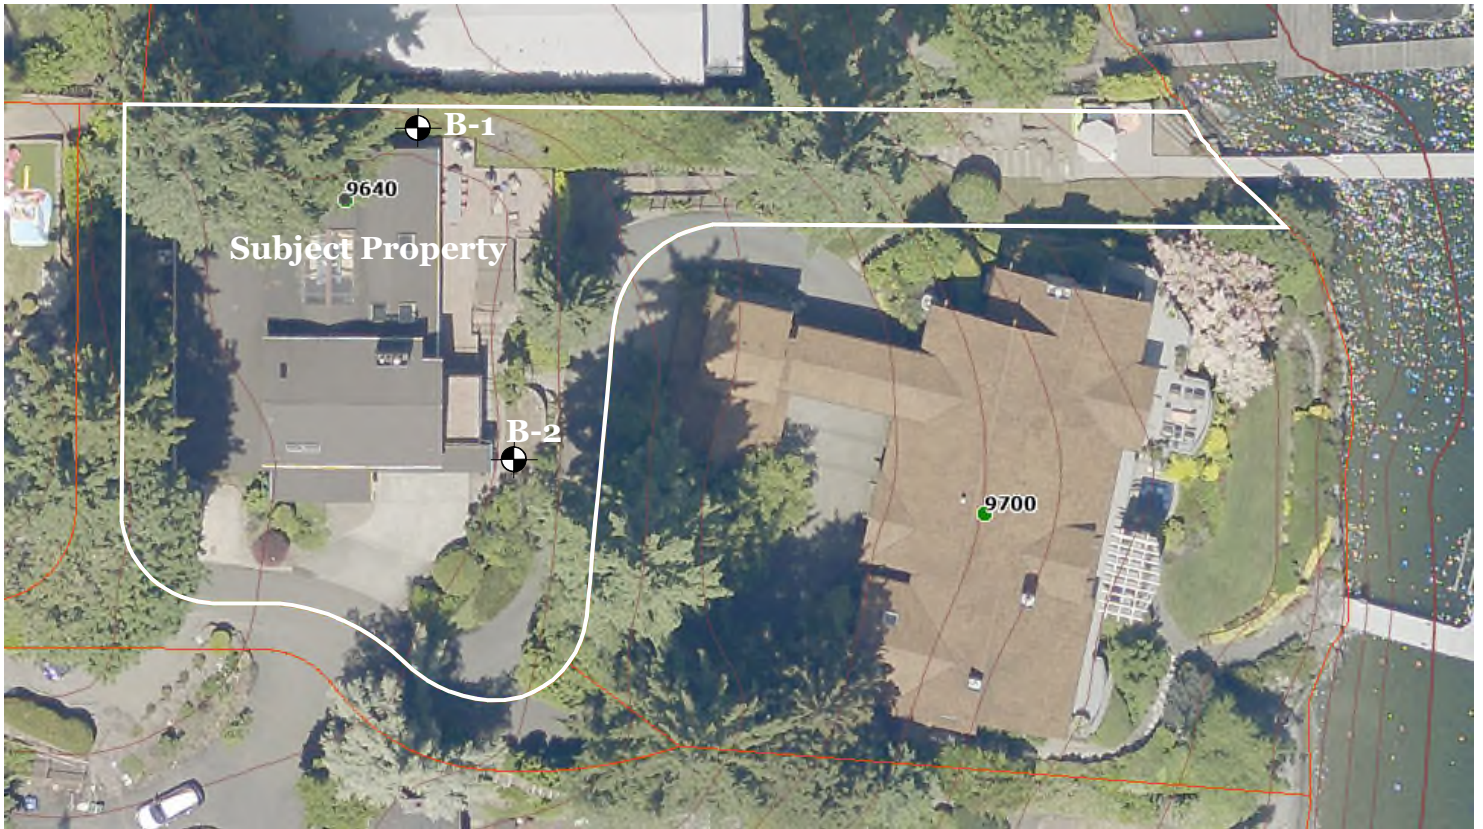
**Site Image**  
**Figure 1**

**Approximate Boring  
Location**  
B-1

King County imap Image

As part of our evaluation, we drilled two hollow stem auger borings where accessible.
