October 31, 2025  
File No. 25-324

Lisa & Ben Jones  
4110 78<sup>th</sup> Avenue SE  
Mercer Island, WA 98040

**Subject:       Geotechnical Report  
                  Proposed House Remodel  
                  4110 78<sup>th</sup> Avenue Southeast, Mercer Island, WA**

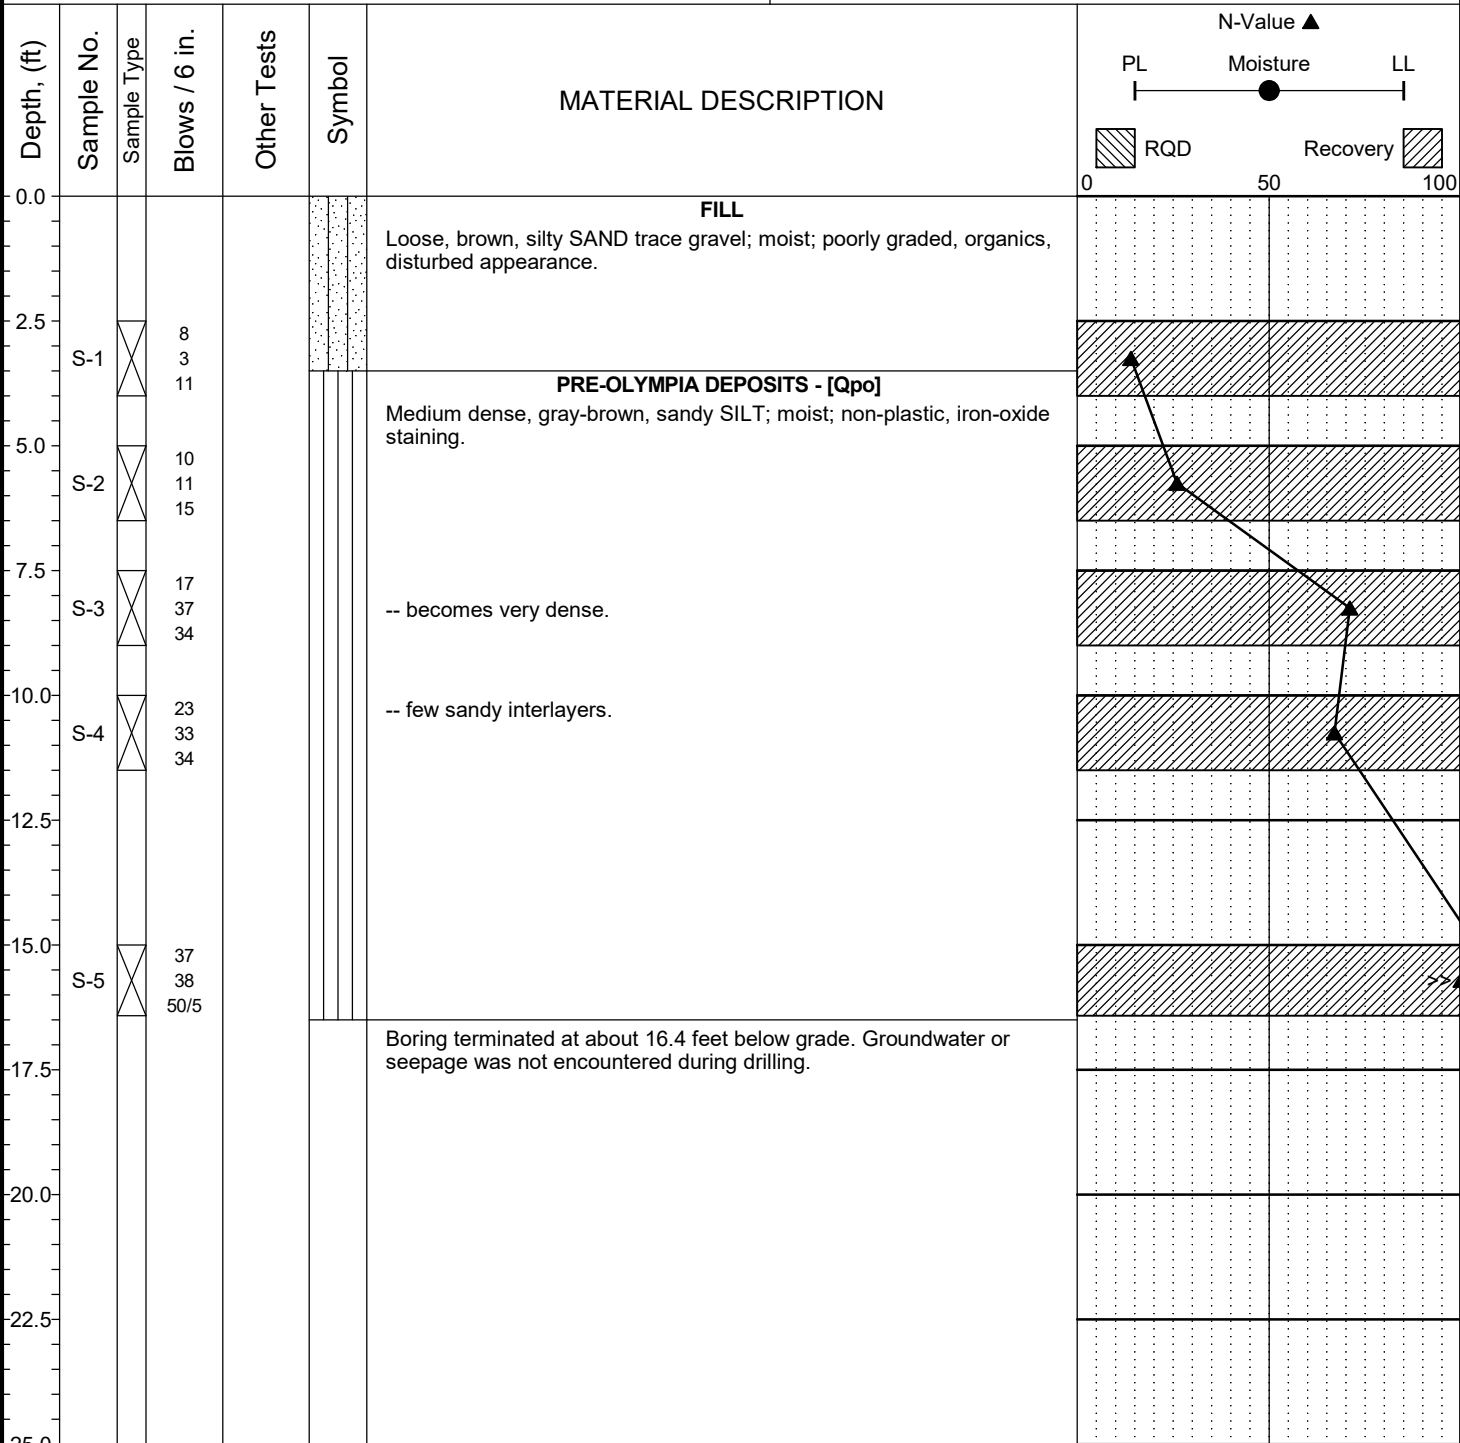
Project:	Proposed House Remodel	Surface Elevation:	185.0ft
Job Number:	25-324	Top of Casing Elev.:	N/A
Location:	4110 - 78th Ave SE, Mercer island, WA	Drilling Method:	HSA
Coordinates:	Northing: 47.5731, Easting: -122.2346	Sampling Method:	SPT

Completion Depth:	16.4ft	Remarks: Borings drilled using a modified Bobcat MT 55 skid steer mini drill rig. Standard penetration test (SPT) sampler driven with a 140 lb. safety hammer. Hammer operated with a rope and cathead mechanism. Surface elevations estimated from Site Plan prepared by H2D Architecture and design dated Sept 1, 2025. <b>Horizontal/Vertical Datum: WGS84/NAVD 88</b>
Date Borehole Started:	9/17/25	
Date Borehole Completed:	9/17/25	
Logged By:	S. Paquet	
Drilling Company:	Geologic Drill Partners

A geologist from PanGEO was present to observe the drilling, assist in sampling, and to describe and document the soil samples obtained from the borings. The soil samples were described and field classified in general accordance with the symbols and terms outlined in Figure A-1 of Appendix A, and the summary boring logs are included as Figures A-2 and A-3.

The soils encountered in the test borings consisted of up to about 3½ feet of loose to medium dense fill overlying medium dense to very dense and hard native sandy silt and silt. This soil unit extended to the maximum depths drilled at about 16½ feet. This soil unit appears to be consistent with the mapped pre-Olympia deposits. Please refer to the boring summary logs in Appendix A for a detailed description of the conditions encountered at each boring location.

Based on the subsurface conditions encountered at the site and our understanding of the current design, it is our opinion that the proposed improvements may be supported on conventional footings. New footings should bear on competent native soils or on newly placed structural fill placed on undisturbed native soils. In summary, the competent bearing soils are estimated at about 3½ feet below the existing grade at boring PG-1, and at about 1½ feet below grade at boring PG-2.

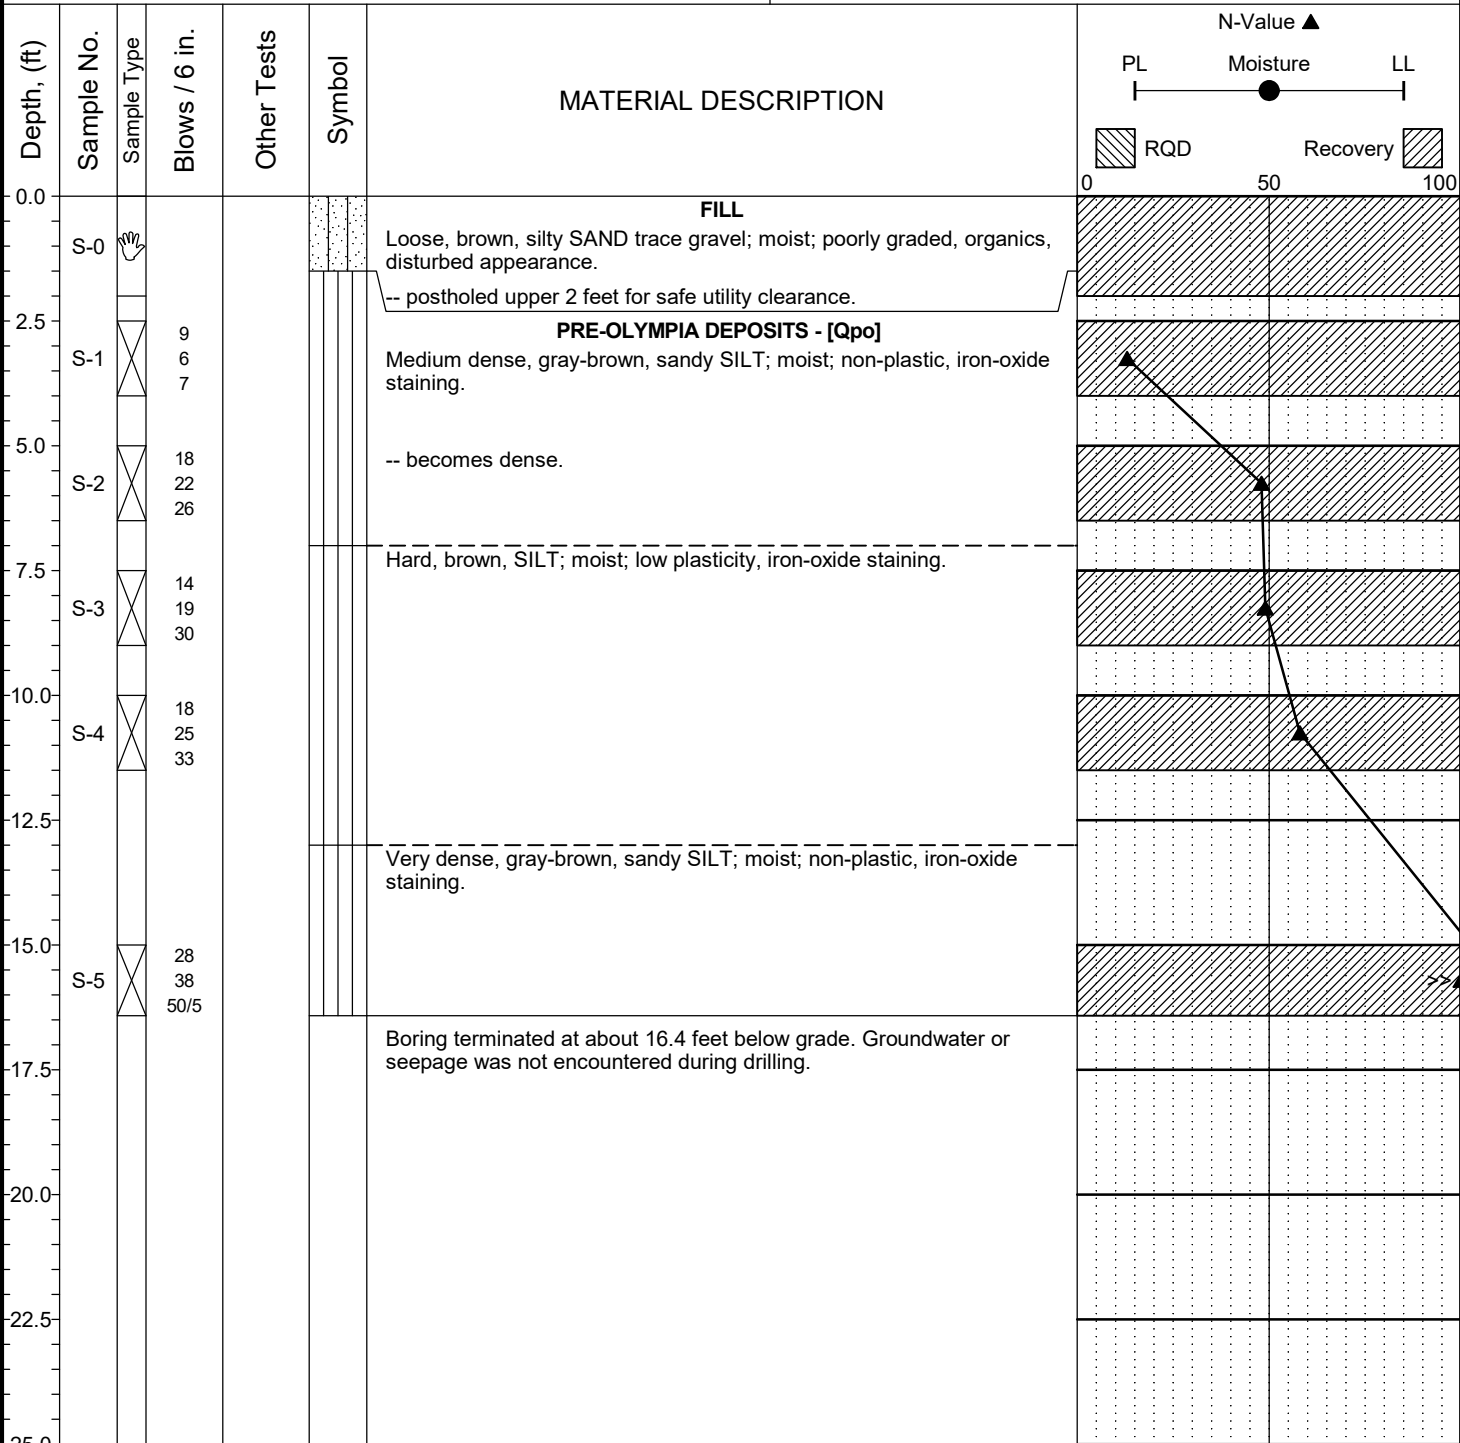
Project:	Proposed House Remodel	Surface Elevation:	176.0ft
Job Number:	25-324	Top of Casing Elev.:	N/A
Location:	4110 - 78th Ave SE, Mercer island, WA	Drilling Method:	HSA
Coordinates:	Northing: 47.5729, Easting: -122.23455	Sampling Method:	SPT

Completion Depth:	16.4ft	Remarks: Borings drilled using a modified Bobcat MT 55 skid steer mini drill rig. Standard penetration test (SPT) sampler driven with a 140 lb. safety hammer. Hammer operated with a rope and cathead mechanism. Surface elevations estimated from Site Plan prepared by H2D Architecture and design dated Sept 1, 2025. <b>Horizontal/Vertical Datum: WGS84/NAVD 88</b>
Date Borehole Started:	9/17/25	
Date Borehole Completed:	9/17/25	
Logged By:	S. Paquet	
Drilling Company:	Geologic Drill Partners
